### MEMORANDUM FOR RECORD

Weather Report – New Smyrna Beach Municipal Airport (EVB), New Smyrna Beach,

Date & Time: October 29, 2014 1420 EDT NTSB Accident Number: ERA15LA039

RE: ERA15LA039 - P-40 Accident

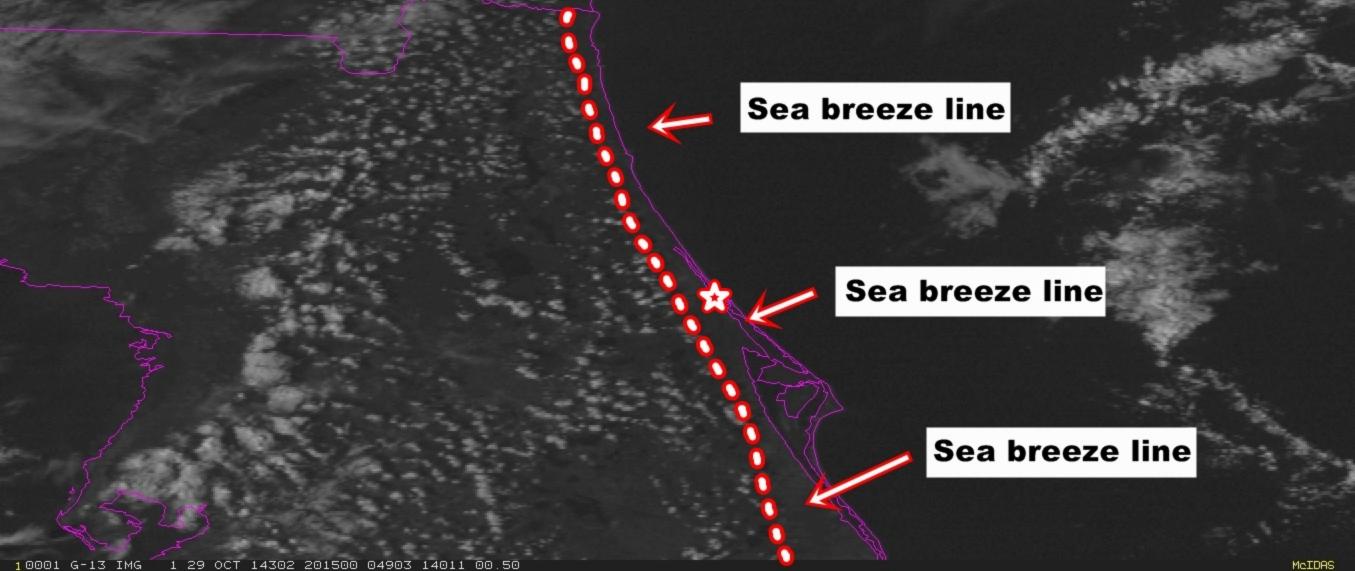
It is likely the wind was more turbulent gusting to 20 knots above the surface. The upper air sounding from 1700 EDT from the accident site also showed downburst possible between 40 and 50 mph with any shower or cloud that was dissipating near the surface (like one would see in the mountain west in the spring through fall time.
