**From:** Eick Donald  
**Sent:** Thursday, July 19, 2012 6:28 AM  
**To:** Jones Patrick  
**Cc:** Lawrence David; Lawrence David; Soper Brian  
**Subject:** WPR12FA305 - Richfield, UT, SR22 accident, N86AA  
**Attachments:** WPR12FA305-IR1730Z.GIF; WPR12FA305-VIS1730Z.GIF; KICX 0.5deg base reflectivity at 1727Z.png

### Weather on July 14, 2012 - WPR12FA305

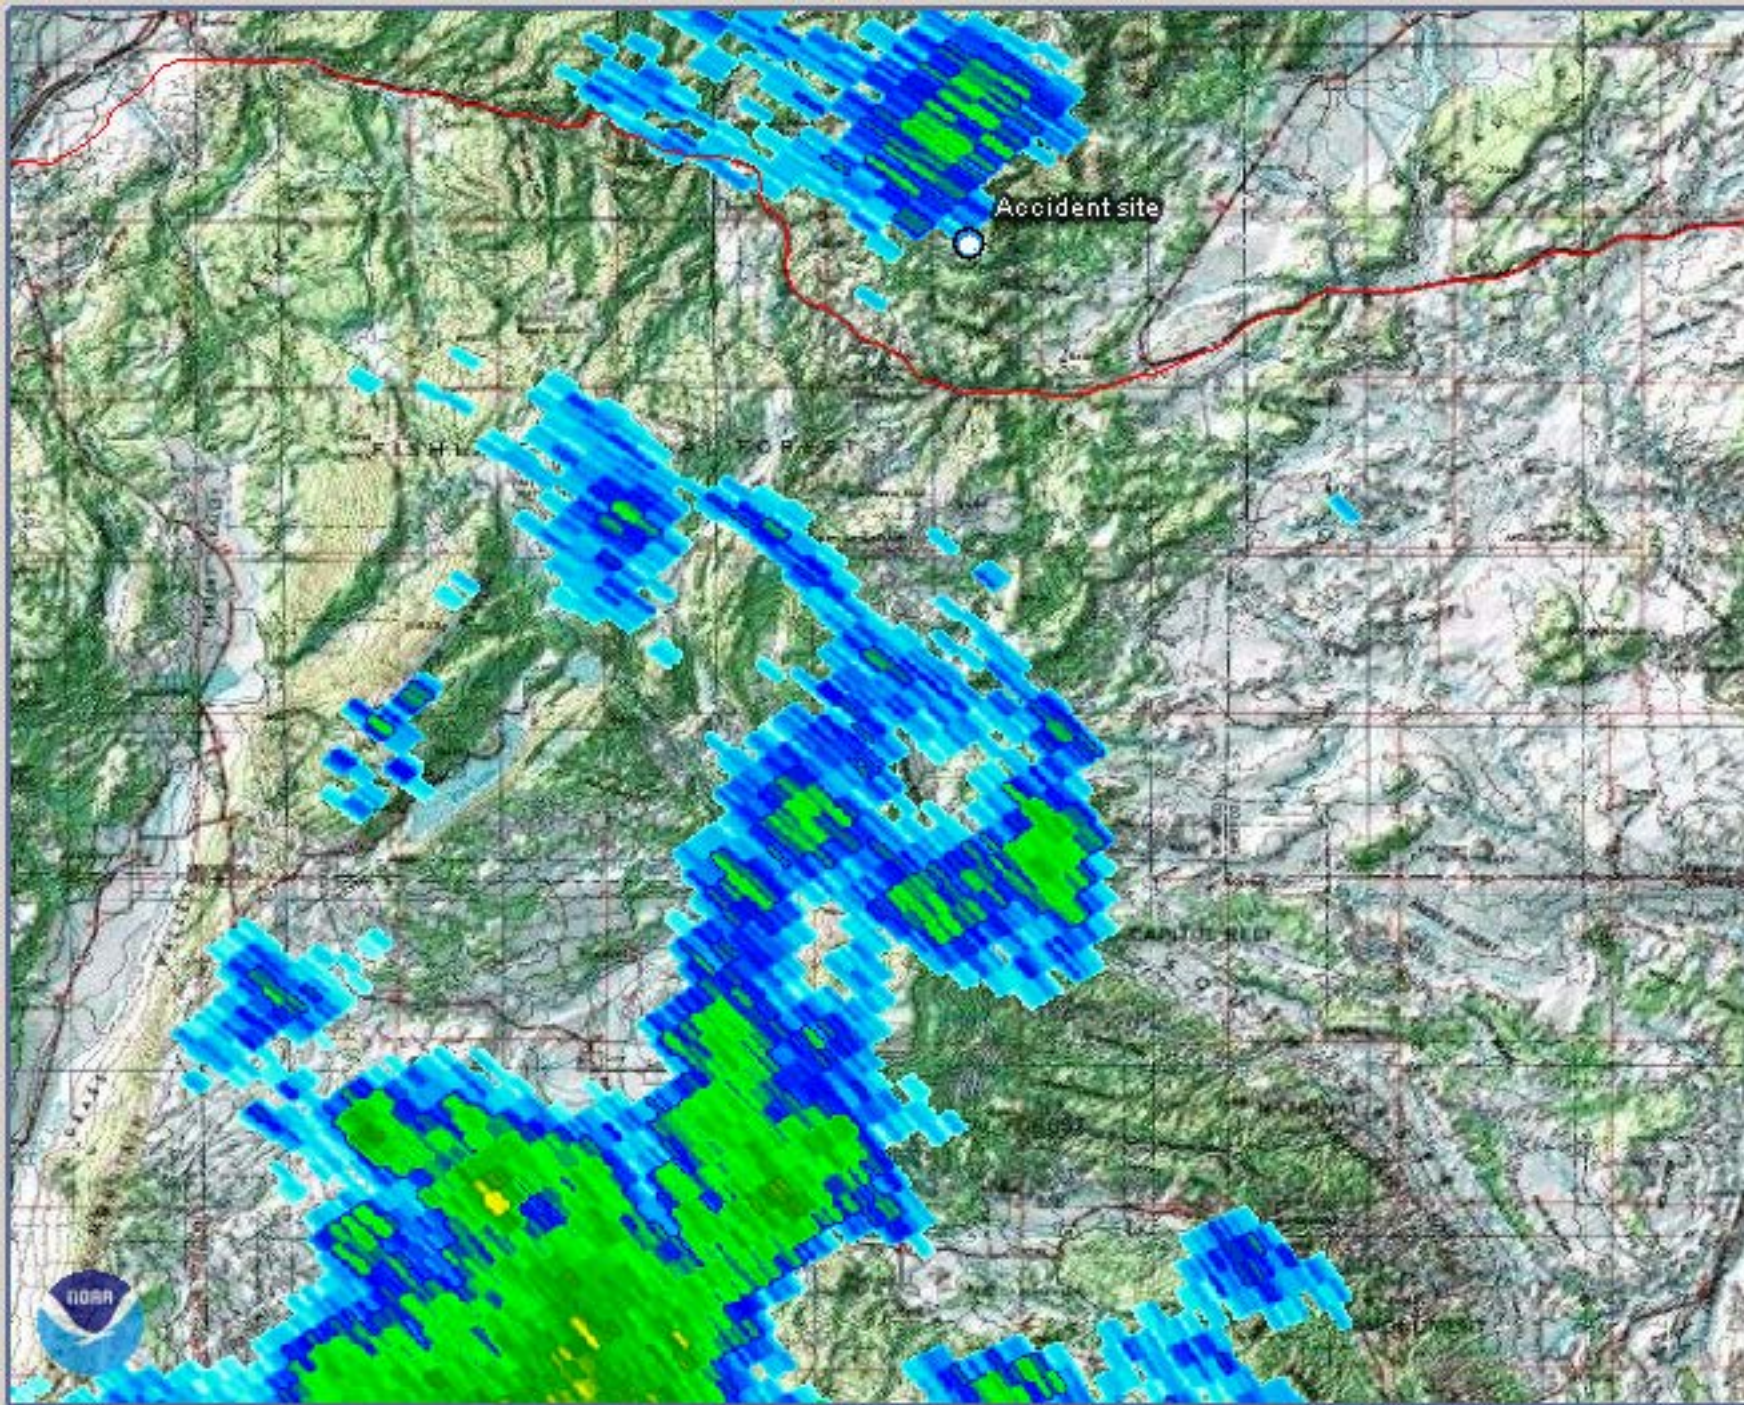
NEXRAD LEVEL-II  
KICX - CEDAR CITY, UT  
07/14/2012 17:27:20 GMT  
LAT: 37/35/27 N  
LON: 112/51/43 W  
ELEV: 10600 FT  
VCP: 212

**Radar Imagery** – The closest NWS WSR-88D was from Cedar City (KICX), Utah, located approximately 100 miles southwest of the accident site or at an azimuth of 42°. Based on the distance from the KICX WSR-88D with an antenna height of 10,757 feet, the center of the 0.5° beam was at 22,685 feet with the base at 17,648 feet and top of the beam at 27,723 feet, with the width of the beam at 10,075 feet. The 0.5 base reflectivity image for 1127 MDT (1727Z) depicted an area of echoes with a maximum reflectivity of 25 to 30 dBZ or light intensity echoes along the flight track with the accident site on the eastern edge of the echoes. The echoes were noted moving northward with time at approximately 20 knots. The echoes were consistent with rain showers and implied that the accident airplane was operating through an area of rain showers immediately prior to the accident site. (image attached)

The radar and satellite imagery depicted convective clouds over the route and the accident site with tops to 27,500 feet, with conditions very similar to what was observed over Bryce Canyon. The radar imagery from Cedar City (KICX), UY, 0.5 degree base reflectivity image was centered at 22,600 feet and depicted very light intensity echoes over the accident site and implied cumulus congestus clouds capable of producing rain showers and reduced visibility.

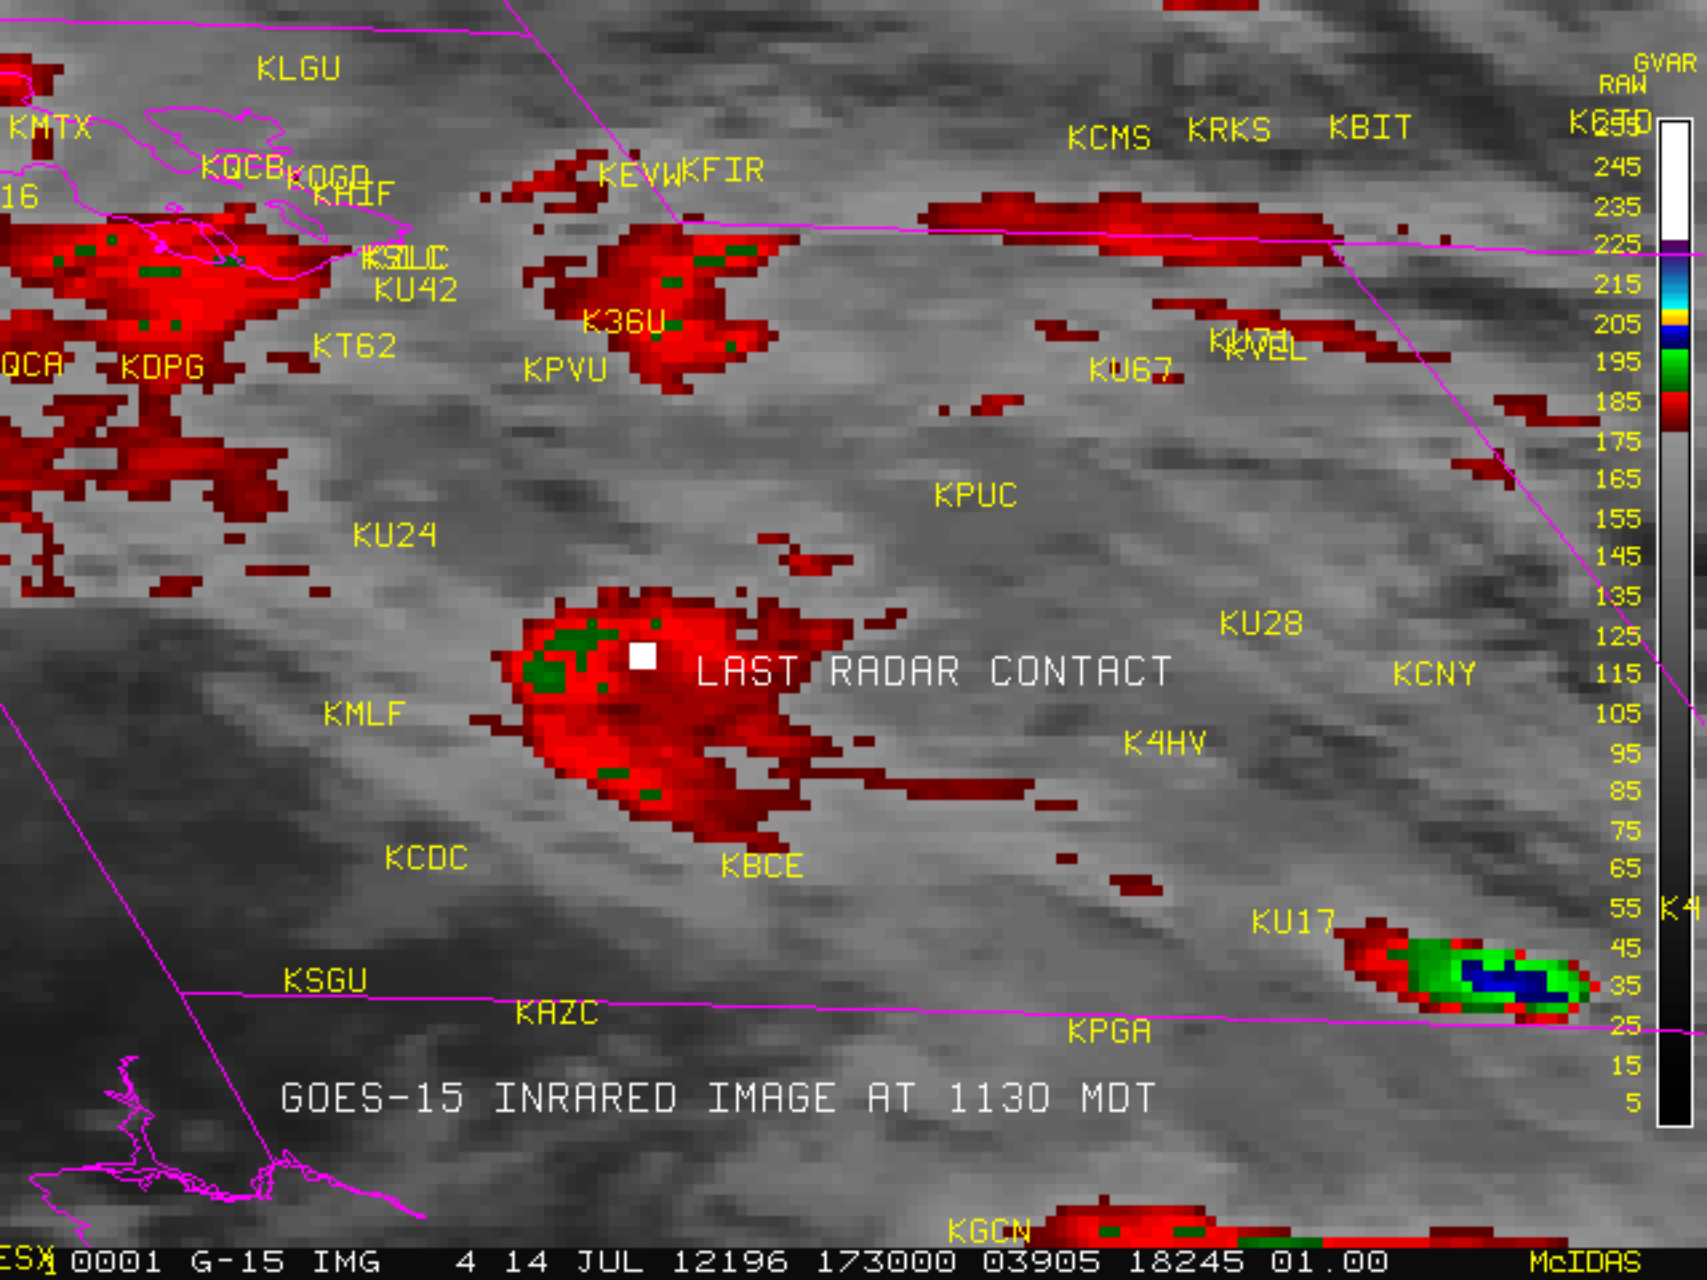
**Satellite Imagery** – the GOES-15 infrared and visible images at 1130 MDT (1730Z) are attached. The images depicted an enhanced area of clouds associated with cumulus congestus type clouds (TCU) with a radiative cloud top temperature of 251° Kelvin or -22.16° Celsius (C), which corresponded to cloud tops near 27,500 feet.
