NATIONAL TRANSPORTATION SAFETY BOARD
Office of Aviation Safety
Washington, DC 20594

Witness Factual Report

Location: Manhattan, New York
Date: October 11, 2006
Time: 1442 Eastern Daylight Time
Aircraft: Cirrus Design SR-20
NTSB Number: DCA07MA003

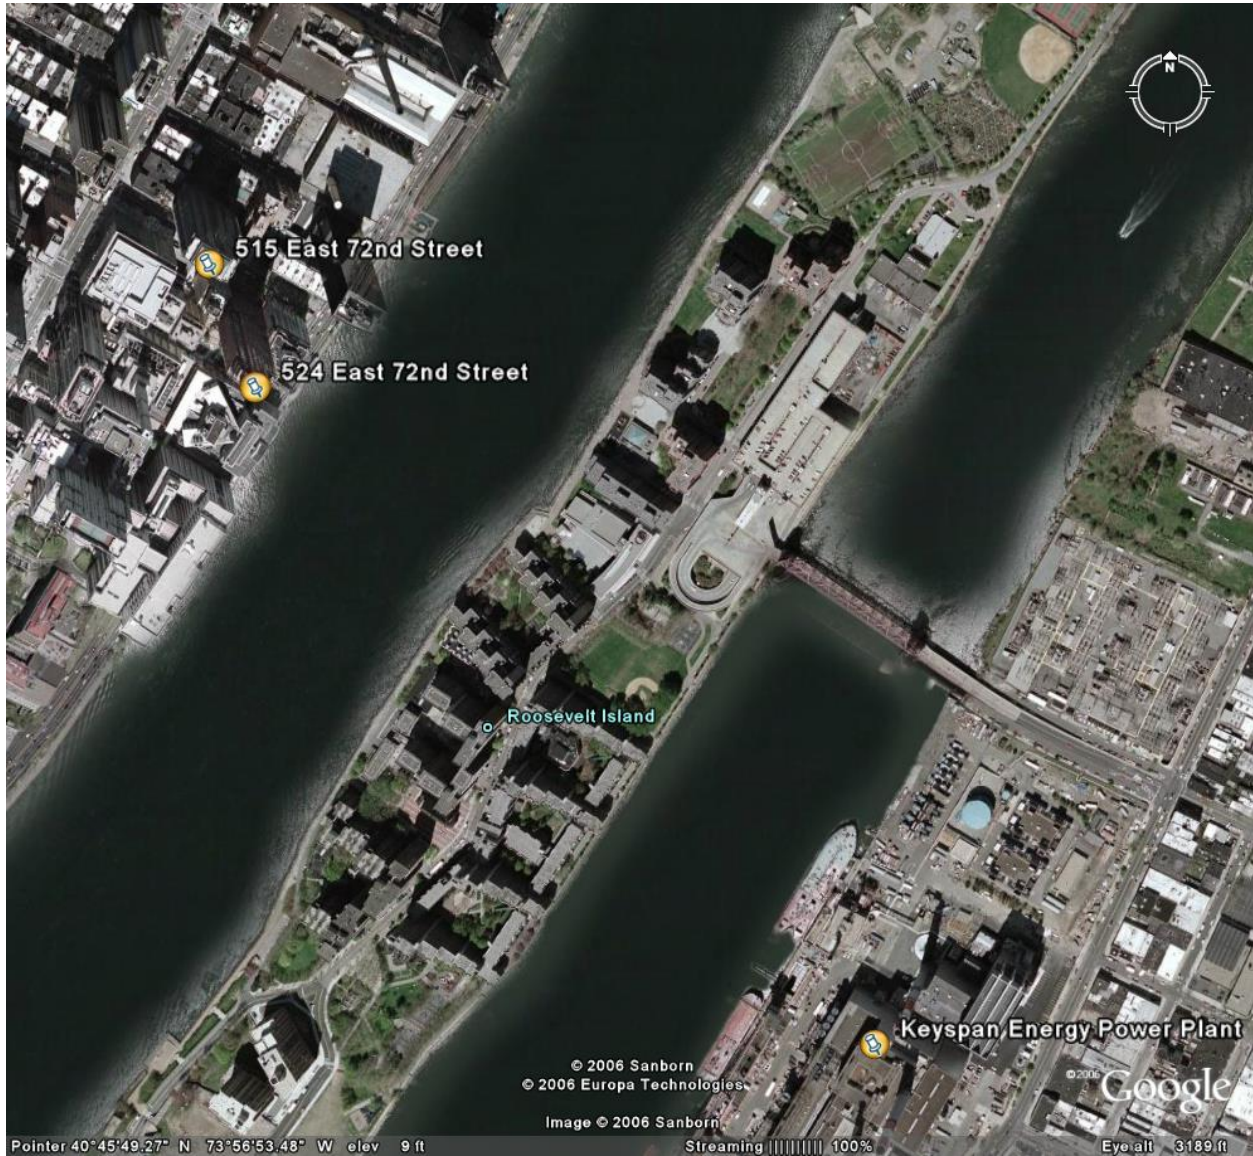
Figure 1: Approximate locations of key eyewitnesses referenced in this report.

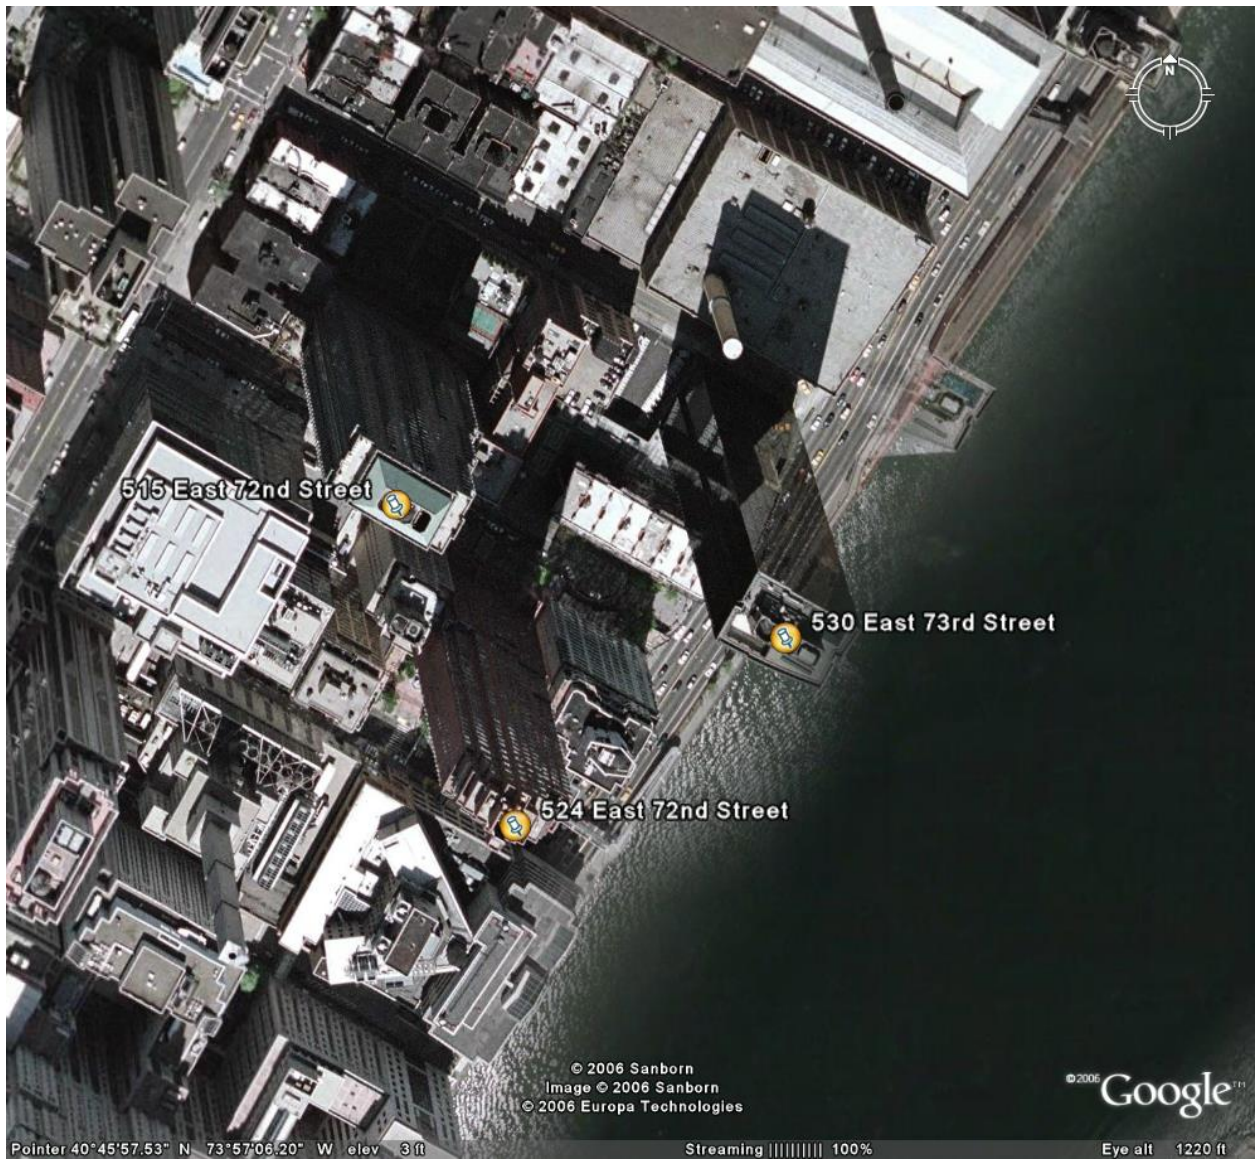
Figure 2: View of buildings surrounding the accident site (524 East 72nd Street).

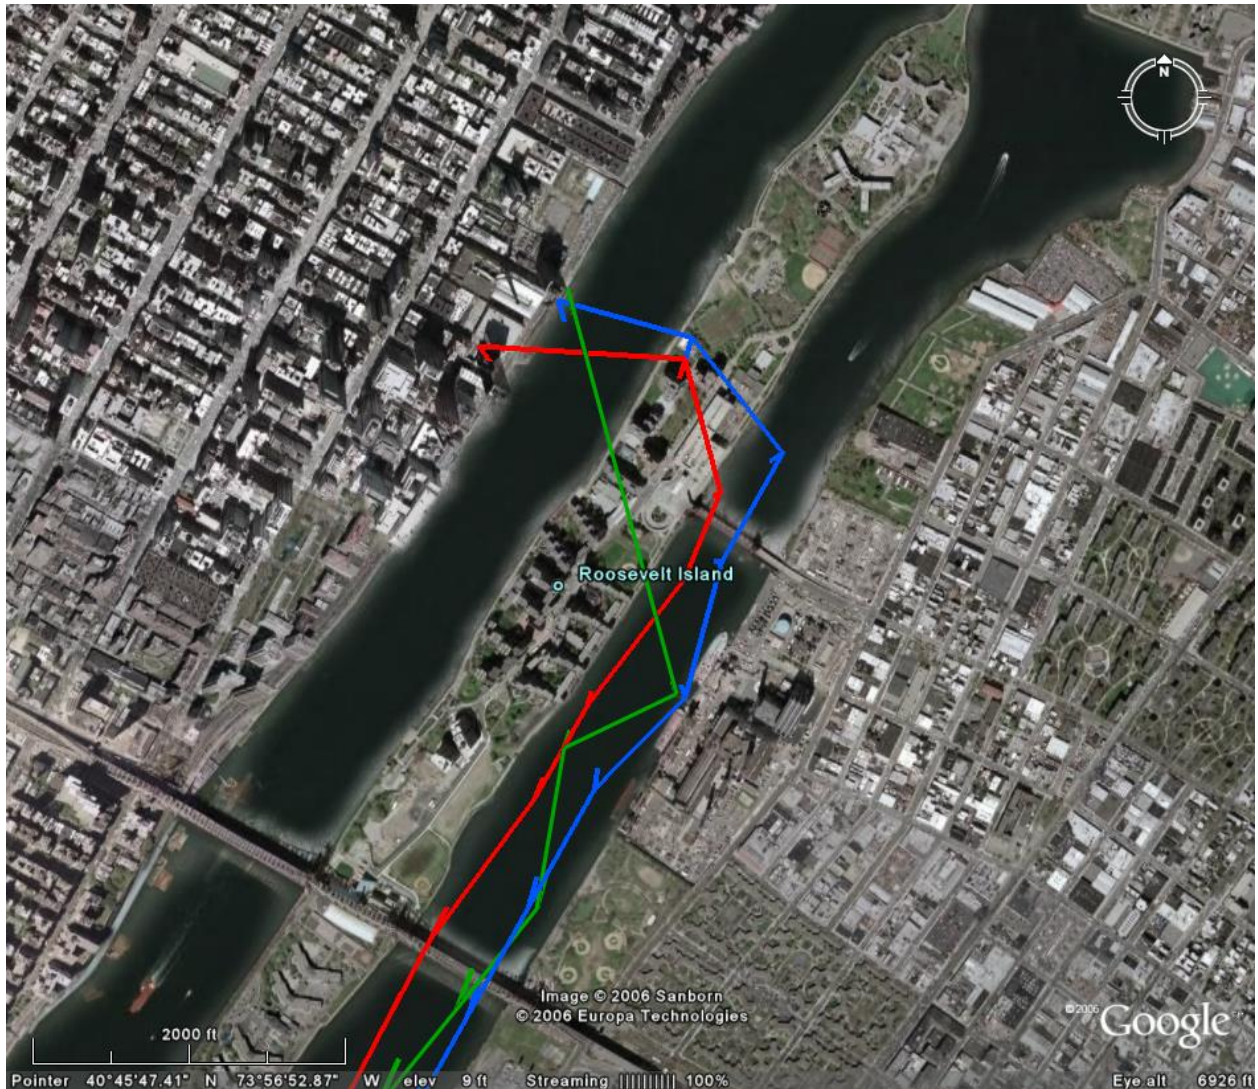
Figure 3: Airplane’s track as viewed by connecting the observed radar targets. Three separate radar sites are plotted. (John F. Kennedy Airport - Red, Newark Liberty Airport – Green, Westchester County Airport - Blue) Please refer to the Aircraft Performance Factual Report contained in the public docket for specific radar and airplane performance information.
