## RECORD OF INTERVIEW

**Date: April 8, 2014**  
**Person(s) Interviewed: Lowell Crandall, Witness**  
**NTSB Case Number: ERA14FA182**

**Date: April 8, 2014**  
**Person(s) Interviewed: John Davis, Witness**  
**NTSB Case Number: ERA14FA182**

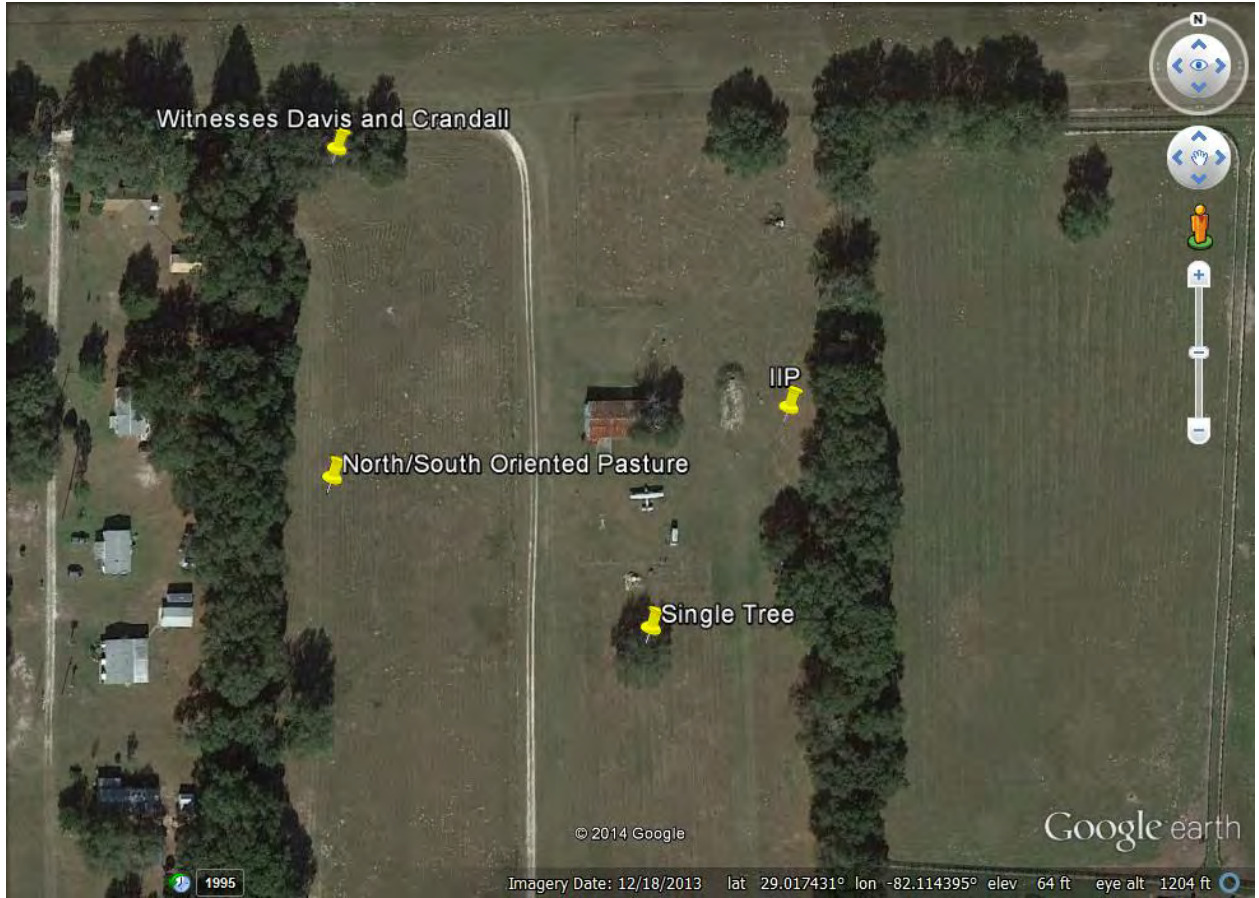
Figure 1 - Witness Location

-During the accident pass, the pilot approached the north/south oriented pasture (see Figure 1) from the north, heading south, parallel with the pasture, at a relatively slow airspeed with the engine "idling." The airplane was positioned about almost overhead of the trees at the west side of the pasture. As the airplane proceeded to a point about 1/3 down the length of the pasture it entered a shallow bank (about 20 degrees) to the left. Simultaneously while banking, the airplane began descending below the height of the trees, as it tracked east. Throughout the turn the bank seemed to remain constant. About 90 degrees into the turn, prior to the airplane reaching the large single tree in the adjacent pasture, the engine power sounded as if it rapidly increased to full for 3 to 4 seconds. As the airplane approached the single tree, the engine power reduced to idle again. The airplane then continued in the turn, descended and impacted the ground.
