4-30-2018

To: Maja Smith, NTSB IIC

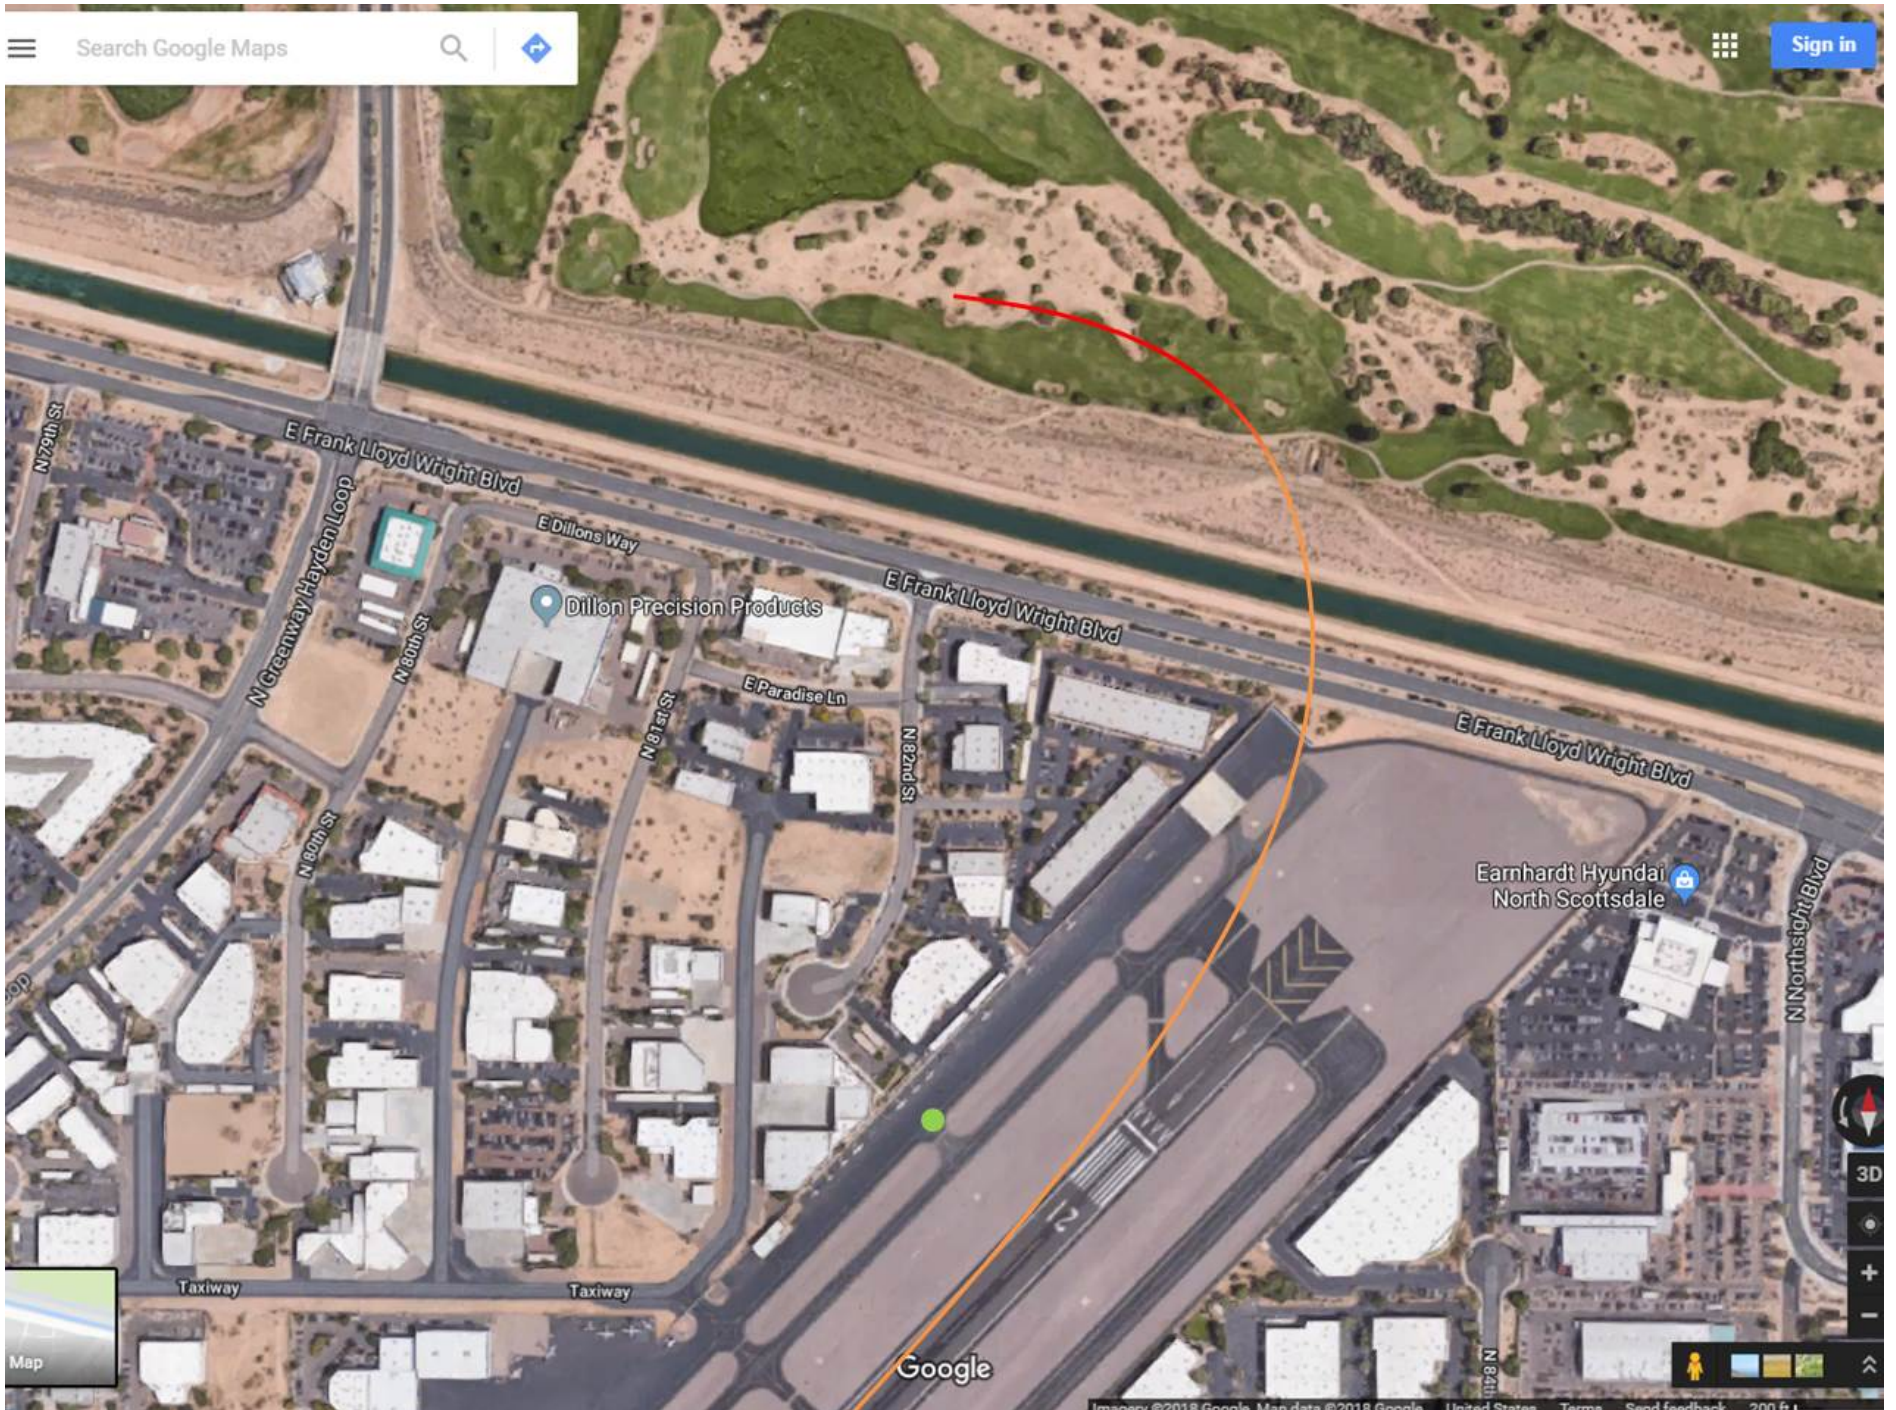
As they flew by I noticed they appeared to drift toward the west side of the runway safety area while at a low altitude. The engine sounded as if it was not completely at full power as other planes have sounded before. I was not sure if it was struggling or if it was just that particular type of engine. It did not sputter or sound rough, nor were there visible smoke, fire or vapors. It was just producing a low tone as if it had lower RPMs.

Before reaching the end of the runway, it started an early left crosswind turn. Continuing in the turn, it started to descend just before disappearing out of sight behind buildings and trees. Hoping and praying they could either gain altitude or land safely, seconds later I heard an explosion and saw the plume of smoke and fire reflecting in the smoke billowing above the nearby rooftops and trees.

The picture below shows the approximate path N9456P took as observed in orange from my position (green dot).
