## RECORD OF CONVERSATION

**Thomas J. Latson, Jr.**  
**Air Safety Investigator**  
**Central Region**

**NTSB Accident Number: CEN13LA409 – N424CT Flight Design CTSW at Taos, NM**

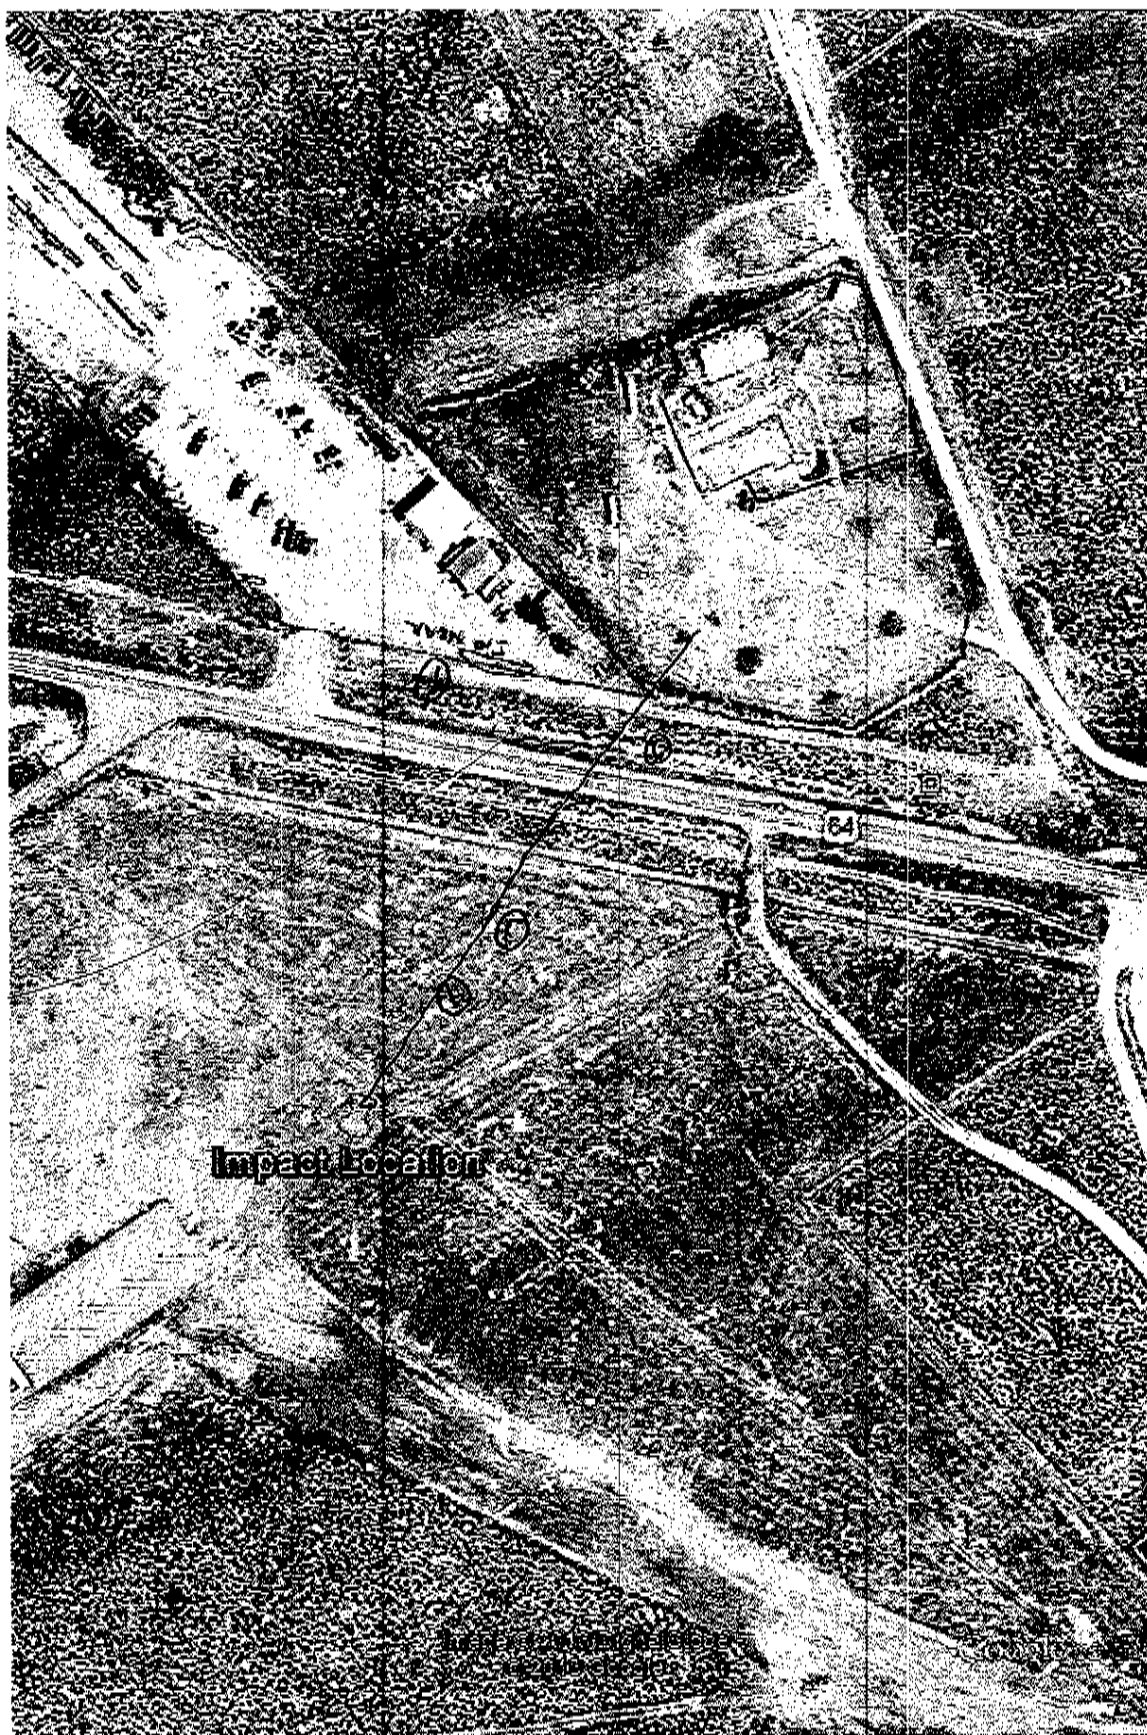
Google earth

I PUNCHED OUT OF WORK AT 11:06 AM  
NUMBER ONE THE MAP MARKS MY LOCATION.

2. I BELIEVE THE AIRPLANE WAS  
APPROX. 80 FEET OFF THE GROUND  
GOING OVER THE FENCES.

3. NUMBER THREE MARKS ABOUT WHERE  
THE PLANE WAS IN TROUBLE.
