INTERVIEW SUMMARY

Elliott Simpson
Aviation Accident Investigator
Western Pacific Region

Interview Date: April 11, 2018
Person Contacted: Briana Carls. [REDACTED]
NTSB Accident Number: WPR18FA119

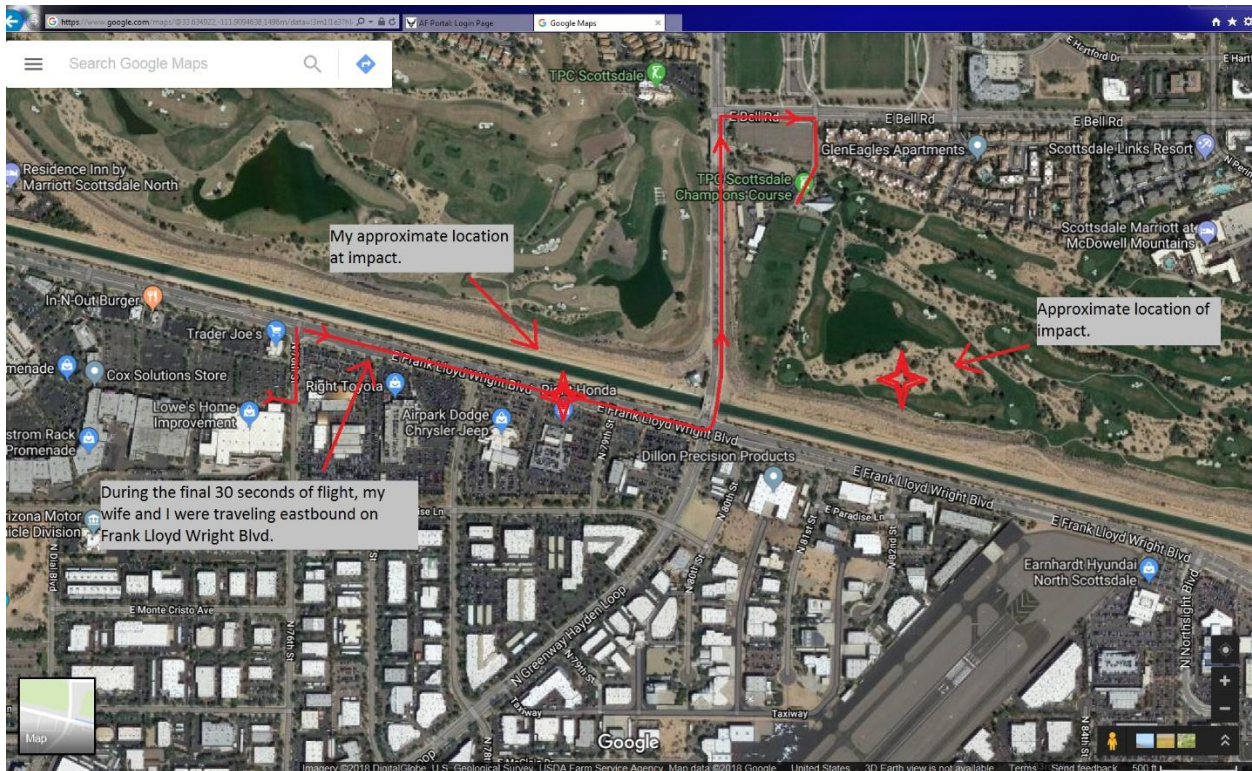
"Here is what I have for my statement. If you have any questions, don't hesitate to reach out. Also, I've attached a picture that describes my location relative to the aircraft impact site which you may find helpful.

On Monday evening, my wife and I were driving eastbound on Frank Lloyd Wright Blvd, east of Lowe's Home Improvement, west of Hayden Road. As we drove east, we identified what we thought to be an airplane. I observed and said, "Look how low that plane is flying." At first glance, I assumed the air traffic was south-flow (that is, landing on Runway 21) and that the lights I saw was an aircraft on final approach for Runway 21. But as we continued eastbound, it became apparent that the aircraft was in fact turning, now pointing west (towards us) in a left hand turn (in what I now understand to be an attempt to return to the airport). In addition to the position lights, I observed two landing lights on each wing, which provided a good picture of the aircraft's attitude as it continued its turn. Because of its low altitude, I continued to watch the aircraft (I was in the passenger seat--my wife was driving). As the aircraft's turn progressed, the angle of bank continued to increase. It passed 45 degrees angle of bank, and continued still until reaching about 70-80 degrees angle of bank. As the bank angle increased, the rate of descent also increased. It was apparent after about 45 degrees angle of bank that the aircraft was in an unrecoverable position. We saw the plane drop behind the trees and dirt embankment, and a second or two later a large fire ball emerged from the crash site.
