INTERVIEW SUMMARY

Elliott Simpson
Aviation Accident Investigator
Western Pacific Region

Interview Date: Aug 14, 2018
Person Contacted: Bob Hinkle [REDACTED]
NTSB Accident Number: WPR18FA218

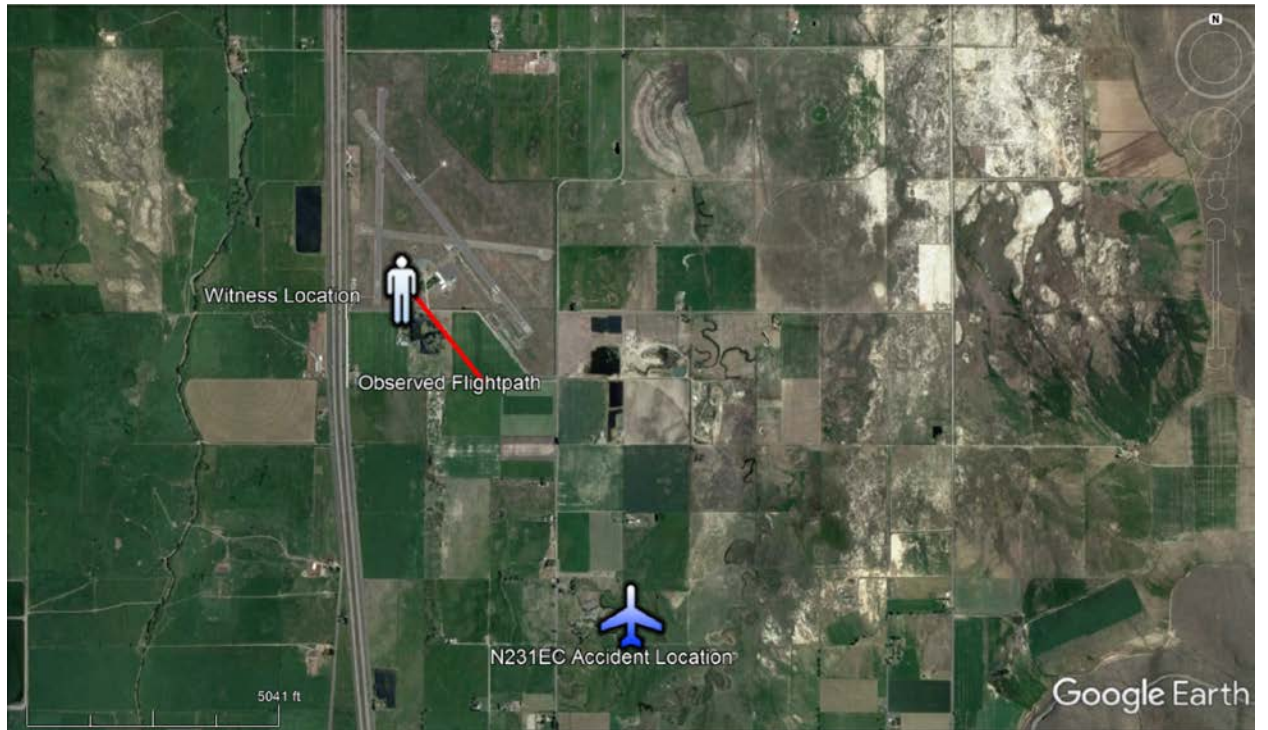
- On the morning of the accident, Mr. Cross was in his hangar, located about 1,300 ft southwest of runway 31 midfield. (see below)
- About 1015, he noticed a low-wing airplane flying directly over the hangar to the south. It caught his attention because it was flying lower than the pattern altitude, between 600 and 700 ft agl. Also, his hangar was well inside the pattern, so the airplane seemed too close to the runway.
