Subject: N262MM, Piper PA-46-500TP, Vero Beach, FL., 04/09/2001			
Digest: <p>He and a friend, Roger Gardner, were on the 15th tee box. They heard an airplane takeoff and turned to watch it. They observed the airplane about 1 mile away, lift off and climb to about 200 feet, heading west. The airplane then made a left turn toward the golf course and he wondered why. He heard a distinct change to lower engine noise at this point. The airplane came toward the golf course and made several course changes. The nose dropped and then pulled up. The airplane cleared one set of trees, but collided with the next set of trees. The propeller was turning. He is a pilot. His friend is not a pilot.</p>

Re: Estate of Leonard Korman, Deceased
Date of Accident: 4/9/01 Vera Beach, Florida
Registration No. N262MM

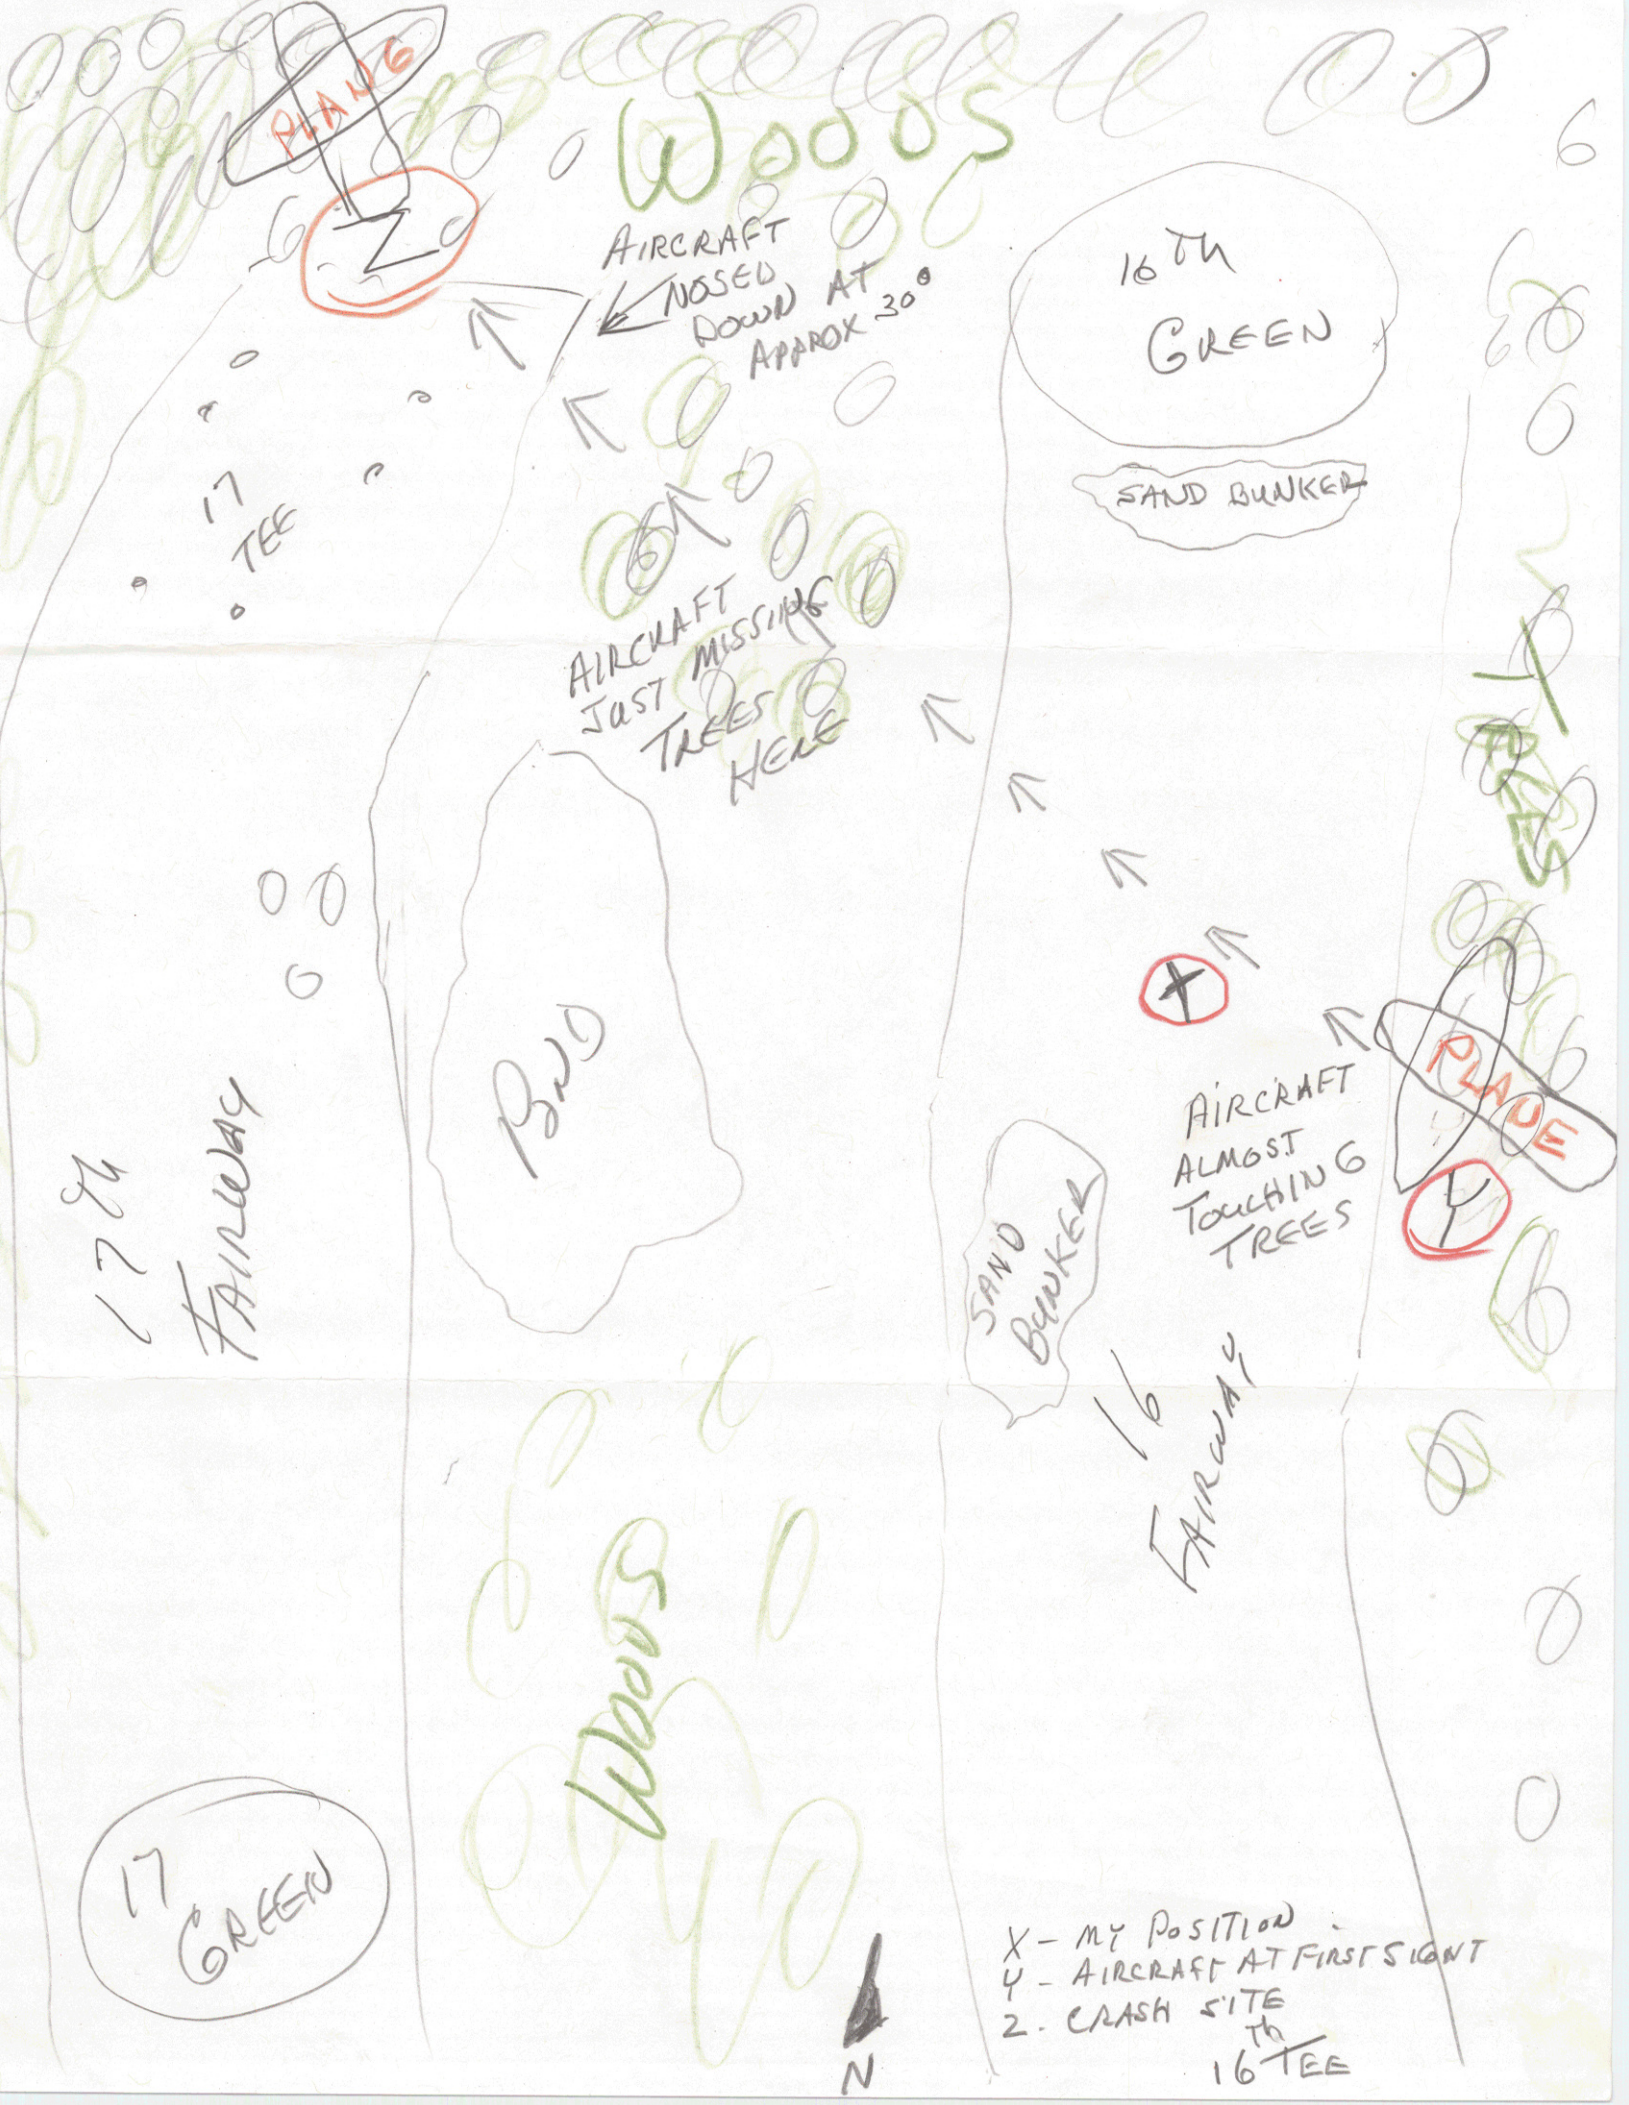
I was standing at point X, see rough sketch, when I first noticed the aircraft at treetop level coming from the West. After passing over the 16th fairway and just clearing the trees between the 16th fairway and the 17th tee box the aircraft nosed down at about 30/35 degrees and struck some large pines 15/20 feet above ground.

Approximately one second after the crash the aircraft burst into flames. The flames were approx. 30ft. wide and 70/80ft high. Bright orange. About 3/4 minutes later there was a small explosion and some black smoke joined the flames.

As the aircraft crossed over My head I noticed the engine was running but at an idle speed, no power what so ever. The landing gears up.

AIRCRAFT
NOSED
DOWN AT
APPROX 30°

AIRCRAFT
JUST MISSING
TREES
HERE

AIRCRAFT
ALMOST
TOUCHING
TREES

X - MY POSITION
Y - AIRCRAFT AT FIRST SIGHT
Z - CRASH SITE
TO
16th TEE

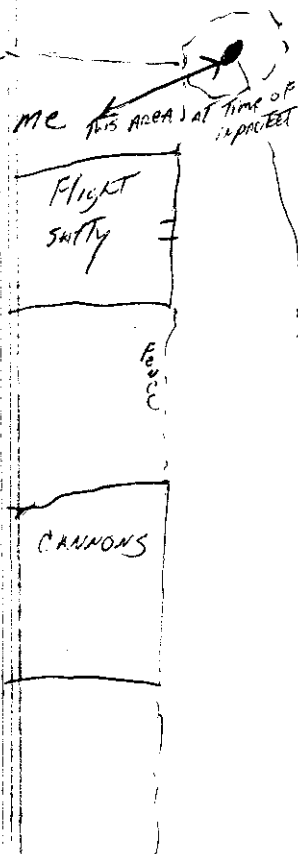
ON The 9th of April 2001 AT ~~12:08~~ ^{12:08} PM I observed
a MARIDIAN AIR CRAFT TAKING OFF FROM THE EAST-WEST
RUNWAY Heading Due West. The AIRCRAFT (A Brownish ^{or Burgundy} ~~to~~
~~and~~ and white.) Took OFF From Vero Beach Airport.
For some reason I Looked at my watch and ~~watched~~
and Listened To The Engine. It sound smooth and steady
but not too loud like it was low on RPMs. The AIRCRAFT
Took OFF and Raised its Landing gear to what seemed
to be a STANDARD TAKE OFF. The AIRCRAFT slowly gained
Altitude To about 350' ^{give or take} ~~maybe~~ if that is

~~Still~~ Still watching The AIRCRAFT
~~But~~ I notice it stopped climbing about ^{455' 105'} ~~to 600'~~
sec. into The flight. The PLAIN started
to ~~be~~ TURN SOUTH SOUTHWEST THEN
SOUTH. IT WAS AT THIS TIME
I Thought There was a problem
The AIRCRAFT wings started
a ~~roll~~ roll ACTION

and started to ~~lose~~ lose
altitude in an uncharacteristic
manner.

W
Run
way

DIRECT
OF
PLAIN
E
