# STATEMENT OF RANDY CLARK ON MISHAP OF 10 MAY 03 AT SALT LAKE, UT

THIS WAS A SCHEDULED FERRY FLIGHT FROM WILLIAMS GATEWAY AIRPORT (K16) IN ARIZONA TO HILL AFB (KHIF) THEN ON TO COLO LAKE, AB (C400).

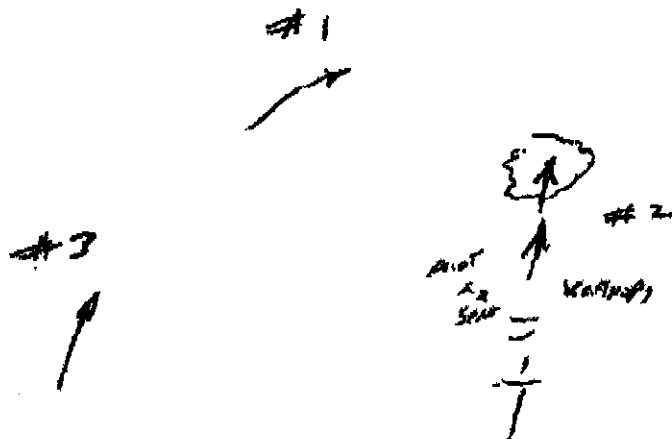
AS WE LEVELLED AT 12000' I TURNED TO LOOK AT #2 (MISHAP AIRCRAFT) AS HE WAS ACTUALLY SLIGHTLY AFT OF MY POSITION AND I WANTED TO PROVIDE ADEQUATE SEPARATION FOR REJOIN. JUST AS I LOOKED AT THE AIRCRAFT, I NOTICED A FAIRLY THICK VAPOR TRAIL (WHITE) EMANATE FROM THE REAR FUSelage OF THE AIRCRAFT AND THEN STOP. DURATION OF THE EVENT WAS LESS THAN 2 SECONDS. I WAS ABOUT TO QUERY THE PILOT ABOUT IT WHEN HE REPORTED,

AS THE AIRCRAFT CONTINUED TO DESCEND, HE REPORTED THAT HE HAD 200 KTS AND 30% RPM. AT THIS POINT HE REPORTS THAT HE'S LOSING FLIGHT CONTROLS, SO HE GOES TO MANUAL. THEN WITH THE AIRCRAFT CONTINUING TO DESCEND AND DECELERATE HE REPORTED, "IT LOOKS LIKE I'M GOING TO HAVE TO GET OUT OF IT."

AT APPROXIMATELY 1000-1200 AGL IT APPEARED THAT HE PULLED THE NOSE UP TO ARREST THE RATE OF DESCENT AND CHANGE THE VECTOR AND ESTABLISHED OVER THE LAKE (N 40° 53' 74" 112° 16' 75") THE AIRCRAFT CONTINUED FOR APPROXIMATELY 500 METERS AND IMPACTED WINGS LEVEL/20° NOSE DOWN.

THE PILOT CAME OUT AFTER CANOPY SEPARATION AND APPEARED TO GO LEFT WITH RESPECT TO THE FLIGHT PATH OF THE AIRCRAFT. I SAW SEAT MAN SEPARATION BEGIN BUT I NEVER SAW A CHUTE OR STREAMER. BOTH SEAT AND PILOT APPEARED TO ~~TURN~~ TUMBLE.

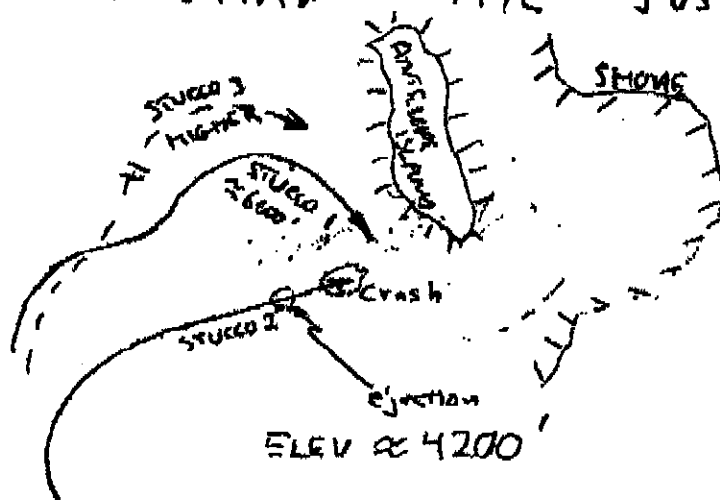
SALT  
LAKE  
CITY

2-3 SEC LATER, NOSE CAME UP,  
CANOPY FIRED / DEPARTED SEAT FIRED.  
FROM 6-7000 FEET <sup>(SLANT RANGE)</sup> AT MISHAP A/C'S  
10:30 TO 11:00 POSITION, AND AT  $\approx$  6000 MSL  
(IN AND OUT OF CLOUDS), MISHAP A/C  
APPEARED TO BE AT APPROX 5500' MSL  
(BROKEN-TO-SCATTERED CLOUD DECK IN  
FRONT AND NORTH OF A/C WAS AT  
5700' -- MISHAP A/C JUST BELOW  
THAT)

CANOPY APPEARED NORMAL  
 SEAT FIRED (BRIGHT FLASH IN COCKPIT)  
 AS SEAT LEFT COCKPIT, IT APPEARED TO VEER  
 LEFT - TO A POINT A LITTLE ABOVE THE  
 TAIL (20-50 FEET) AND LEFT OF THE  
 LEFT WING TIP  
 MAN-SEAT SEPARATION OCCURED JUST ABOVE,  
 AFT, AND LEFT OF THE AIRCRAFT.  
 SEPARATION APPEARED TO BE FAIRLY  
 VIOLENT (UNSTABLE) AND PILOT AND  
 SEAT STAYED VERY CLOSE TOGETHER  
 THROUGHOUT REST OF FREE-FALL.  
 NO CHUTE OBSERVED

AIRCRAFT REMAINED WING'S LEVEL SLOWLY NOSED  
 OVER AND IMPACTED WATER (EST. '20-25 nose low)  
 FIREBALL EXTINGUISHED VERY QUICKLY. IMPACT  
 SW OF ANTELOPE ISLAND (APPROX 150/23 FROM HILL)  
 IN SHALLOW WATER

3-4 SECONDS AFTER A/C IMPACT, CANOPY HIT  
 (APPROX 3000' SW OF CRASH) FOLLOWED BY NEAR  
 SIMULTANEOUS IMPACTS OF PILOT AND SEAT -  
 VERY CLOSE TOGETHER AND CLOSER TO CRASH  
 SITE THAN CANOPY IMPACT.
