WITNESS STATEMENT SYNOPSIS:

NATIONAL TRANSPORTATION SAFETY BOARD

STATEMENT OF WITNESS

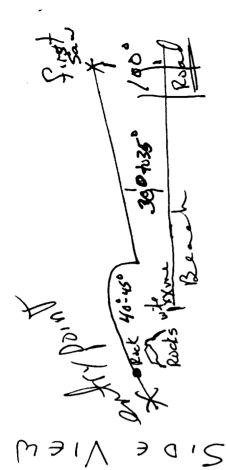
DIAGRAM ON BACK

8. Tell in your own words what you saw or heard of I was an the beach taking a pri West (N.W) and I was facine Sound words ing out as i it. I Looked to the Sou locate the sound and saw headed to the North at at an angle of about pilot though the pring worker a d'trived tora The nose raised a b t and the draging the angle to a aircroft into the worter the Rocks to the right Edg Stalled when the nose was raised.	cture Fast fyou thous so-35 ht hu set ben t bout	sf My WIFE. (se). I head had removed in my right mall ultr t 100 ft in in It appo t the beac he noso of espectingt t 10-15 fe the big roc	SHEWAS FACING rd a motor the load from Shoulder to a light averatt elevation ar ed that the hvice the f the averatt. I backover of caring the et beyond kowteropping. not some ifit
