NATIONAL TRANSPORTATION SAFETY BOARD
Vehicle Recorder Division
Washington, DC 20594

Witness and Onboard Video

Specialist's Factual Report
By Bill Tuccio, Ph.D.

Location:	San Juan, Puerto Rico
Date:	July 4, 2017
Aircraft:	Piper PA-28-180, N9427J
Operator:	Horizon Aviation
NTSB Number:	ERA17LA227

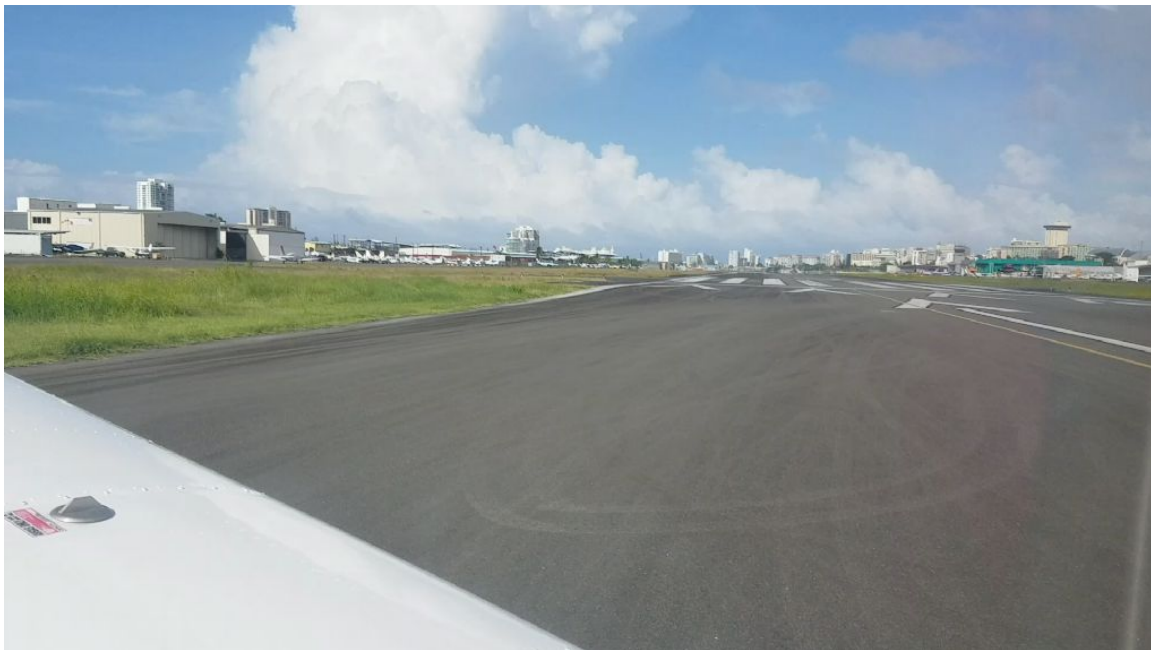
At 00:00:00, the airplane was entering the runway, about to start takeoff roll, as seen in figure 1. Visibility was greater than 10 miles, with scattered clouds. Background noise was loud. Later in the video it was evident the video was being taken by the passenger in the rear left seat and the pilot window was open throughout the recording, causing variations in microphone noise. The left fuel cap was in place and no fluid was leaking from it.

Figure 1. Image at start of video, 00:00:00 onboard video elapsed time.

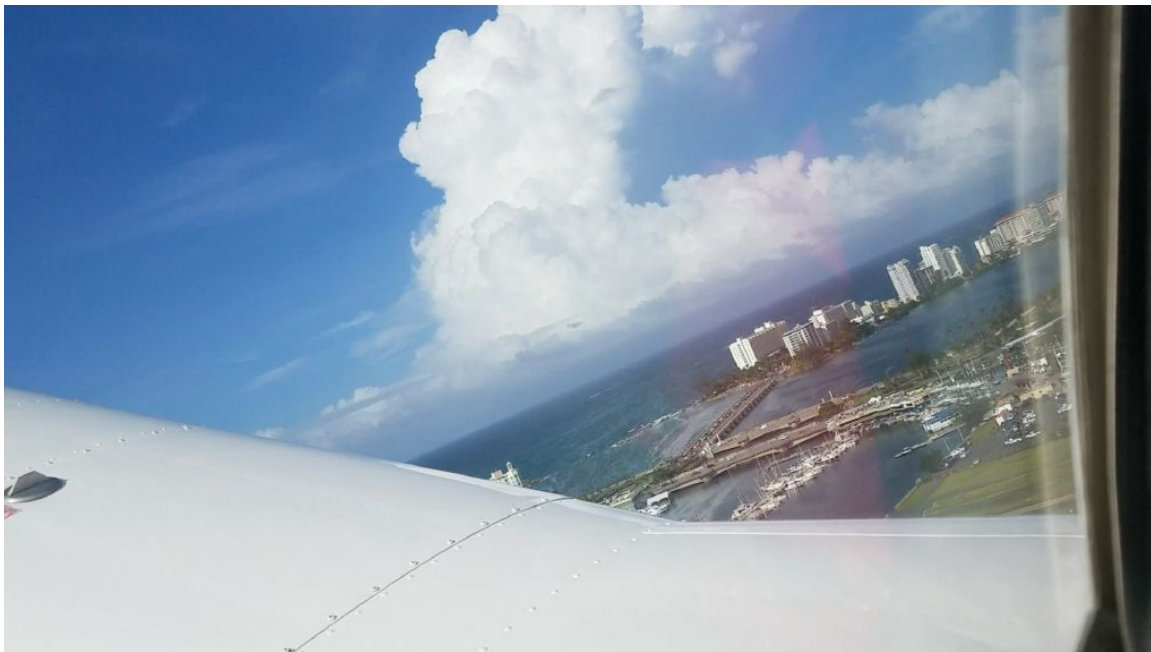
At 00:01:16.3, the airplane rolled slightly right, as shown in figure 2. Prior to this time, the airplane roll (bank angle) had been essentially level.

Figure 2. Image at 00:01:16.3 onboard video elapsed time.

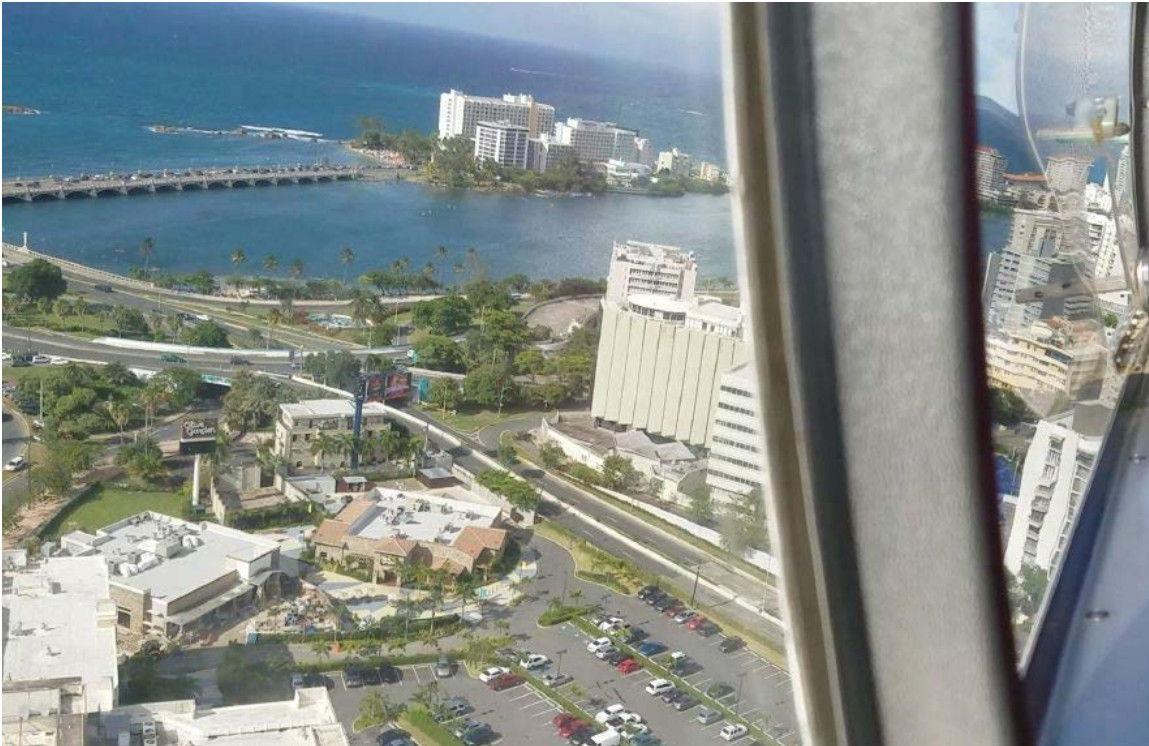
Figure 3 shows the aircraft left bank angle at 00:01:32.2, which had increased from 00:01:30.8. The right side of the image is cropped to eliminate a view of the interior occupants.

Figure 3. Image at 00:01:32.2 onboard video elapsed time.

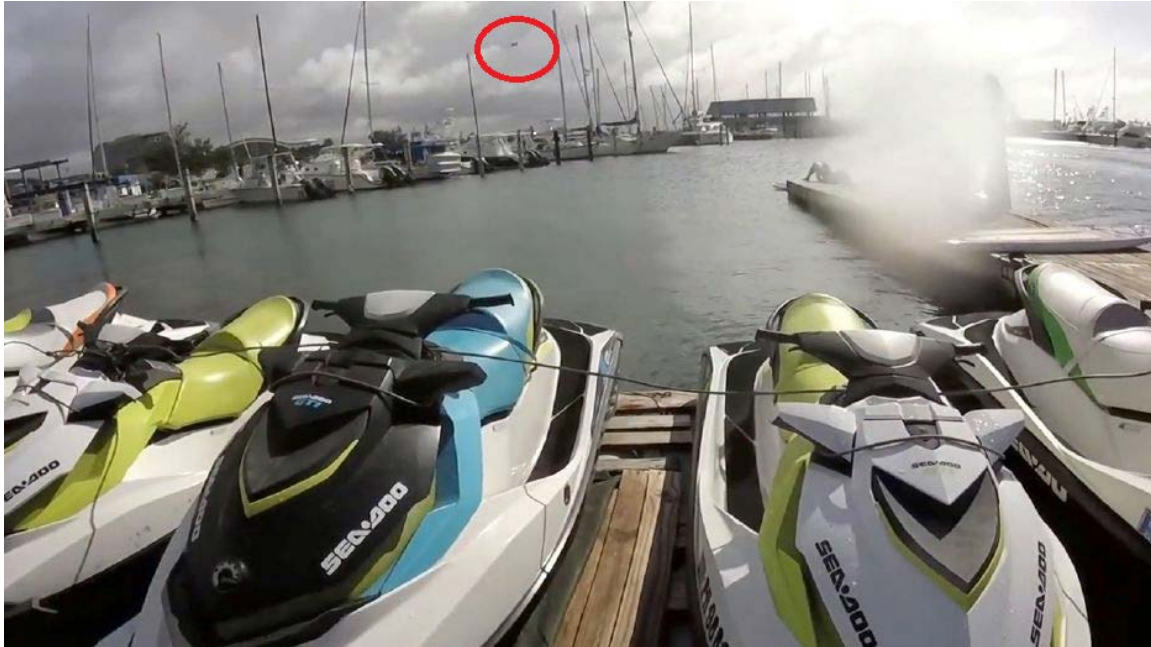
At 00:00:15.3, the accident airplane was visible in the video (see figure 4), flying level in roll (climb/descent/pitch was not discernable), and the airplane's engine noise was faintly recorded.

Figure 4. Witness video at 00:00:15.3 (annotated).

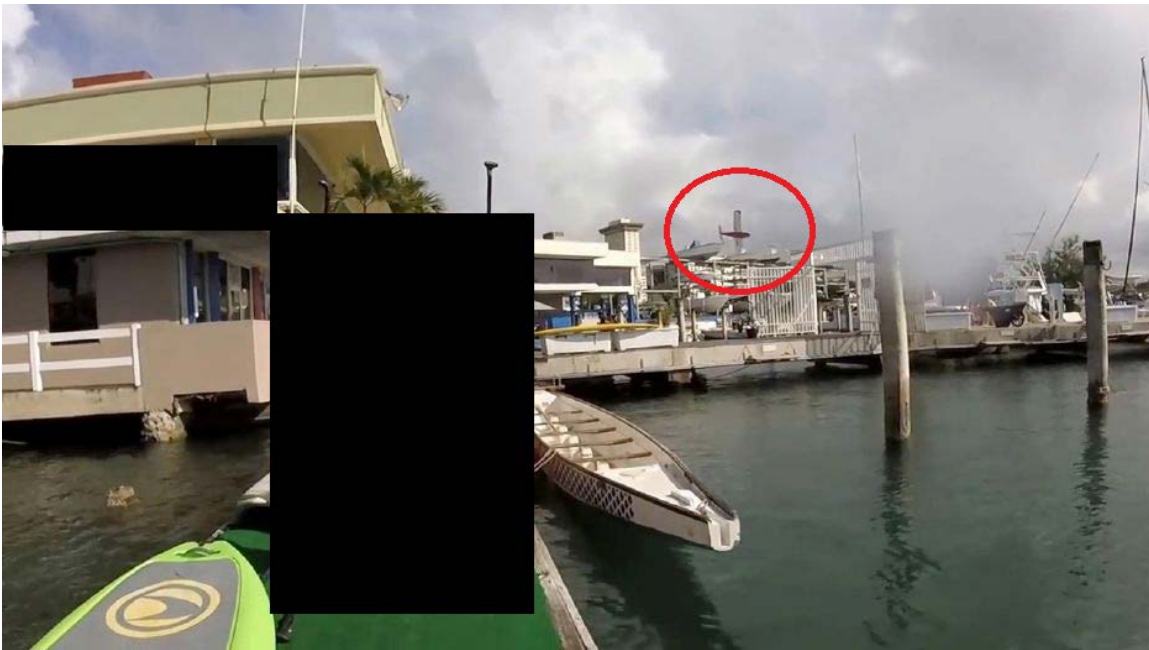
By 00:00:41.5, the airplane's bank was about 45 degrees left and the pitch was slightly nose down, as shown in figure 5.

Figure 5. Witness video at 00:00:41.5 (annotated and redacted).

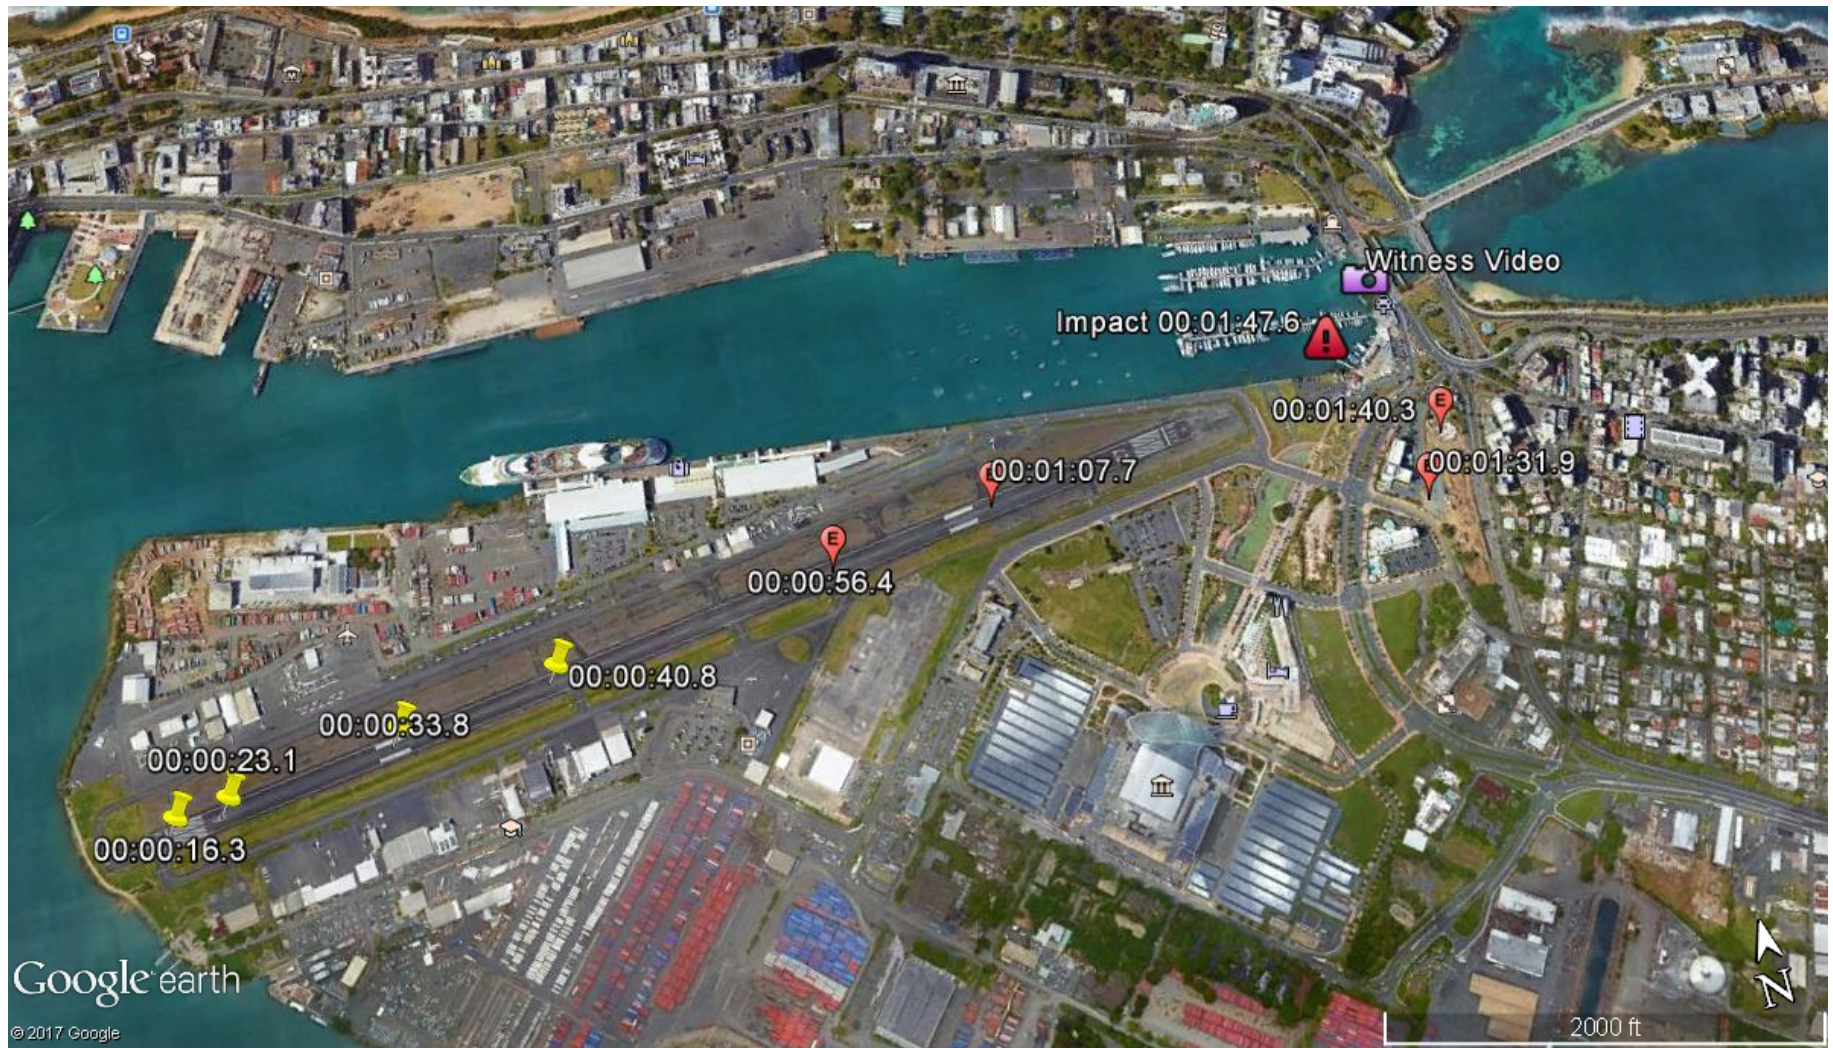
Figure A-1 shows points along the aircraft path, in onboard video elapsed time, produced in Google Earth. The yellow pin markers (📌), show precise measures of aircraft position; the red “e” markers (📍) show approximate positions; and the remaining markers show the approximate location of the witness video and impact point.

Figure A-1. Aircraft trajectory points in onboard video elapsed time.
