CUSTOMER <b>HONEYWELL ENGINES &amp; SYSTEMS</b>		INVESTIGATION NO <b>1048953</b>	
CUSTOMER ORDER <b>NONE</b>	WOODWARD SALES ORDER <b>2985386</b>	WOODWARD WORK ORDER <b>8057566</b>	
CUSTOMER REJECTION DOCUMENT (CAR, QN, RFA, DMR, ETC.) <b>N/A</b>		WARRANTY DISPOSITION <b>N/A</b>	PRODUCT DISPOSITION <b>N/A</b>
PROGRAM/ENGINE TYPE <b>N/A</b>		ITEM RECEIVED <b>210739</b>	ENGINE MFR MODEL RECEIVED <b>N/A</b>
PROGRAM CODE <b>83344 SML</b>	SERIAL NUMBER <b>1434485</b>	ITEM SHIPPED <b>210739</b>	ENGINE MFR MODEL SHIPPED <b>N/A</b>
PARENT ITEM NUMBER <b>210739</b>	PARENT ITEM SERIAL NUMBER <b>1434485</b>	FIRST SHIPPED <b>N/A</b>	LAST SHIPPED <b>N/A</b>
CUSTOMER SERIAL NUMBER <b>N/A</b>	APPLICATION <b>TPE331</b>	VESSEL TYPE & VESSEL NUMBER <b>Cessna 441, N48BS</b>	SITE & LOCATION GRID ID <b>N/A</b>
TIME/CYCLES SINCE NEW, OVERHAUL, OR REPAIR <b>N/A</b>			
DATE REPORT OPENED <b>27-AUG-2012</b>		DATE PART REMOVED <b>N/A</b>	DATE RECEIVED <b>21-JUN-2012</b>

Reported Problem: UNIT WAS REPORTEDLY INVOLVED IN AN ACCIDENT ON DEC 22, 2011 IN NASHVILLE PA JUST AFTER FINAL APPROACH (Right engine, actuator serial number 1-08665-143)

**MATERIALS LABORATORY  
INVESTIGATION REPORT**

**PART OR MATERIAL:*

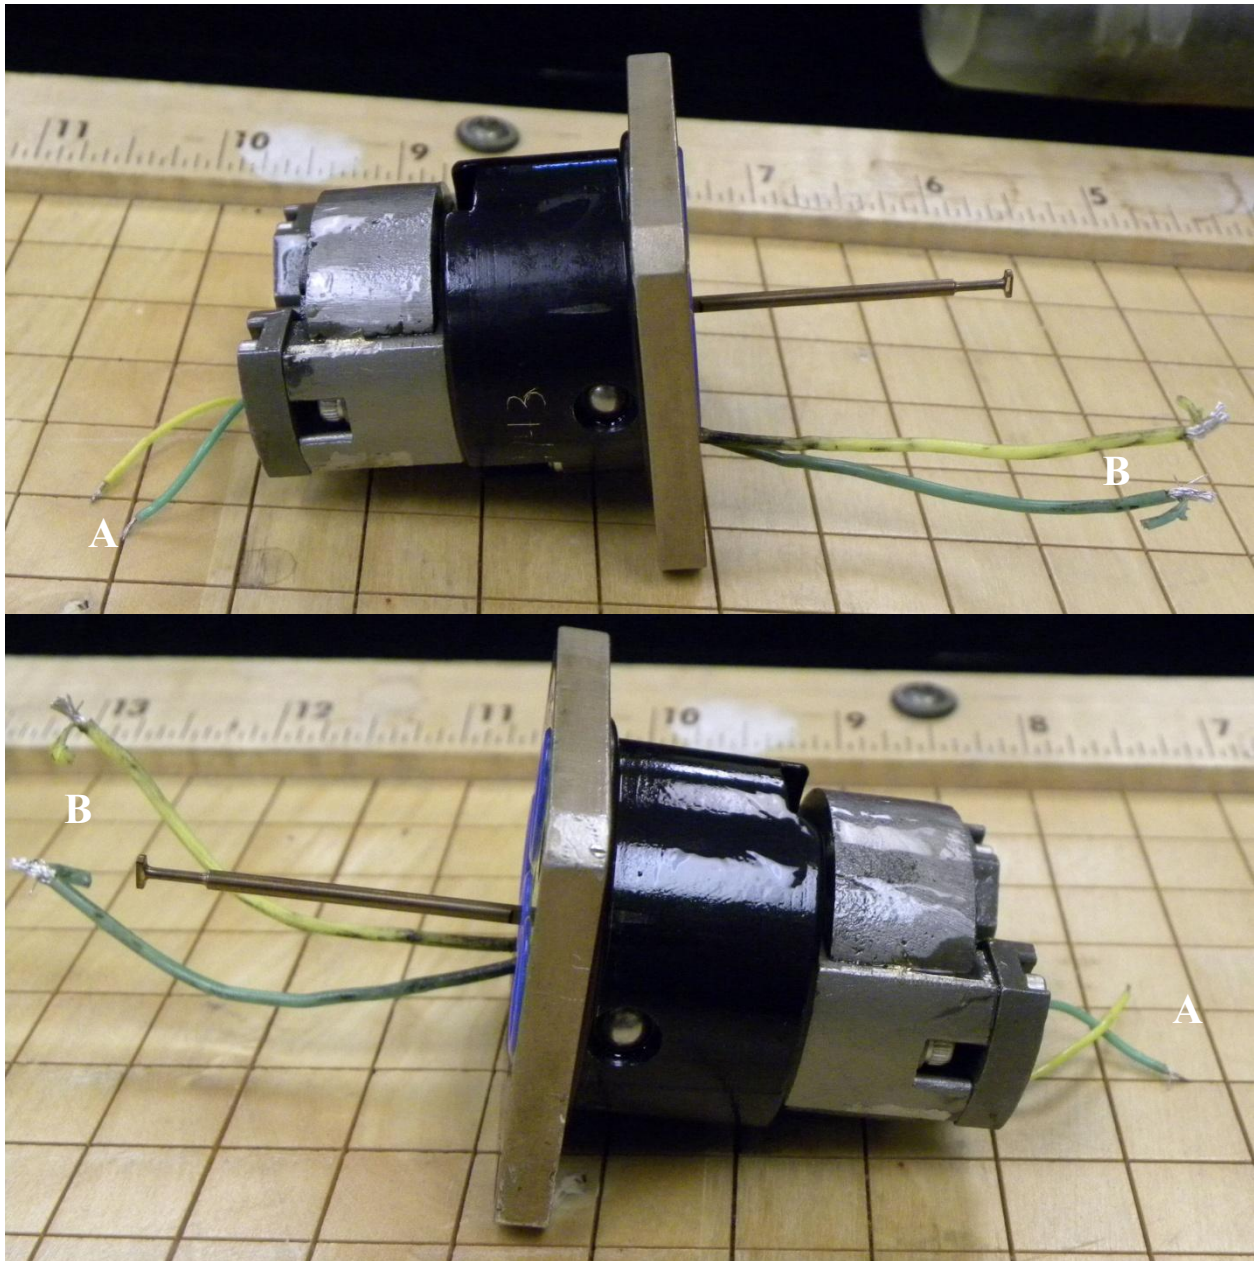
The Servoactuator, as-received had already been partially disassembled. The cover had been removed and the lead wires from the coil to the connector and from the connector to the external lead wires had already been cut (see figure 1). The coil, the connector wires, and the external lead wires were all checked and found to have continuity. Next all the lead wires and connections were carefully examined for damage other than what had occurred when the wires were sliced. All were as expected, with the lead wires showing clear indications of having been sliced (see figure 2 for a representative example), except for the green lead wire attached to the coil. Two of the wires were broken off well below the rest of the wires in the bundle (see figure 3).

**Figure 1. The partially disassembled servoactuator, P/N 100380-7, as-received. The wires labeled A are the lead wires from the coil, while the wires labeled B are from the connector.**

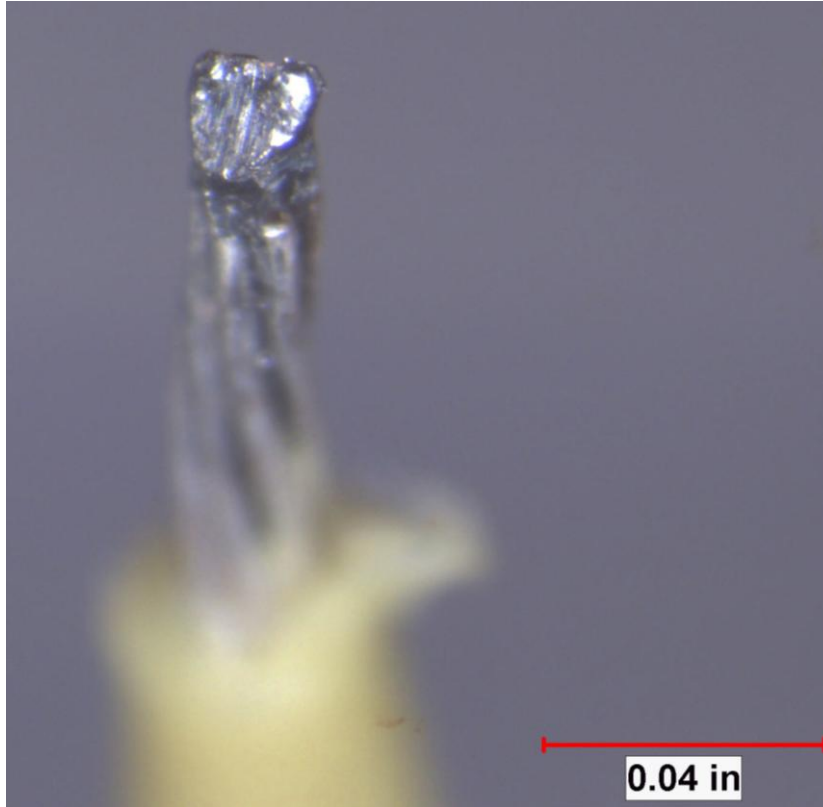
**Figure 2.**

**The yellow lead wire from the coil. This image shows the typical “sliced” structure demonstrated by all of the cut wires of the servoactuator.**

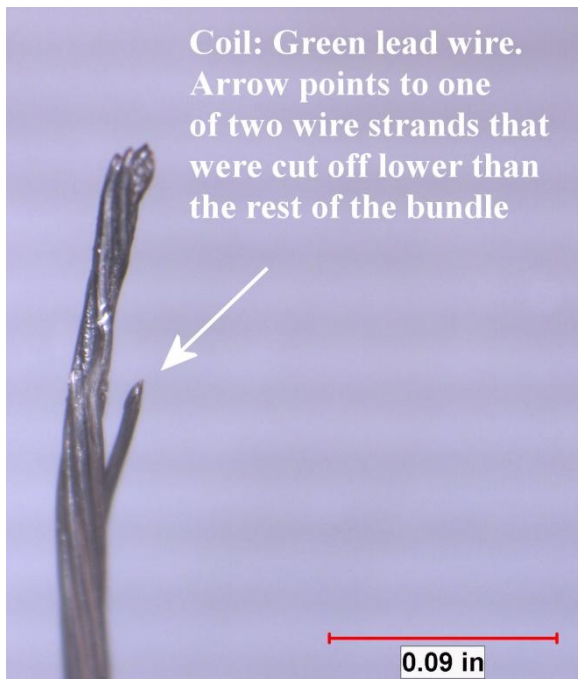
**Figure 3.**

After testing the various lead wires of the servoactuator and finding all had continuity and then examining the wires, where they had been cut, no reason for an open circuit was found. Only one set of lead wires, the green wire from the coil showed any abnormalities. Those consisted of two of the wires, fractured below the rest of the bundle. But while this may have resulted in increased resistance in the lead wire, it should not have registered as an open circuit.

**The green lead wire from the coil. This was the only cut wire that demonstrated any irregularities in the cut surface.**

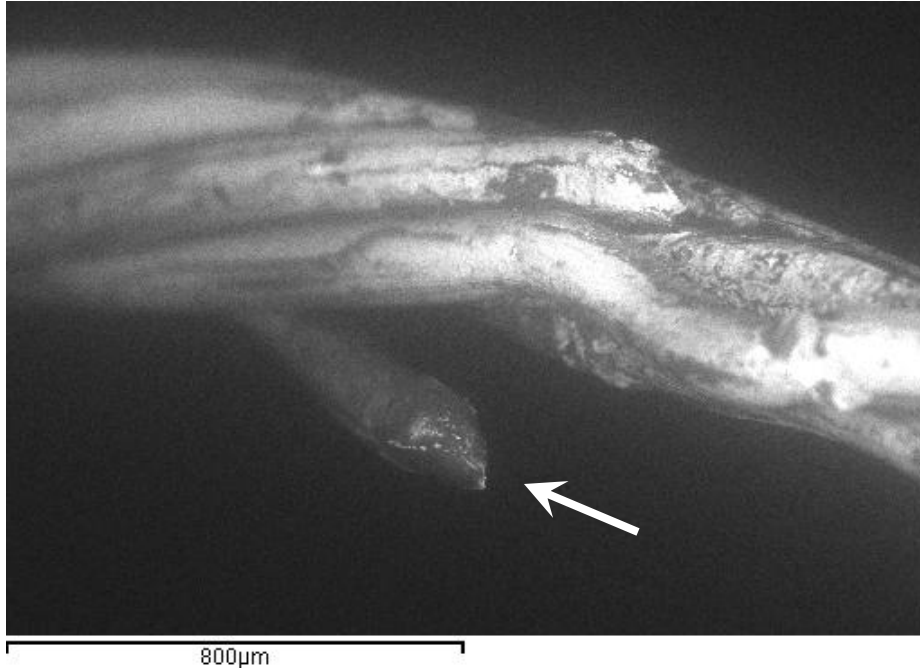
The servo valve was further disassembled and the coil removed. The coil was placed into the scanning electron microscope (SEM), so the green lead wire could be examined in more detail. The majority of the wires in the bundle show signs of having been cut (see figure 4), as shown by the angled surface and the smearing of the silver plating over the surface. But two of the wires from the bundle were separated at a level below the rest (as was shown in figure 3). When those were examined in the SEM, they had a more "cone" shaped fracture (see figure 5). This is more typical of a tensile overload and may indicate that the two wires from the bundle had separated before the rest of the wires were cut.

**Figure 4. SEM image of the wire (arrow) from the green coil that was not cut at the same place as the rest of the wires. The cone shape to the fracture, indicates it likely failed due to overload.**

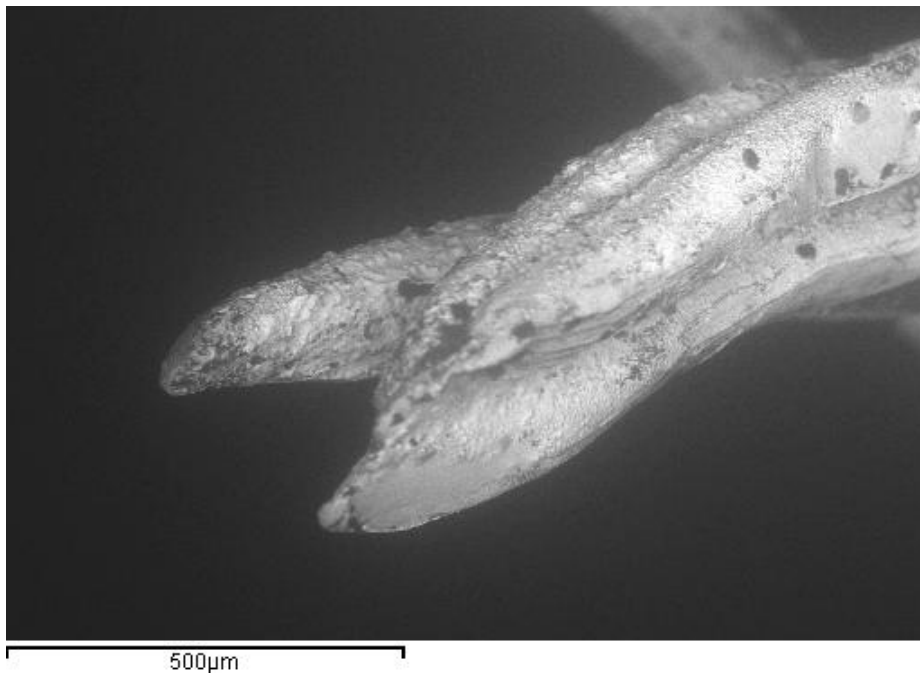
**Figure 5. The other wires from the green coil leadwire. They're fracture surfaces are smooth and inclined at an angle, typical of a cut and/or slice.**

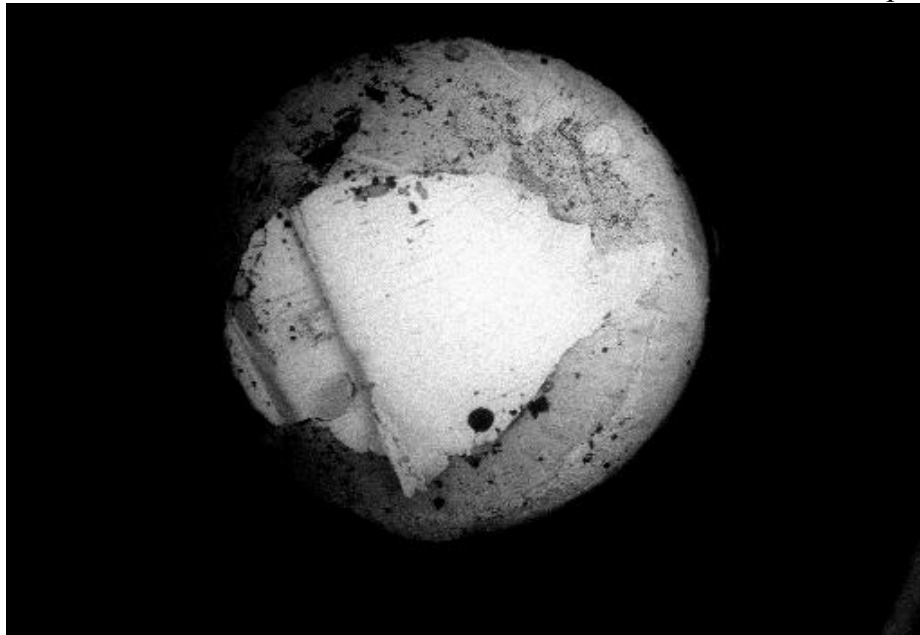
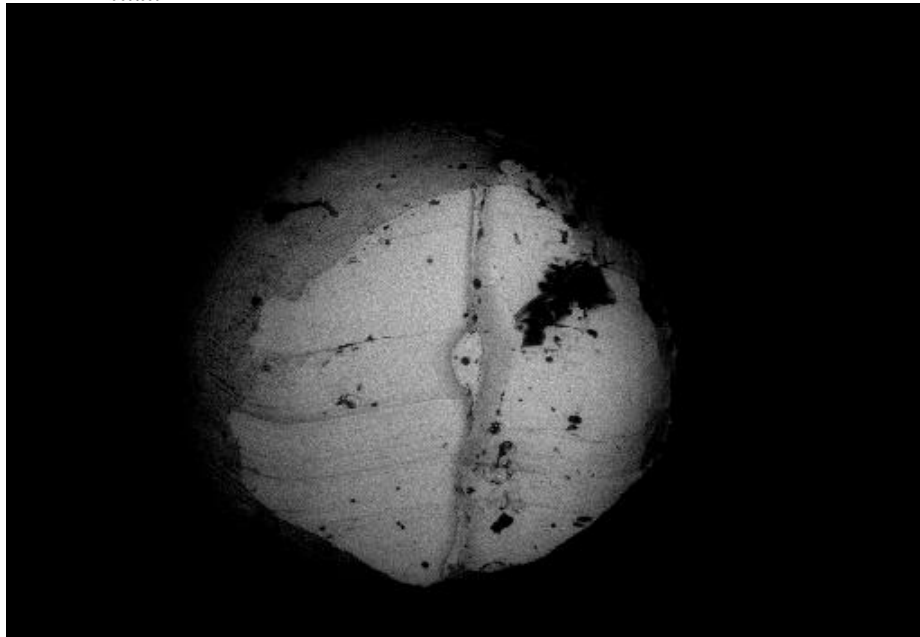
Finally the connector was placed in the SEM and the solder joints at the cut examined. As with the lead wires, it appears that the wires were separated just above the solder joints by a cutting action (see figure 6),

**Figure 6. The two connectors from the servoactuator housing. As the SEM images show, both show signs that the wires were disconnected from them by a deliberate cut.**
