# WPR18FA200

## Shebogan, WI

### WRECKAGE AND IMPACT INFORMATION

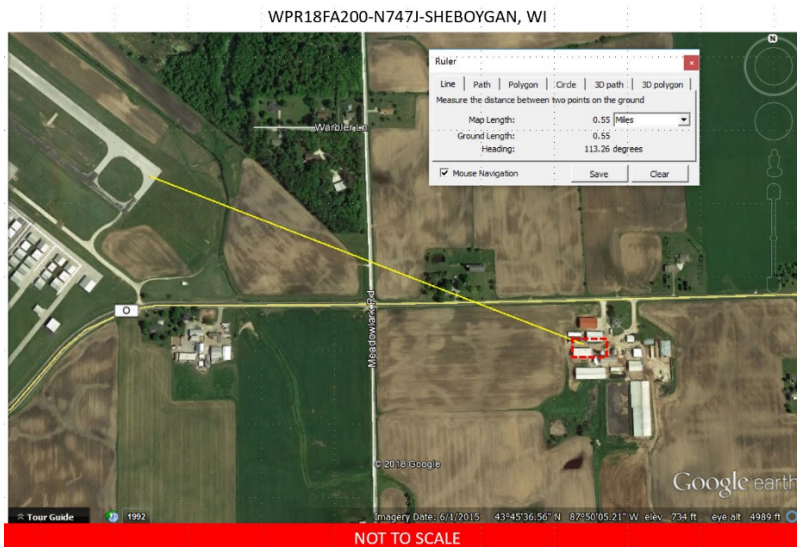
Figure 1

The airplane impacted flat terrain about .5 mile south east of the departure airport. The first identified point of impact was an area of corn that was missing on the edge of the debris field, about 50 feet west of the first piece of identified wreckage (FPIW). The debris path was about 200 ft by 40 ft on about 140° magnetic heading, and all major pieces of the airplane were found between the FPIW and the last piece of identified wreckage (LPIW).

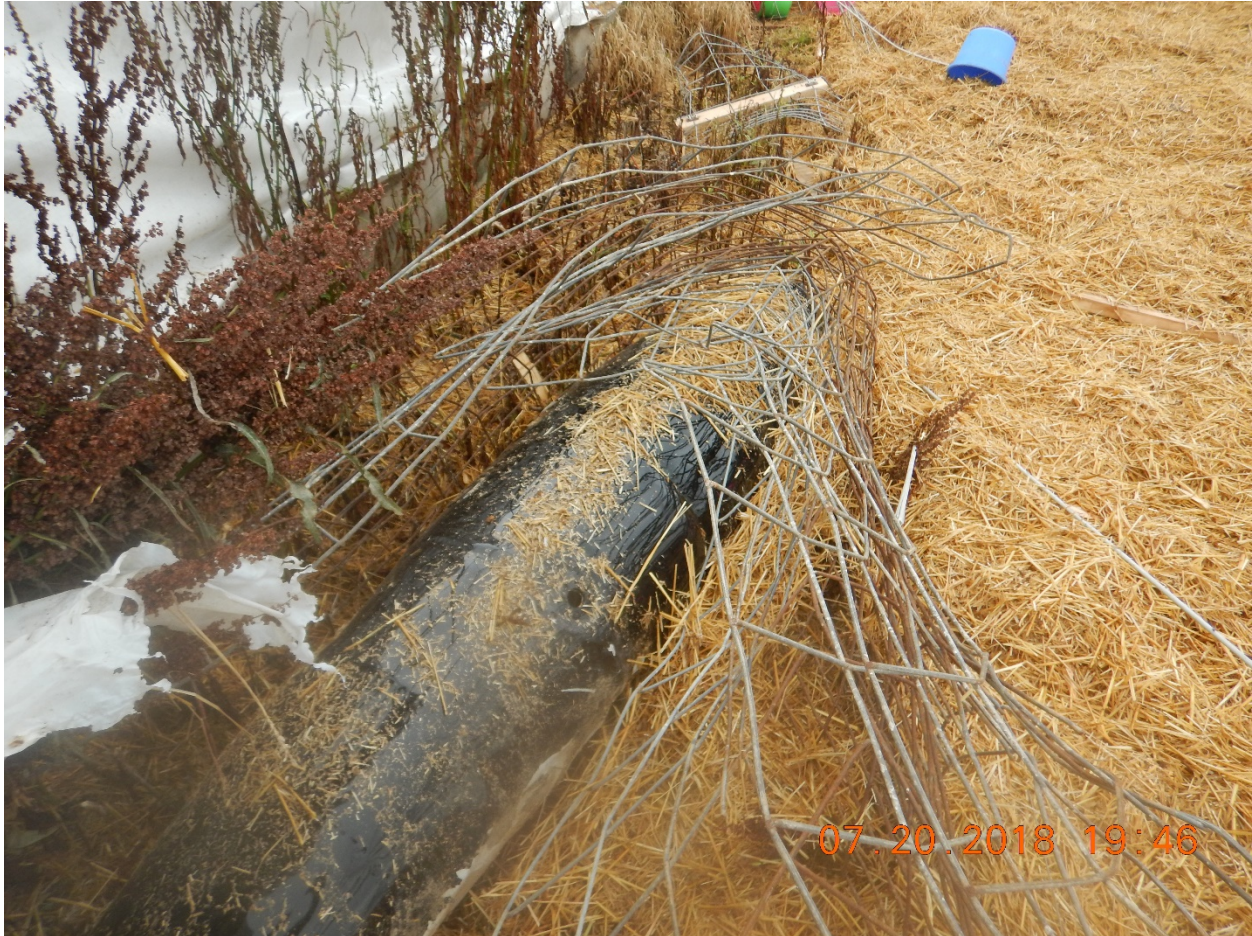
Figure 3

The FPIW was the left wing fuel tip tank. It was located about 125 ft from the main wreckage. The forward and aft section of the tank was breached, and a strong fuel odor was present. Very little thermal damage was noted. (Figure 3)

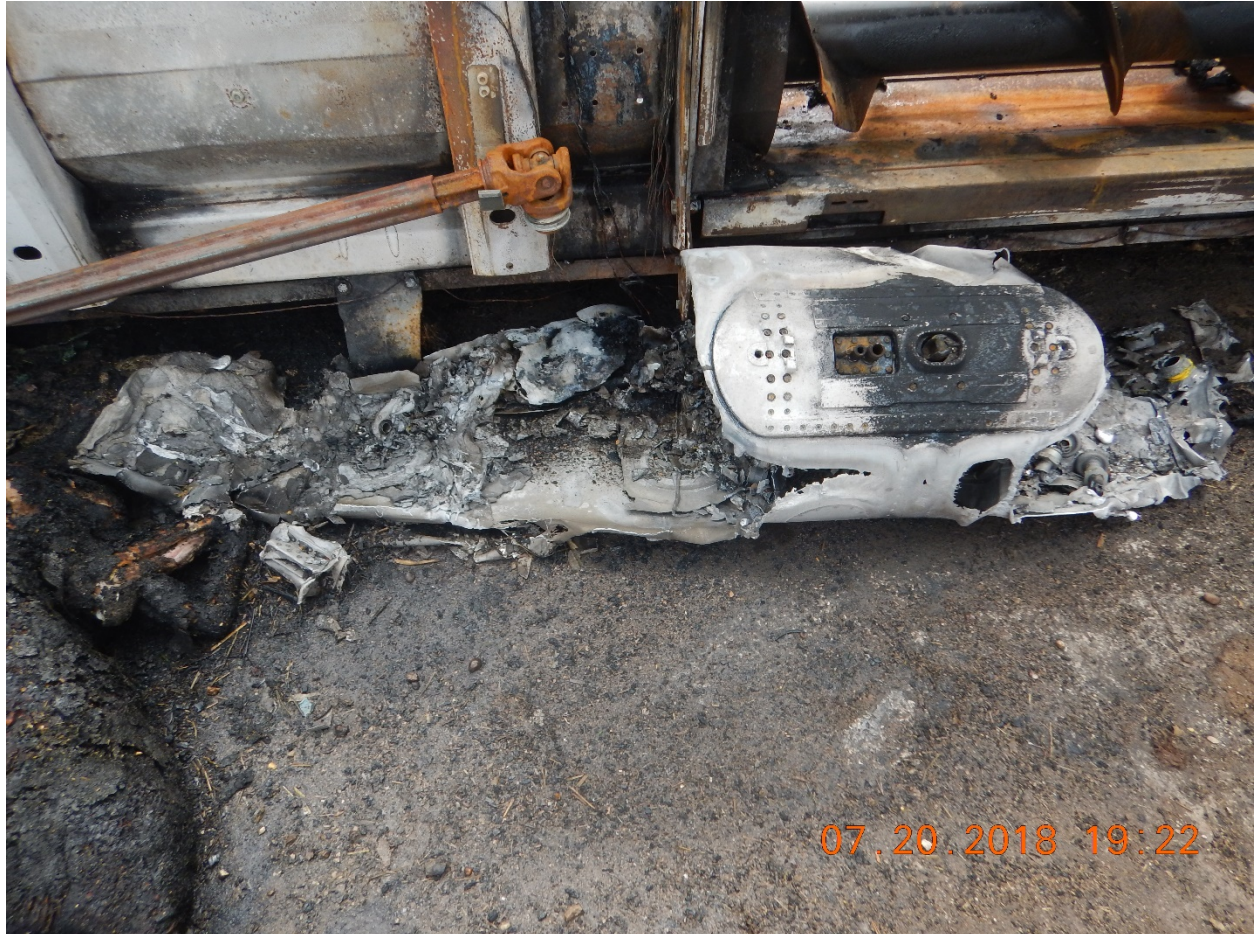
Figure 4

The LPIW was the right wing fuel belly tank. It was located about 70ft from the main wreckage and was destroyed during the post impact fire. (Figure 4)

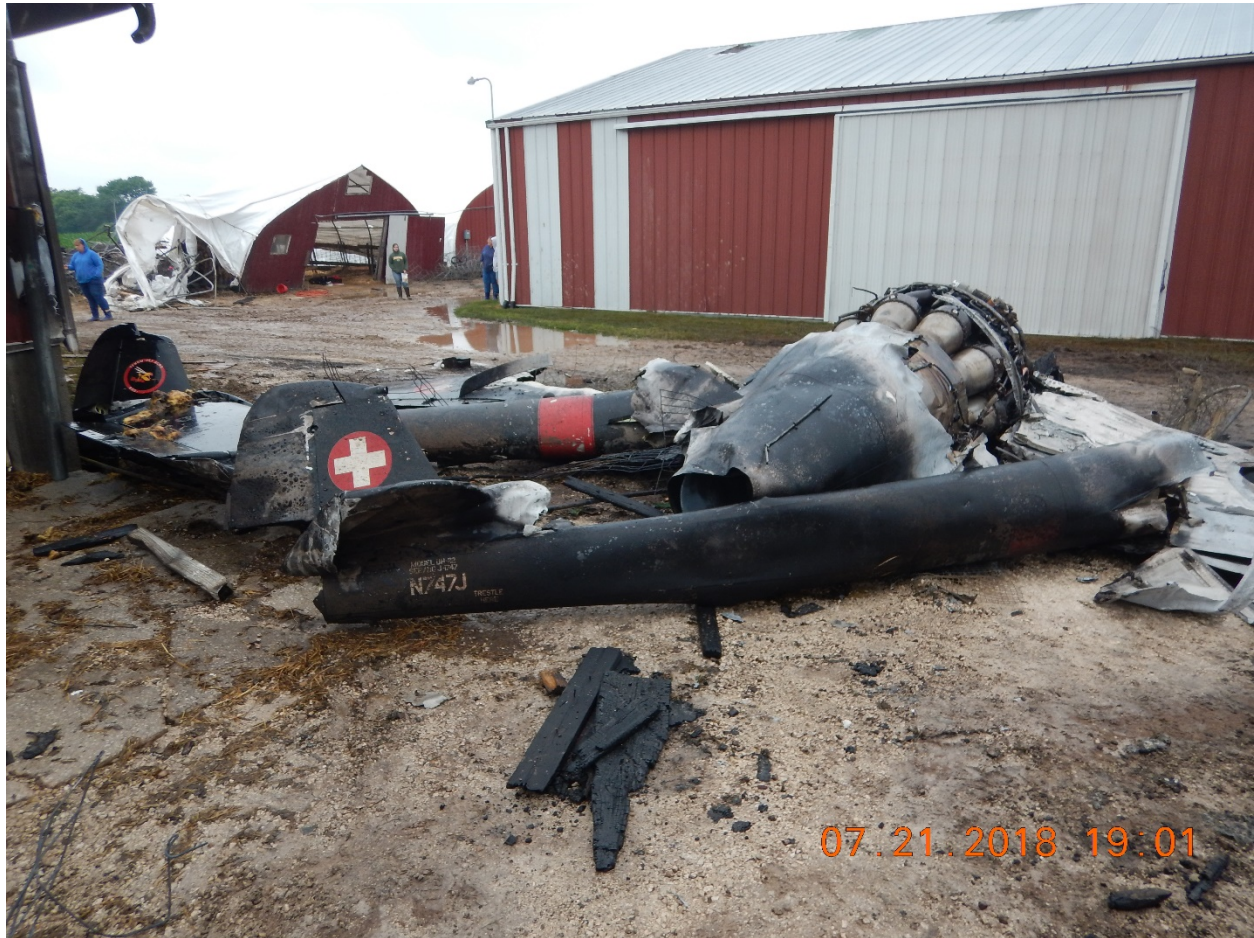
Figure 5

The main wreckage consisted of the fuselage, both wings, both tail booms, and the engine. The cockpit was orientated on about 15° magnetic heading. Most of the cockpit was destroyed during the post impact fire. (Figure 5)

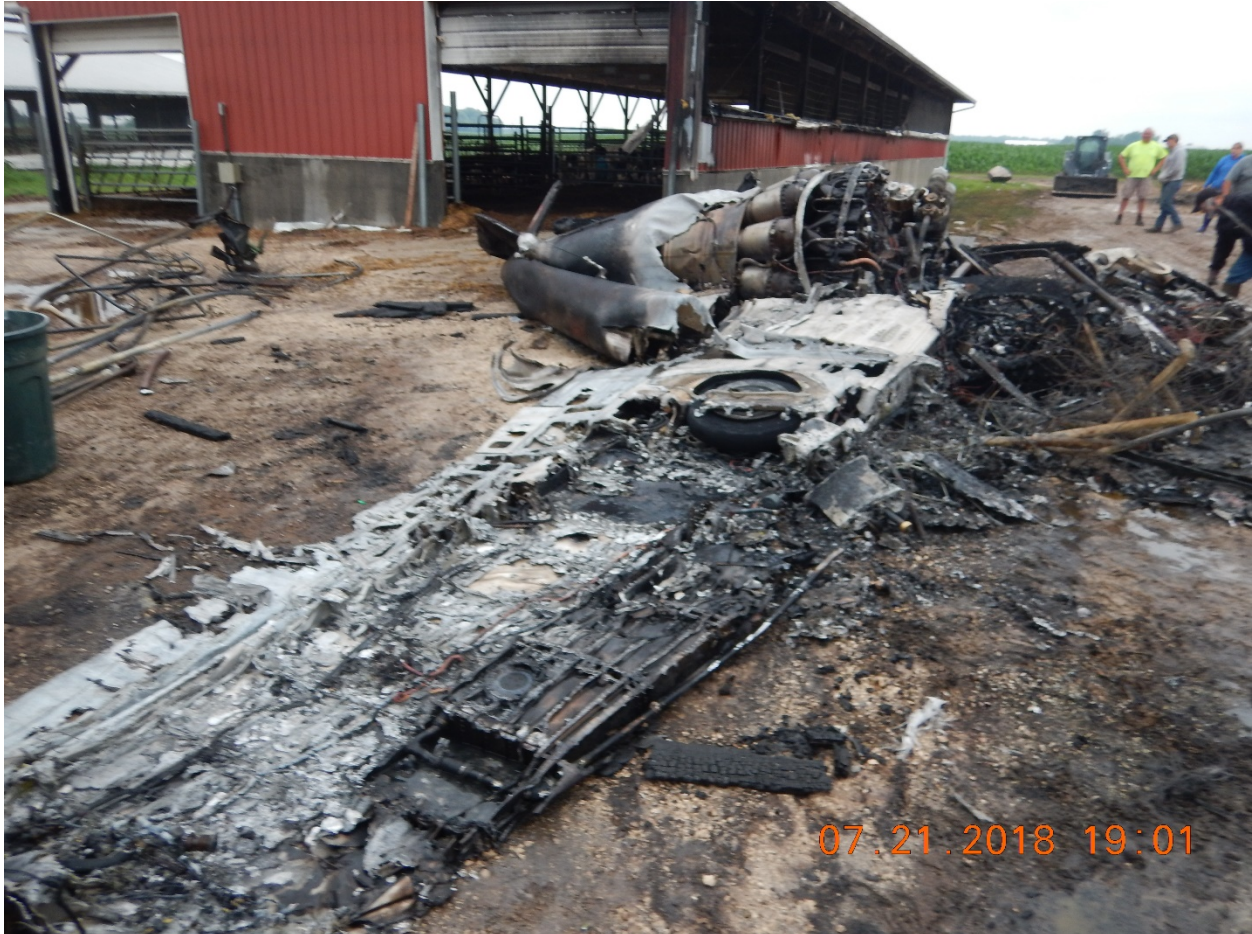
Figure 6

The right wing remained attached to the fuselage. The upper and lower surfaces displayed extensive thermal damage. The aileron remained attached to the wing and the control cables appeared to be intact. The flap was a split flap and the position of the flap during impact could not be determined on site. The speed brakes were not deployed. The landing gear was stowed in its housing. The right fuel tip tank remained attached to the wing and extensive thermal damage was noted. (Figure 6)

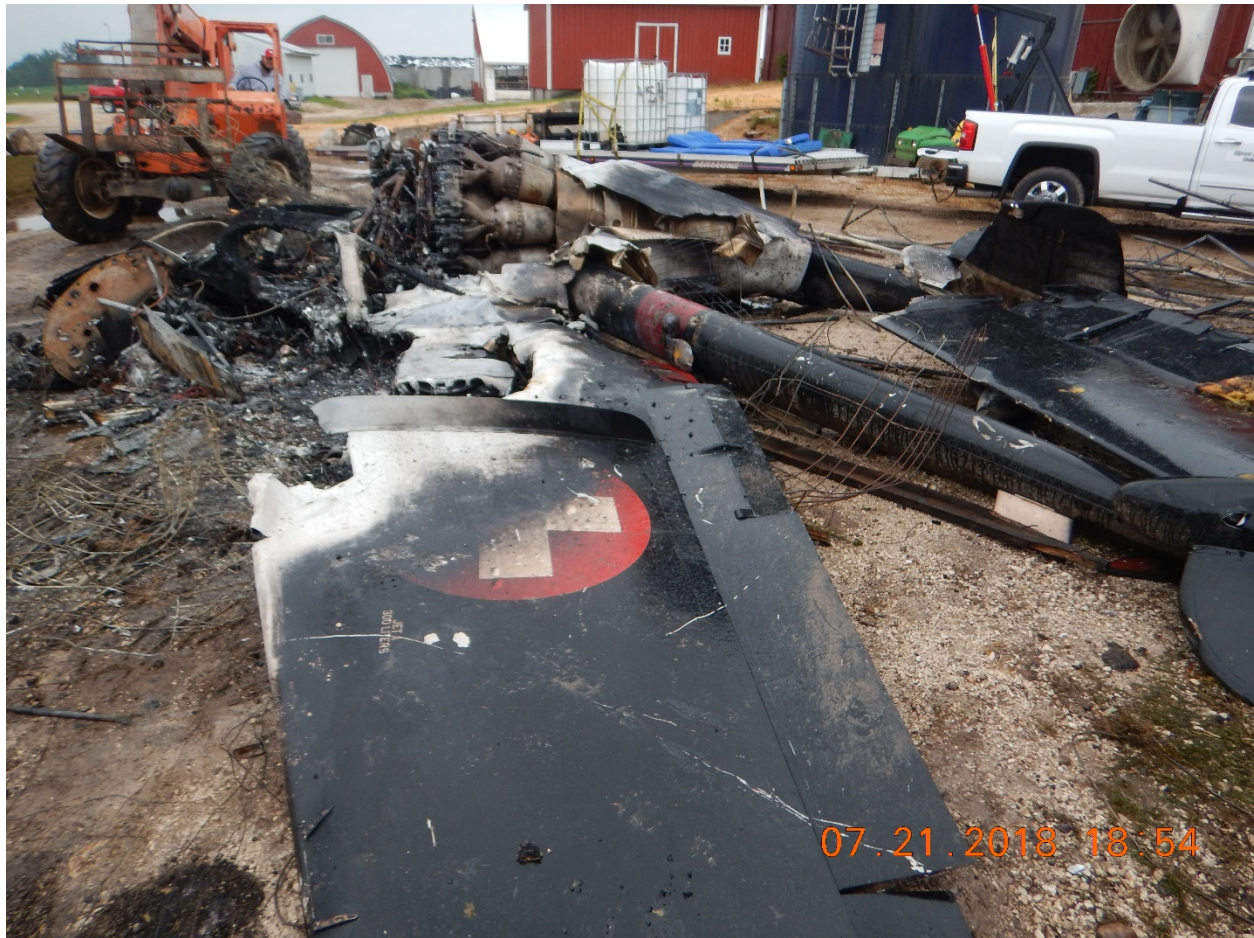
Figure 7

The left wing remained attached to the fuselage. The upper and lower surfaces displayed extensive thermal damage about midspan. The aileron remained attached to the wing and the control cables appeared to be intact. The flap was a split flap and the position of the flap during impact could not be determined on site. The speed brakes were not deployed. The landing gear was stowed in its housing. The belly fuel drop tank was separated and located about 50 ft northwest of the main wreckage. The forward and aft section of the tank was breached, and a strong fuel odor was present. Some thermal damage was noted. (Figure 7)

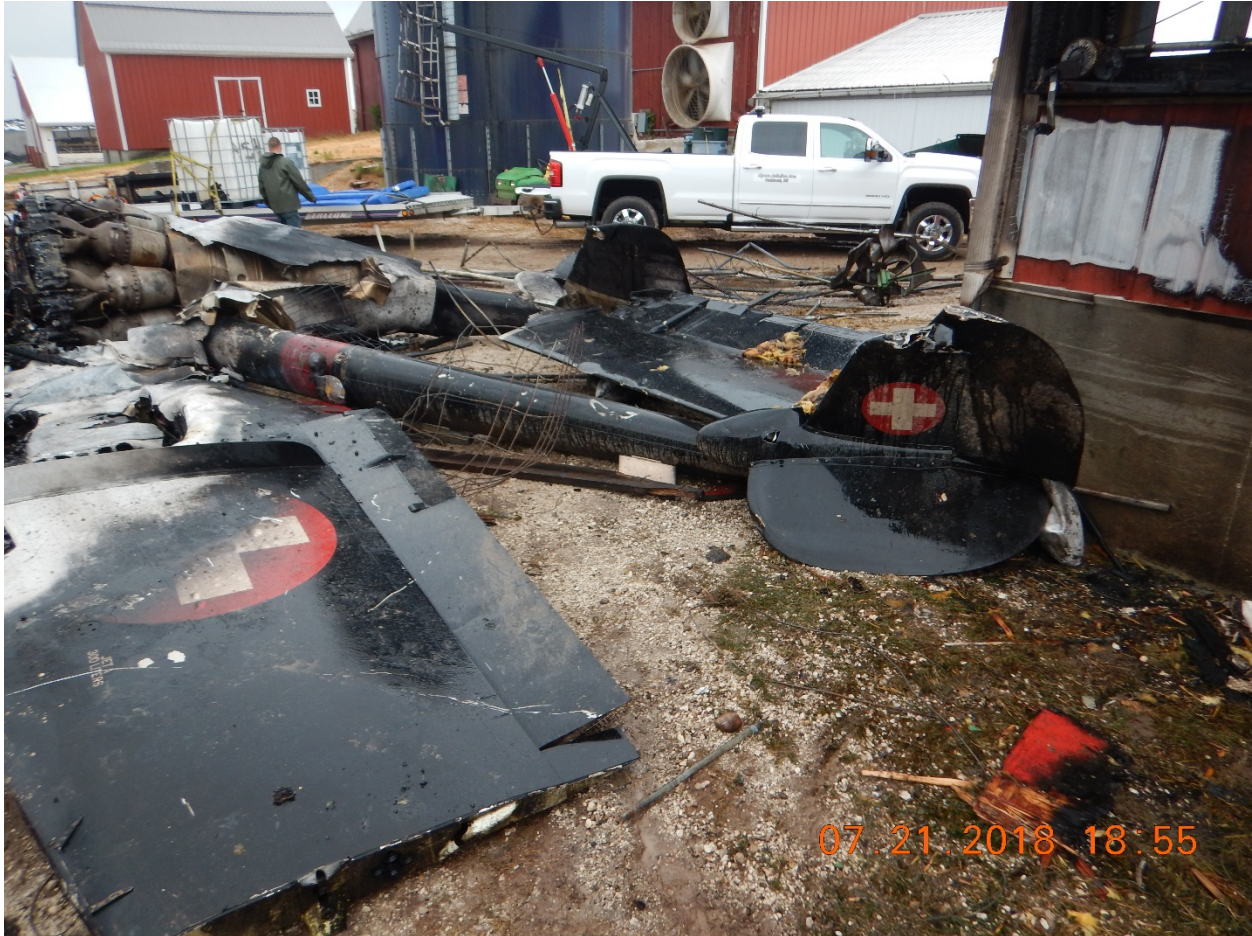
Figure 8

Both tail booms remained connected to the fuselage but were displaced about 30 degrees to the left. Both rudders remained attached (figure 8). The elevator was separated at the torque tube from the tail booms but remained with the main wreckage. (Figure 9)

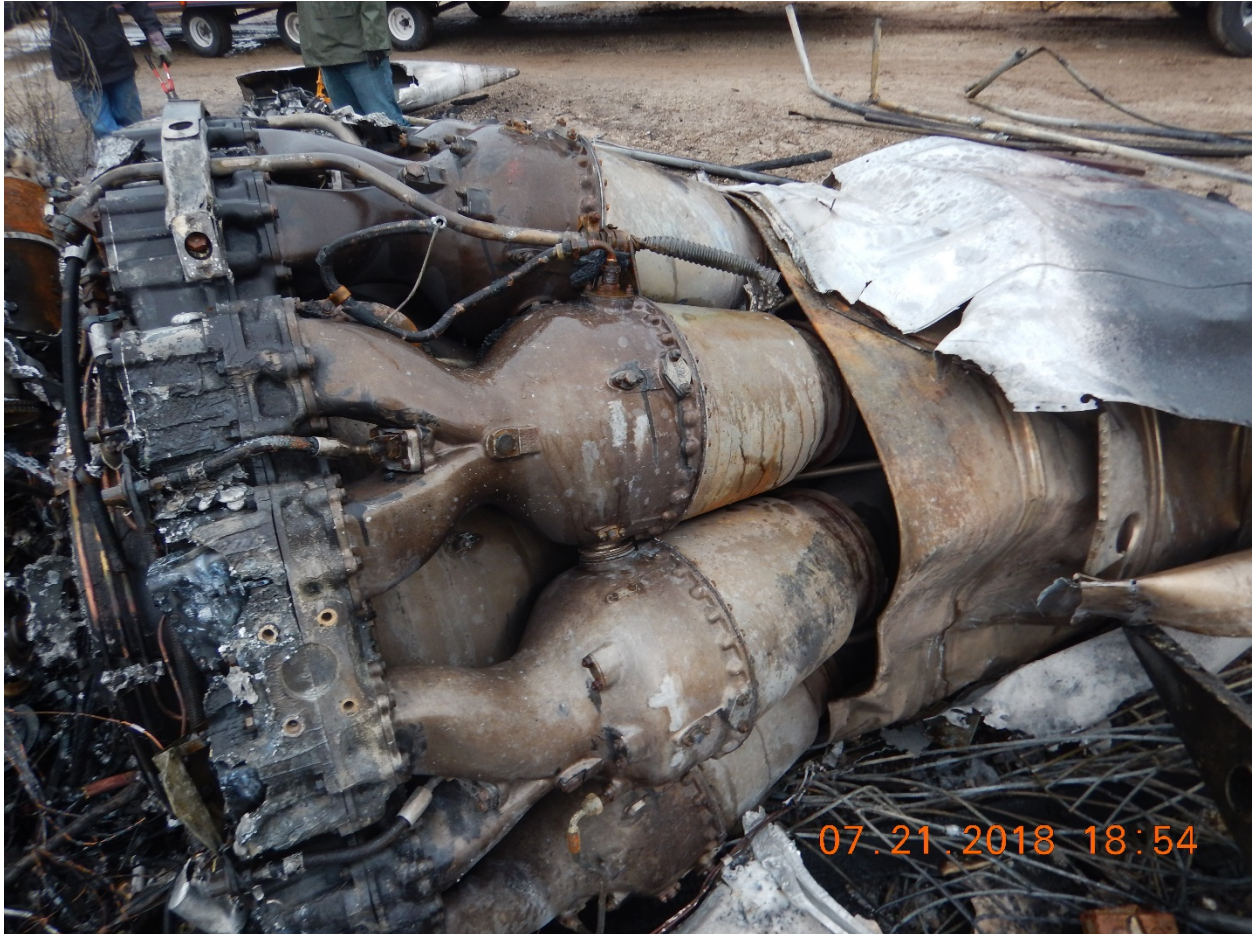
Figure 10

The engine remained attached to the fuselage. The compressor blades displayed some impact damage from about the 5 o'clock position to the 9 o'clock position. (Figure 10)
