N11QV, EC130B4, S/N:4909, Pukoo, HI, 11/10/11

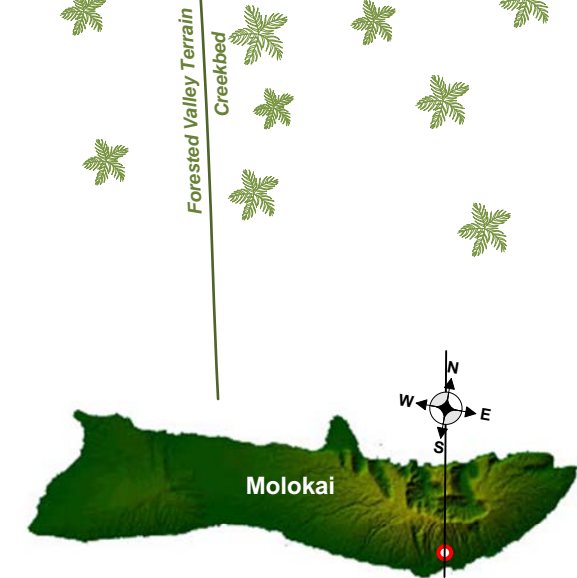
Main Wreckage
 N21° 04.050'
 W156 50.578'
 Elev. 530'

- Approximate Nose Direction at Main Wreckage (West)
- Approximate Attitude at Main Wreckage (Inverted)

Fenestron Gear Box
 N21° 04.071'
 W156 50.577'
 Elev. 562'

Three blade strike signature on ground
 The 1st had a piece of the metal end plate in ground
 The 3rd exhibited a full length impact along the ground and to a rock at the tip similar to Blade "C"

Ground Impact made by rotor hub Starflex arm (outer section) in ground

Tail Cone with... Lt. (Burnt) & Rt. (Damaged) Horizontal Stabilizer

Burnt FWD Section of TRDS Fenestron Cover

Approximately 8' of TR Drive Shaft (Center Section)

Engine, Main Rotor Hub and Transmission

Landing Gear Skids Inverted
 Interior Debris
