NATIONAL TRANSPORTATION SAFETY BOARD

AIRFRAME AND ENGINE EXAMINATION

WPR15LA137

Examination Report N9133G - Piper PA-46-310P

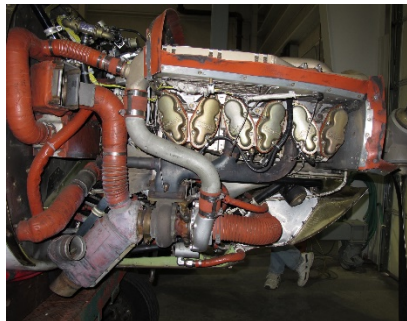
Right side

- External examination revealed no fluid leaks or stains that might indicate past leaks.
- The alternate air door was in the OPEN position.
- 8 qt of oil indicated on the dip stick

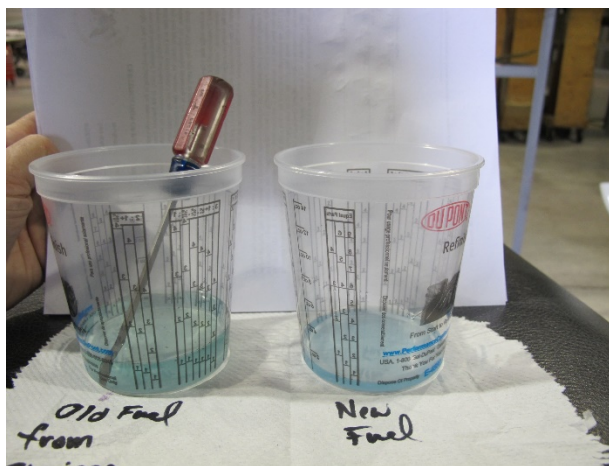
Fuel from fuel strainer.

- Fuel was drained from the fuel strainer. The fuel was light green in color. Photo shows the color of the fuel from the fuel strainer compared to new 100LL.
- A drop of fuel was allowed to evaporate from a white paper towel and left no oil stain or residue.
- Fuel tested negative for water using water detection paste

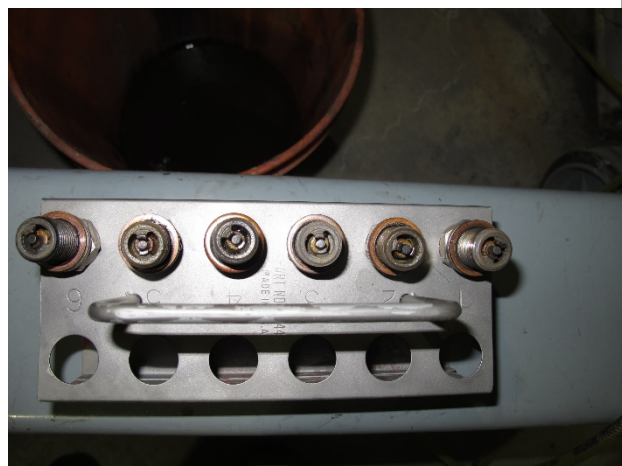
- Bottom spark plugs were removed. All exhibited normal wear signatures, and no mechanical damage noted.
- All cylinders were visually inspected using a bore scope. No anomalies were noted, within the cylinders, valves, valve seats, or piston faces.

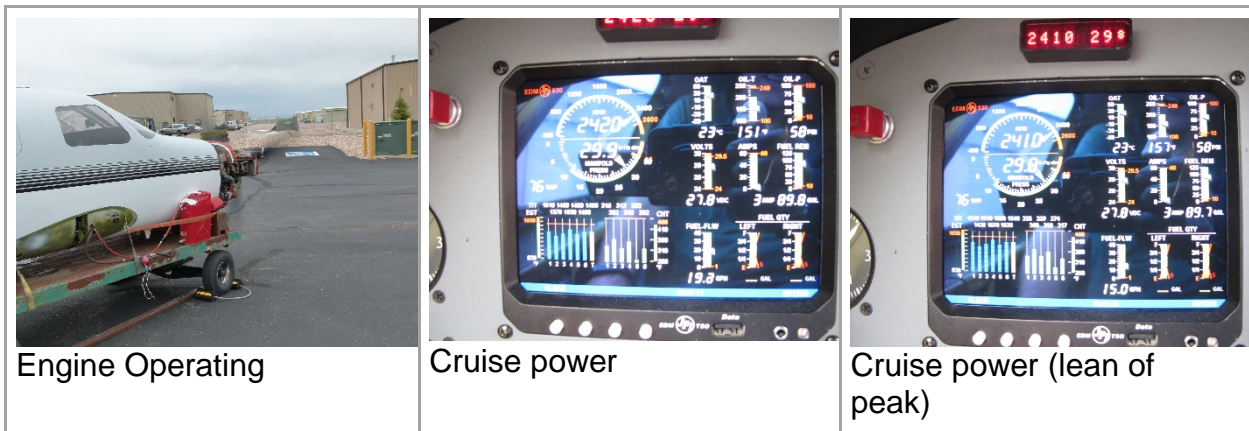
Idle	1520 rpm	R Mag 60 rpm drop	L Mag 50-60 rpm drop
Max Power	2600 rpm	35 in. man pres	
Cruise Power	2420 rpm	29.9 in. man pres	19.2 gph
Cruise Power Lean of peak	2410 rpm	29.8 in. man pres	15.0 gph

- The #5 CHT was notably 50°-70° lower than the other 5 cylinders at cruise power; 260°-280°F
