MEMORANDUM OF RECORD

Subject: ERA12FA012 – Wreckage and Impact description

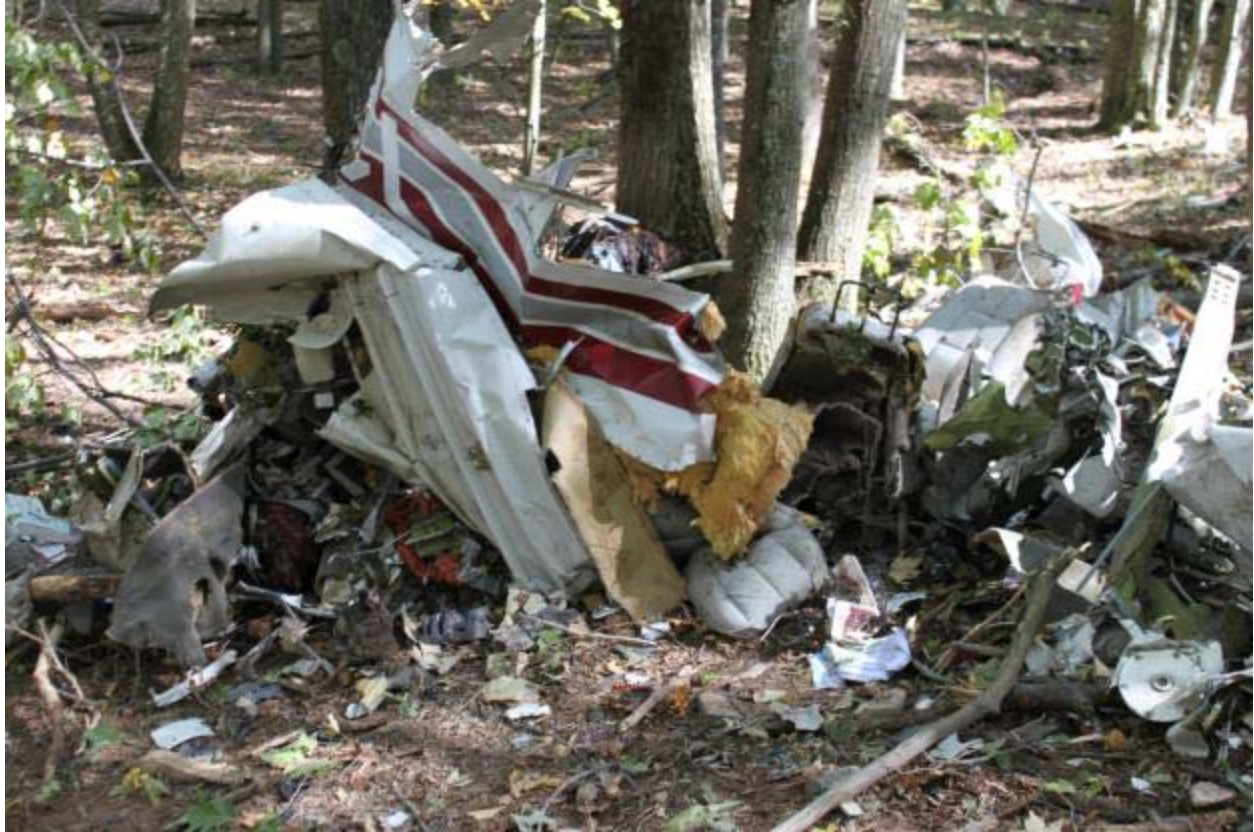
The airplane was found inverted in a mountainous wooded area. The main wreckage was located at N38°50.919' W079°00.938' at an elevation of 2,936 feet above mean sea level (msl). The first tree impact point was located at N38°50.941' W079°00.989'. The crest of the hill was located at N38°50.868' W079°00.880' and at an elevation of 2,988. The debris path was 650 feet in length. The engine was impacted separated from the airplane and was in the vicinity of the main wreckage. The wreckage debris path was oriented on 045 degree magnetic heading. A review of Washington Center radar data indicates that the last radar return was at 2,200 feet agl and was 255 degrees and 0.62 miles from the accident location.

Photo 1: Main Wreckage

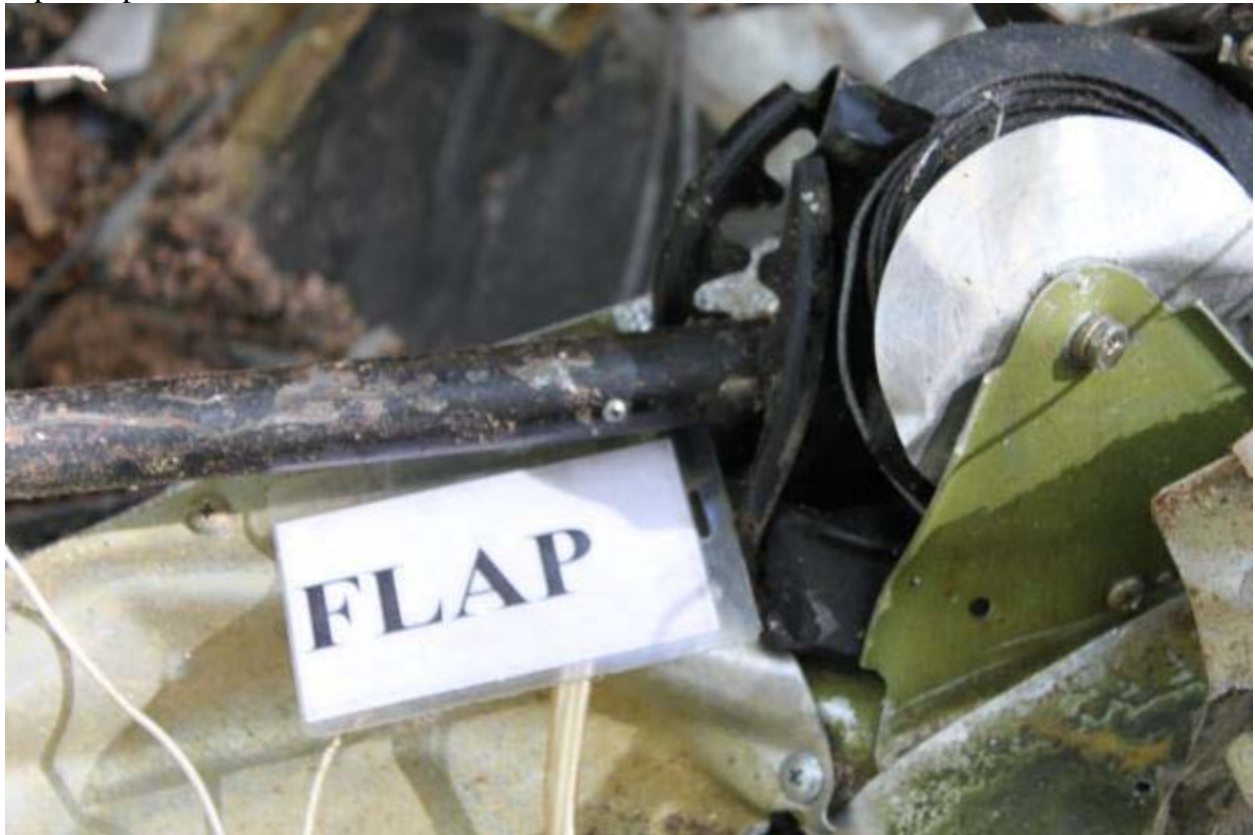
Photo 2: Cockpit Flap Handle

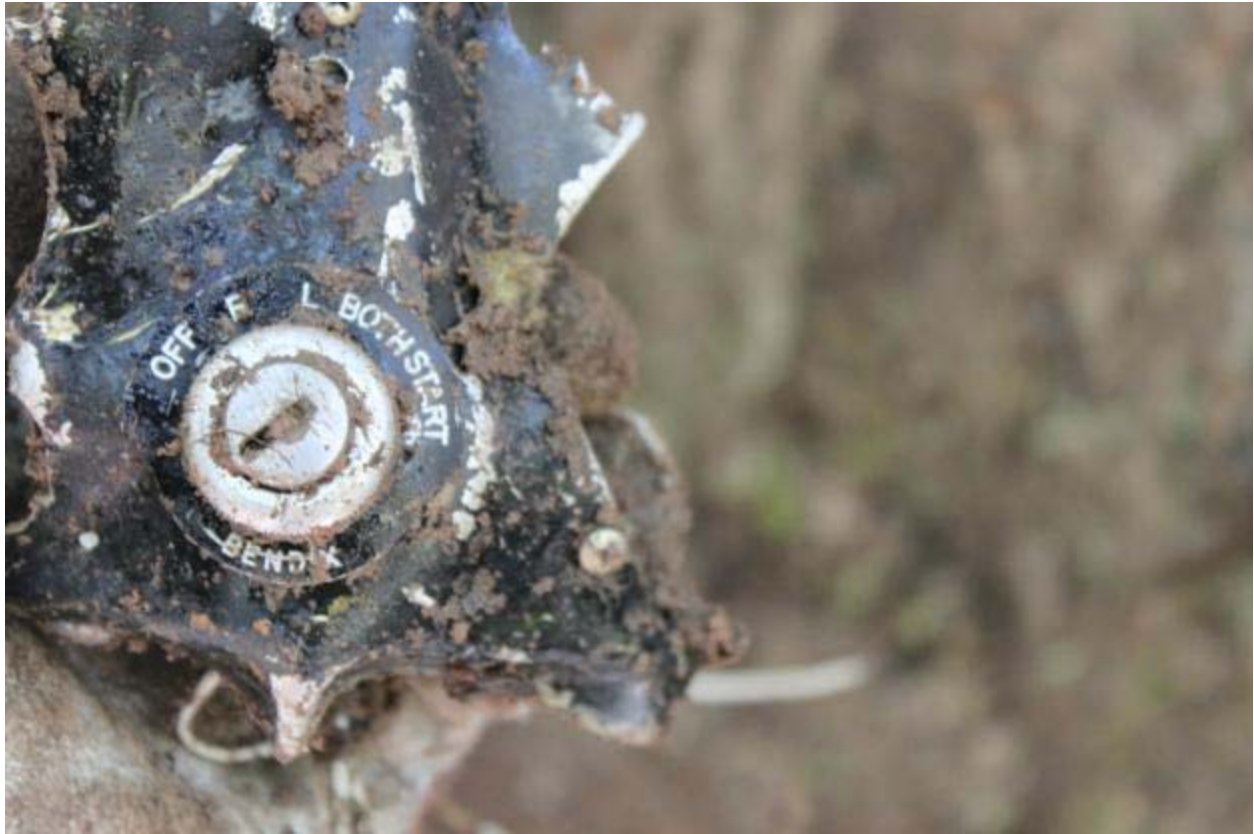
Photo 3: Magneto Ignition Switch in Both

The magneto was impacted separated, located 68 feet forward of the main wreckage. When rotated by hand spark was observed. The magneto switch was located in the impact crater and was found in the both position; however, the key was sheered and part remained inside the key hole.

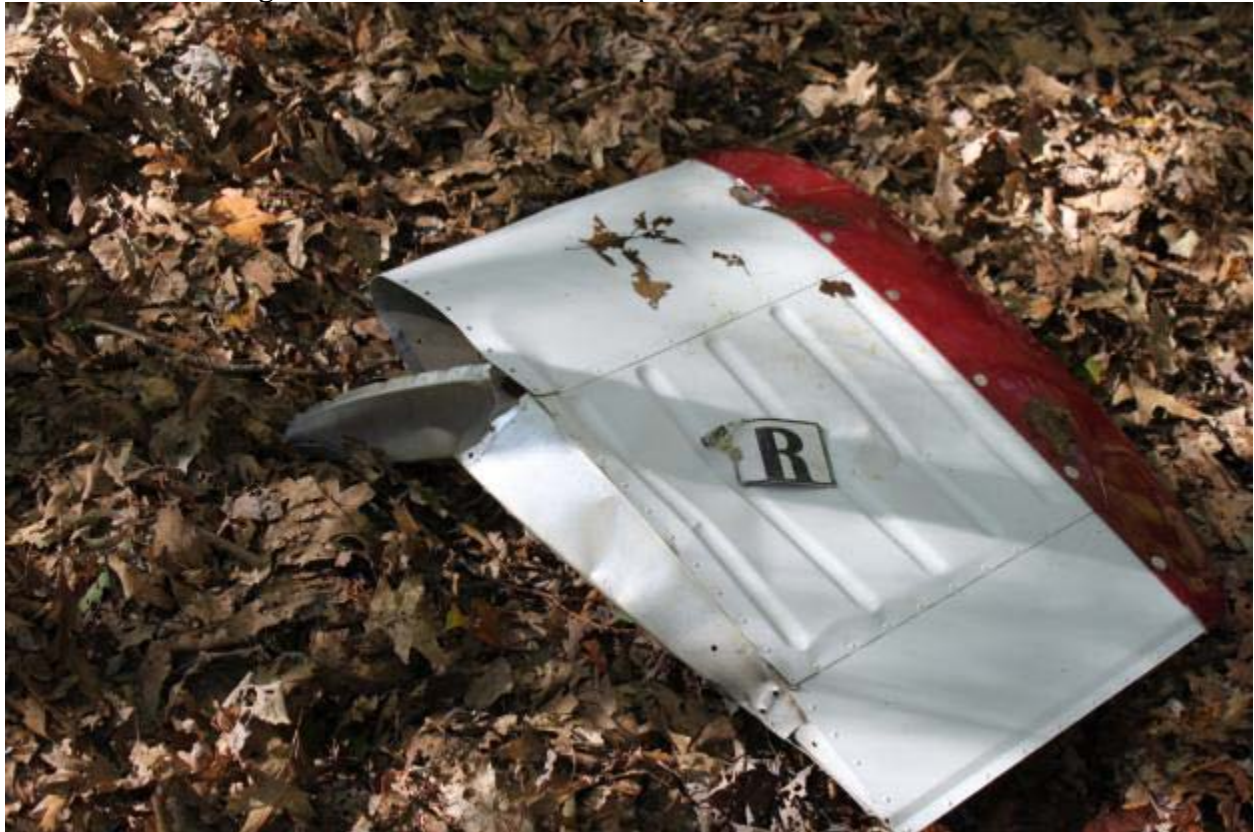
The stabilator was separated from its mounting. Both tips sections were separated and examined and both tip weights were attached. The main stabilator assembly was located in an approximate 100 foot tall tree near the initial impact location. The primary balance weight was located in the ground impact debris field approximately 60 feet forward of the main impact area. Control cable sections were attached and exhibited tensile overload separation. The left and right tip sections were located on the ground forward of the tree impact area. The trim drum was not located.

Photo 4: Right Stabilator Tip

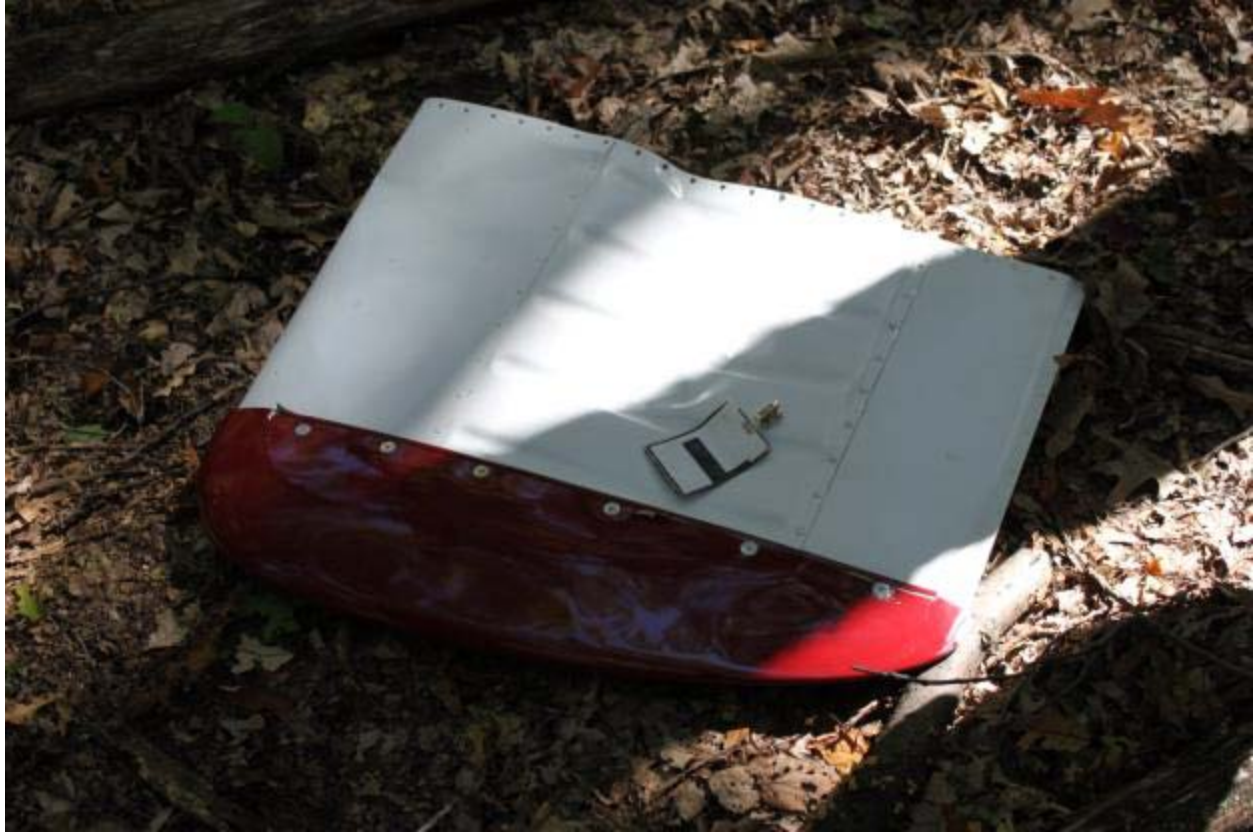
Photo 5: Left Stabilator tip

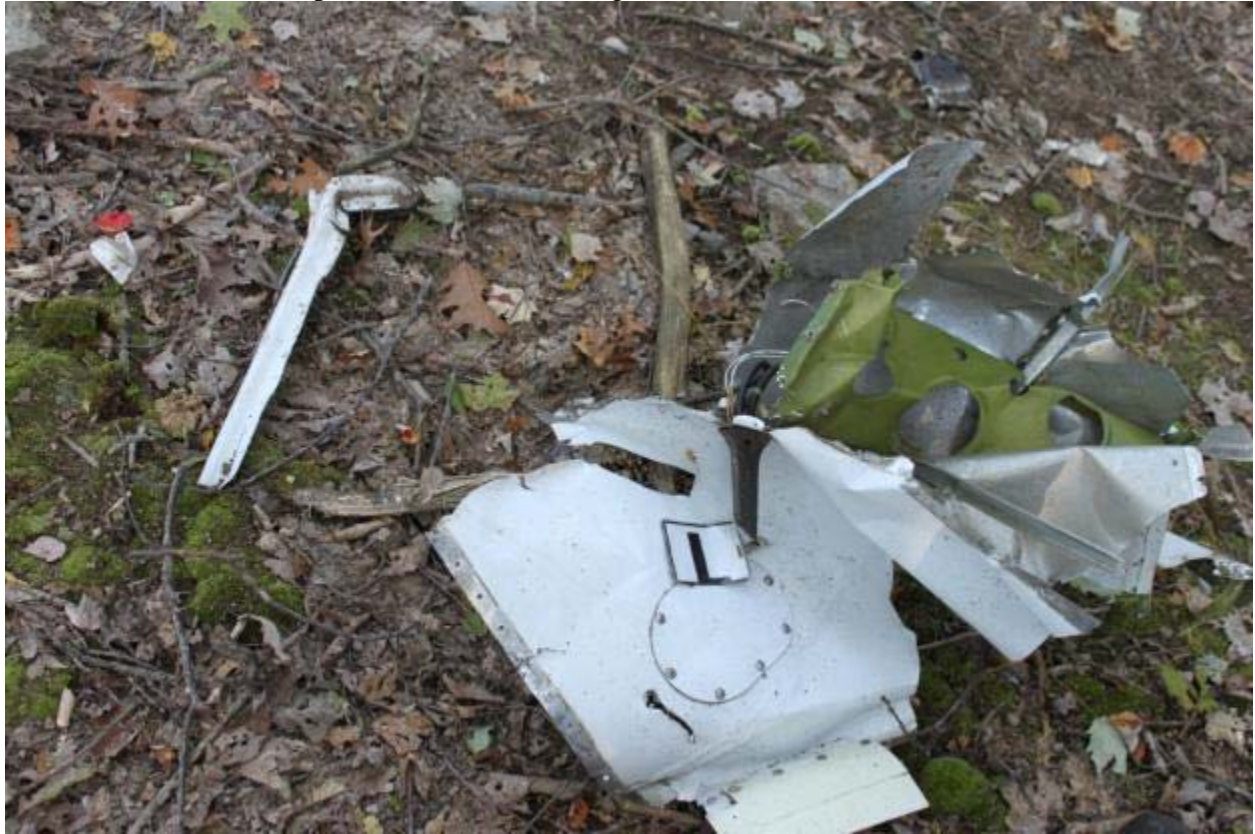
The left wing was separated and segmented. The fuel tank was impacted damaged, breeched and void of fuel. The fuel cap remained secure and in place. The flap was partially attached and segmented. The aileron was segmented and partially attached. Aileron balance weight was not located. An aftermarket gap seal kit was installed on the flap and aileron. The primary balance cable was segmented and showing tensile overload. Control continuity was partially established. The fiberglass wing tip was separated and segmented. The left main landing gear was separated and the strut tube was separated from its housing and located within the debris field.

Photo 6: Fragments of the Left Wing

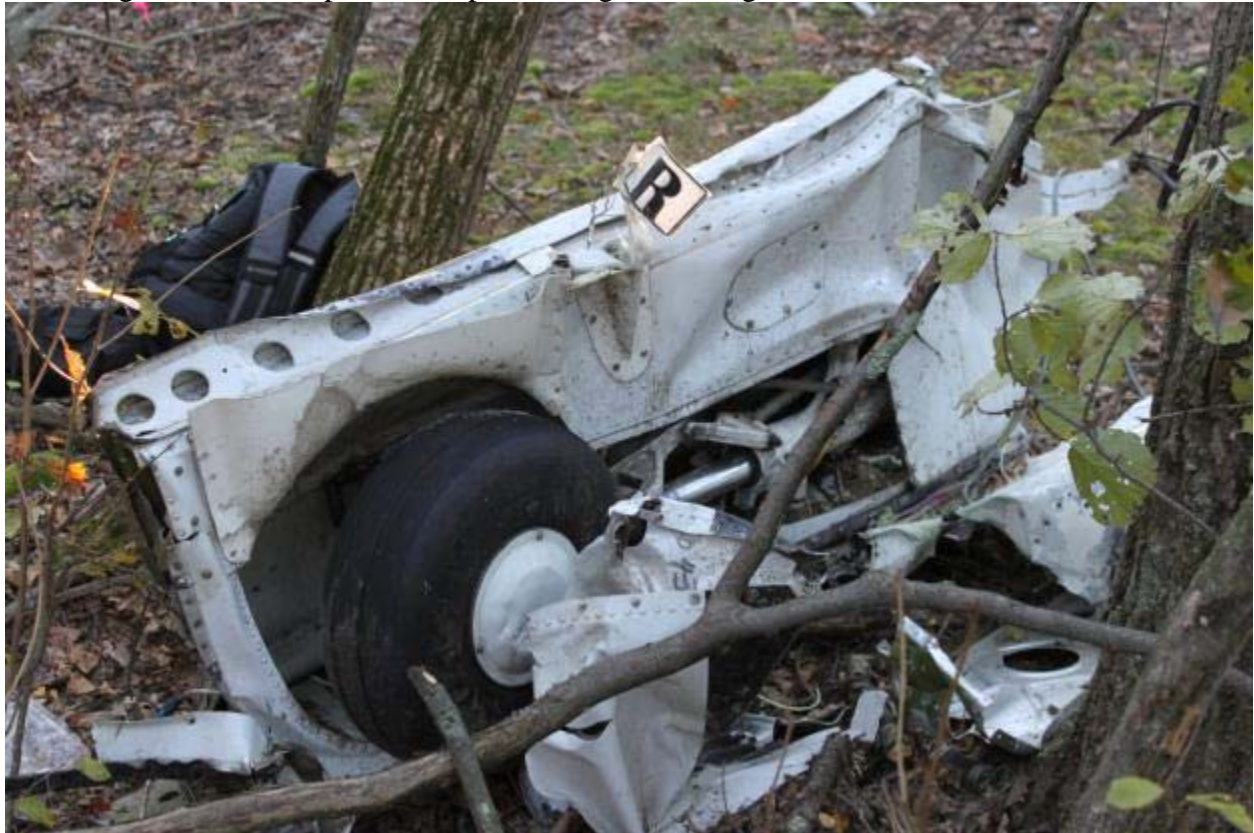
The right wing was impact separated and segmented. The wing root section was located forward of the main impact area in the debris field. It contained the right main landing gear and appeared to be in the "UP" position. The outboard wing section was segmented from impact and the fuel tank was fragmented; void of fuel, and the fuel cap was impact separated and was located approximately 40 feet from the fuel tank. The wing tip was separated, segmented, and impact damaged. The aileron was separated and the aileron control sector was located within the debris field. It contained segments of the primary and balance cables attached and they exhibited tensile overload condition. The right flap was impact damaged, partially attached and segmented. The control rod was broken and the flap and aileron had aftermarket gap seals installed. The wingtip was fiberglass but was separated, impact damaged, and segmented.

Photo 7: Right Wing at Rest

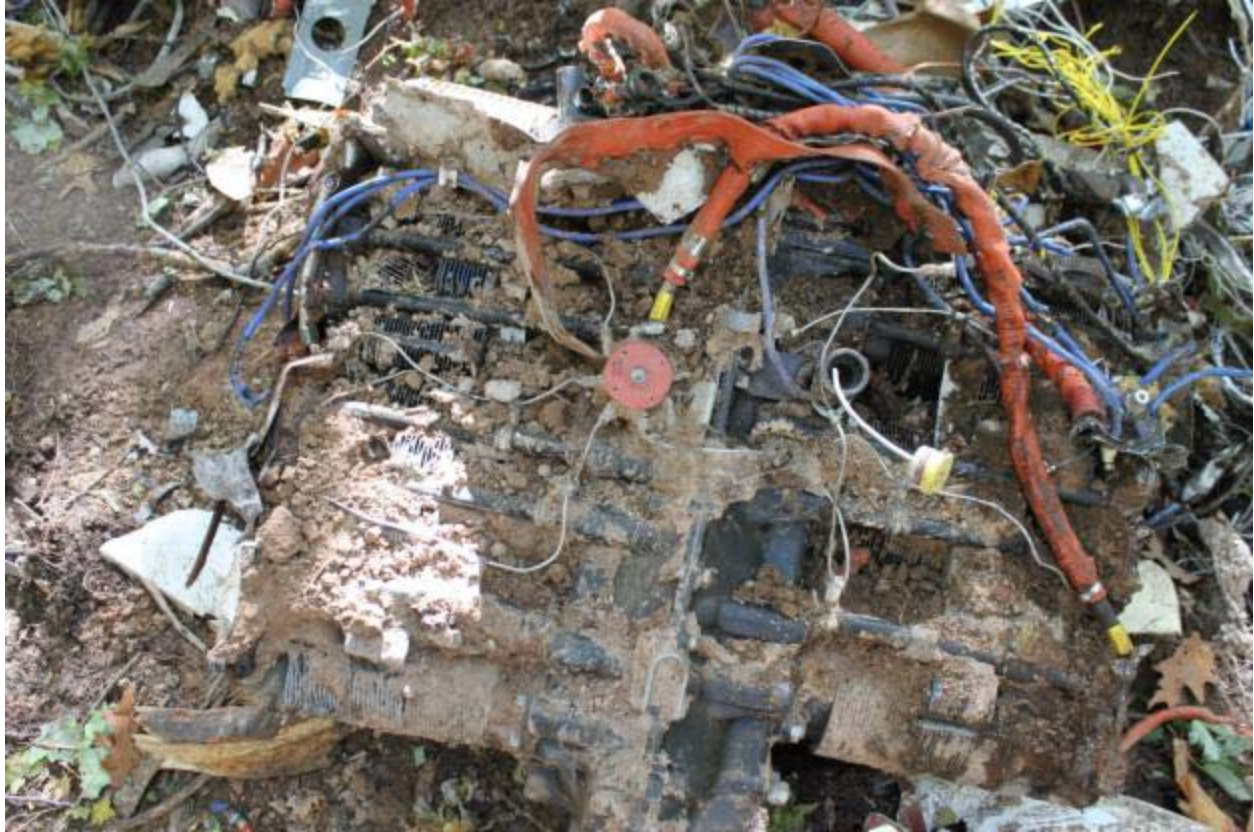
The 300 hp Lycoming engine was an IO-540-K1650, serial number L-15035-48A was impacted separated from the engine mounts. The No.s 2, 4, and 6 cylinders exhibited impact damage and the No.2 cylinder was the most extensively damaged. The top spark plugs were removed except for cylinder No. 2 which was absent from the spark plug cylinder hole. The No.s 4 and 6

cylinders spark plugs remained attached in the cylinder plug hole but were fractured slightly above the threads. Cylinder No.s 1, 3, and 5 remained attached and all plugs appeared gray in color with no wear indicated. The engine sump pump exhibited impact damage and oil was present.

Photo 8: Engine After Recovery from Impact Crater

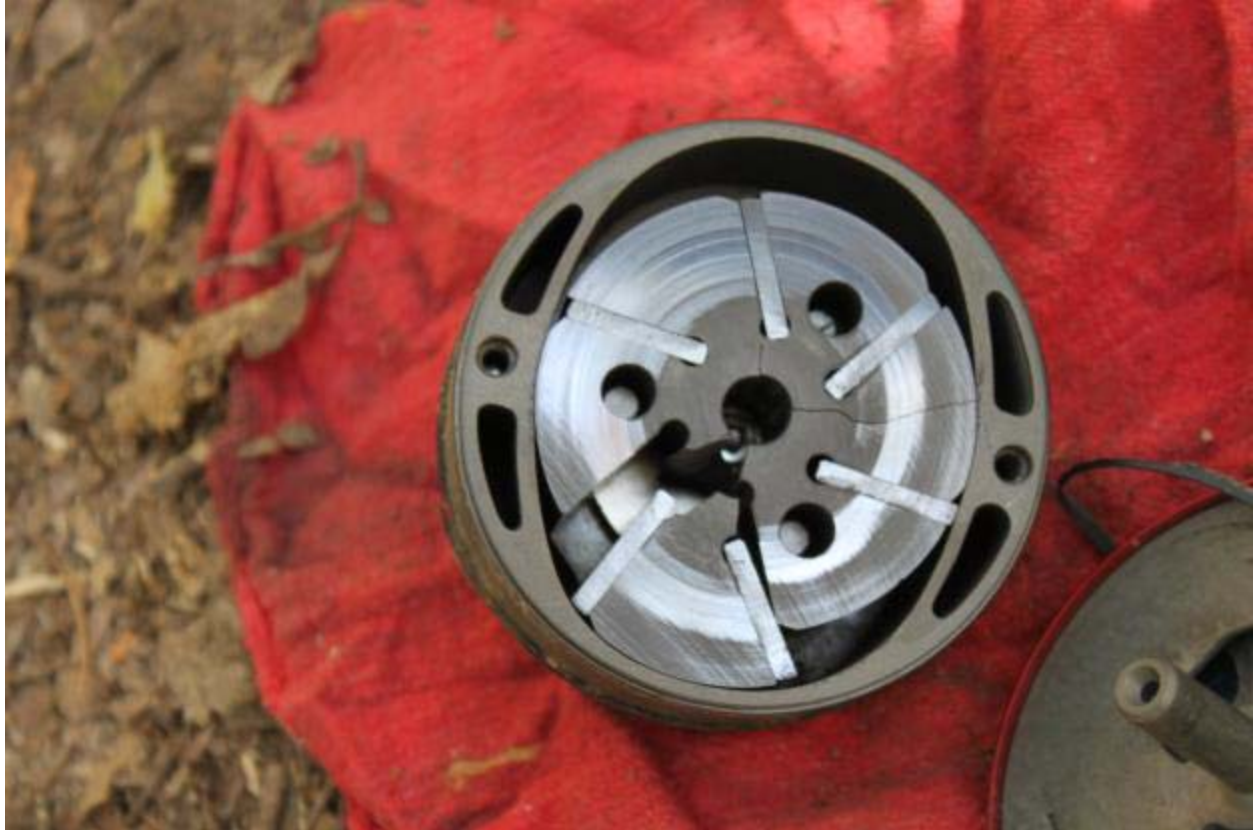
The vacuum pump remained attached, was disassembled and the vanes were cracked with rotational scoring noted inside the case.

Photo 9: Vacuum Pump After Disassembly

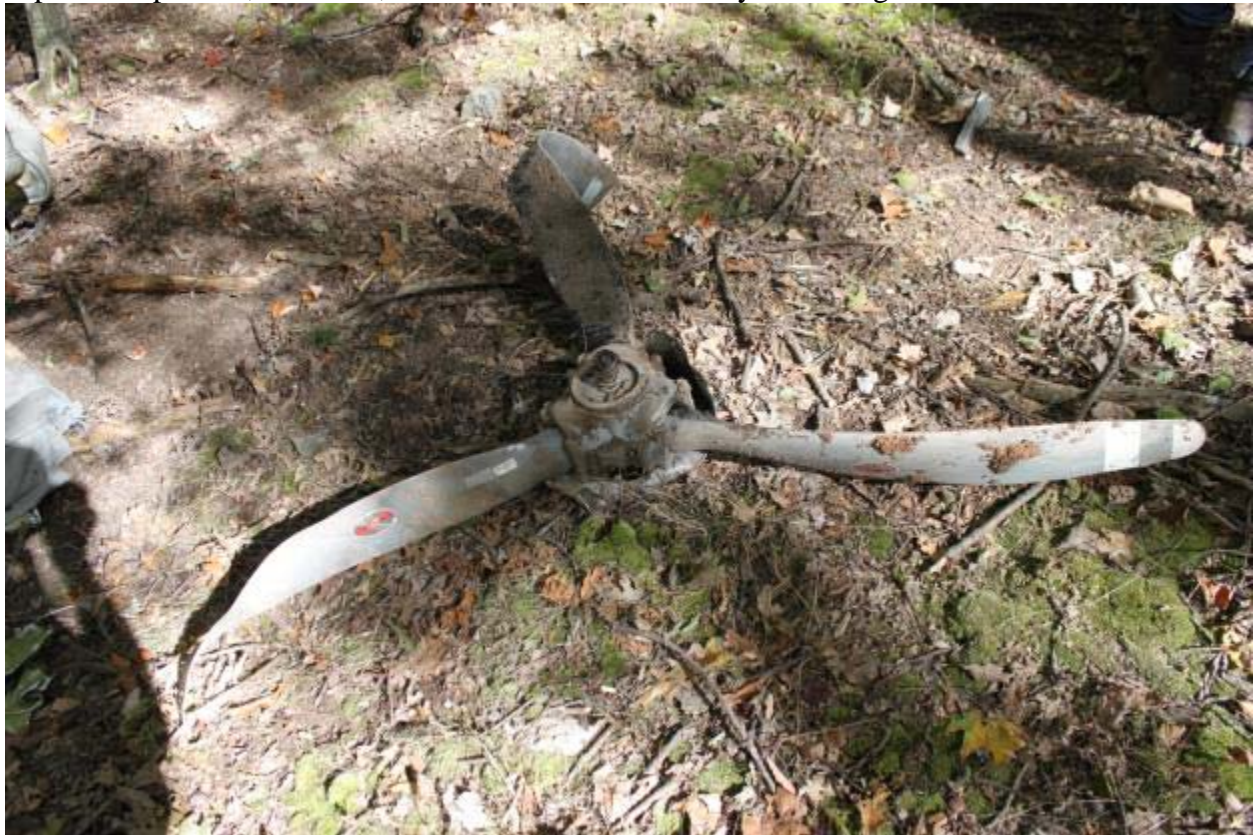
The Hartzell 3-bladed propeller was impacted separated and located up the hill and 40 feet in front of the main wreckage, partially imbedded in the ground and all three blades remained attached to the spinner. Two of the propeller blades exhibited extensive tip curling on the outboard approximate one-third, and S-bending. One propeller blade remained relatively straight, embedded in the ground and exhibited chordwise scratches. The propeller governor was impacted separated, fractured, and remained in the vicinity of the engine.

Photo 10: Propeller at Rest

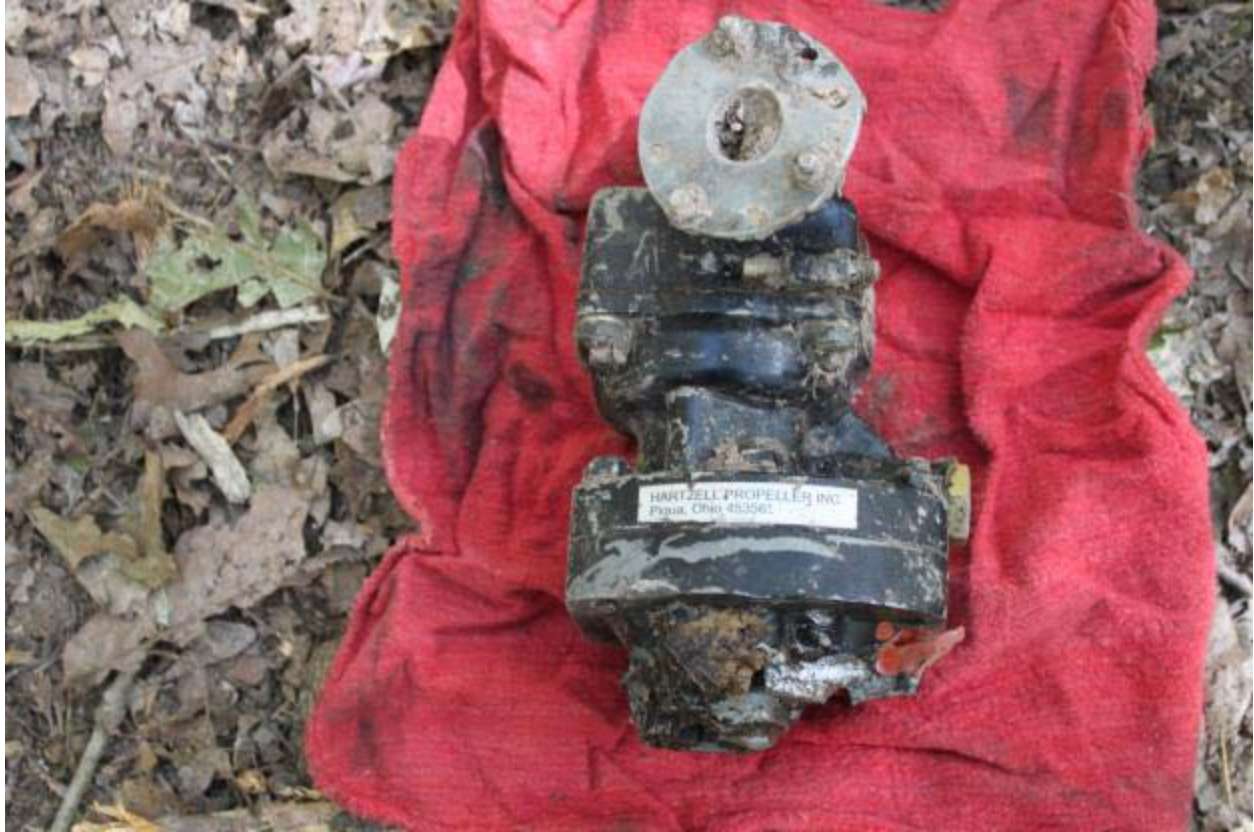
Photo 11: Propeller Governor

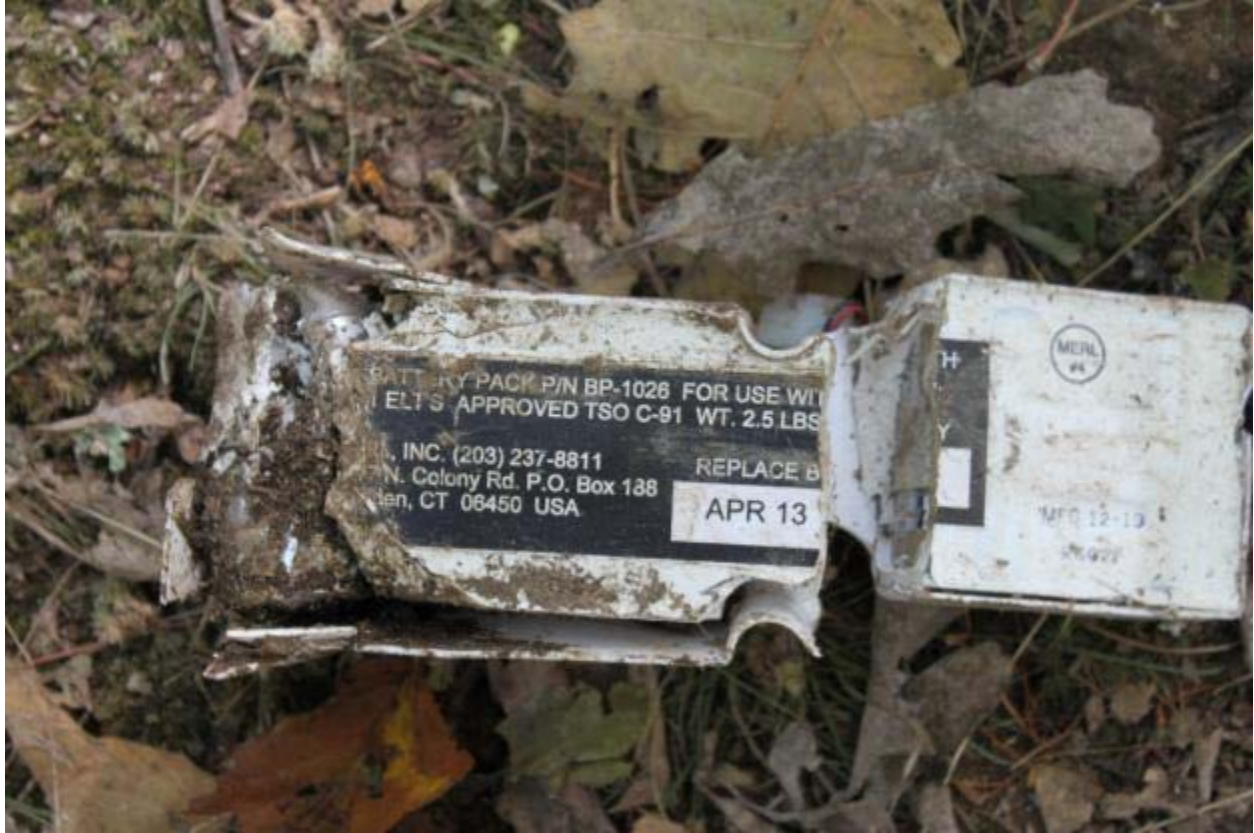
The ELT was located in the impact crater. The unit was a C-91 type ELT unit, had a replace battery date of "APR 13," and was fragmented due to impact forces,

Photo 12: ELT
