3.0 2021 Tesla Model 3 Vehicle Inspection

The Tesla was impounded at Downtown Towing, located at 1101 SW 69th Ave Miami, FL. The NTSB investigators inspected the vehicle on September 20 through 23, 2021. The Tesla had VIN: 5YJ3E1EB2MF037962.

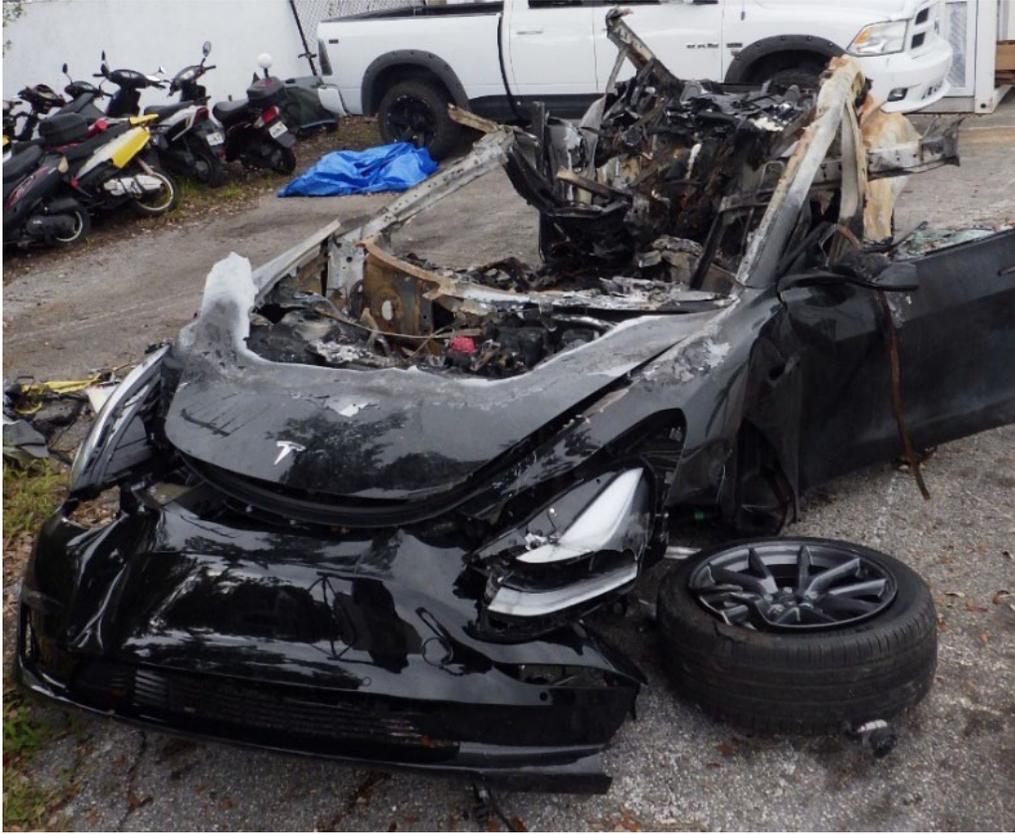
The vehicle sustained an extremely severe tree impact to the middle right (passenger) side in-between the A and B pillars with severe intrusion that is described below. The vehicle also sustained severe thermal damage to the interior, roof, and both right and left sides of the vehicle. Figure 1 shows a left front view of the Tesla.

Figure 1: Left front view of the Tesla

The left front suspension components had cast aluminum mounting components that were fractured in several places; tree bark was found on some surfaces. The left front wheel and tire showed indications of a severe impact with a ruptured tire and a fractured wheel. Tree bark was found on the damaged portions of the tire and wheel. The tire, other than the portion ruptured by impact, appeared nearly new, and did not exhibit significant scuffing or abrasions.

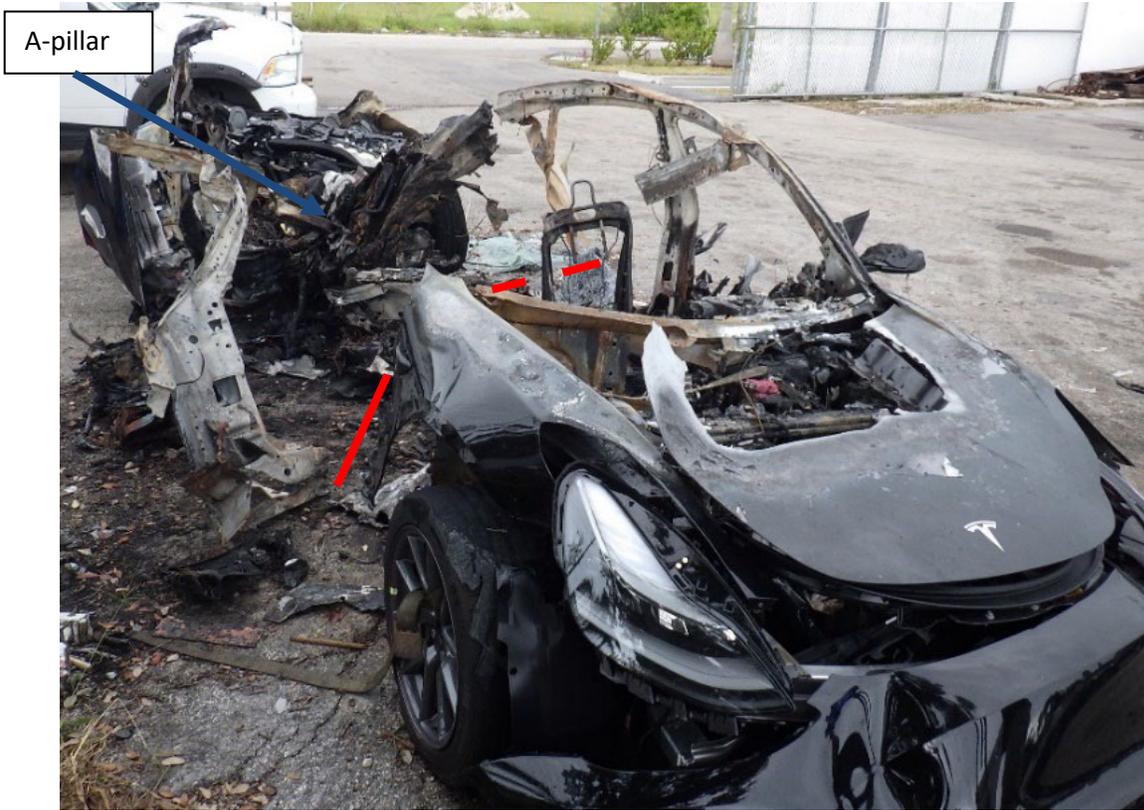
The second tree impacted the right side of the vehicle just forward of the B-pillar. The high voltage (HV) battery caught fire and the middle of the vehicle was fire damaged. The vehicle structure was compromised, separating the vehicle along a diagonal pattern, from the rear/left to the front/right. This separation occurred just aft of the C-Pillar on the left side of the vehicle and extended forward near the front of the A-pillar on the right side. The right side A-pillar separated from the dashboard and right front the wheel well, and was displaced several inches inward and aft.

The front-left side of the vehicle remained intact back to the C-pillar, but the rear seats separated and remained with the rear of the vehicle. The driver seat and front seat floor pans, including the floor under the front passenger seat, remained with the front portion of the vehicle. Figure 2 provides a right-front view, and Figure 3 a left-rear view. The approximate lines of structural separation are shown with red lines.

Figure 2: Right-front view of the Tesla

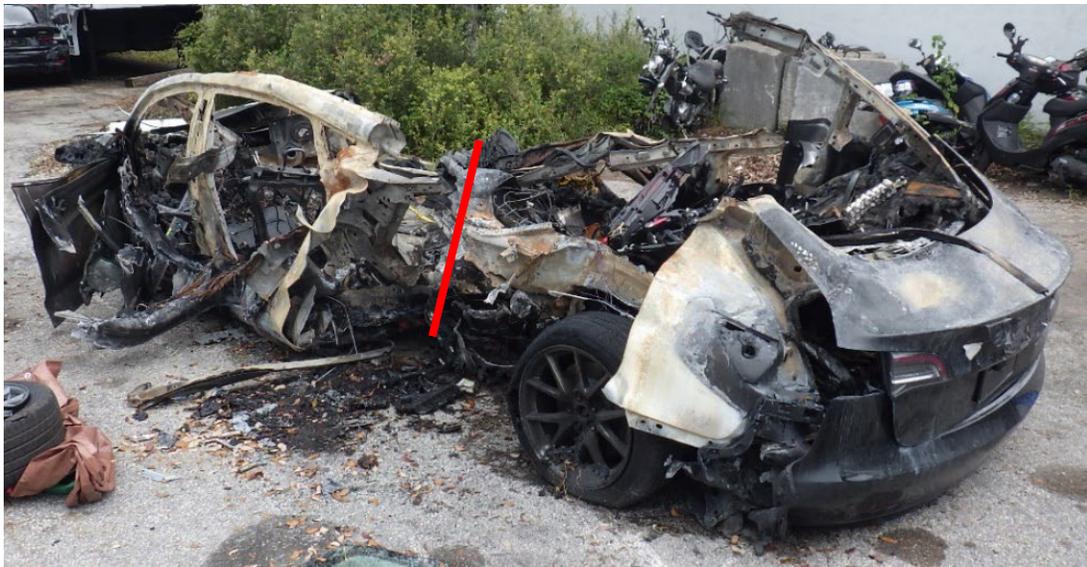
Figure 3: Left rear view of the Tesla

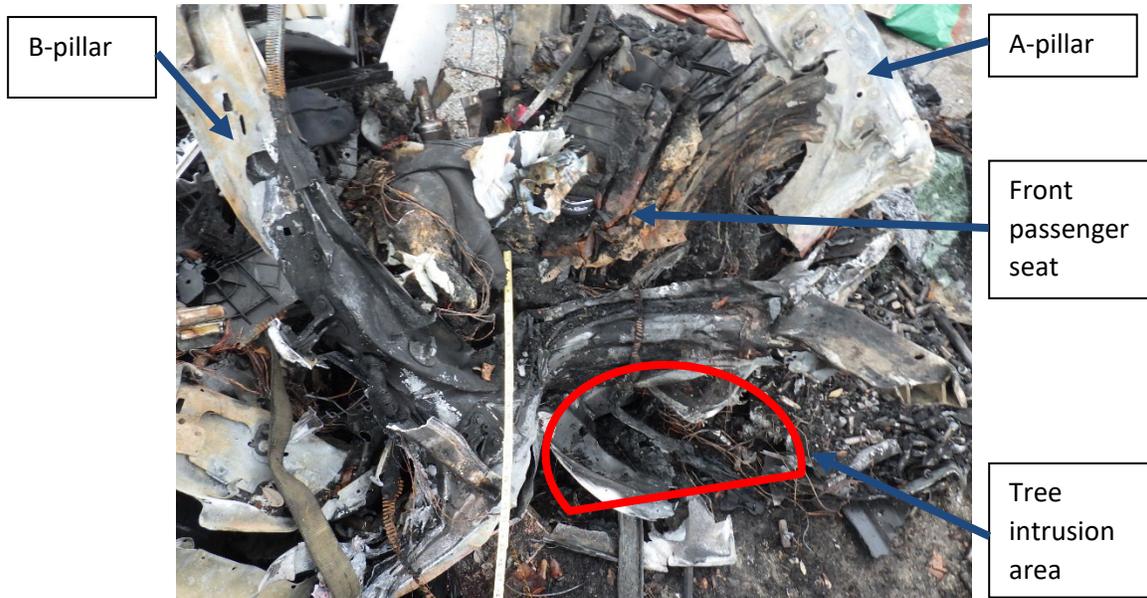
The tree impacted the right side of the Tesla at a location just forward of the B-pillar, and intruded the floor approximately 17 inches, as shown in figure 4.

Figure 4: Right side of the Tesla at the tree impact location

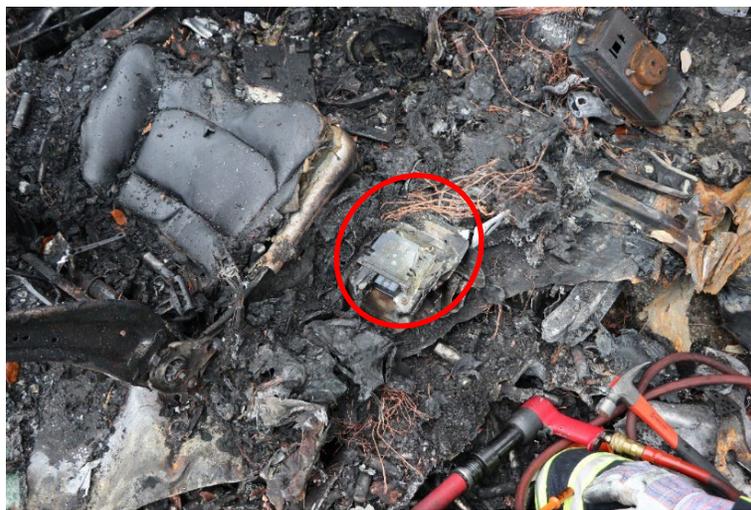
The right-side A-pillar was displaced aft, and found near the aft surface of the driver seat during inspection.¹¹ The C-pillar was displaced aft and inward, and the right side roof structure was folded inward above the rear seats. The right-side rocker panel remained with the rear of the vehicle, while the floor and battery case remained with the front of the vehicle. The fire damaged airbag control module (ACM) was found in the center console area and delivered to the NTSB for forensic evaluation.¹² The ACM as located under fire debris in the Tesla is shown in figure 5.

Figure 5: Tesla interior with airbag control module circled

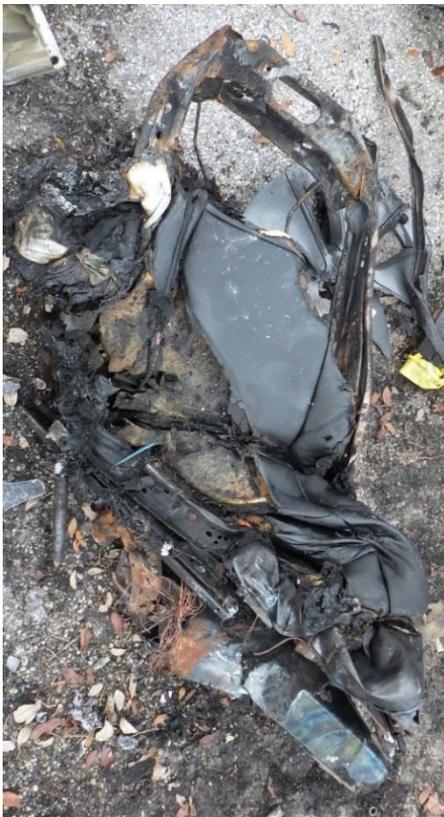
The passenger frontal and side curtain airbag areas were also consumed by fire. The passenger seat was displaced aft, inward and upward. It had become separated from the floor and was found in the wreckage with the rear section of the vehicle. The upper portion of the backrest and portions of both sides of the seat sustained fire damage. Upholstery remained in the center of the seat. The partially burned and deployed side-seat airbag was visibly attached to the right side of the seatback. The right side of the seat was crushed inward to about half its original width. The seatbelt in the vicinity of the passenger seat was burned away, and the latch plate was found in the wreckage near the center of the vehicle. The inertia reel was found at the B-pillar with a significant portion of the webbing unspooled.¹⁴ Figures 6 and 7 provide frontal views of the passenger and driver seat respectively.

Figure 6: Front passenger seat

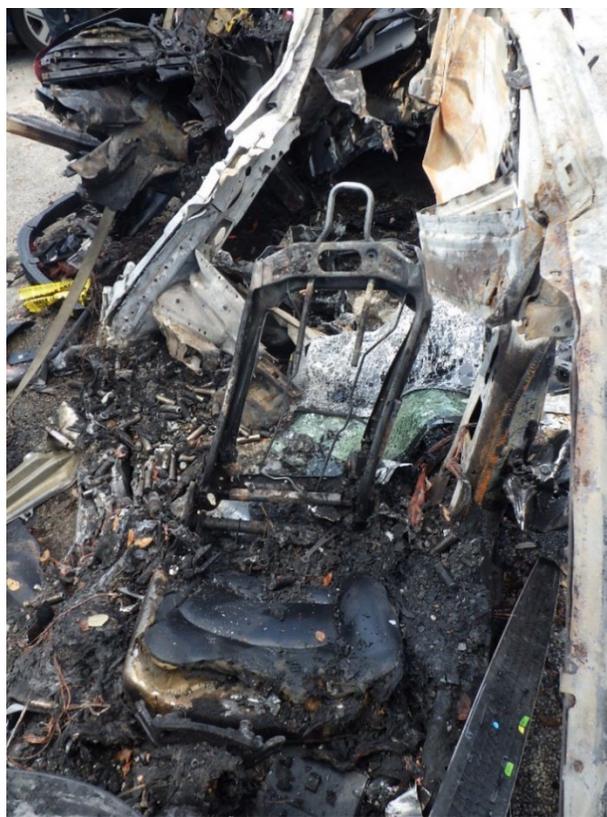
The driver area containing airbags were consumed by fire. The driver seat remained attached to the floor. The backrest was twisted clockwise approximately 15 degrees, and the upper portion displaced outboard about 3 inches. Portions of the seat, including the backrest and right side of the seat pan, had non-metal components which were consumed by fire. The upholstery on the center and left side of the seat pan remained intact. The driver seat belt was consumed by fire; the latch plate was found connected to the buckle.¹³

Figure 7: Driver seat

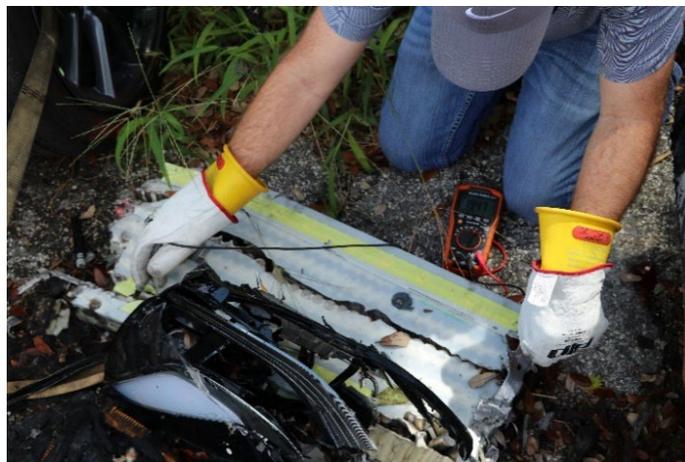
To obtain an estimate of the state of charge, a selection of individually displaced but intact cells were measured. They were found to have about 3.8 volts. To assess potential for stranded energy, multiple voltage measurements were taken across the large portions of the displaced module. The maximum voltage measured was 19 volts. At full state of charge, a complete module has a maximum voltage of about 100 volts across. Similarly, the maximum voltage across 2 modules is 200 volts, and so on. The total maximum pack voltage is about 400 volts. The battery pack contains a pyrotechnic fuse that are triggered under certain conditions such as airbag deployment or faults detected in the battery. These fuses isolate high voltage components to within the pack (cuts off high voltage lines going the motors outside the pack), and divides modules 1 and 2 from 3 and 4, resulting in a maximum of 200 volts on each side of the vehicle. Figure 9 shows measurement of voltage across the large section of the displaced battery module.

Figure 9: Voltage measurement of the displaced battery module section

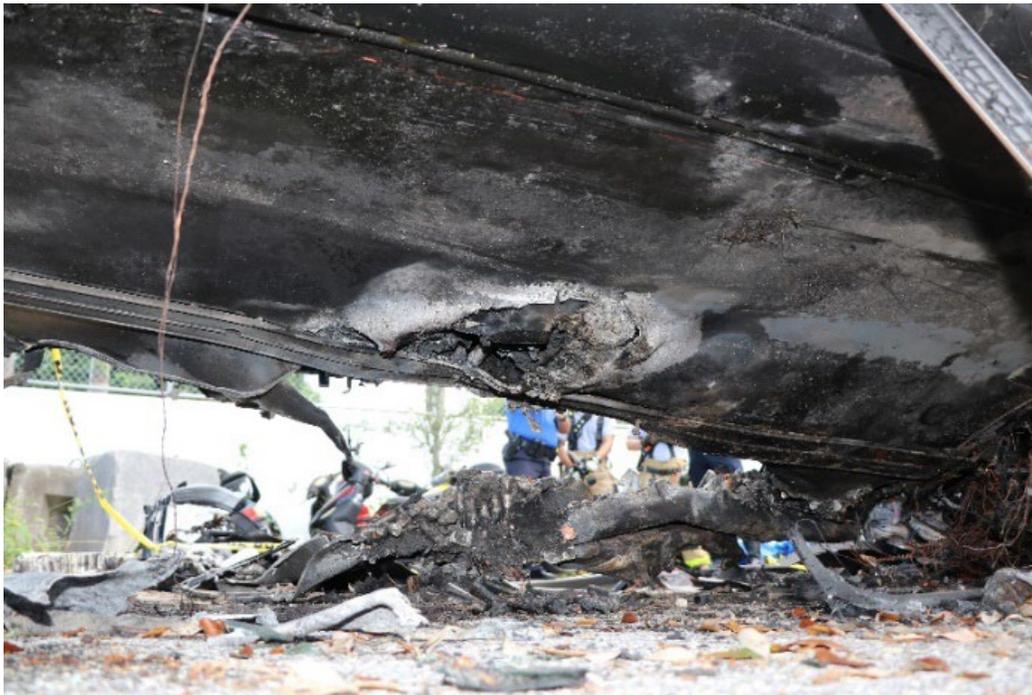
The vehicle was vehiclefully lifted off the ground while being monitored with a thermal camera. No hot spots were identified during or after movement. Severe impact damage to the battery case was evident, extending laterally completely through the width of module 4 and most of module 3, near the center of the vehicle. Module 2 had a large, approximately 10 inch diameter, hole through the bottom of the case, located just left of the centerline of the vehicle, and roughly in line with the tree impact. The materials in the vicinity of the hole exhibited severe thermal damage. The battery case in the vicinity of module 1 did not exhibit ruptures or burns. The battery case exhibited thermal damage and heat warping throughout the intact sections beneath the vehicle. Figures 10 shows the hole in the middle of the battery case in the vicinity of module 3.

Figure 10: Underside of Tesla showing burn hole in the battery case

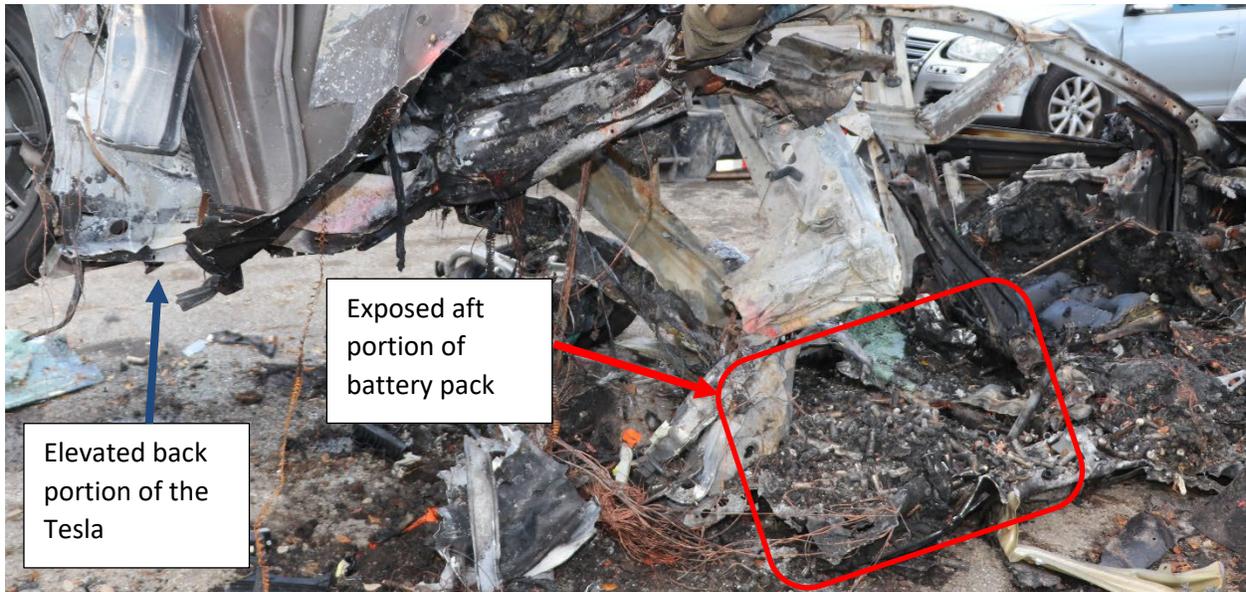
The battery case was not removed from the vehicle. However, when the rear section was elevated, the separation of the vehicle floor exposed the damaged aft portion of the battery case. The entire aft portion of the battery pack had cells in disarray, as shown in figure 11.

Figure 11: Tesla with back half elevated and exposed battery pack

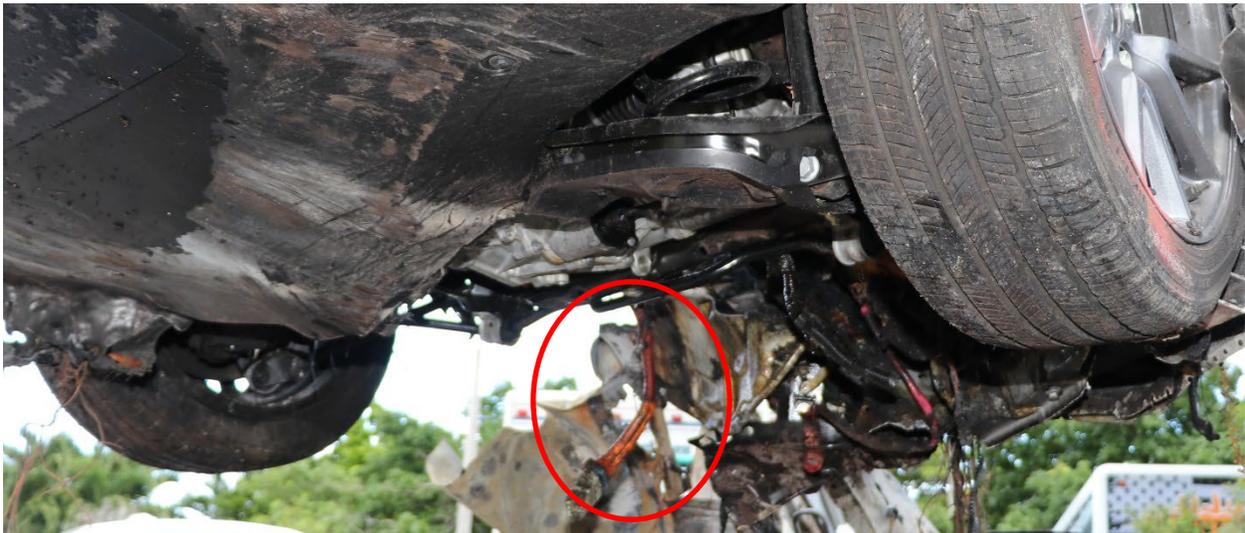
The elevated rear section of the vehicle also showed that the HV electrical connections from the battery pack to the rear motor were damaged and disconnected, as shown in figure 12. Other high voltage lines at the rear of the battery pack were also damaged and displaced.

Figure 12: Underside of the back of the Tesla showing disconnected HV lines to rear motor

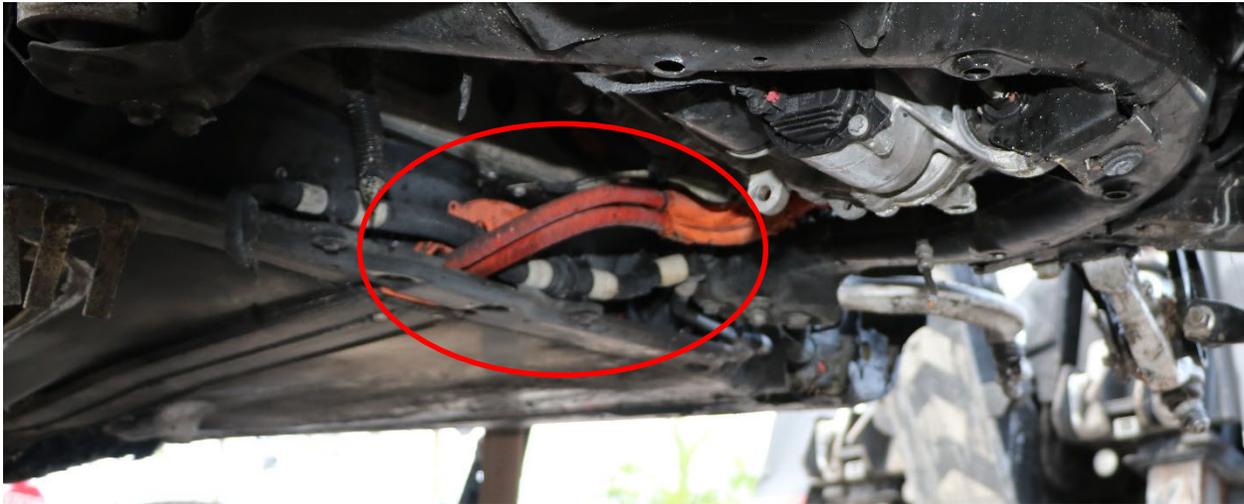
The elevated front section of the vehicle showed that the HV electrical connections from the battery pack to the front motor were intact, as shown in figure 13.

Figure 13: Underside of the front of the Tesla showing intact HV lines to the front motor
