**NATIONAL TRANSPORTATION SAFETY BOARD
OFFICE OF HIGHWAY SAFETY
WASHINGTON, D.C.**

**TECHNICAL RECONSTRUCTION and HIGHWAY FACTORS
GROUP CHAIRMAN'S FACTUAL REPORT**

CORAL GABLES, FLORIDA – HWY21FH011

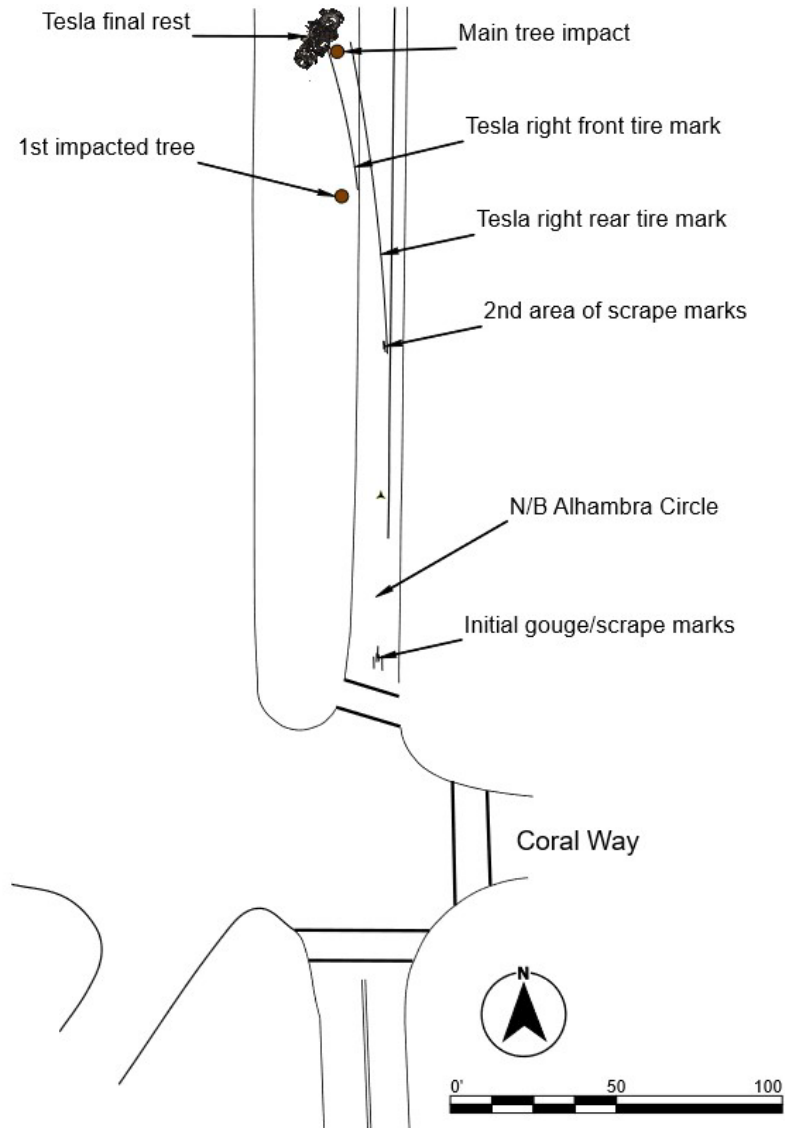
NTSB investigators examined and documented the collision site and other roadway and environmental features on September 21st, 2021, eight days after the collision using ground photography and three-dimensional laser scanning. Site documentation data acquired by the CGPD investigators before the scene was cleared included ground-based photographs and evidence documentation with an electronic total station.¹

Figure 1: Diagram created from NTSB on scene scan data, and total station data received from Coral Gables Police Department.

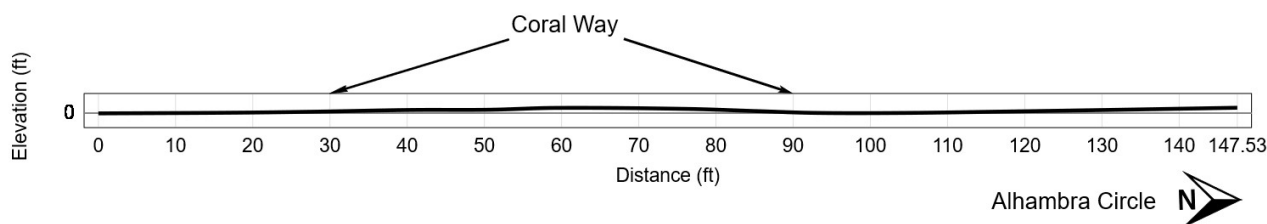
The vertical alignment for vehicles traveling on Alhambra Circle approaching Coral Way in the northbound direction consisted of a 1.2% upgrade slope.³ Continuing northbound from the center of the intersection the vertical alignment transitioned to a 1.1% downward grade leading into the cross pan. The cross pan had a width of about 11 feet. The vertical alignment of Alhambra Circle after the cross pan consisted of a 1.2% upgrade slope. **Figure 3** is a profile diagram of the vertical alignment changes for northbound Alhambra Circle crossing Coral Way.

Figure 3: Diagram of Alhambra Circle elevation profile.

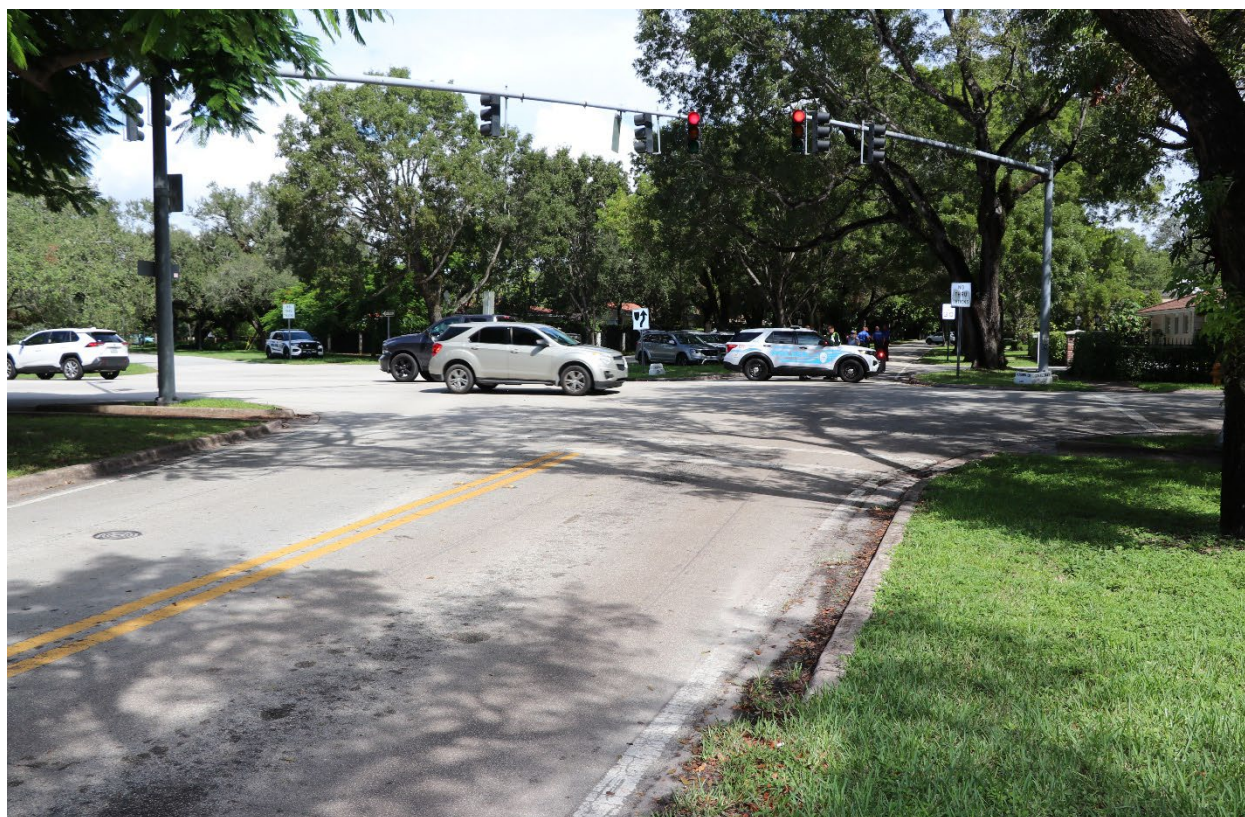
The signal heads are mounted on signal mast arms with support poles located in the northeast, southwest, and southern median. Each approach direction was faced with two signal heads. All signal heads display 8-inch red, yellow, and green circular lamps. **Figure 4** is a photograph depicting the traffic signals and supports.

Figure 4: Photograph depicting traffic signals and signal supports looking northbound on Alhambra Circle. (Source: NTSB)

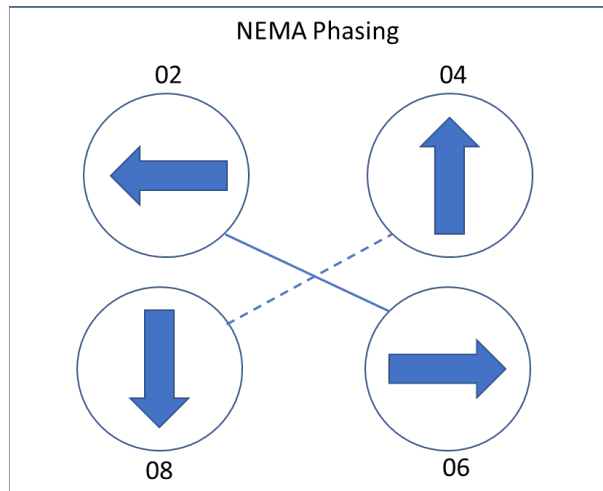
Phase	Direction
2	Westbound Coral Way
4	Northbound Alhambra Circle
6	Eastbound Coral Way
8	Southbound Alhambra Circle

Figure 5: NEMA phasing diagram and direction description

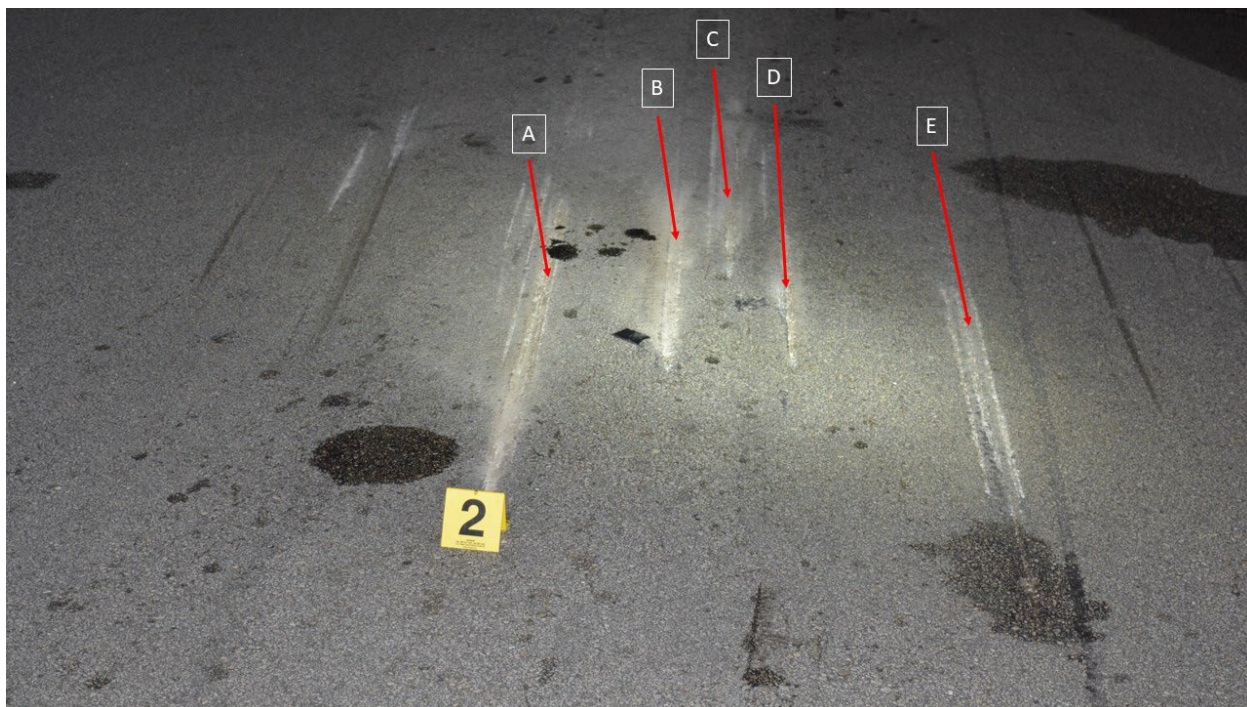
Preceding the collision, the Tesla had been traveling northbound. The onset of evidence appeared in the northbound lane north of the intersection with Coral Way. The evidence began approximately 5 feet north of the northern most crosswalk line and consisted of five large gouge marks coupled with minor scuff marks which all paralleled each other. The area of the evidence was about 8 feet in length and 2.5 feet in width. The lengths of each gouge mark are summarized in Table 3.

Figure 6 is a photograph depicting the area gouge marks listed in the Table 3. The documentation of the gouge marks can be seen in the photograph and are marked by the yellow evidence marker (2).

Figure 6: Image depicting the initial gouge mark evidence in the northbound Alhambra travel lane. (Source: Coral Gables Police Department)

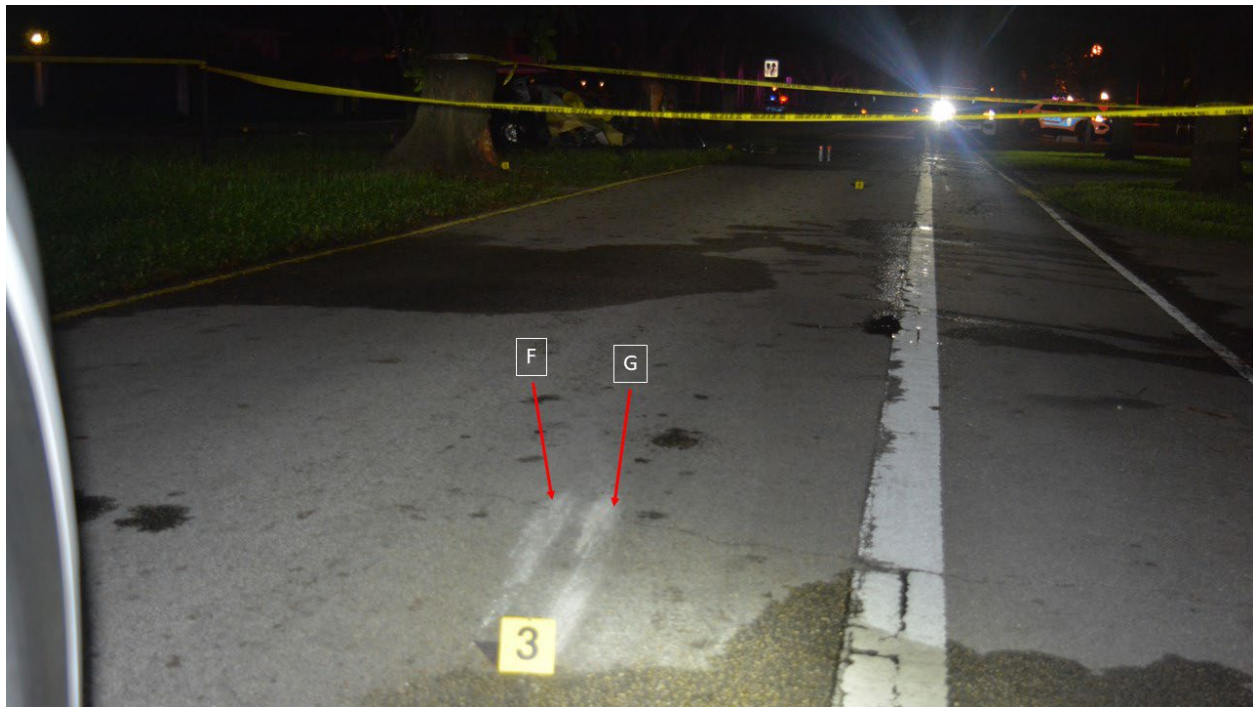
Observed approximately 93 feet north of the initial onset of evidence were two additional scuff marks. The scuff marks paralleled each other and were approximately 0.26 feet apart. **Figure 7** is a photograph showing the two scuff marks the night of the collision. The documentation of the marks can be seen in the photograph and are marked by the yellow evidence marker (3).

Figure 7: photograph depicting the second area of evidence marks. (Source: Coral Gables Police Department)

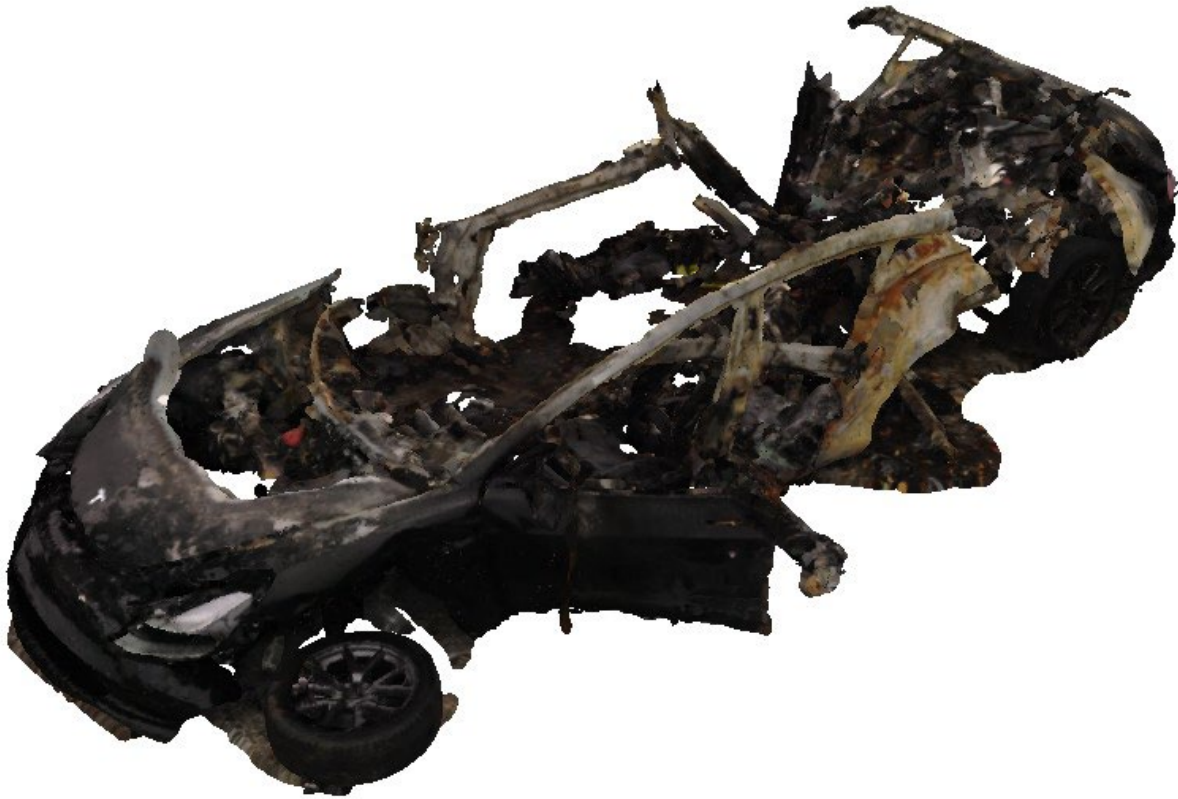
Figure 8: Screen capture depicting the Tesla’s top left side as viewed in the point cloud rendered from the three-dimensional scans through the FARO Scene software.

Overall, the vehicle exhibited catastrophic damage. Fire damage had consumed the interior, roof, and right and left sides. The right side of the vehicle had separated from the frame resulting in the rear of the vehicle partially separating. There was visible intrusion on the right side of the vehicle that began around the right “A” pillar extending rearward to about the midline of the vehicle. The front passenger seat was crushed and had been pushed rearward into the rear seating area. The floor pan was torn open exposing the vehicles high voltage lithium-ion battery case. The left front wheel assembly had been torn from the vehicle. According to measurements obtained from the scene by CGPD investigators the left wheel assembly was located approximately 107 feet northwest of the first tree impact. The wheel was cracked with the rim broken and pushed upward toward the center of the wheel. The tire sidewall exhibited a tear in the rubber that lined up with the break in the wheel rim.

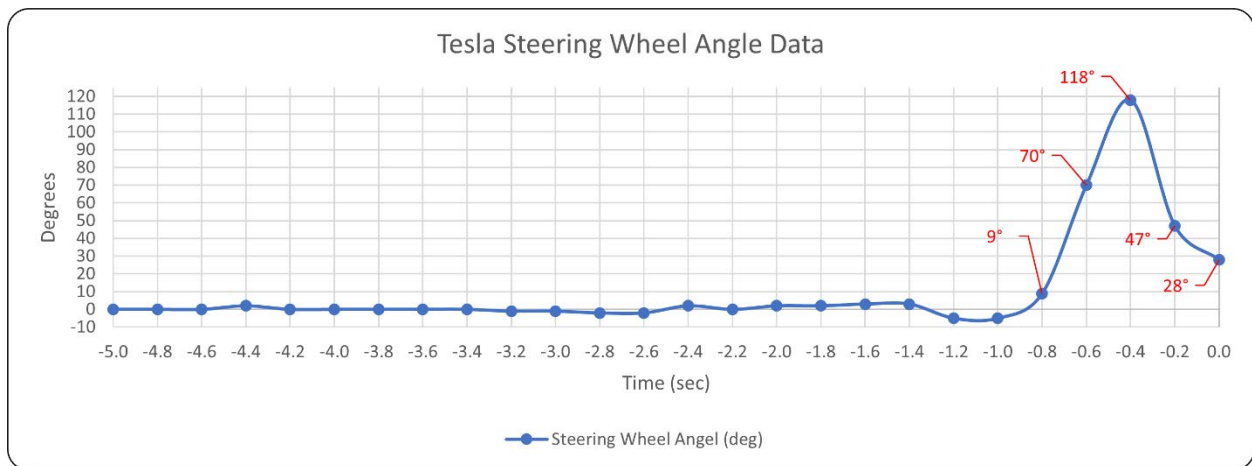
The Tesla had accelerated from 68 mph to a top speed of 90 mph. The Tesla then decelerated to 52 mph at time zero.⁹ The accelerator pedal percentage fluctuated from a low of 0.0% to a high of 100%. The service brake was reported as “off” for the five seconds, the stability control reported as “Not Engaged” at the 5 second data point until the 1.4 second data point. From the 1.2 second data point to time zero the stability control reported as “Faulted”. The EDR also recorded steering wheel angle. The steering wheel was reported as either a negative or positive value. A positive value indicated right-hand steering while a negative value indicated left-hand steering. The values reported ranged from -5° to 3° with a peak steering value of 118° reported at 0.4 seconds.

Figure 9 below shows the reported steering wheel angle in relation to the pre-crash time series data.

Figure 9: Graph depicting the reported steering wheel angle data.
