**PRELIMINARY REPORT**  
**HIGHWAY**  
**Electric Vehicle Run-Off-Road Crash**  
**and Postcrash Fire**  
**(HWY21FH011)**

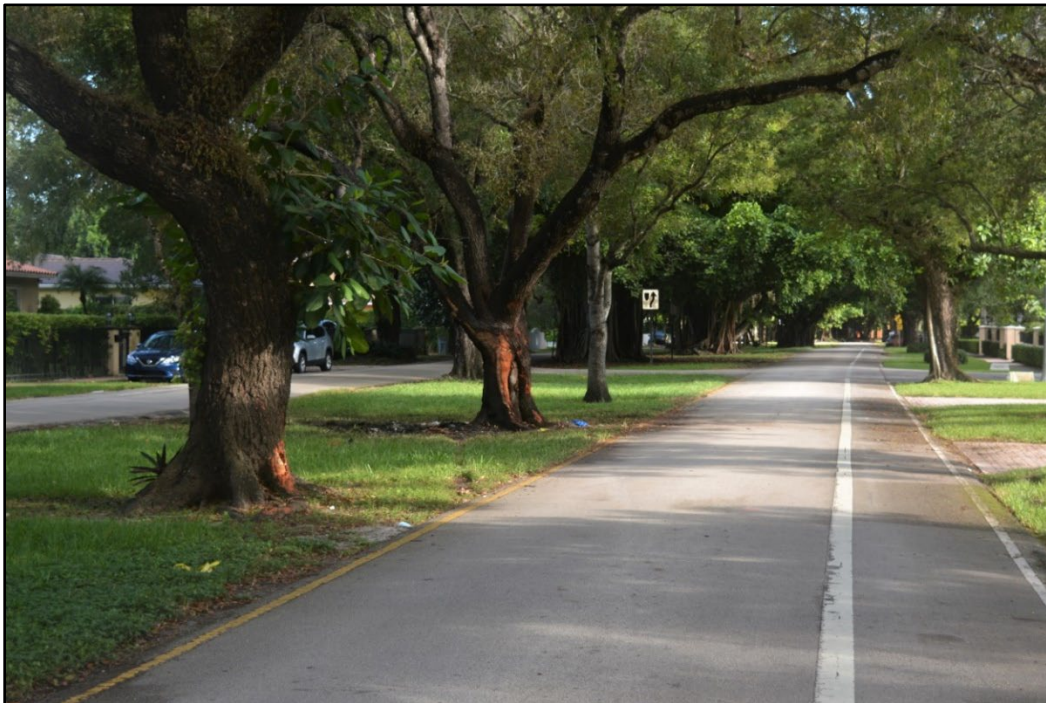
About 8:55 p.m. eastern daylight time on Monday, September 13, 2021, a 2021 Tesla Model 3 Long Range Dual Motor electric car traveling north on Alhambra Circle in Coral Gables, Miami-Dade County, Florida, accelerated through an intersection, left the roadway, crashed into two trees, and caught fire. Alhambra Circle is a residential street with a 30-mph speed limit. As the car approached the signal-light-controlled intersection with Coral Way, it passed another car and accelerated as it neared the yellow signal light at the intersection. The car continued north through the intersection, traveled about 140 feet, and departed the roadway. The left front of the car struck a tree, after which it rotated 90 degrees counterclockwise. It then continued north another 42 feet until the passenger side collided with a second tree (figure 1).

**Figure 1.** Alhambra Circle looking north from Coral Way intersection, with two trees hit by car visible on left. (Source: Coral Gables Police Department)

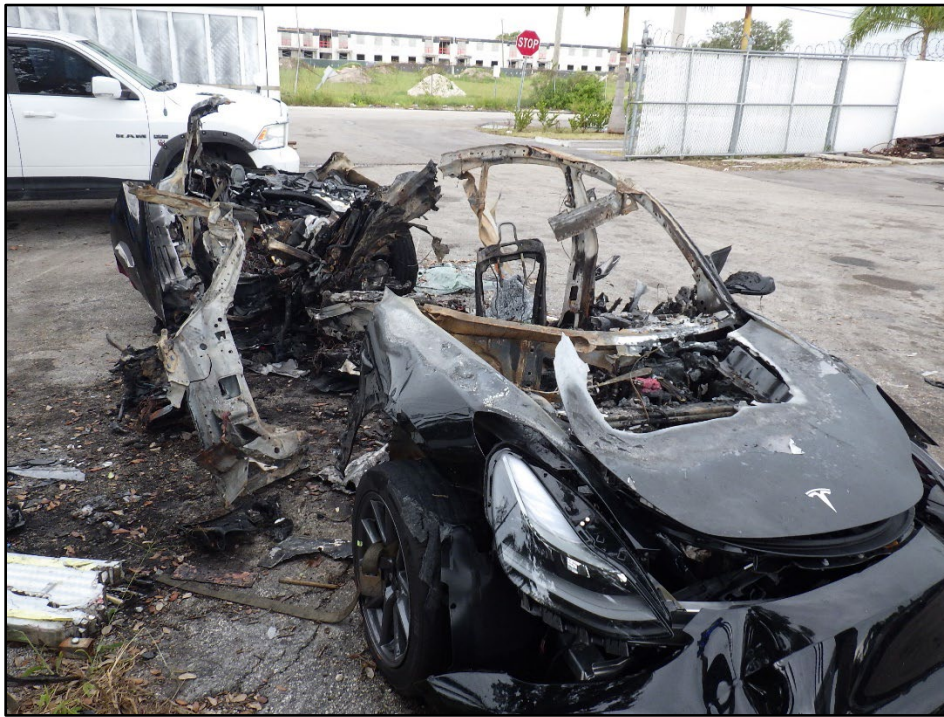
The crash damaged the car's high-voltage lithium-ion battery case, which is where the fire started. The fire destroyed much of the vehicle's interior (figure 2), including the infotainment console, which contained the car's onboard data storage device. The vehicle's event data recorder (EDR), which records and stores data associated with vehicle speed, acceleration, seat belt status, and airbag deployment, was recovered but had sustained fire damage. The EDR was taken to the National Transportation Safety Board (NTSB) Recorder Laboratory, where the damaged data chip was repaired and installed into an exemplar EDR so that the data could be retrieved. The process yielded about 5 seconds of precrash and crash data. Preliminary evaluation of the data indicated that application of the accelerator pedal ranged from 0 to 100 percent, the service brake remained off, and the maximum recorded vehicle speed was 90 mph.<sup>1</sup>

**Figure 2.** Impact damage to passenger side and fire damage to vehicle interior.
