# National Transportation Safety Board

HWY23MH006

## **HUMAN PERFORMANCE**

Group Chair's Factual Report

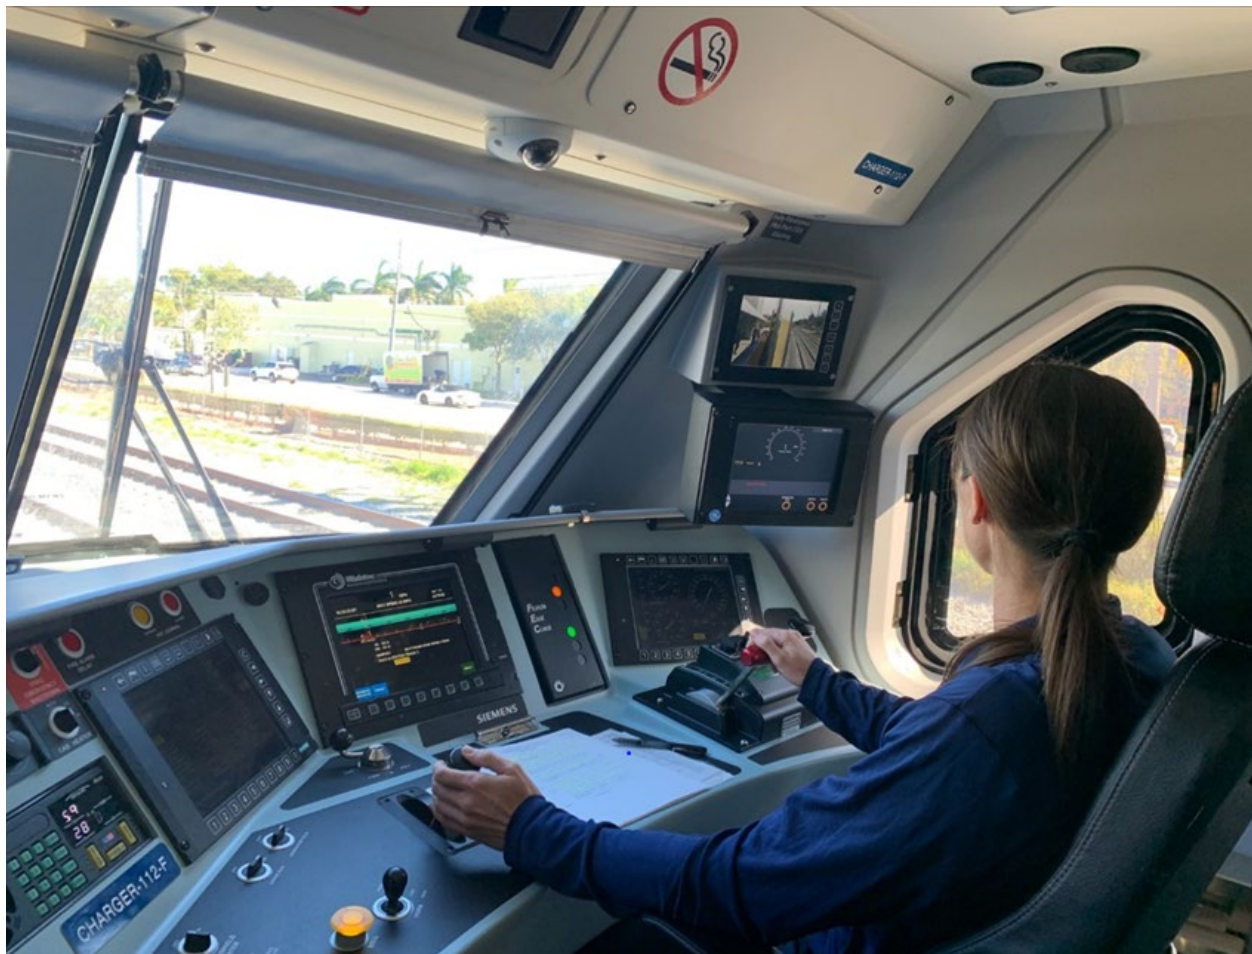
**Figure 1.** Photograph of an exemplary locomotive engineer working at her locomotive engineer's station, located on the right side of the locomotive cab.

Figure 1 shows - an engineer's left hand on the locomotive throttle. The engineer's right hand is on the automatic brake valve which brakes the entire train. The independent brake valve, which brakes the locomotive only, is positioned to the right of the engineer's hand, out of sight in the photograph.

Figure 1 also shows rearview camera's video displayed on the top screen on the right. This display shows side-by-side camera views looking down both sides of the train's exterior. The Positive Train Control (PTC) screen is in the center and to its right is the Aspect Display Unit for the Automatic Train Control System (working in conjunction with the signals system). The orange button on the lower left is the train's bell. This is required to be activated at every grade crossing. The black lever to the right is the train's air horn. The train's bell comes on automatically and the exterior auxiliary lights are activated when the air horn is activated (blown).

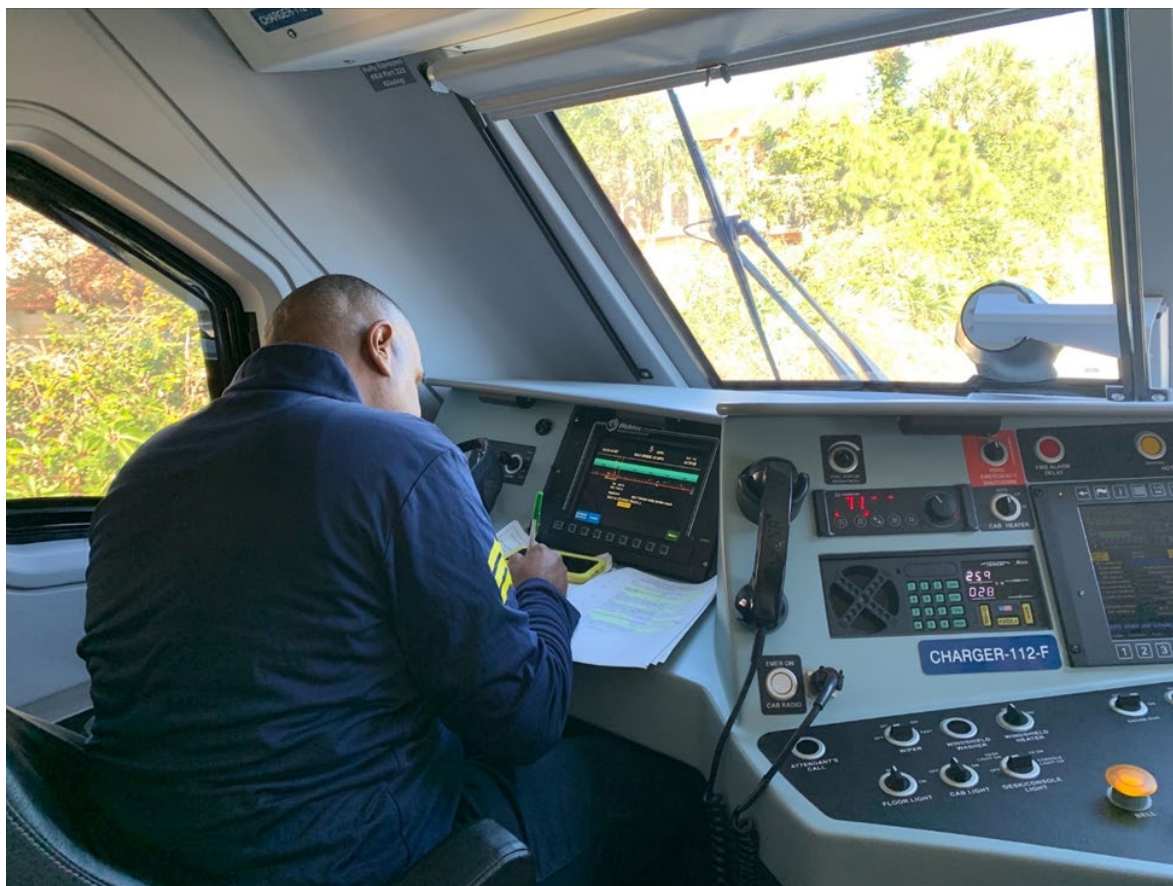
**Figure 2.** Photograph of an exemplary conductor's station, located on the left side of the locomotive cab, showing a Brightline conductor working.

Figure 2 shows an exemplary Brightline conductor working while the train is stopped. The PTC screen in front of him is a repeat of the engineer's PTC screen. The conductor uses the VHF radio handset in the middle of the photograph to call the employee in charge, dispatcher, other trains and signal maintainers for routine and emergency situations.

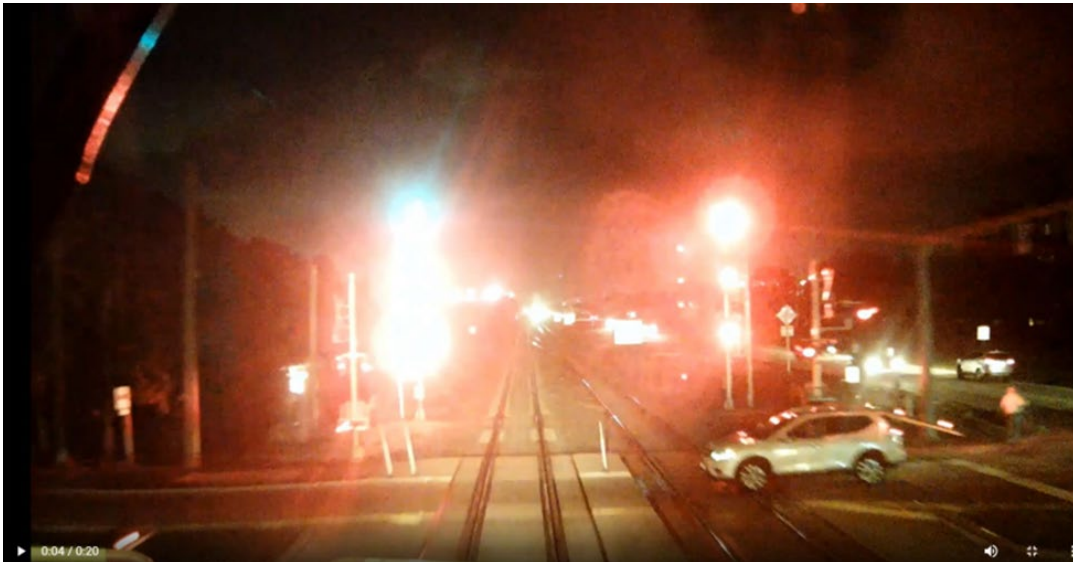
Images from the freight train outward facing video show the SUV stopped with its front tires inside the foul of the track and the gate crossing arm lowered behind the vehicle (Figure 6). The driver and passenger were both seated in the vehicle.

**Figure 6.** This photograph of the accident scene, captured from the freight train's outward facing video at 20:05:55, provides a northbound view of the grade crossing prior to the Brightline train's impact with the SUV on the right side of the screen. The gate arm is visible, fully lowered behind the SUV. A pedestrian is on the sidewalk behind the SUV. The headlight of the oncoming Brightline train is seen in the middle of the photograph.
