National Transportation Safety Board

HWY23MH006

RAILROAD SIGNAL AND HIGHWAY FACTORS GROUP

Group Chair's Factual Report

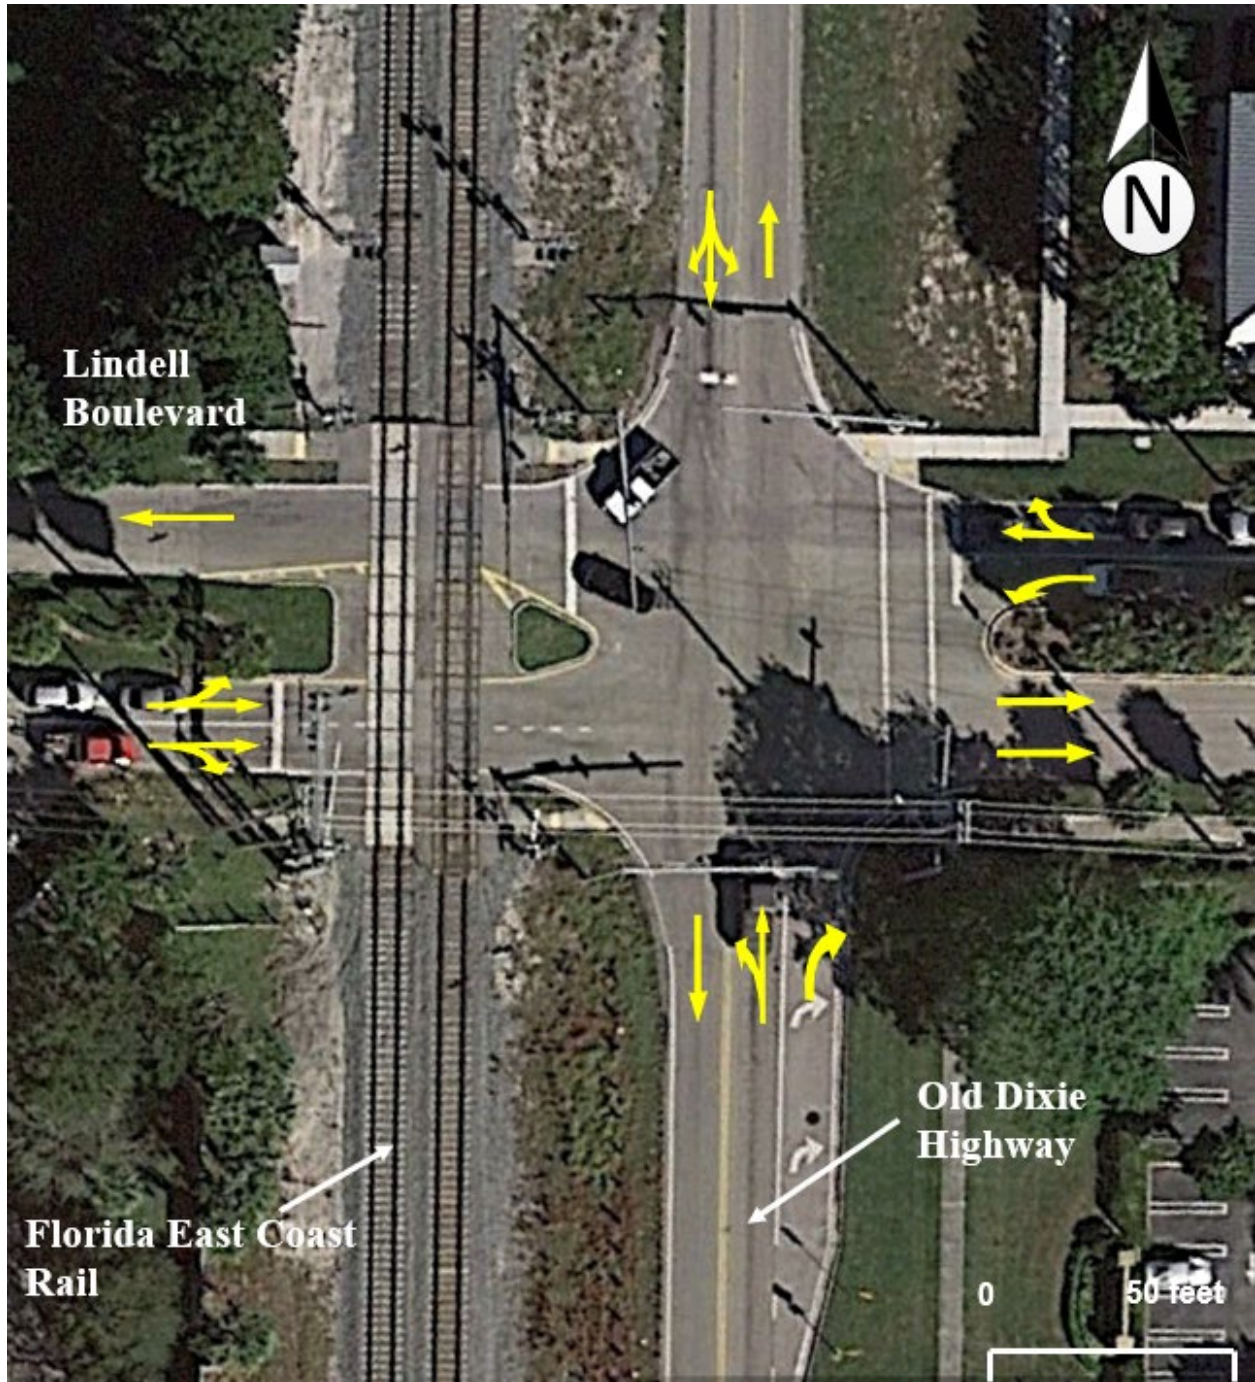
Figure 6 illustrates the geometry and lane designations for the Lindell Boulevard grade crossing, the subject of the 2-fatal grade crossing crash.

Figure 6 - Geometry and lane designations for the Lindell Boulevard grade crossing (Source: Google Earth revised).

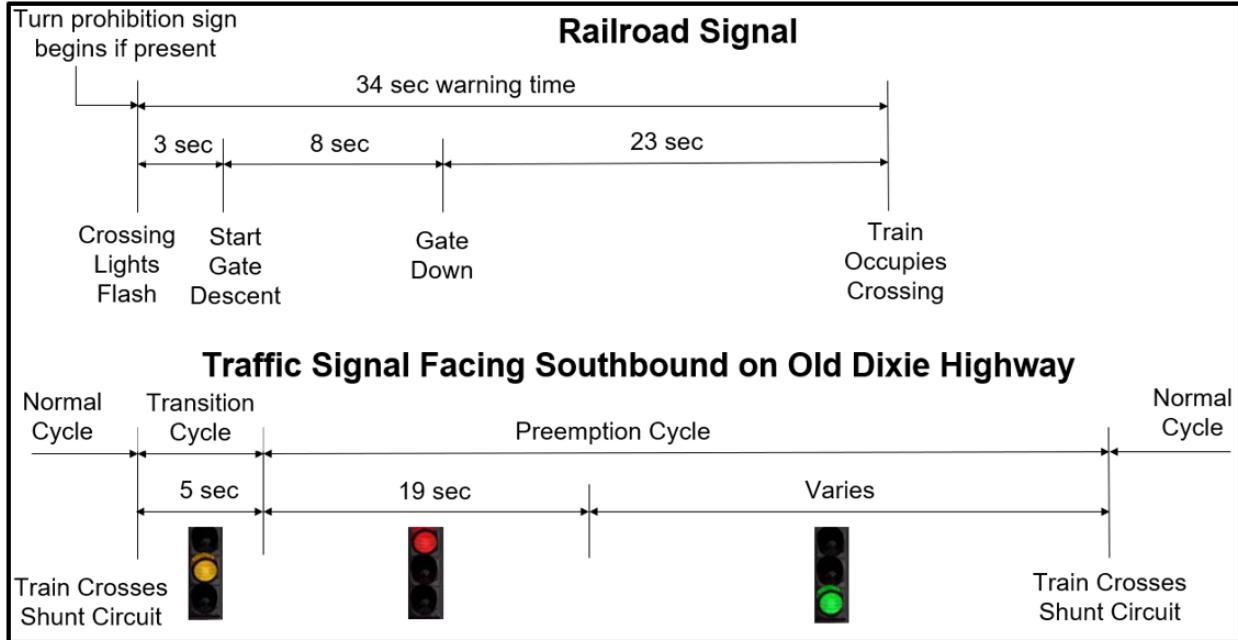
Figure 8 illustrates the timeline configuration of the railroad and traffic signal timing for the Lindell Boulevard grade crossing. The railroad signal time is in the upper half of the slide and the traffic signal facing southbound on Old Dixie Highway approaching Lindell Boulevard is in the lower half of the slide. **Figure 8** shows the typical design condition for the railroad and traffic signal time and does not represent the conditions at the time of the crash in which the northbound freight train activated the warning devices initially on approach to the grade crossing and the southbound Brightline passenger train came immediately thereafter.

Figure 8 - Timeline of the railroad and traffic signal time with the railroad signal time in the upper half of the slide and the traffic signal facing southbound on Old Dixie Highway approaching Lindell Boulevard in the lower half of the slide.

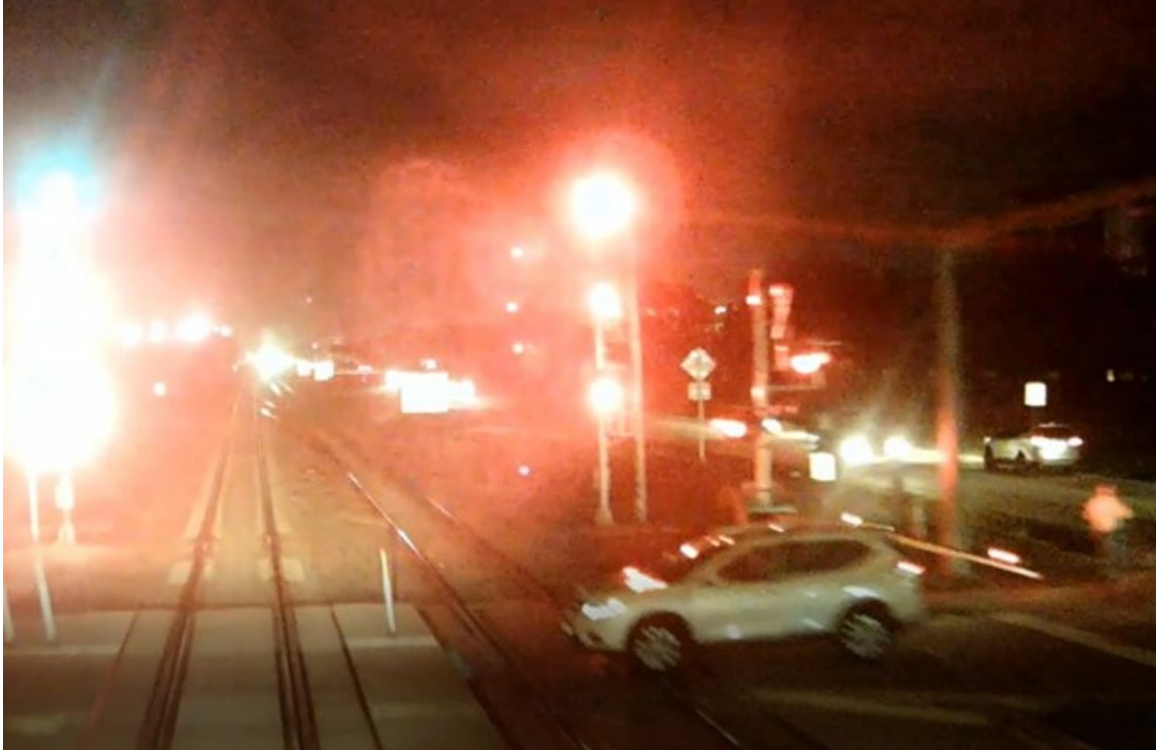
Figure 9 illustrates the northbound freight train video and the gate down and fully lowered behind the SUV at the Lindell Boulevard grade crossing. The approaching southbound Brightline passenger train is shown in the background.

Figure 9 - Freight train video and the gate down and fully lowered behind the SUV at the Lindell Boulevard grade crossing looking to the north (Source: Florida East Coast Railway).

At the Lindell Boulevard grade crossing, the distance from the lowered gate to the centerline of the eastern track (mid-point between rails) was approximately 16 feet which complied with the 2023 MUTCD in which locations of gates are to be determined by the Diagnostic Team.²⁹ The painted white stop line was placed about 8 feet from the lowered gate, which complied with the 2023 MUTCD guidance that a stop line be placed approximately 8 feet from a gate, when present.³⁰

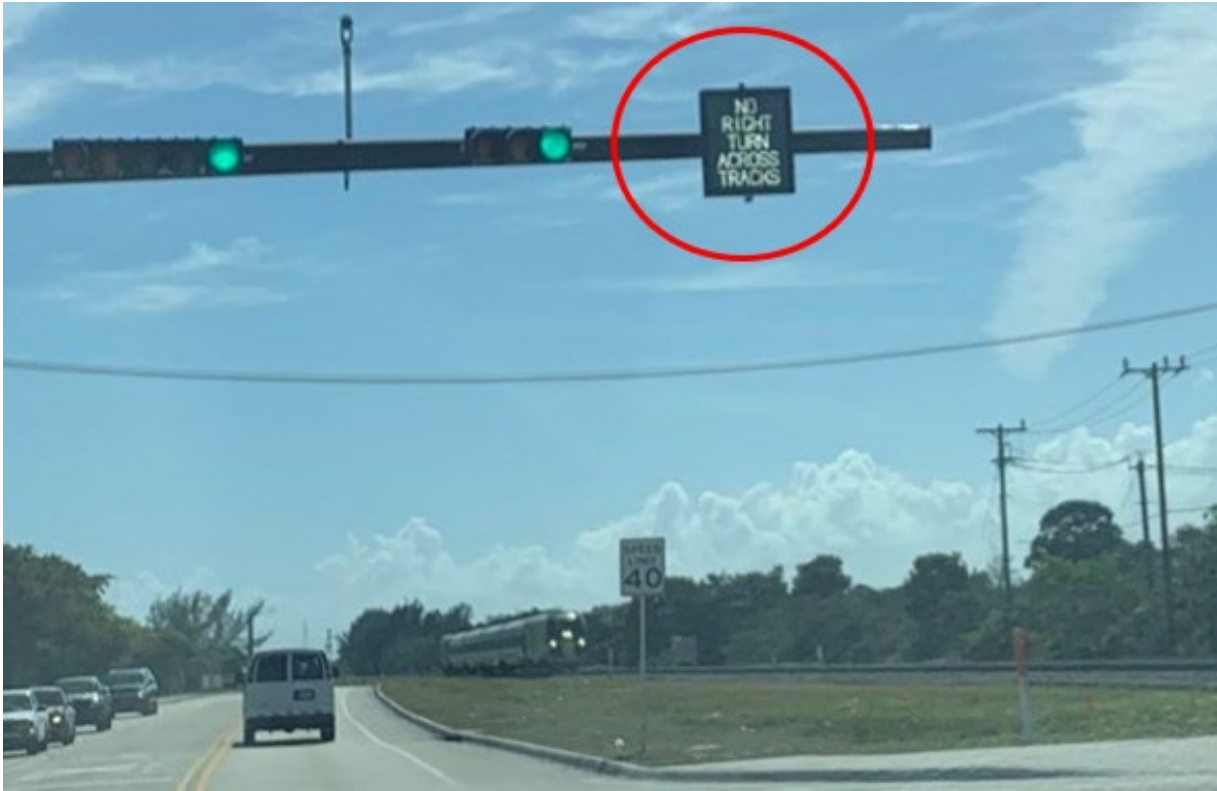
The Lindell Boulevard grade crossing did not have turn prohibition signs as was found at the Hidden Valley Boulevard grade crossing shown in **Figure 10** and the Linton Boulevard grade crossing shown in **Figure 11**.³¹ Both grade crossings were located approximately one-half mile to the south and one mile to the north, respectively. The Hidden Valley Boulevard grade crossing had the text only turn prohibition sign indicating “No Right Turn Across Tracks” with the train shown in the

Figure 10 - Hidden Valley Boulevard grade crossing illustrating text only turn prohibition sign indicating "No Right Turn Across Tracks" with the Brightline passenger train shown in the background looking to the south.

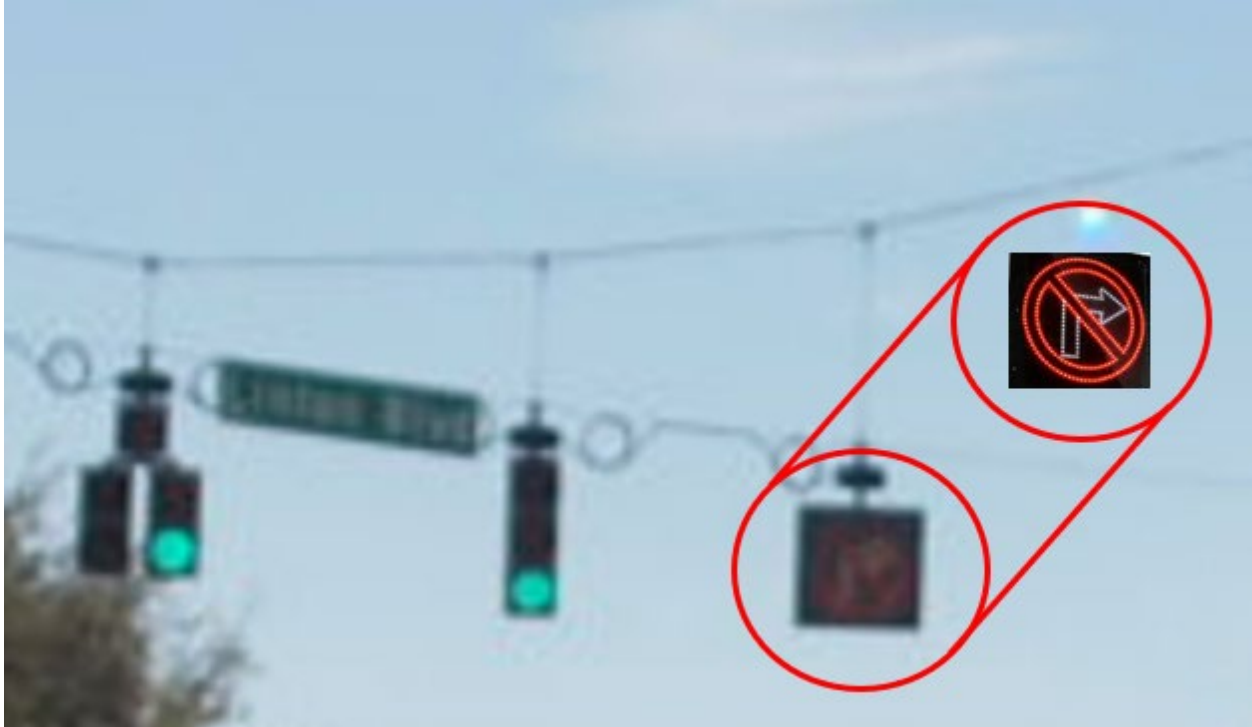
background of the photo. The Linton Boulevard grade crossing had the figure-only turn prohibition sign indicating "No Right Turn".

Figure 11 - Linton Boulevard grade crossing illustrating figure-only turn prohibition sign indicating “No Right Turn” looking to the south. A clear image of the figure-only turn prohibition sign indicating “No Right Turn” is shown to the upper right when active.
