# National Transportation Safety Board

HWY23MH006

## **SURVIVAL FACTORS**

Group Chair's Factual Report

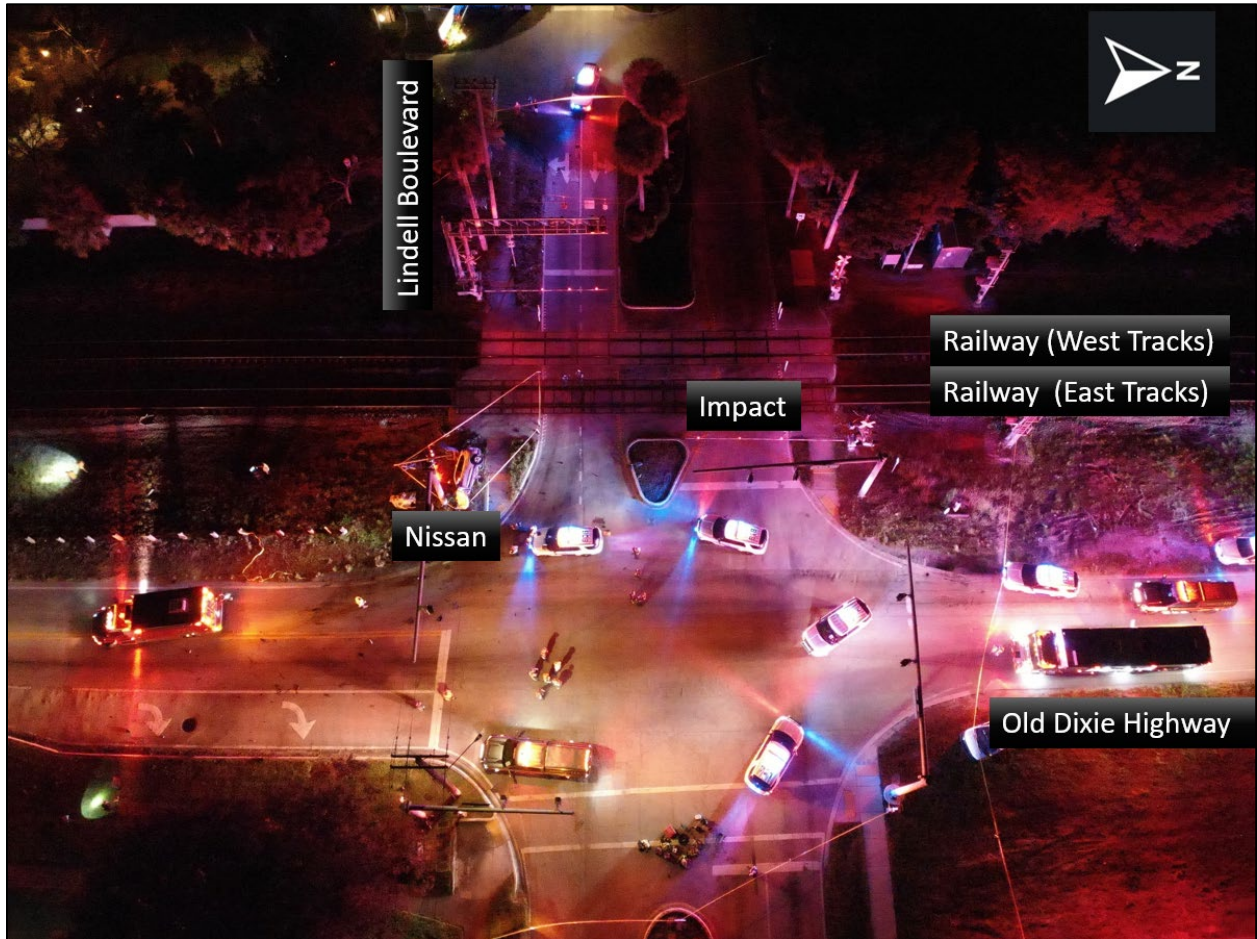
**Figure 2: Aerial of Crash Scene Post-Impact**  
Source: Delray Beach Police Department

artificial lighting at the intersection of the FECR railway and Lindell Boulevard, nor the northbound or southbound leadup on Old Dixie Highway to the intersection of Lindell Boulevard. During the nighttime inspection, terrestrial photographs and video were taken by NTSB investigators. Video footage of a northbound and southbound Brightline train were captured. An overview of the crash scene location can be observed in Figure 2. In Figure 2, the Delray Beach Police Department (DBPD) and Delray Beach Fire Rescue (DBFR) are still present on scene, and the Nissan's final rest position can be observed.

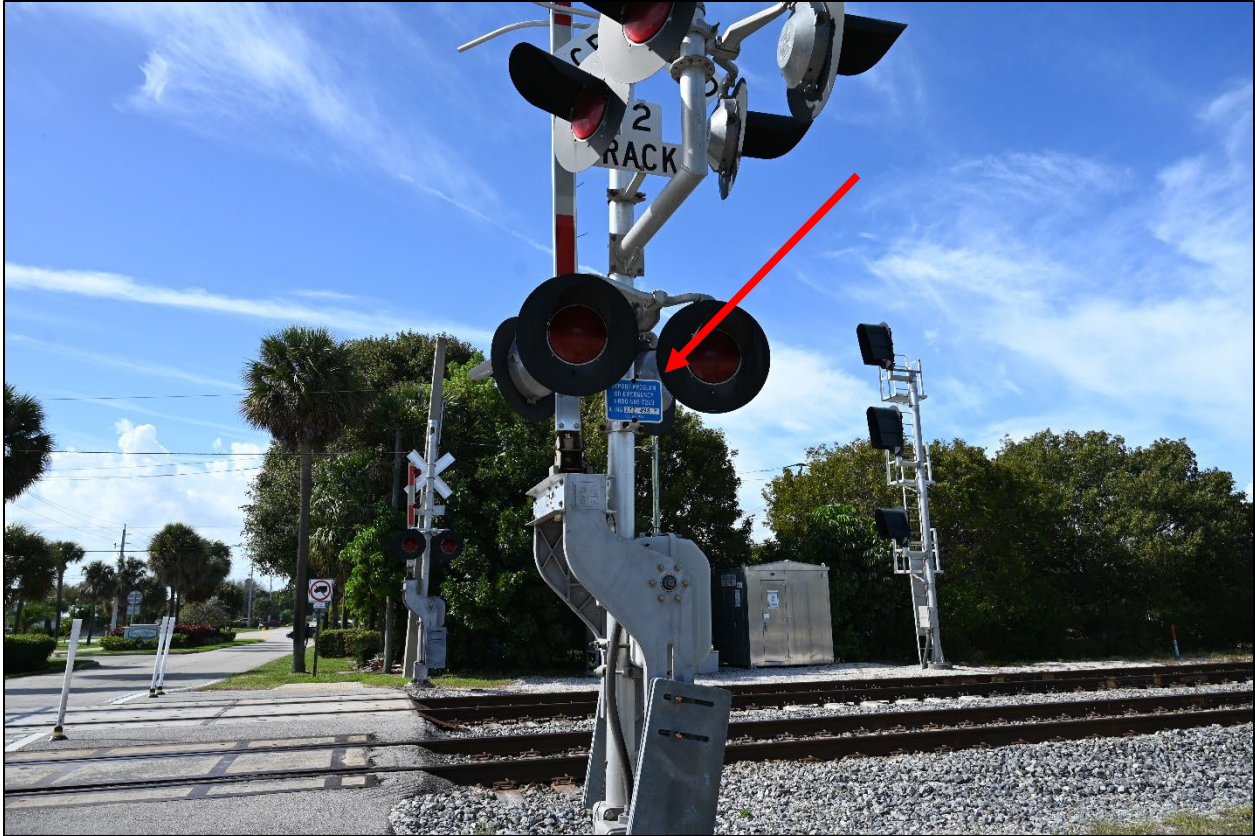
**Figure 3: Westbound Lindell Boulevard Emergency Signage**

The rail crossing was equipped with eastbound and westbound vehicle and pedestrian gate arms with gate arm lamps, alternating red flashing signals, and signage containing an emergency phone number and DOT crossing information. The westbound emergency signage, as observed in Figure 3, measured 9x12 inches, was retroreflective, and contained white and black characters and a blue background. The emergency signage was located behind to the flashing signals, and the base of the emergency signage measured approximately 91 inches above the ground. The eastbound and westbound signage was not visible from the Nissan's perspective while positioned on the tracks. The eastbound emergency signage had similar dimensions as the westbound signage.

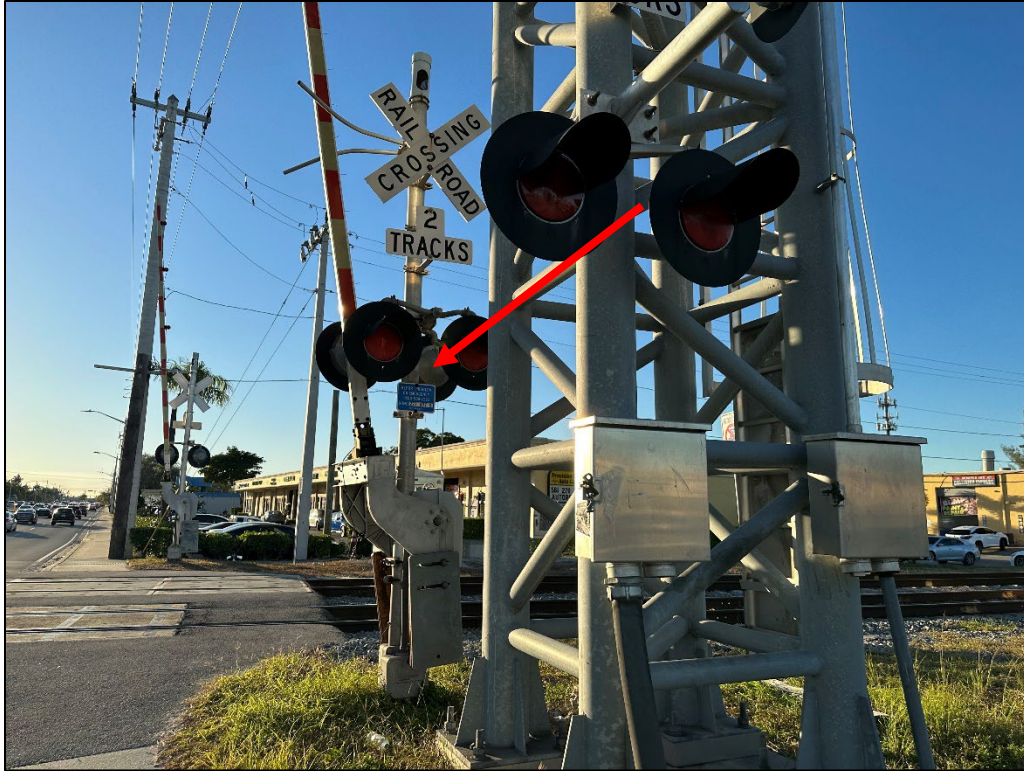
**Figure 5: Westbound Linton Boulevard Emergency Signage**

The rail crossing was equipped with eastbound and westbound vehicle and pedestrian gate arms with gate arm lamps, alternating red flashing signals, and signage containing an emergency phone number and DOT crossing information. The westbound emergency signage, as seen in Figure 5, measured 9x12 inches, was retroreflective, and contained white and black characters and a blue background. The emergency signage was located aft to the flashing lights, and the emergency signage measured approximately 96 inches above the ground. The eastbound emergency signage had similar dimensions as the westbound signage.

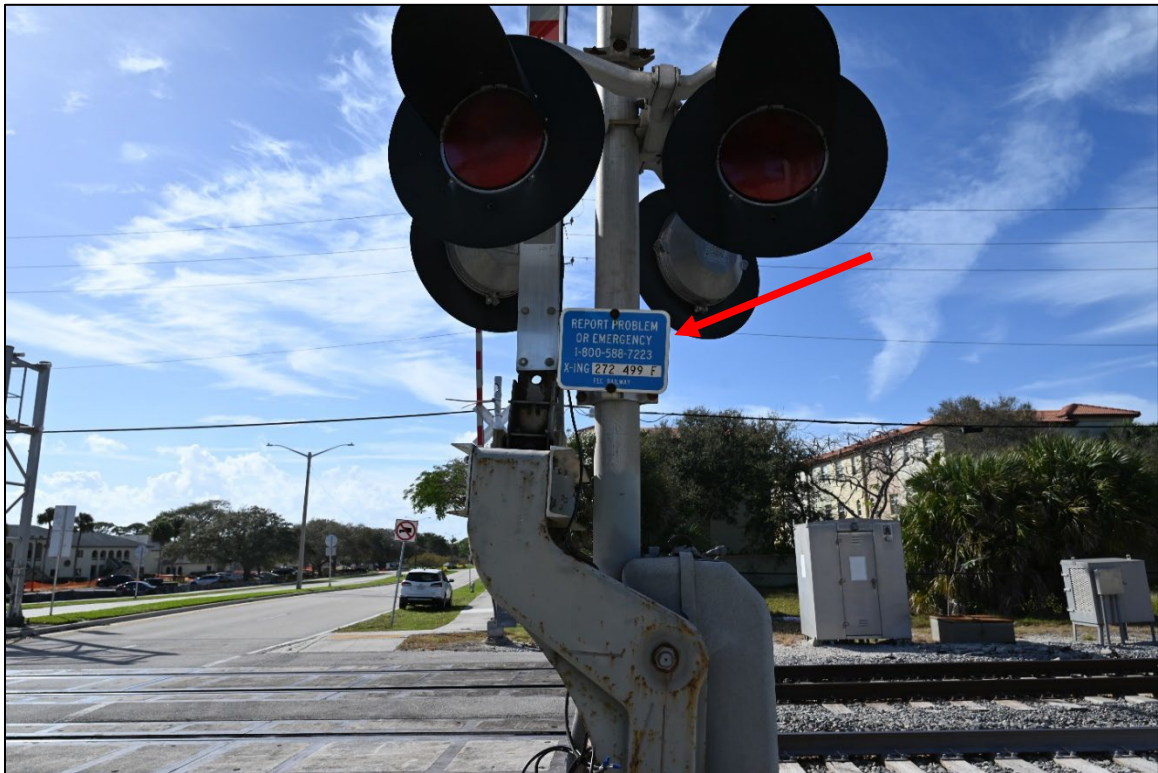
**Figure 7: Westbound Hidden Valley Boulevard Emergency Signage**

The rail crossing was equipped with eastbound and westbound vehicle and pedestrian gate arms, flashing lights, and signage containing an emergency phone number and DOT crossing information. The westbound emergency signage, as seen in Figure 7, measured 9x12 inches, was retroreflective, and contained white and black characters and a blue background. The emergency signage was located behind the flashing lights, and the emergency signage measured approximately 90 inches above the ground. The eastbound emergency signage had similar dimensions as the westbound signage.

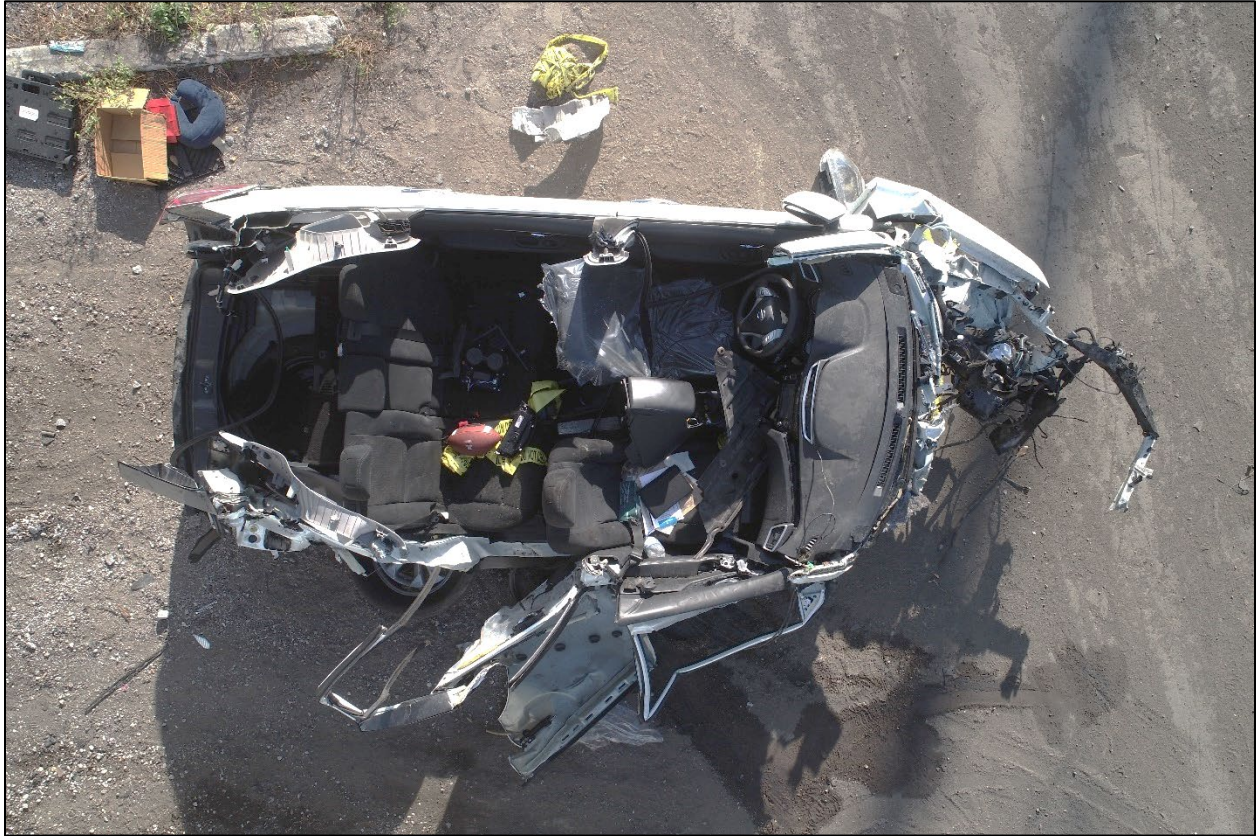
**Figure 8: Aerial Photograph of Nissan Post-Collision**

As the collision between the front-right of the Nissan and the front of the Brightline train occurred, the Nissan came to a final rest, overturned on its right side, on the southwest corner of Lindell Boulevard and Old Dixie Highway. The engine from the Nissan was located southeast across the street from the Nissan's final rest location. Post-collision, the train stopped an unknown distance south of the subject intersection.

The 2015 Nissan Rouge SV AWD was inspected on February 12-14, 2023, at Westway Towing, located in Boca Raton, Florida. The Nissan sustained significant front-end damage from the collision and damage consistent with extrication attempts from first responders, as observed in Figure 8. The engine and most of the Nissan's engine compartment separated from the vehicle at the vehicle's firewall. There was no supplemental restraint or inflatable restraint activation observed for any of the vehicle's

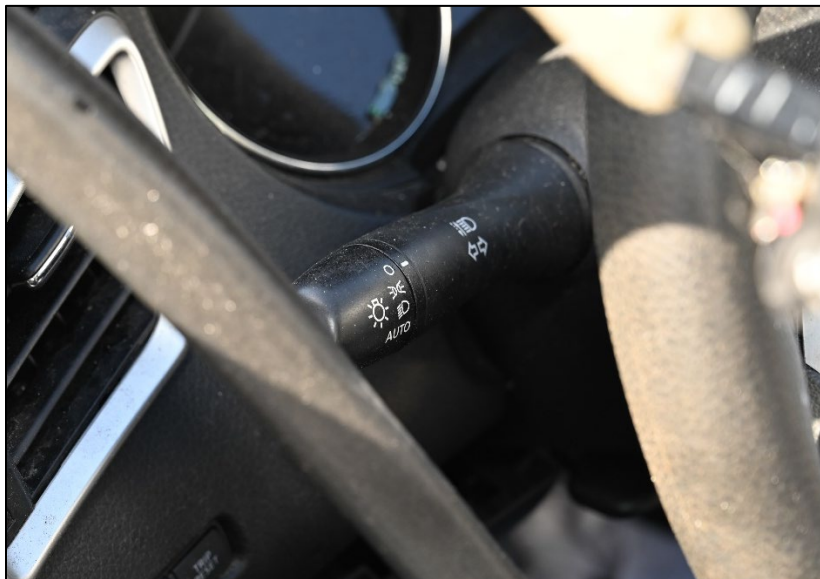
**Figure 9: Nissan Headlight Switch - Off**

airbags or pyrotechnic pretensioners. The Nissan was equipped with a push-to-start/stop switch. The Nissan's headlight setting was positioned in the "off" setting during the inspection, as seen in Figure 9. When interviewed by NTSB investigators, both police and rescue first responders stated that they did not modify the headlight position of the vehicle during rescue operations. <sup>2</sup>

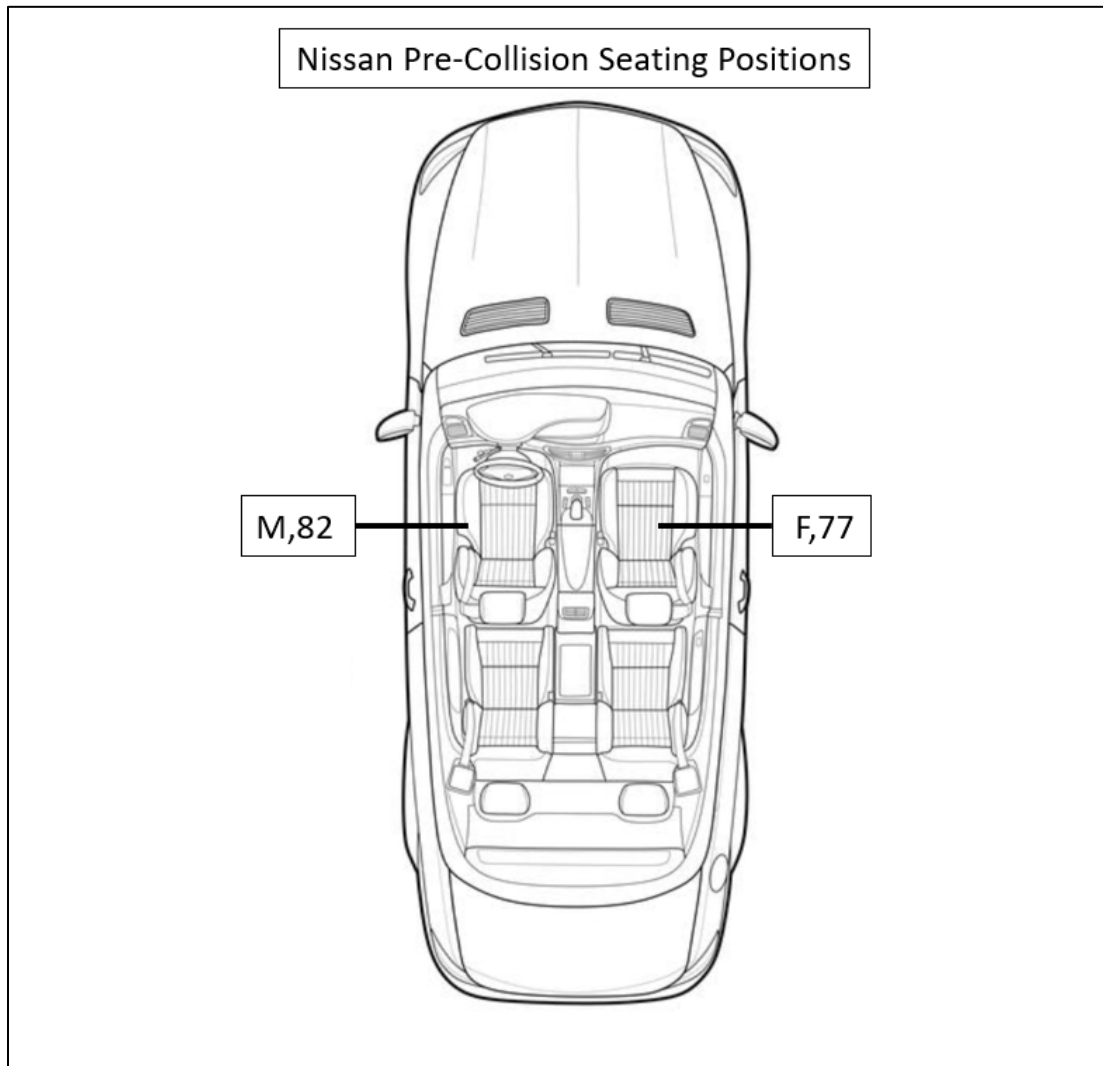
**Figure 10: Nissan - Pre-Collision Seating Positions**

Through witness testimony and occupant kinematic analysis, it was determined that the male was seated in the driver's seat area and the female was seated in the front-passenger seat area during impact, as seen in Figure 10.

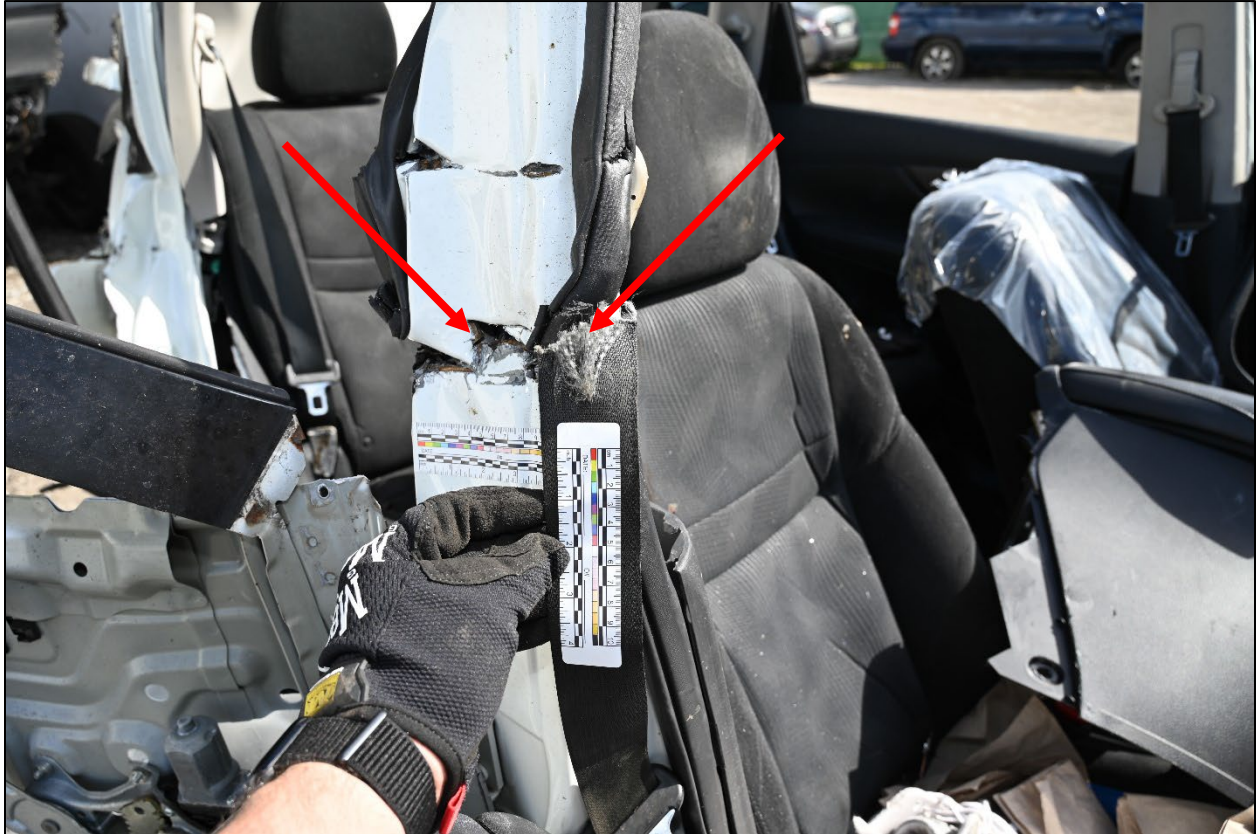
**Figure 11: Nissan Front-Passenger Seatbelt**

The front-passenger seatbelt's upper webbing was separated from the lower webbing. Upon closer inspection, the seatbelt was cut during extrication efforts to remove the roof. The cuts observed on the B-pillar and the front-passenger seatbelt were the at the same height as the lowest cut-mark observed on the B-pillar, as observed in Figure 11. There were three cuts attempted during rescue on the passenger-side B-pillar during extrication attempts. During the first two cut attempts, rescue encountered resistance from the portions of the seatbelt mechanism, which

required additional higher cuts on the B-pillar to aid with the extrication efforts. The lower webbing to front-passenger seatbelt was caught in the damaged front-right door. An inspection of the three rear seatbelts did not result in any evidence that was consistent with seatbelt usage by a passenger involved in a significant collision.

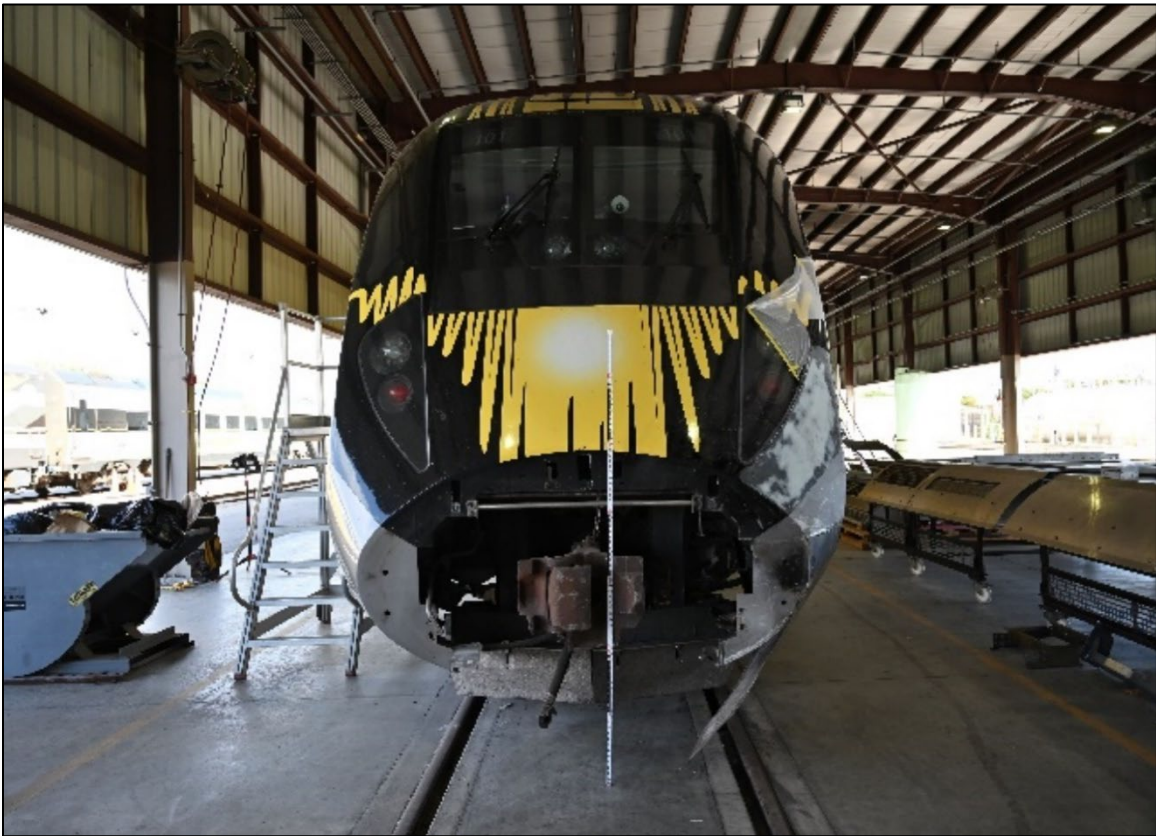
**Figure 12: Brightline Train Post-Collision**

An interior and exterior inspection of the Brightline train was conducted on the morning of February 11, 2023. The inspection occurred at the Brightline Maintenance Facility, located in West Palm Beach, Florida. During the inspection, train's audible and visual components were tested. The Brightline train's horn and lights were activated, which was recorded. Photographs of the damaged exterior of the train were taken. The train had begun repairs prior to the NTSB's arrival, as observed in Figure 12, which was reportedly halted upon notification of the NTSB's investigation.

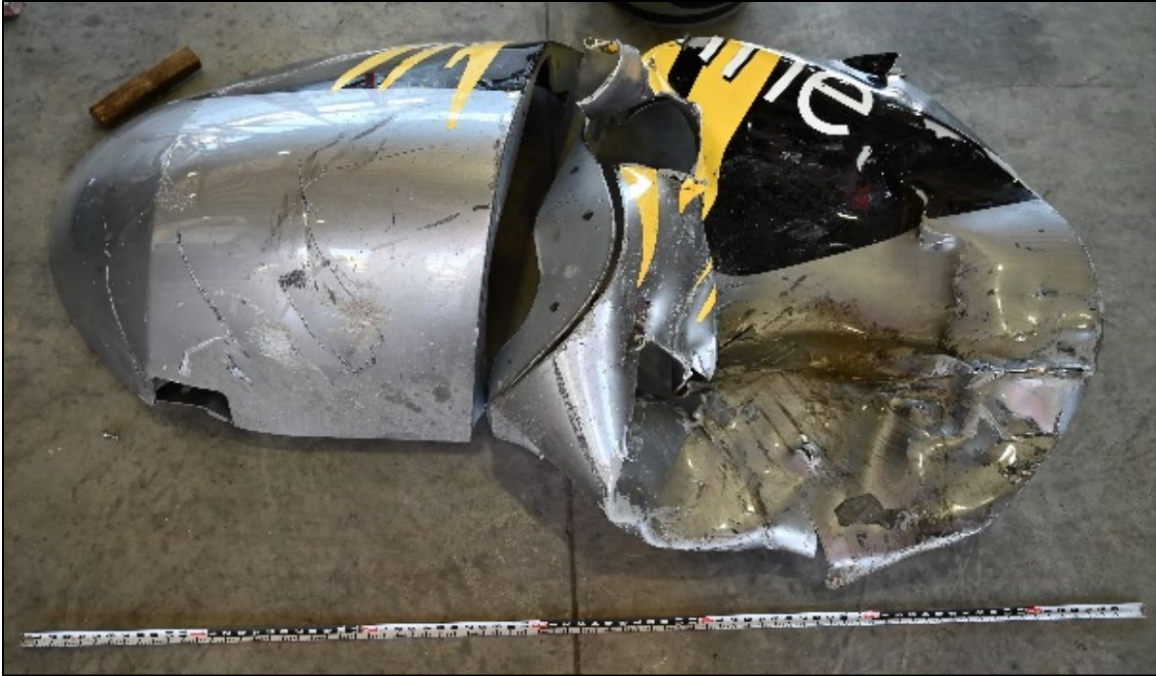
**Figure 13: Damaged Nose of the Brightline Train**

The nose of train was removed prior to the NTBS's arrival but was preserved at the maintenance facility for inspection. The nose, which measured approximately six feet long and two feet tall, sustained crush damage as observed in Figure 13. The train's left sidesteps, and other miscellaneous components were damaged during the collision. The parts were preserved and made available during the inspection of the train.

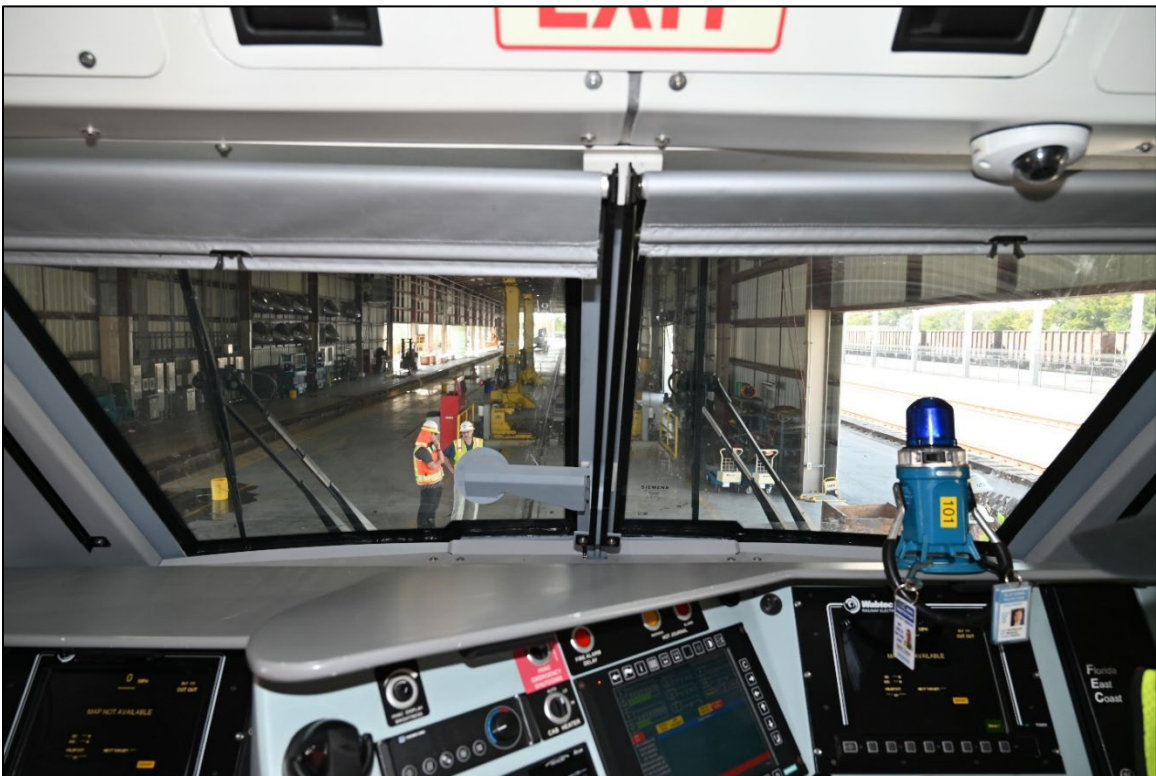
**Figure 14: View from the Interior of the Brightline Train**

The train was occupied by 66 passengers in addition to crew members. None of the passengers or crew members of the train sustained any injuries. Figure 14 shows the available view from the interior of the Brightline train, looking outward.
