National Transportation Safety Board

HWY23MH006

TECHNICAL RECONSTRUCTION

Group Chair's Factual Report

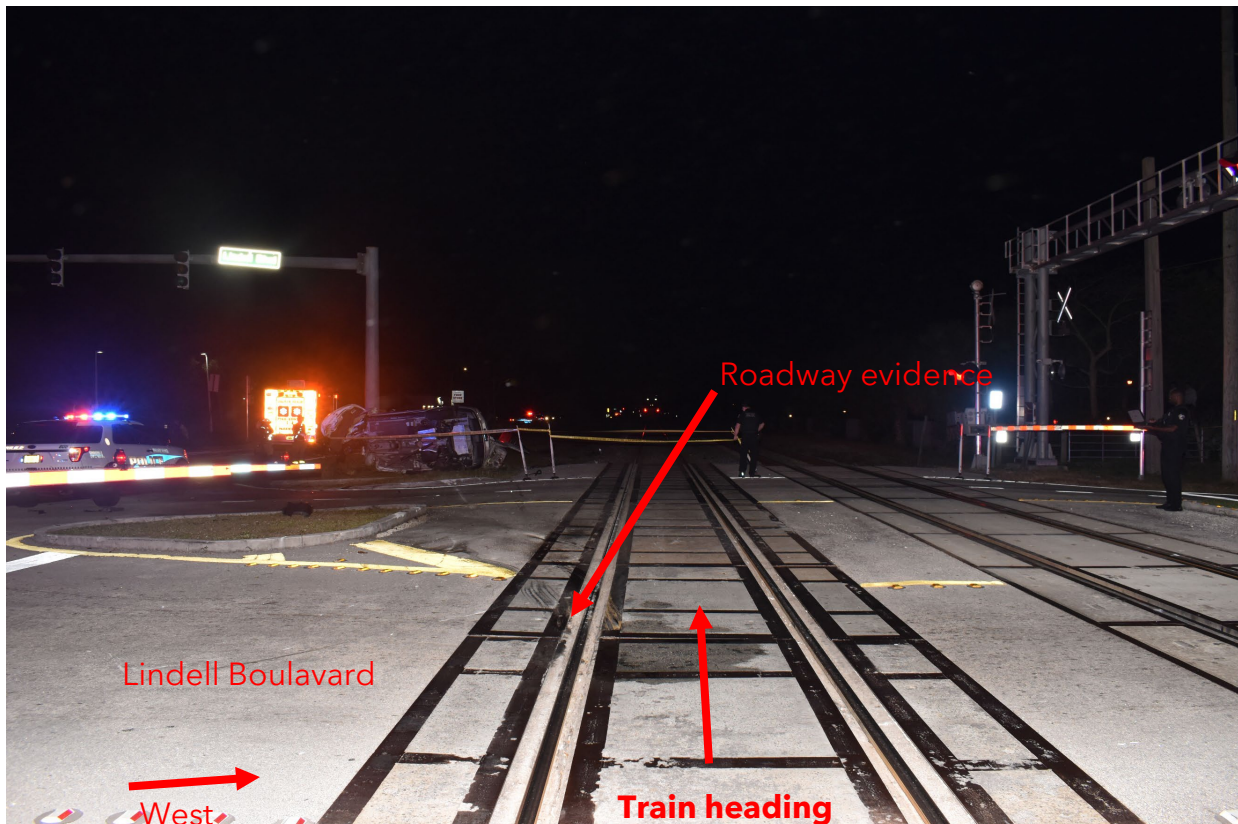
Tire friction marks, roadway surface scraping, and orange marking paint, were observed by NTSB investigators on the road surface. The evidence of impact originated on the east rail of the east main track and was approximately 20 feet west of the stop line and about 13 feet south of the westbound Lindell Boulevard white edge line. A tire friction mark initiated at the area of impact angling southeastward from the eastern rail at an angle of approximately 25° and measured about 12 feet in length. A second tire friction mark began in the same area as the first. The second mark paralleled the first one and measured about 2.6 feet in length. Both tire marks extended towards the median located east of the grade crossing. Evidence of scrape/gouge marks were observed on the west side curb of the median. As

measured from the initial tire friction mark, a third tire mark began approximately 18 feet south and continued southeastward at an approximate 12° angle relative to the track. The fourth mark began about 27.5 feet south of the initial tire mark and extended southeastward for approximately 22 feet. The third and fourth marks paralleled each other and slightly diverged towards the end. The marks terminated at the edge of the roadway/curb along the south side of eastbound Lindell Boulevard. Again, scrape marks were observed along the height of the curb in line with the tire marks. Additional scrape marks were identified across the width of the sidewalk located at the southwest corner of the intersection. The scrape marks were in line with the described third tire mark and terminated at the final rest of the vehicle. The road surface evidence was consistent with impact and post-impact vehicle movement. No pre-collision roadway evidence was observed. **Figures 3 and 4** are photographic images taken by police investigators showing the roadway collision evidence that traveled southeastward from the area of impact.

Figure 3. Modified photographic image taken by DBPD investigators showing the roadway evidence. The photograph was taken north of area of impact facing southeastward. The final rest to the Nissan is depicted in the distance.

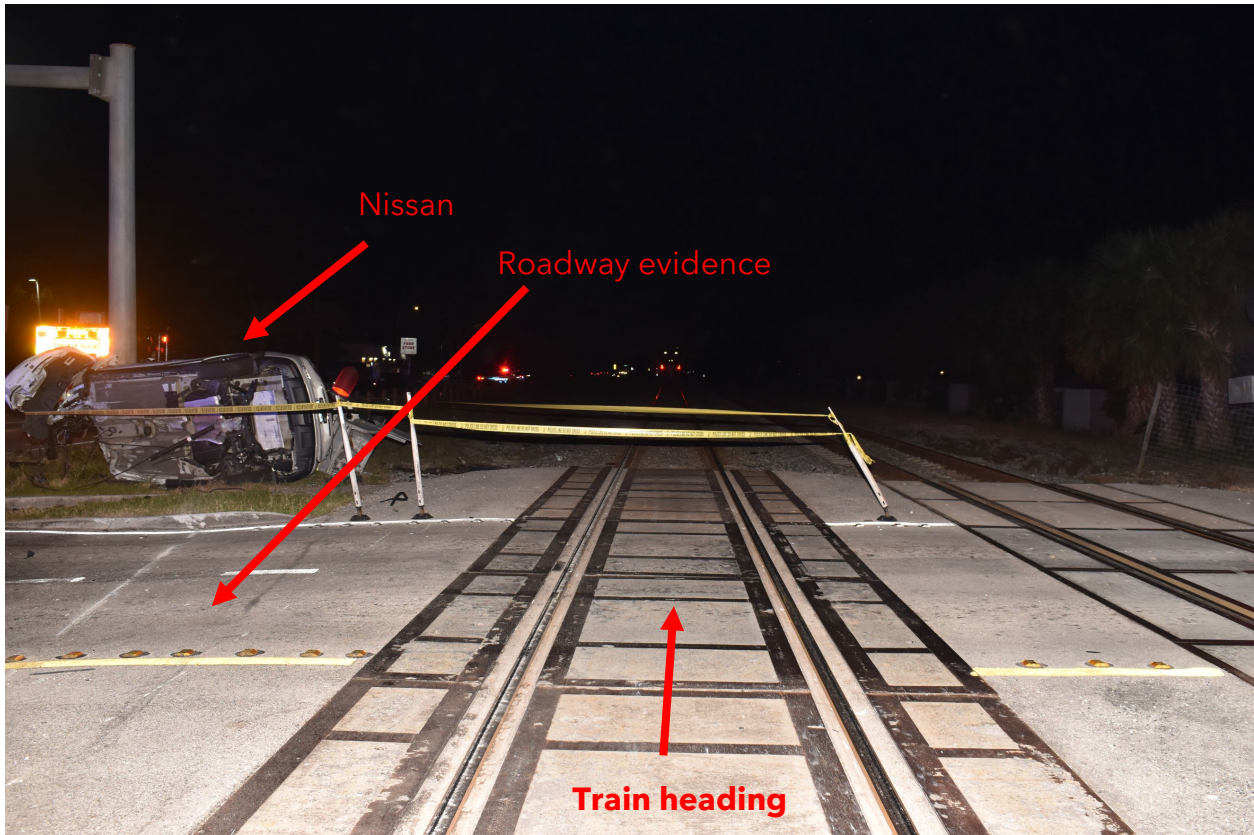
Figure 4. Modified photographic image taken by DBPD investigators showing the roadway evidence. The view is looking south with the evidence visible continuing southeastward.

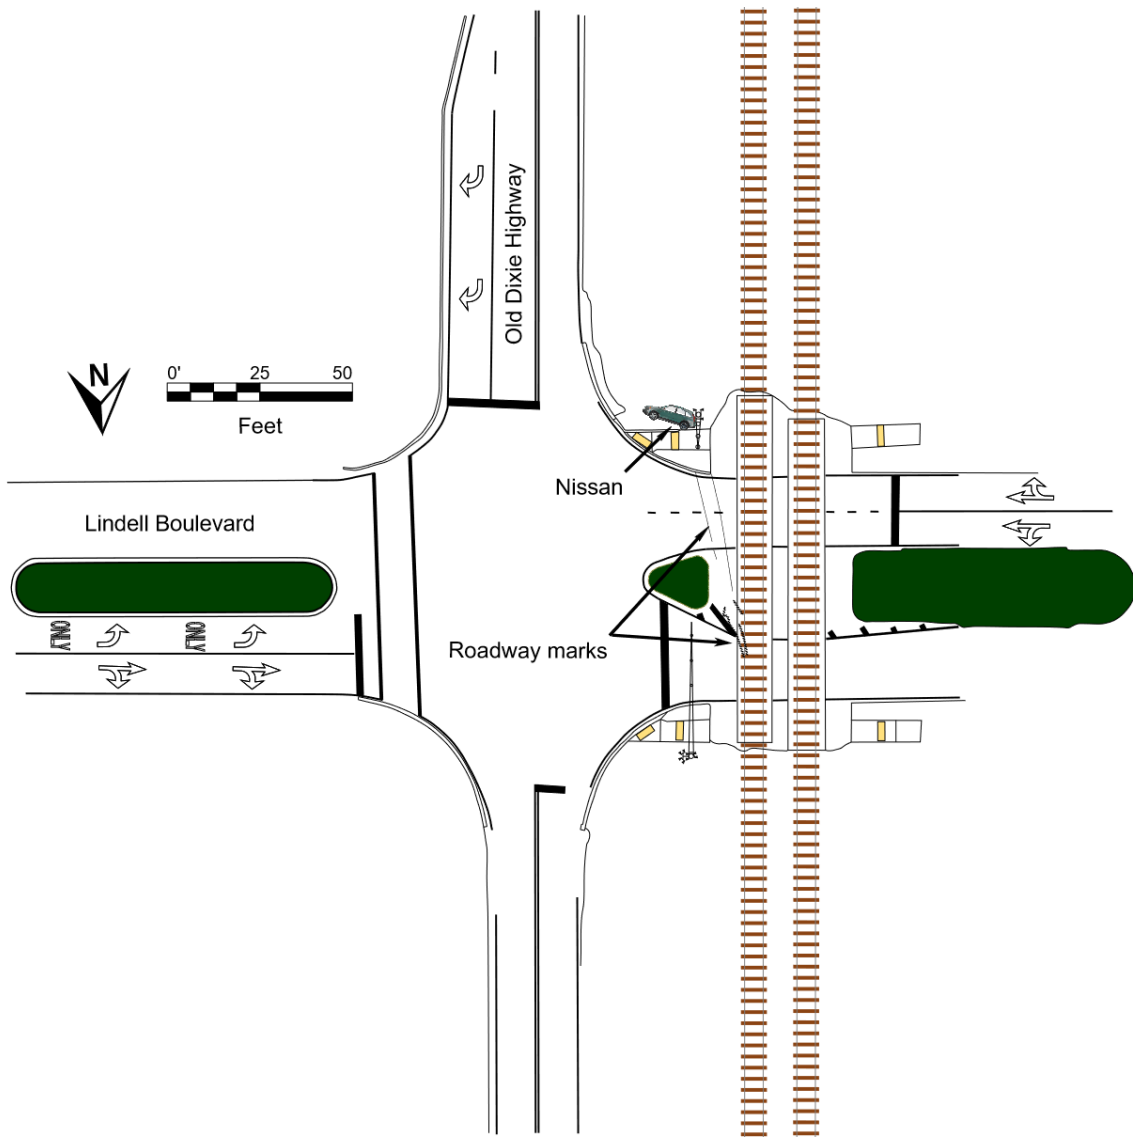
The post-collision position of rest for the Nissan and train was determined through police photographs. **Figure 5** is a two-dimensional diagram of the intersection showing the final rest position of the Nissan.

Figure 5. Two-dimensional diagram depicting final rest position of the Nissan following the collision event. Also displayed are the post-crash roadway marks.

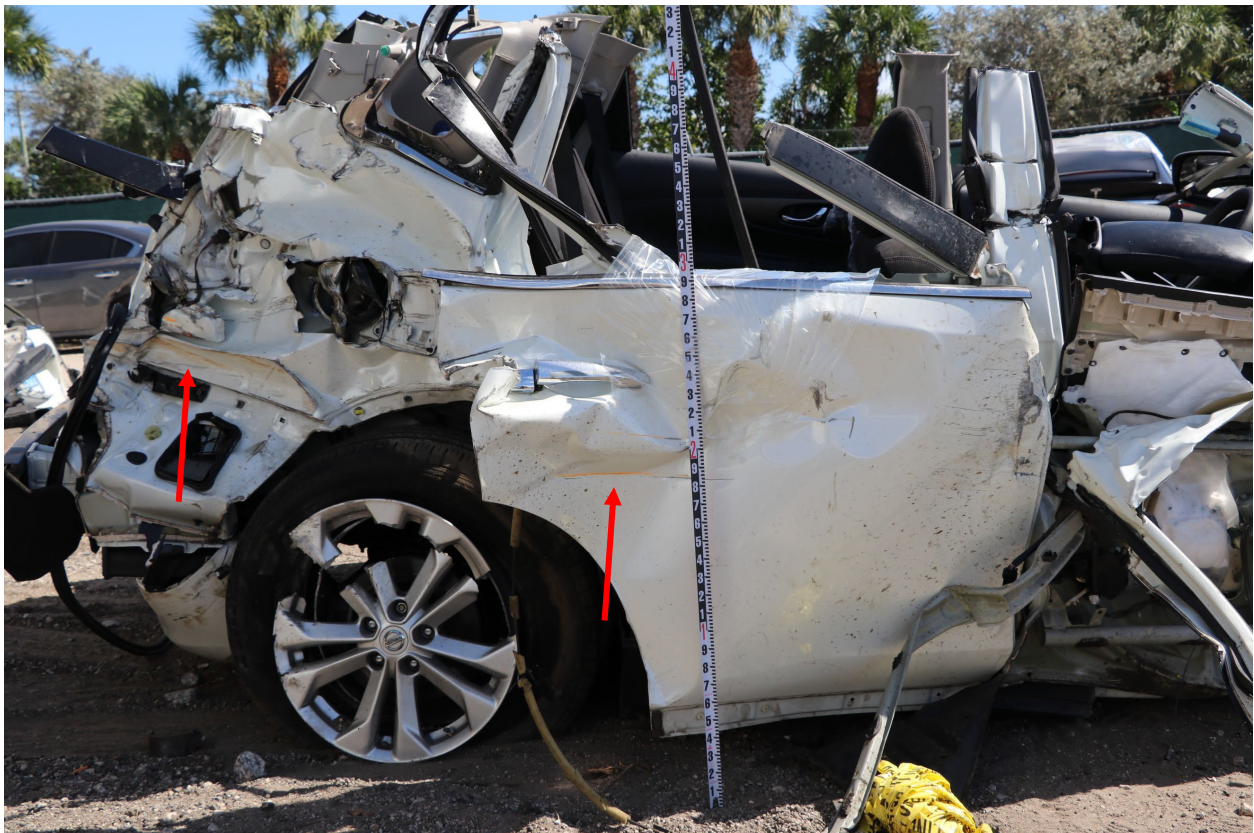
The Nissan was identified by police investigators through forward facing video from the Brightline train, as stationary within the grade crossing at the time of the collision. The vehicle exhibited evidence of contact damage to the right-front and rear of the vehicle. The most substantial impact was on the front-right. The right fender, engine, axle assembly, and front grille were torn from the vehicle up to the firewall. Evidence of secondary contact was observed along the right-side. Exhibited within the damage to the right-rear door and right quarter-panel were areas of yellow-colored material transfer. The rear of the vehicle exhibited a passenger-side to driver side displacement. **Figure 6** depicts the observed material transfer on the door and quarter panel.

Figure 6. Image of the right side of the Nissan. Red arrows are pointing to the areas of yellow-colored material transfer.

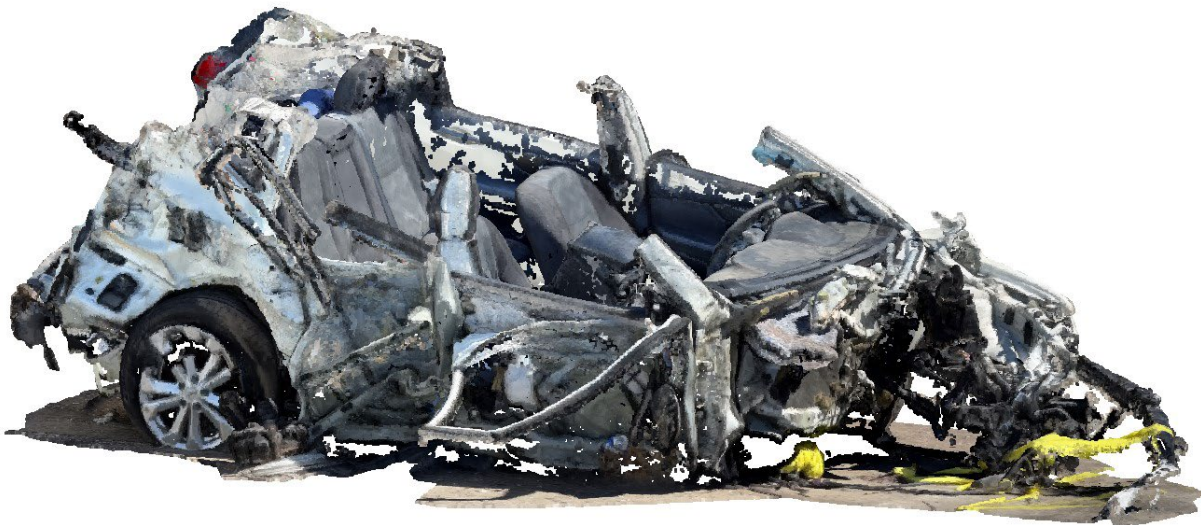
At its position of final rest, the Nissan was on its right-side facing southeastward, positioned about 70 feet southeast of the area of impact and just over 15 feet off the roadway. **Figures 7** and **8** depict images of the three-dimensional point cloud from the scanning of the Nissan. **Table 1** provides a sampling of dimensional data for the Nissan.⁴

Figure 7. Screen capture image showing 3D point cloud of Nissan as viewed from the right-side of the vehicle. The impact damage to the front is visible.

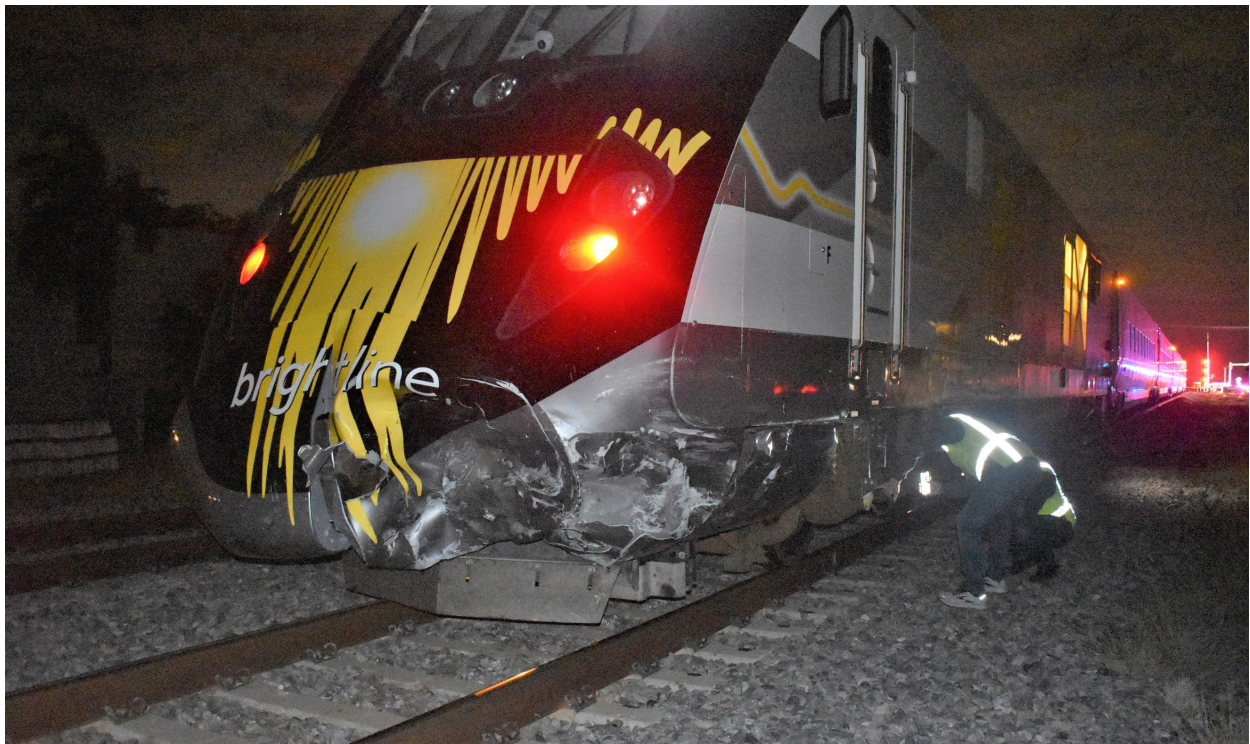
Figure 9 is a photograph of the locomotive and consist at final rest showing the overall damage. Scene photographs taken by DBPD show that the contact damage was to the front nose cone and lower left-front of the locomotive. The left-side of the nose cone exhibited displacement rearward, and the front-left corner exhibited displacement inward from left to right. There were several tears noted in the sheet metal along with scrapes and scars. A second area of damage was noted aft

Figure 9. Image depicting damage to the front and left side of the locomotive. View of the photograph is looking northwest. (Source: DBPD revised)

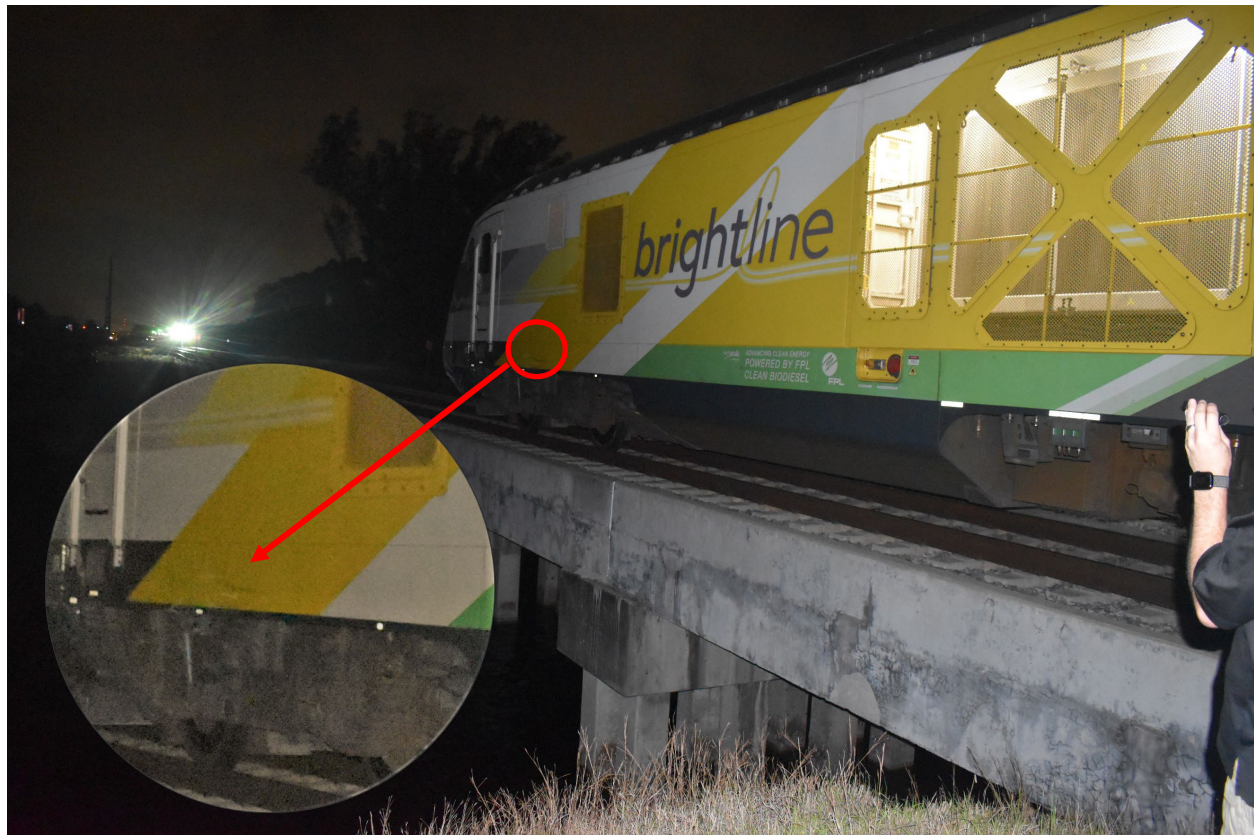
of the left side door. The DBPD photograph depicted an area within the yellow paint that had been scraped and scuffed.

Figure 10. Image of the left side of locomotive looking southwest. Area of second impact circled in red. Inset in lower left corner enlarged image of area circled in red. (Source: DBPD revised)

Figure 10 depicts the left-side of the locomotive looking southwest. The inset photograph is an enlarged image of the area circled in red, secondary impact.

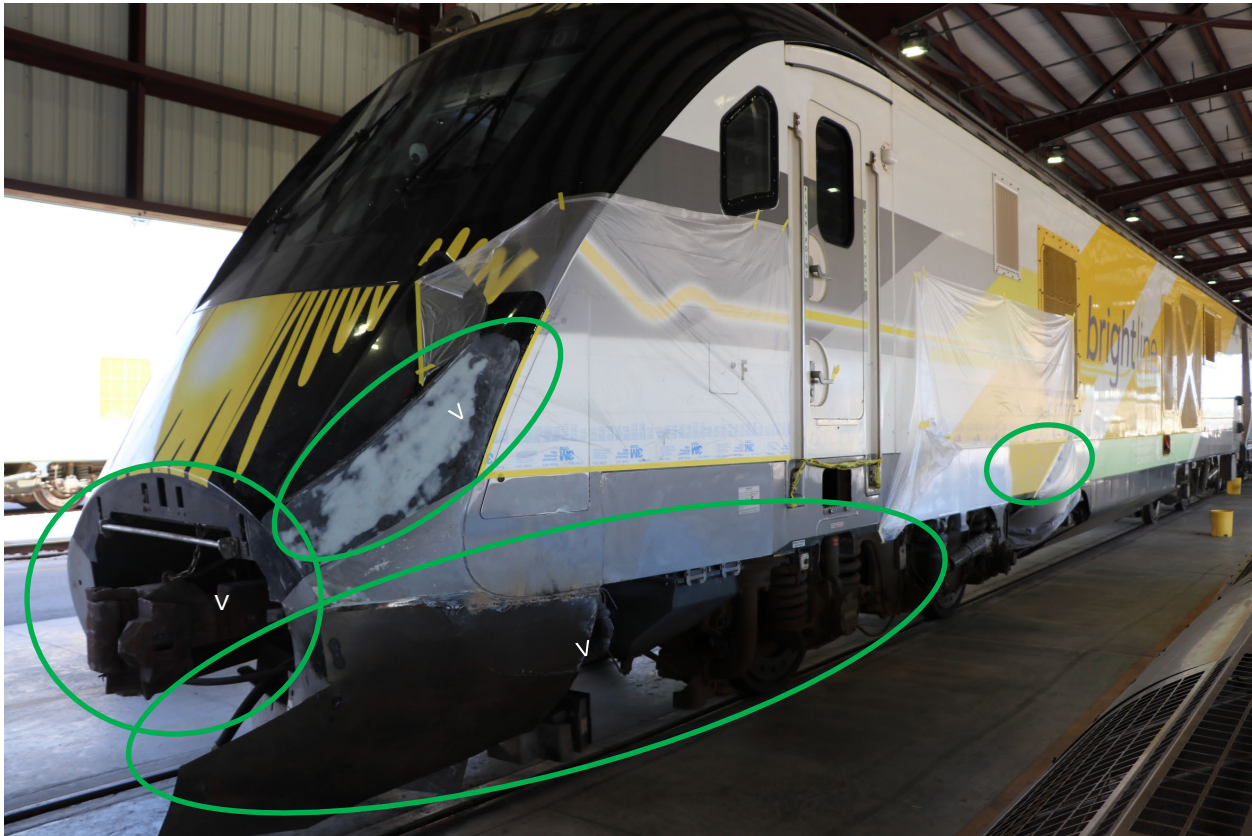
Figure 11. Image showing the left front and left side of crash locomotive. Areas circled in green are areas of repair prior to the inspection.

Following the crash, the locomotive was moved to a Brightline facility in West Palm Beach, FL. When NTSB investigators inspected the locomotive on February 11th, 2023, repairs to the train were underway. The extent of the repairs was documented via terrestrial photography. The nose cone had been removed and was located with the locomotive. Evidence of repair was observed along the left-side of the locomotive. The damaged sheet metal along the lower portion, below the doorstep and forward of the left-side door, had been removed and a new piece of sheet metal had been attached. The lower doorstep was also removed. Paint repairs were visible to the yellow area aft of the left side door. **Figure 11** is an image showing the repairs that were made prior to the inspection by NTSB employees. The main areas are circled in green.

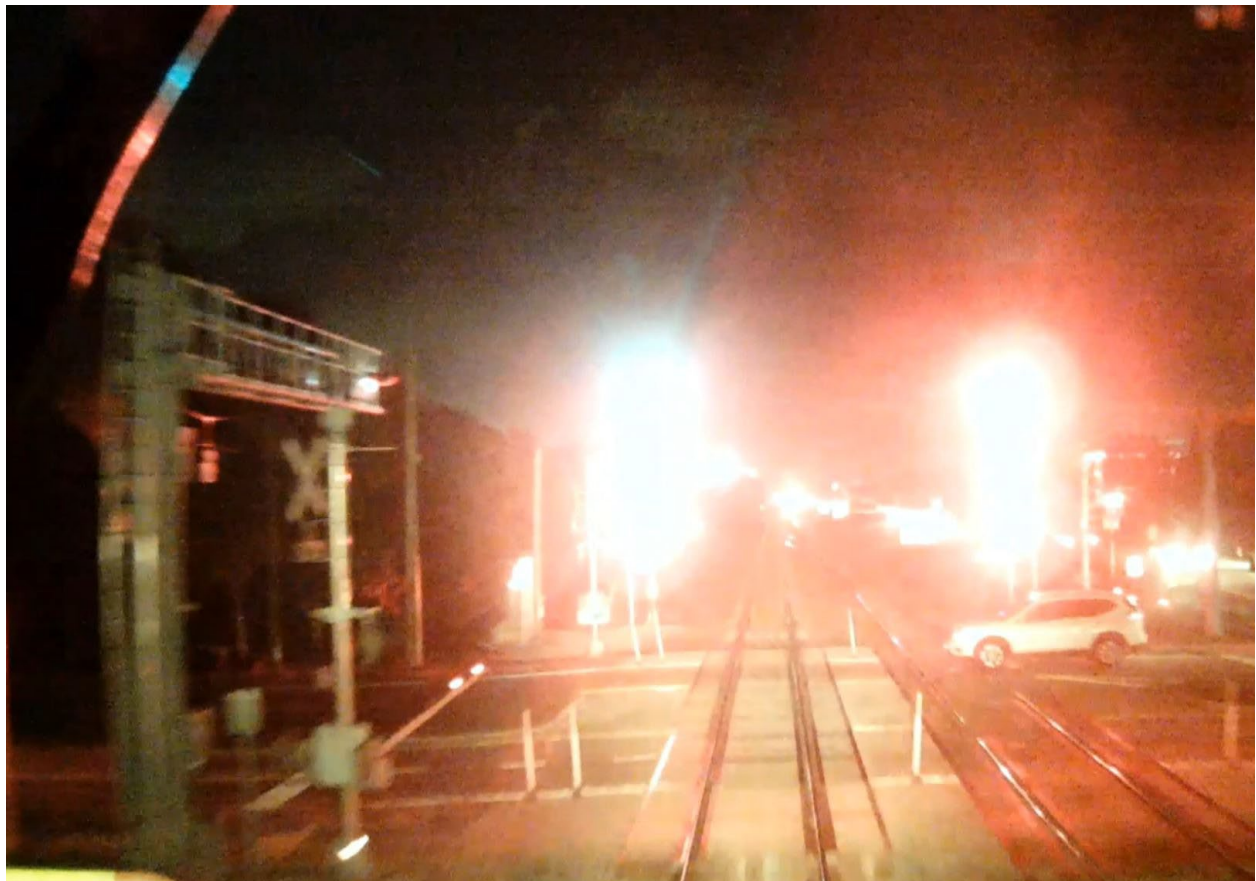
NTSB investigators obtained an event recorder file and an outward facing video from the Brightline locomotive as well as the FEC locomotive. The outward facing video obtained from the northbound FEC freight train showed the Nissan stopped within the grade crossing with the front wheels atop the eastern most rail of the east main track. Looking north of the grade crossing the front lights of the

Figure 13. Image from the outward facing camera of the northbound FEC freight train locomotive. The Nissan can be seen stopped on the east side rail and north of the grade crossing the light of the Brightline locomotive are visible. (Source: FECR)
