National Transportation Safety Board

HWY23MH006

VEHICLE FACTORS

Group Chair's Factual Report

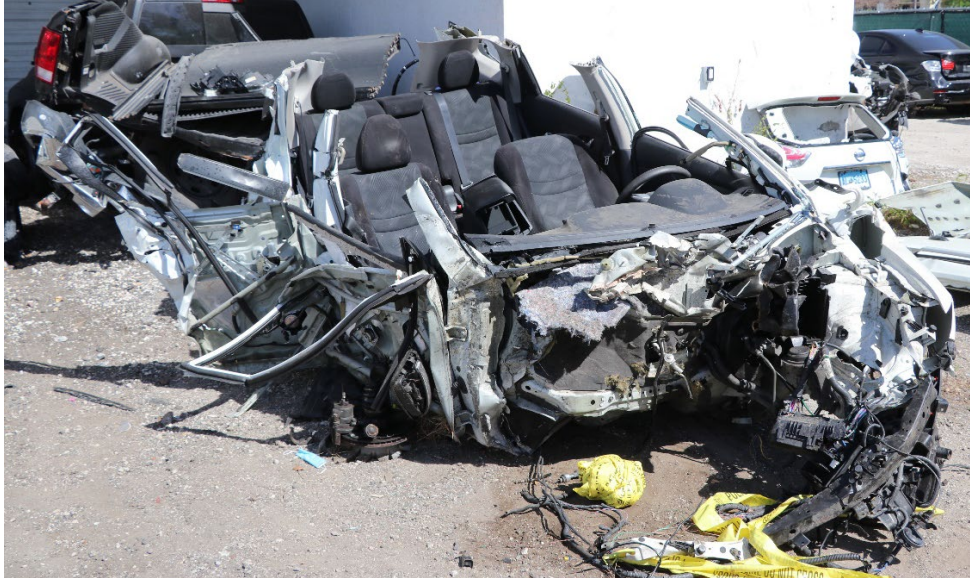
The right-front fender along with the hood, radiator, air conditioning condenser, engine, transmission, the right-side frame horn, and both front drive axles and tires had separated from the engine firewall to the front bumper during the crash sequence. The left-side fender, wheel well, frame horn, and brake master cylinder all sustained crash damage, but remained attached to the SUV - **See Figure 1**. The exterior sheet-metal skin for the right-side passenger doors was missing. During recovery activities, the roof of the SUV had been cut off as indicated by the cut marks on the A through C pillars. All vehicle glass, except for the rear hatch door, was missing. The right-rear quarter fender was crushed inward toward the left side. The rear hatch door was found detached from the SUV but was located inside the passenger compartment with other crash debris. The rear bumper cover had torn away from the rear bumper and was displaced to the left. The left side driver and passenger doors were wedged closed.

Figure 1. Damage sustained to the right front and side of the SUV.

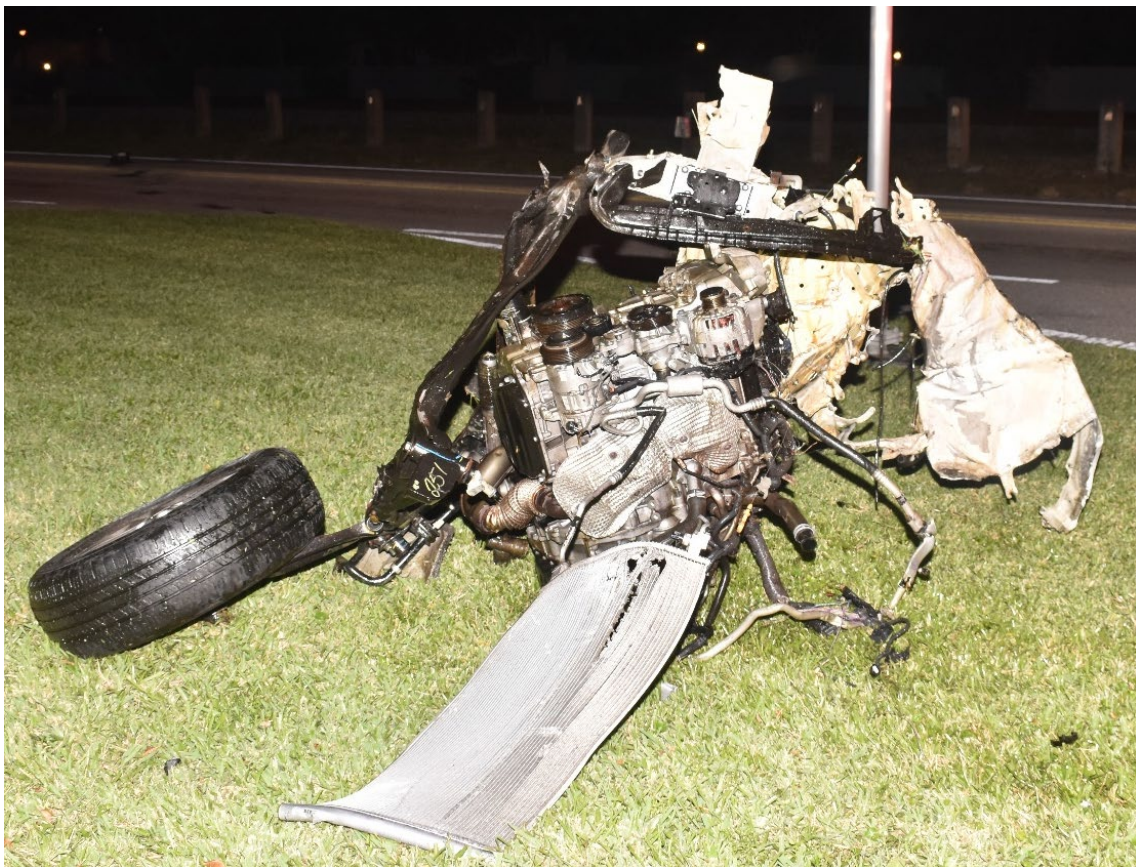
sequence. The separated vehicle components traveled about 188-feet from the point-of-impact before coming to rest - **See Figure 2**. The internal components of the engine and transmission were visible in multiple locations due to the broken engine and transmission cases. Most of the plastic covers and connections were broken or missing.

Figure 2. Looking at the point-of-rest for the front of the SUV. (Source: Delray Police Department)

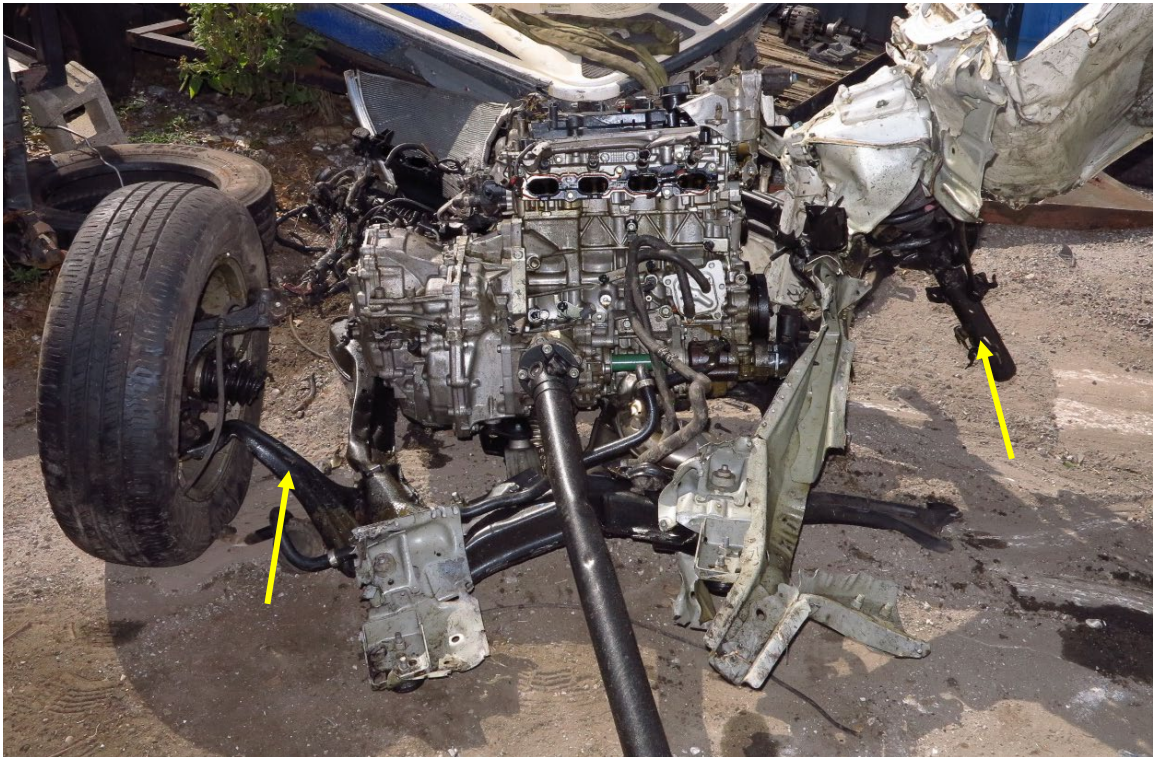
The front suspension was no longer attached to the vehicle. Some of the left-side suspension components remained attached to the displaced engine compartment components - **See Figure 3.**

Figure 3. Looking at the engine and front suspension from what would have been the passenger compartment. The yellow arrow on the right is pointing to the coil-spring strut and the yellow arrow on the left is pointing to the lower control arm.
