NATIONAL TRANSPORTATION SAFETY BOARD

Group Chairman's Factual Report

HIGHWAY FACTORS

HWY22FH008

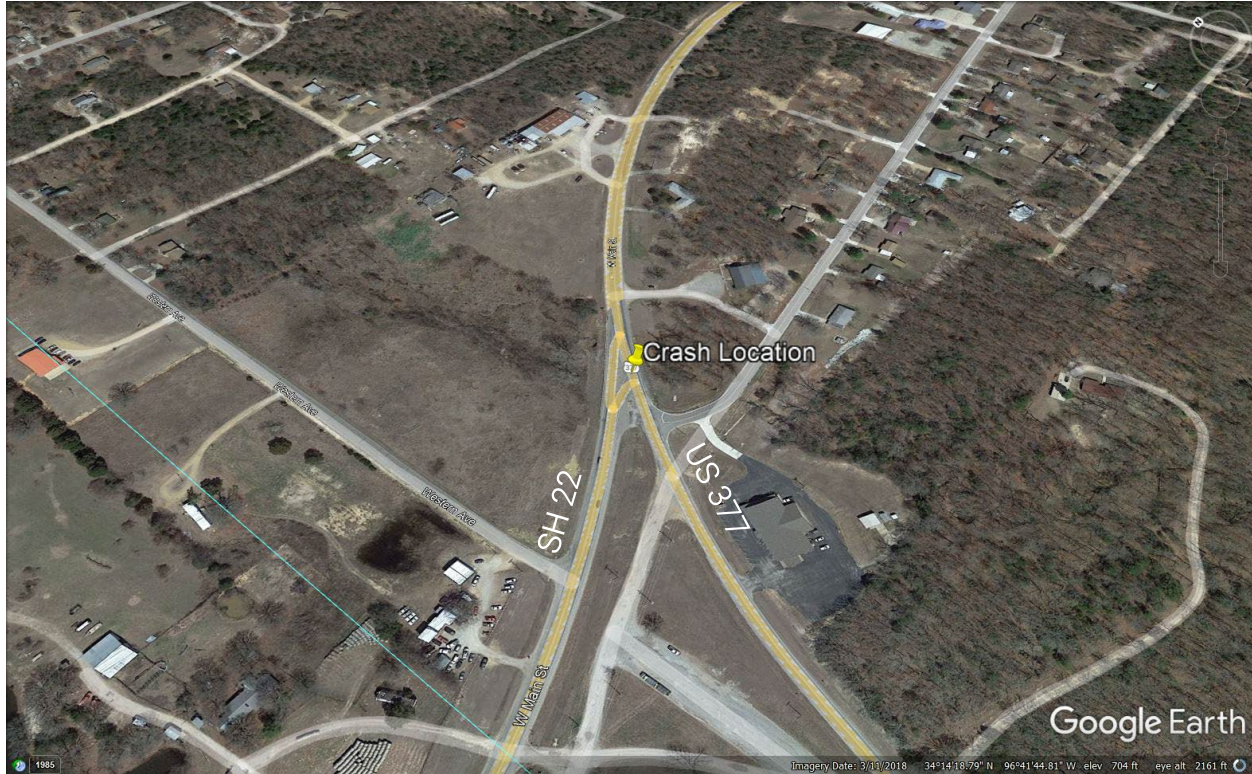
Figure 1. View looking east on SH 22 where the Chevrolet was traveling where it intersects US 377 where the Peterbilt combination was traveling south (source: Google Earth, annotated by NTSB).

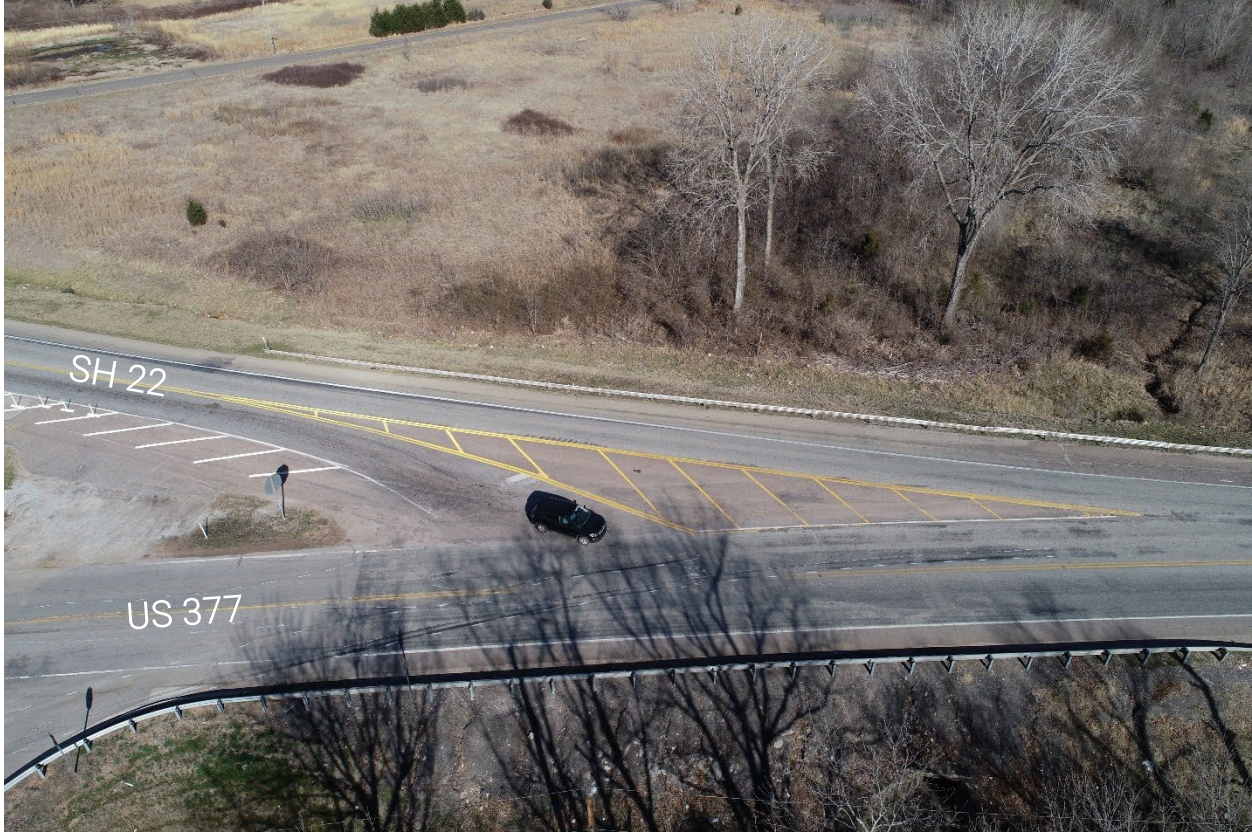
Figure 2. View of an exemplar passenger car on eastbound SH 22 pulling into intersection to turn left onto northbound US 377. The crash vehicle made a similar maneuver when the crash occurred.

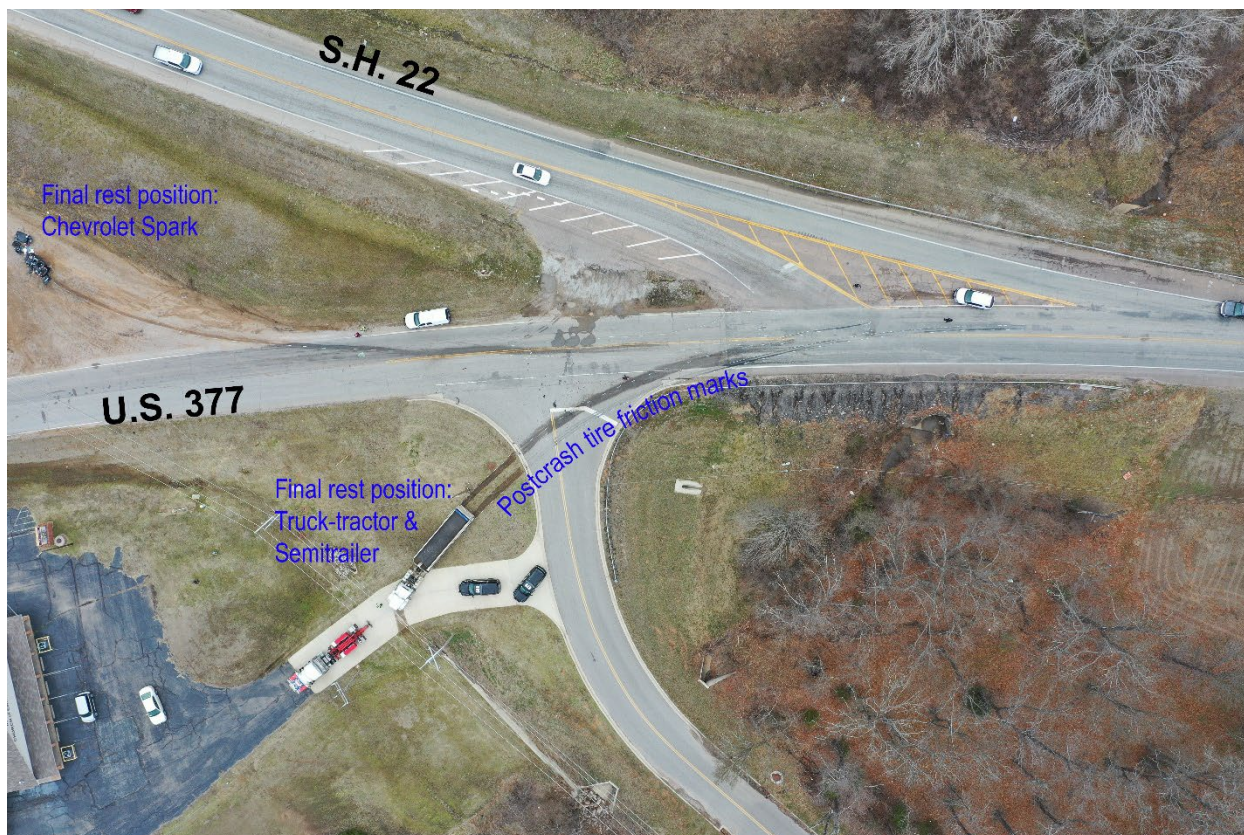
Figure 3. Aerial view of the intersection where the crash occurred. The roadway along the top of the photo is SH 22 and US 377 is shown below, going from left to right in center of the photo. The photo also shows the tire friction marks from where the collision occurred in the intersection and the final rest positions of both vehicles. (source: Oklahoma Highway Patrol, annotated by NTSB).

There were pre-impact tire friction marks followed by pavement gouges where the impact occurred. Locked wheel skid testing was conducted, and the test vehicle skidded 111.4 feet at a speed of 48.3 mph, resulting in a drag factor was 0.719 longitudinal Gs as measured by a VC3000 accelerometer supplied by the Oklahoma Highway Patrol.

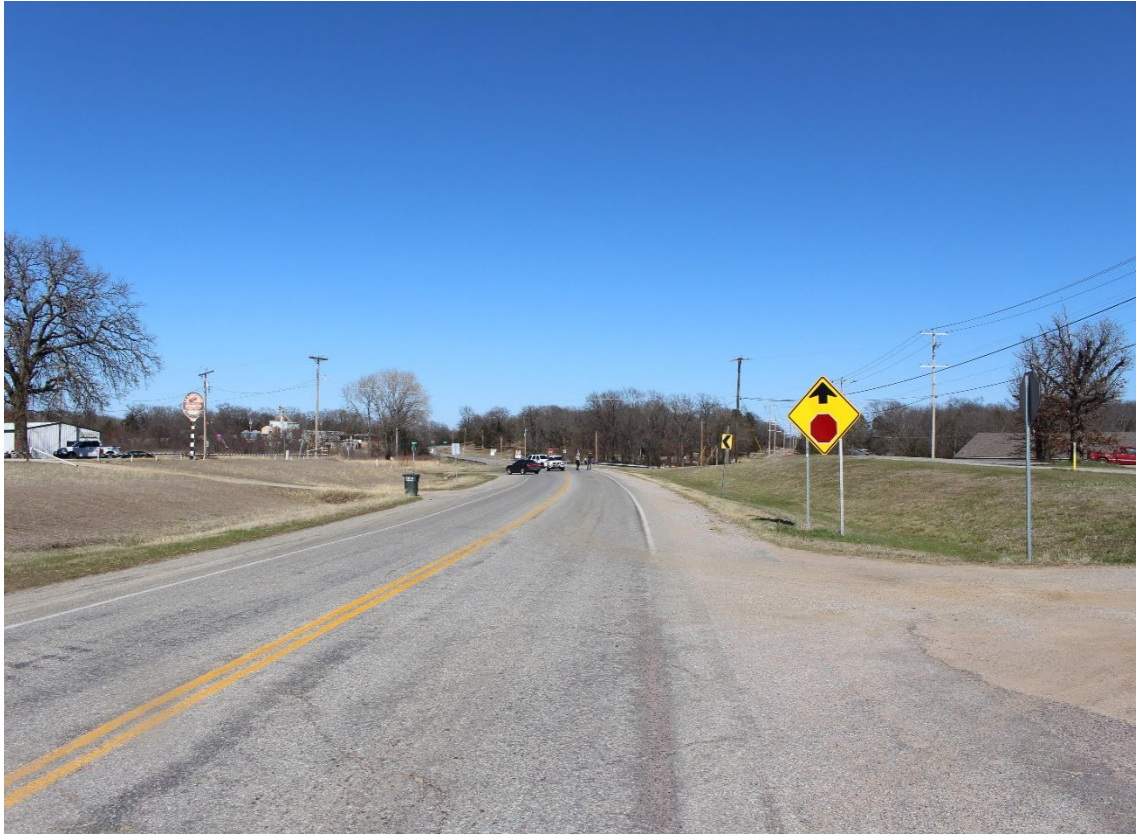
SH 22 intersects US 377 at an approximate 65-degree angle. An approximate 120-foot-long curve that has a radius of approximately 239 feet precedes the intersection. The approach on US 377 is on a 2.4-degree or 2,148.59-foot radius, left-hand curve that begins at Station No:55 + 64.22. The crash occurred at Station No: 59. US 377 slopes downward approximately 1 percent at this location. US 377 has two 12-footwide lanes; one in each direction with 5-foot-wide paved shoulders. The southbound and northbound lanes are delineated by a double yellow pavement stripe. SH 22 also has two 12-footwide lanes; one eastbound and one westbound, which are also delineated by a double yellow pavement stripe. SH 22 has 8-foot-wide paved shoulders. On the eastbound SH 22 approach to the intersection at US 377 a 48-inch-wide STOP AHEAD sign is posted approximately 750 feet from the intersection, and a 48-inch-wide STOP sign is posted at the intersection. The STOP sign is posted approximately 41 feet from the roadway edge and the center is mounted approximately 7 feet above the pavement. The stop line had a faded appearance. It was set back from the US 377 pavement edge approximately 14 feet on the right and 36 feet on the left.¹⁰ The variation is due to the intersection angle and curved approach of US 377. On the immediate approach to the intersection a channelizing pavement

Figure 4. View of STOP AHEAD advance warning sign.

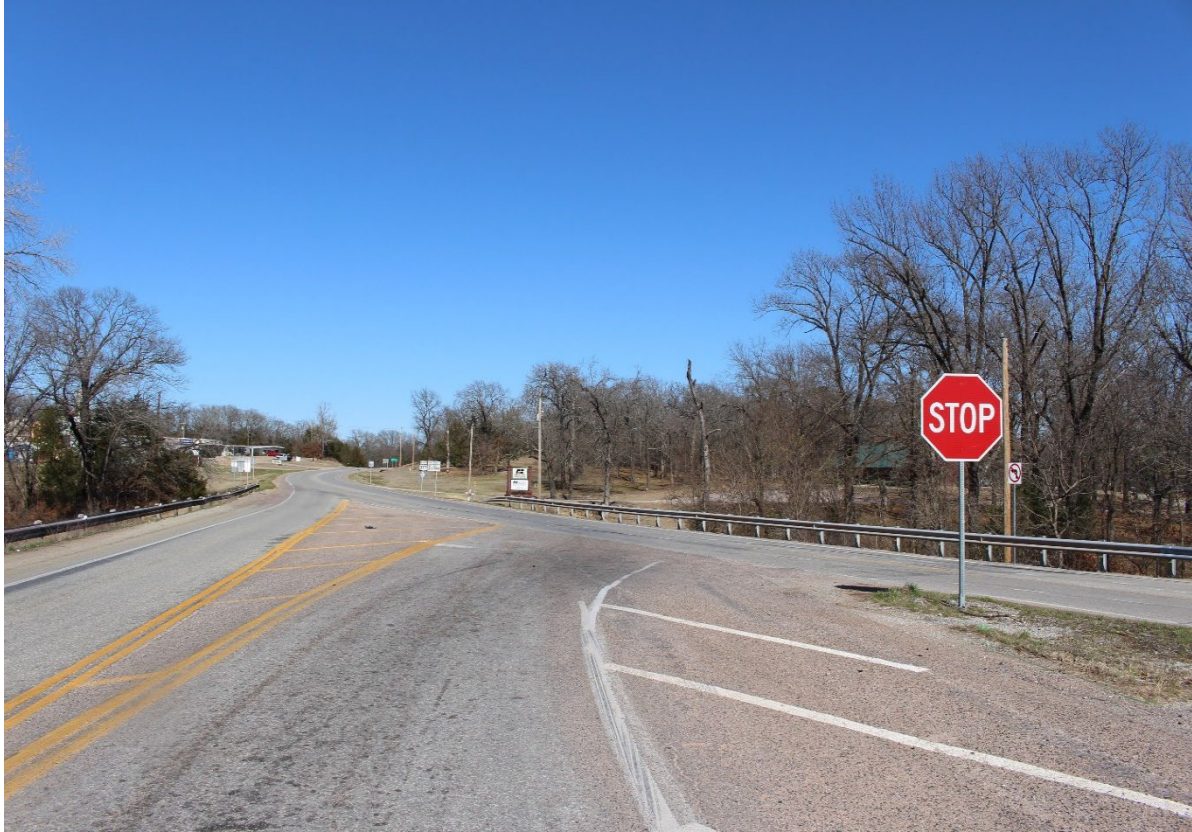
Figure 5. View of STOP sign on eastbound SH 22 at US 377.

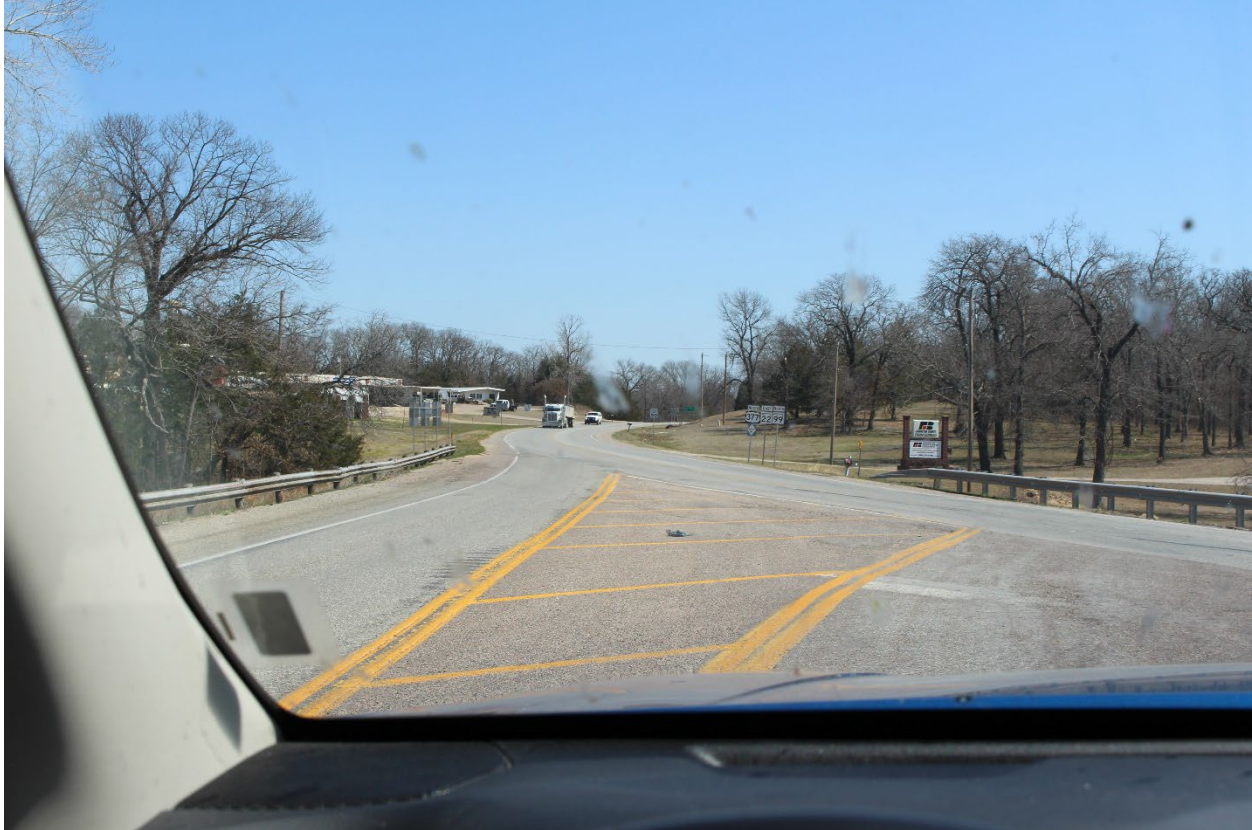
A sight triangle was measured at the intersection with a test vehicle placed 10 feet before the stop sign with the driver viewing angle approximately 18 feet rearward of the stop sign on SH 22. ¹¹ A 7.5 second gap-acceptance time was used to measure the viewing distance at the 50-mph speed limit on US 377, which was 550 feet or rounded up to a 555-foot design distance.¹² At this distance there were no sight obstructions that limited the driver's view from the 555-foot mark on US 377 back to the test vehicle driver's eye position. See figure 6 for a view of a stopped Peterbilt combination unit viewed from the test vehicle.

Figure 6. View of Peterbilt combination unit 555 feet from the intersection.

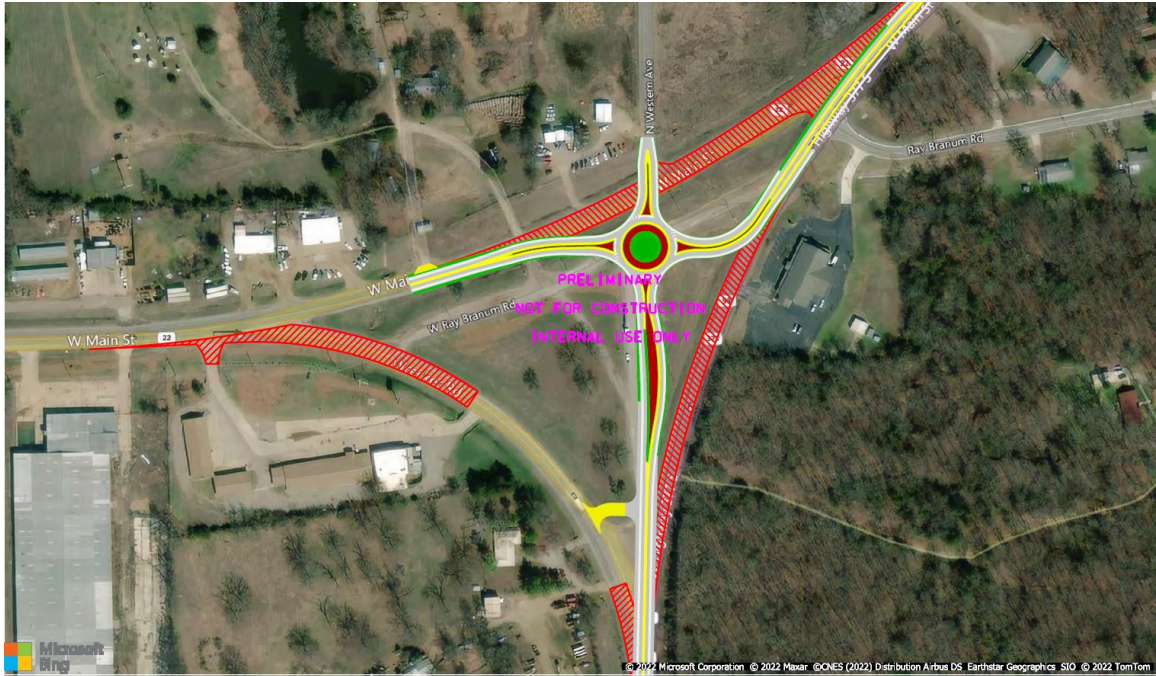
Figure 7. View of roundabout concept drawing being considered to re-align the intersection of SH 22 and US 377.

After the fatal crash that occurred November 2021, ODOT began developing design concepts for realigning the intersection of SH 22 and US 377. One concept shared with the NTSB was a re-alignment of the intersection using a modern roundabout design (figure 7). ODOT has not made any decisions on realignment at this time but, according to the Division 3 engineer, ODOT has reserved 2 million dollars for a future project. Other conceptual designs are shown in figures 8-11.

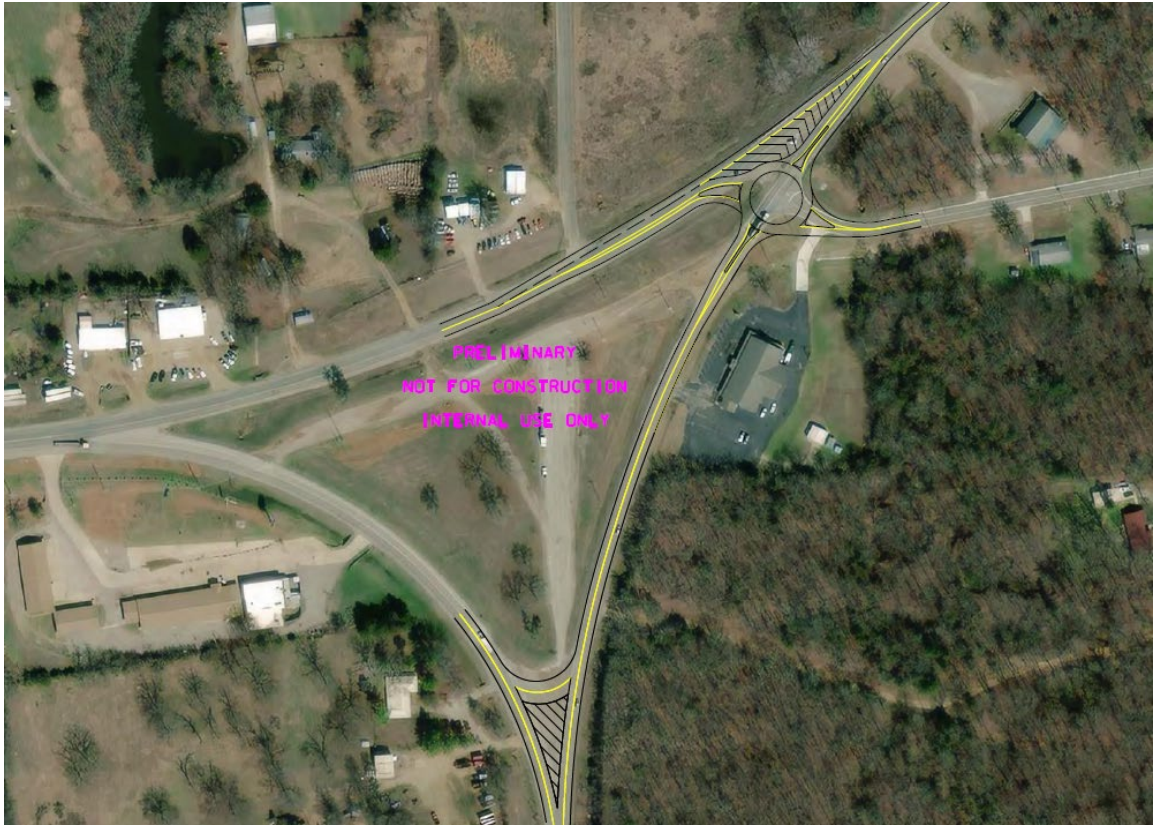
Figure 8. View of additional roundabout design being considered.

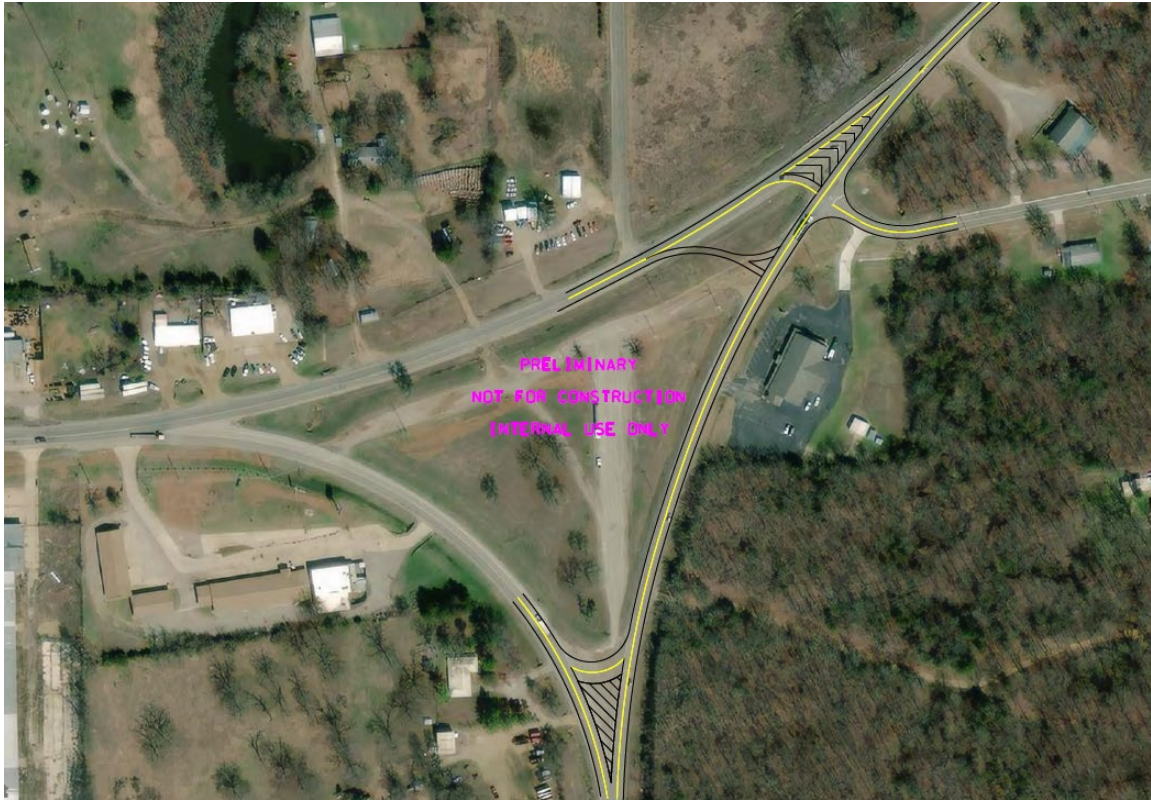
Figure 9. Concept drawing with intersection aligned closer to 90 degrees.

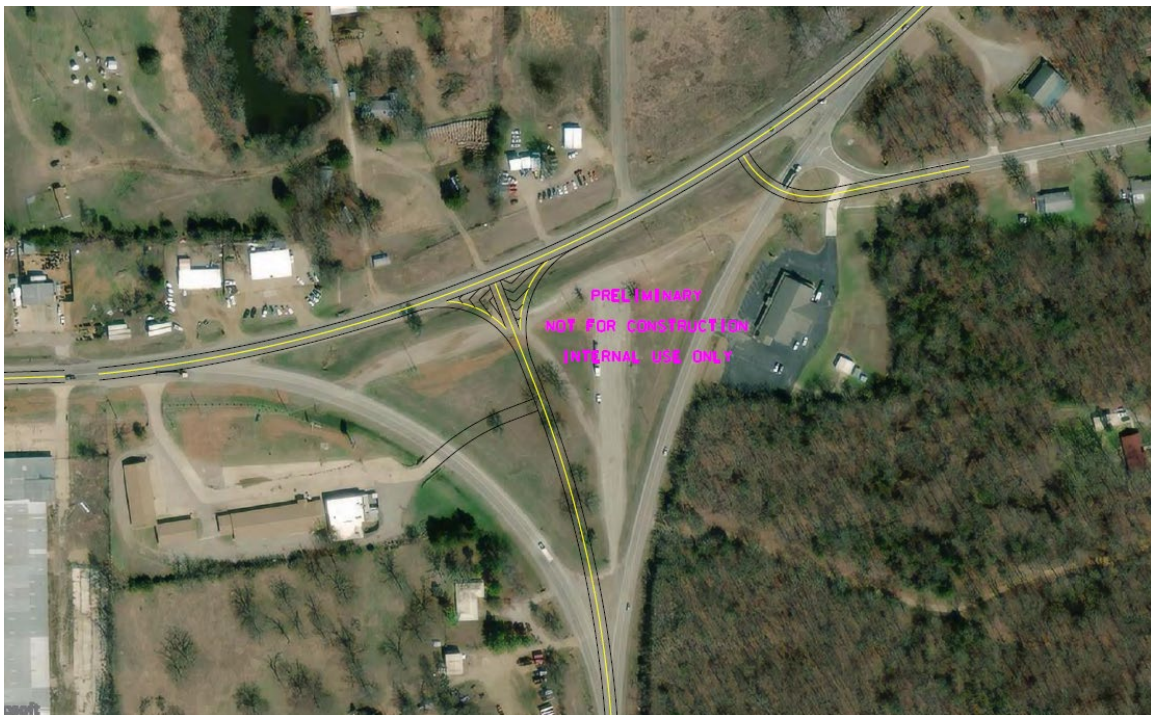
Figure 10. Concept drawing with US 377 routed through the triangle area to intersect SH 22 near 90 degrees.

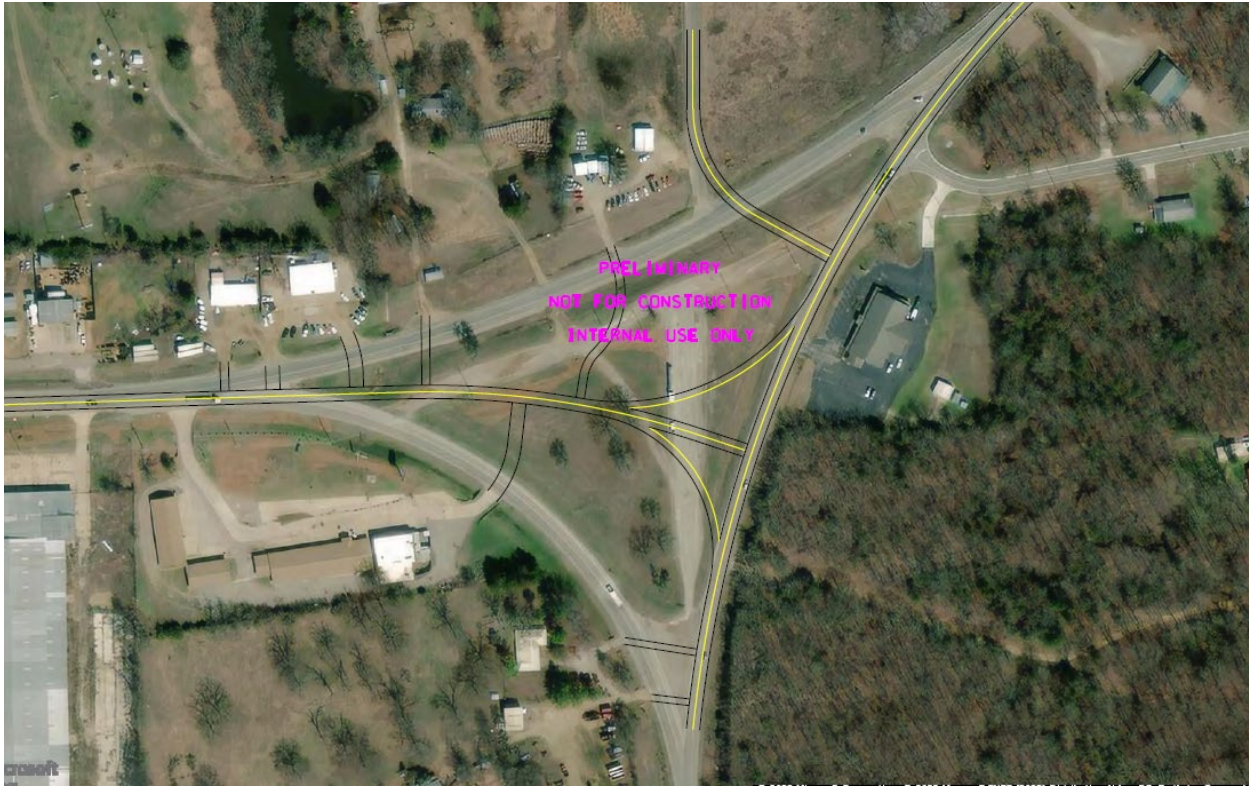
Figure 11. View of concept drawing with eastbound SH 22 re-aligned through the dirt triangle area to intersect US 377 near a 90-degree angle.

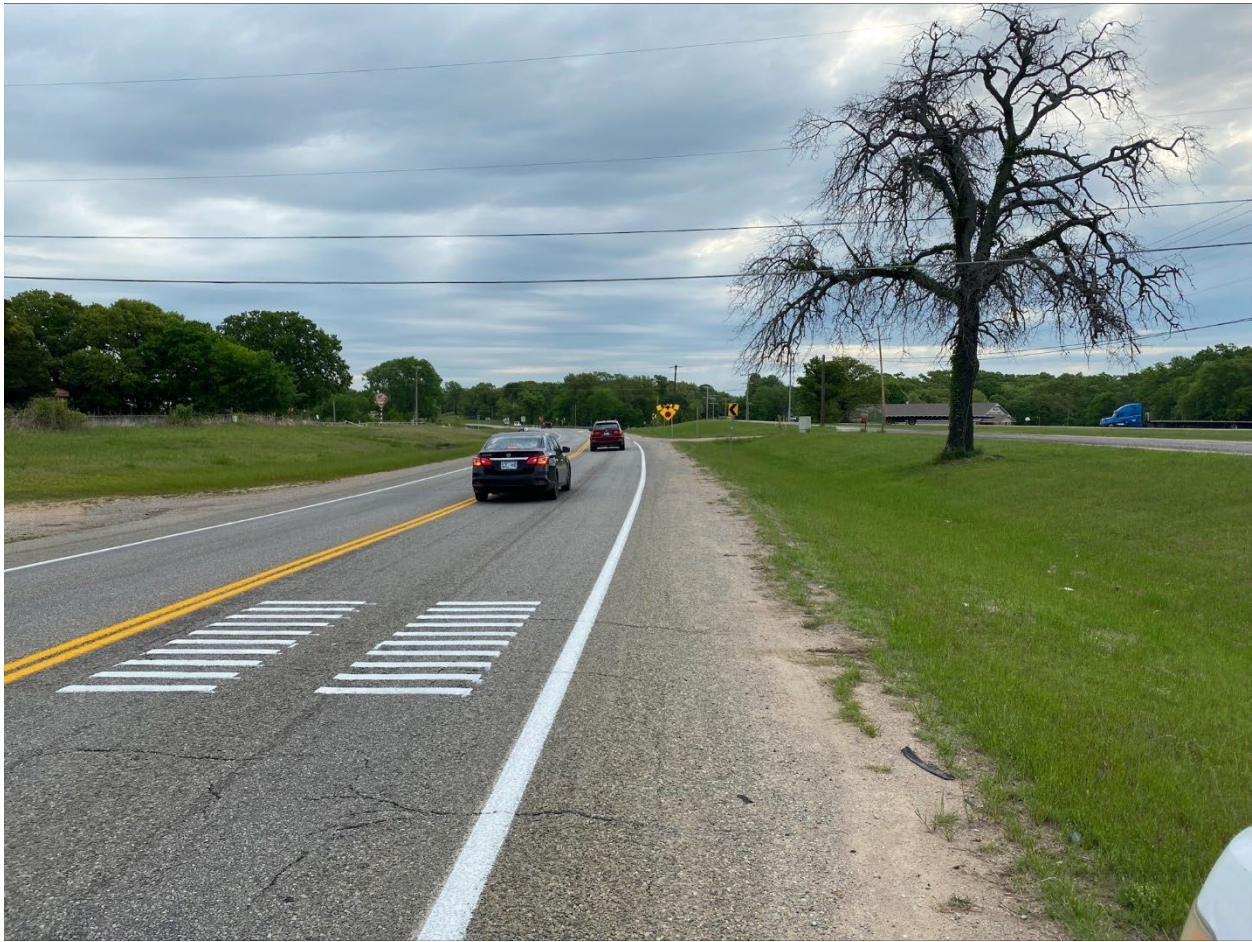
Figure 12. View of transverse rumble strips preceding the STOP AHEAD advance warning sign on eastbound SH 22. (source: ODOT)

1. The pavement striping on all approaches to the intersection was refreshed.
2. The stop bar on eastbound SH22 at US 377 was re-striped.
3. Flags were added to the STOP AHEAD sign and STOP sign.
4. Flashing beacons were added to the STOP SIGN.
5. Two sets of transverse rumble strips were added to eastbound SH 22 on the approach to the STOP SIGN.
6. New NO LEFT TURN signs were added for northbound US 377.

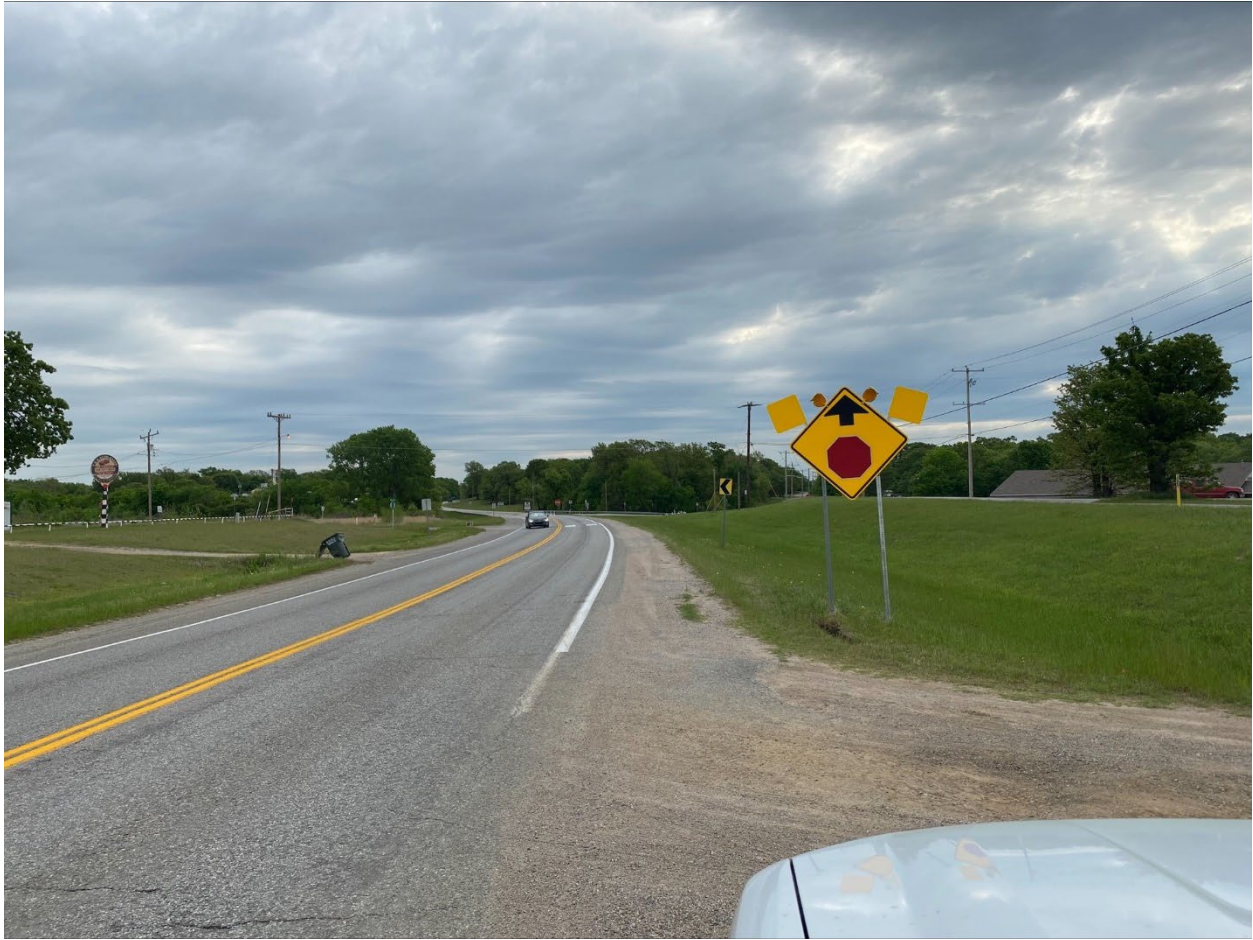
Figure 13. View of the STOP AHEAD advance warning sign equipped with flags on eastbound SH 22. (source: ODOT)

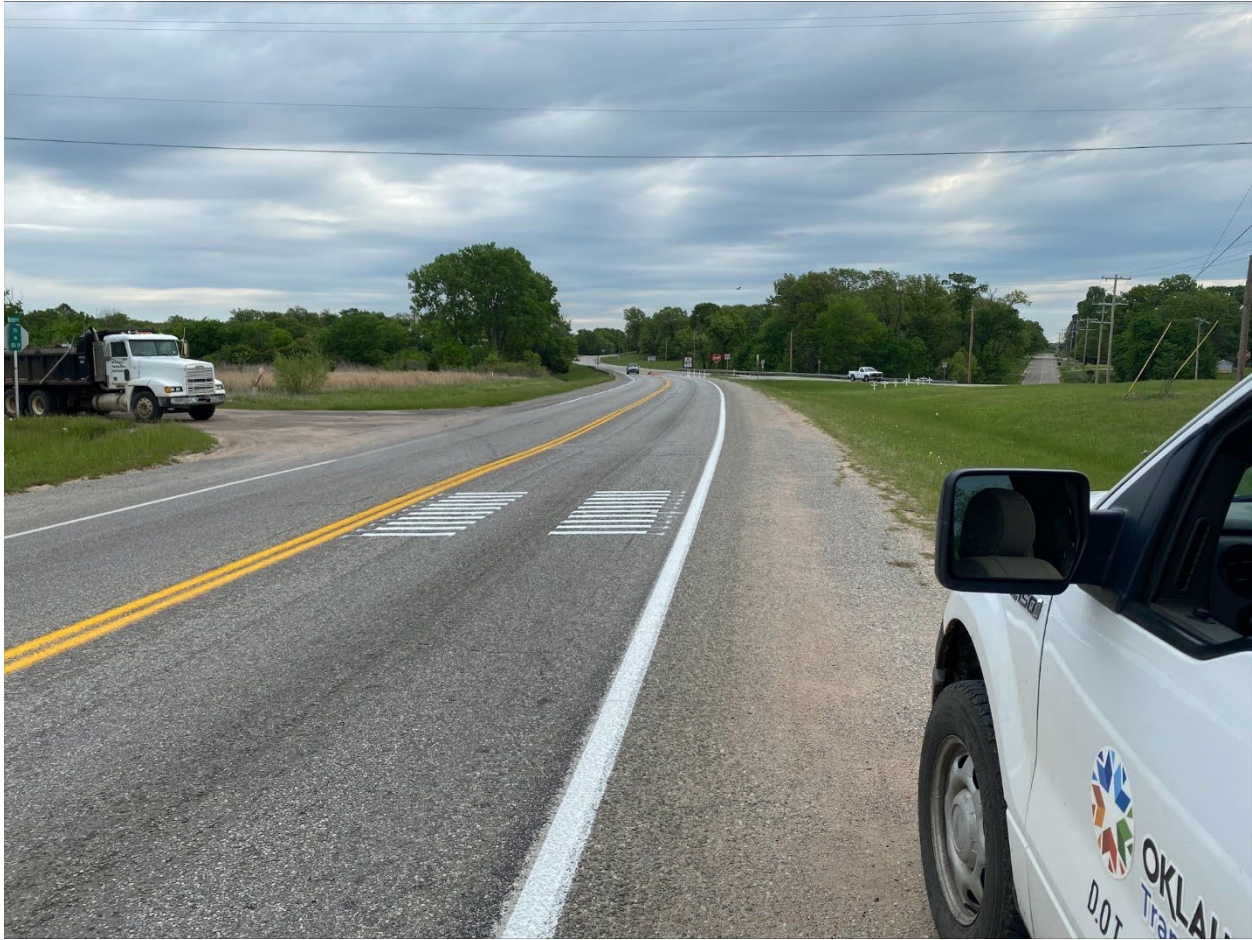
Figure 14. Close-up view of transverse rumble strips on eastbound SH 22 on the approach to the STOP sign. (source: ODOT)

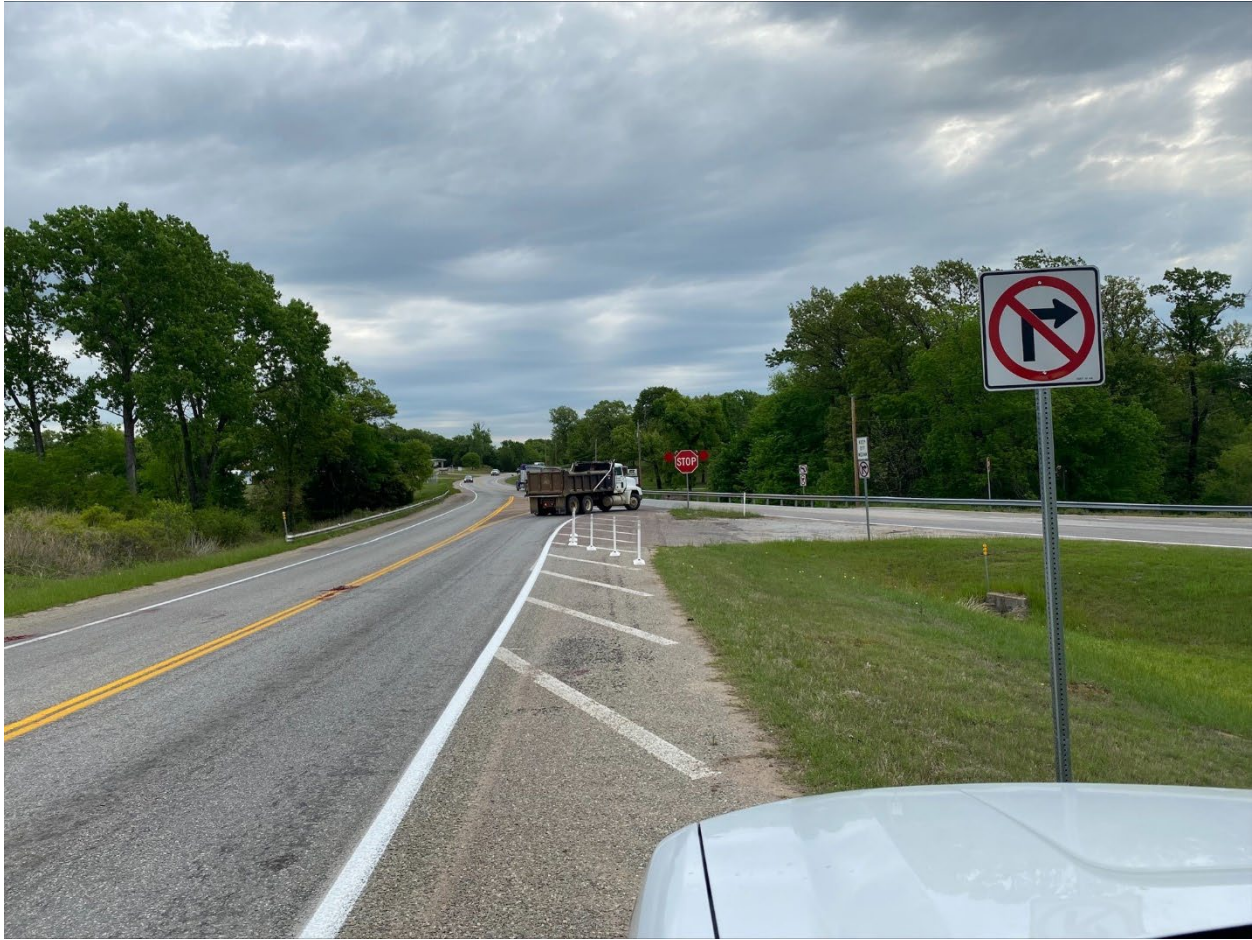
Figure 15. View of new NO RIGHT TURN sign with STOP sign in the background on eastbound SH 22. (source: Oklahoma DOT)

7. New NO RIGHT TURN signs were added to eastbound SH 22.

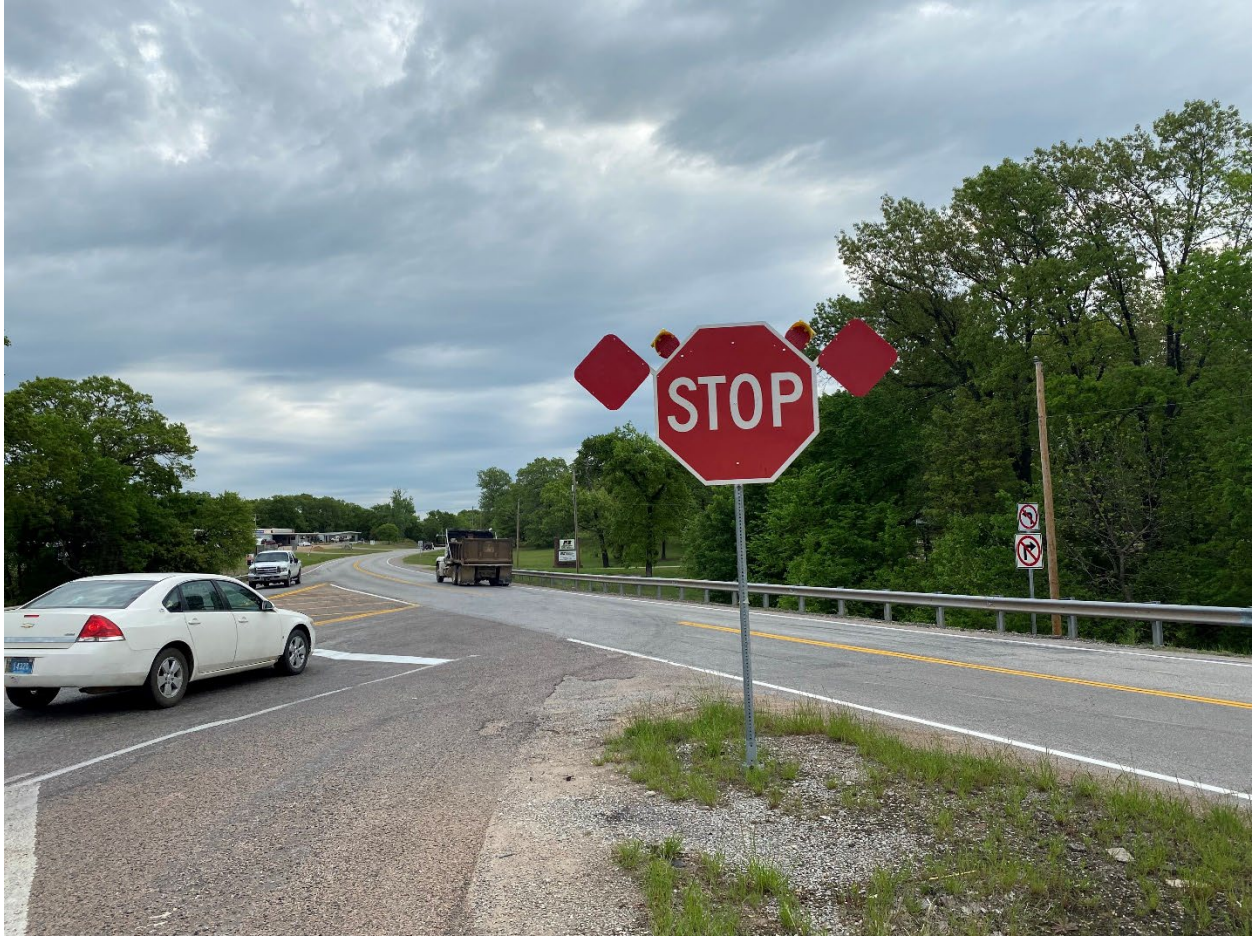
Figure 16. View of STOP sign equipped with flags and flashing beacon at the intersection of SH 22 and US 377. (source: Oklahoma DOT)

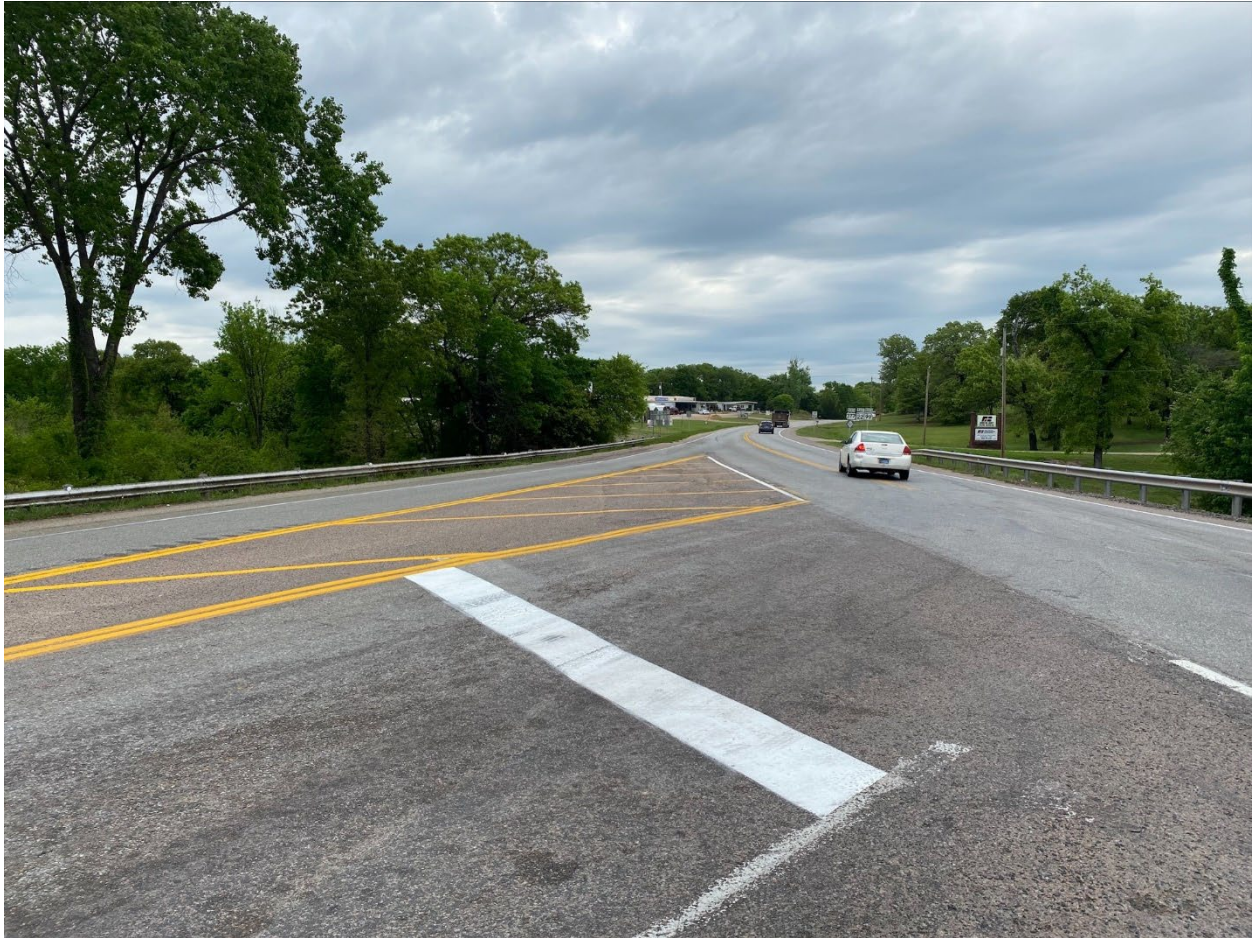
Figure 17. View of re-stripped STOP bar on eastbound SH 22. (source: Oklahoma DOT)
