# National Transportation Safety Board

HWY24FH002

## **FACTUAL REPORT OF INVESTIGATION**

Group Chair's Factual Report

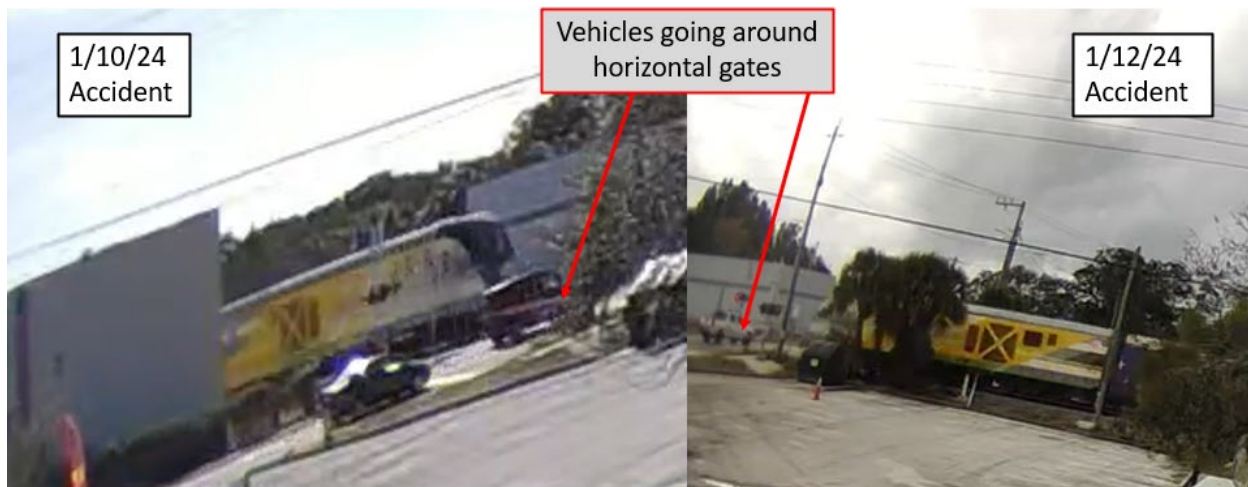
**Figure 2.** Video screen shots of accident vehicles driving around horizontal crossing gates (edited Ring video screen shots).

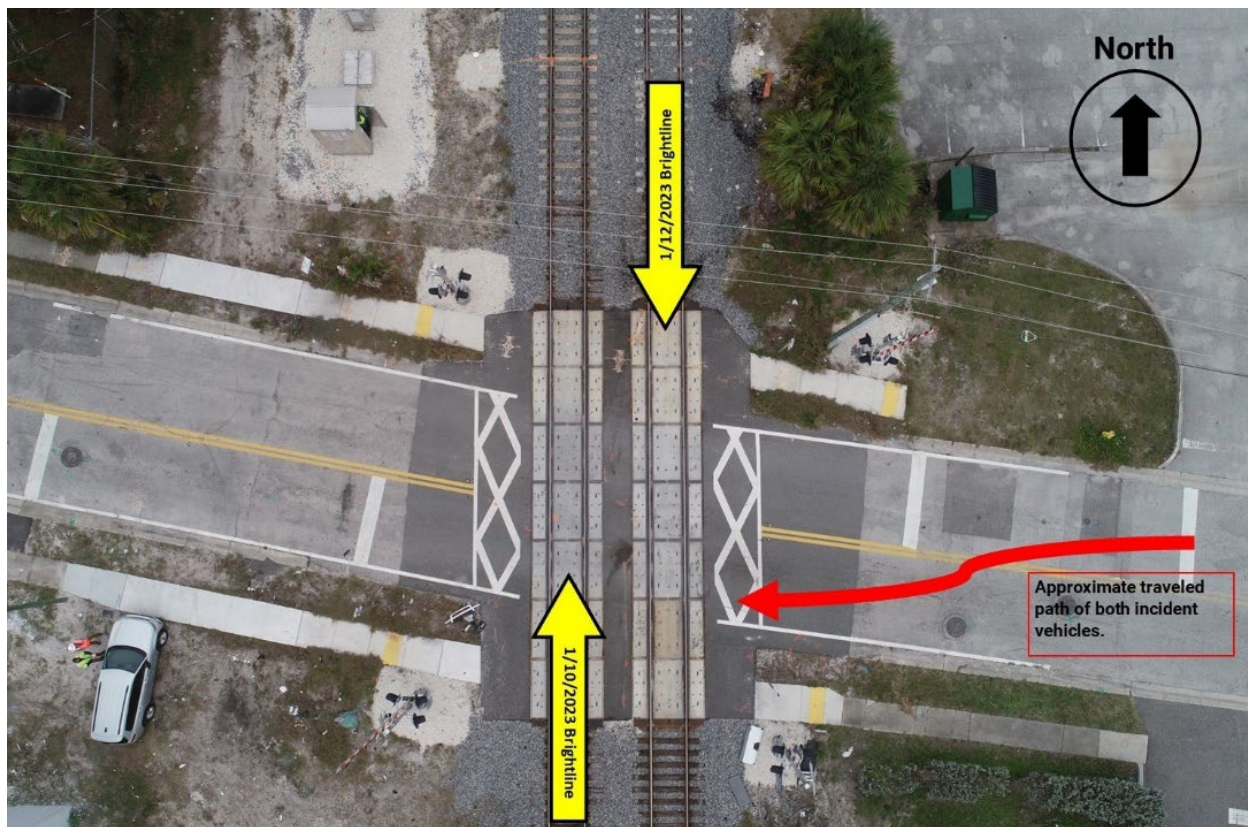
**Figure 3.** Traveled path of both accident vehicles (edited drone photo).

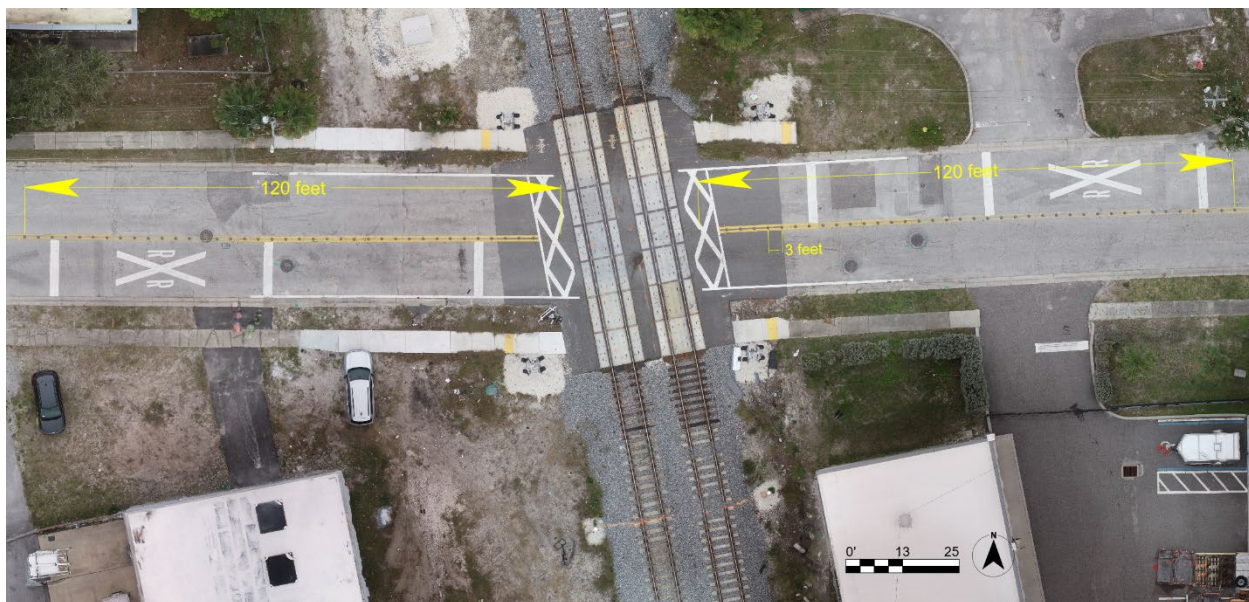
**Figure 6.** Screen capture of the generated orthomosaic with depicting the added raised delineators.

On January 19, 2024, following the two crashes, Brightline received a right-of-way use permit from the City of Melbourne to install centerline delineators along WH Jackson Street east and west of the grade crossing.<sup>15</sup> Figure 6. Screen capture of the generated orthomosaic with depicting the added raised delineators. the location of the delineators.

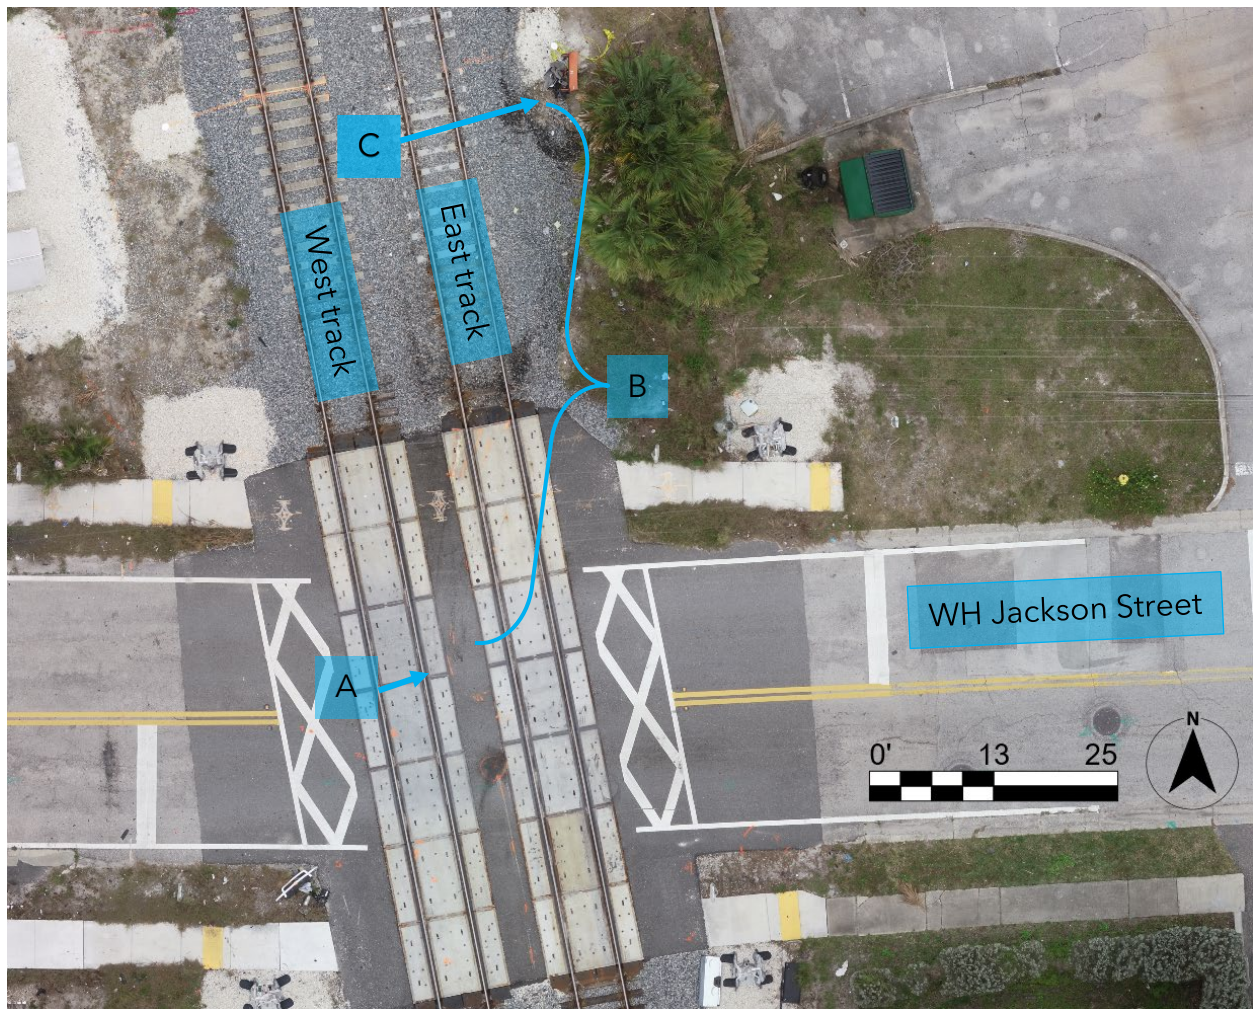
The area of impact (AOI) was established at a location where tire friction marks, surface scrapes/scratches, and vehicle fluid spray were identified within the westbound lane. Pre-collision, the vehicle was traveling westbound on WH Jackson St., and the train was traveling northbound on the west track. The tire friction mark (A) originated approximately 1.50 feet east of the eastern rail of the west track. The post-collision roadway marks (B) continued northeast in a clockwise rotation for approximately 57 feet terminating at the final rest of the Honda. The Honda came to rest (C) approximately 11 feet east of the eastern rail of the east track and had overturned onto

the driver's side. Figure 8 is an image of the orthomosaic rendered from the three-dimensional point cloud depicting the post-collision physical evidence.

**Figure 8.** Image of the orthomosaic three-dimensional point cloud depicting 1/10/2024 physical evidence.

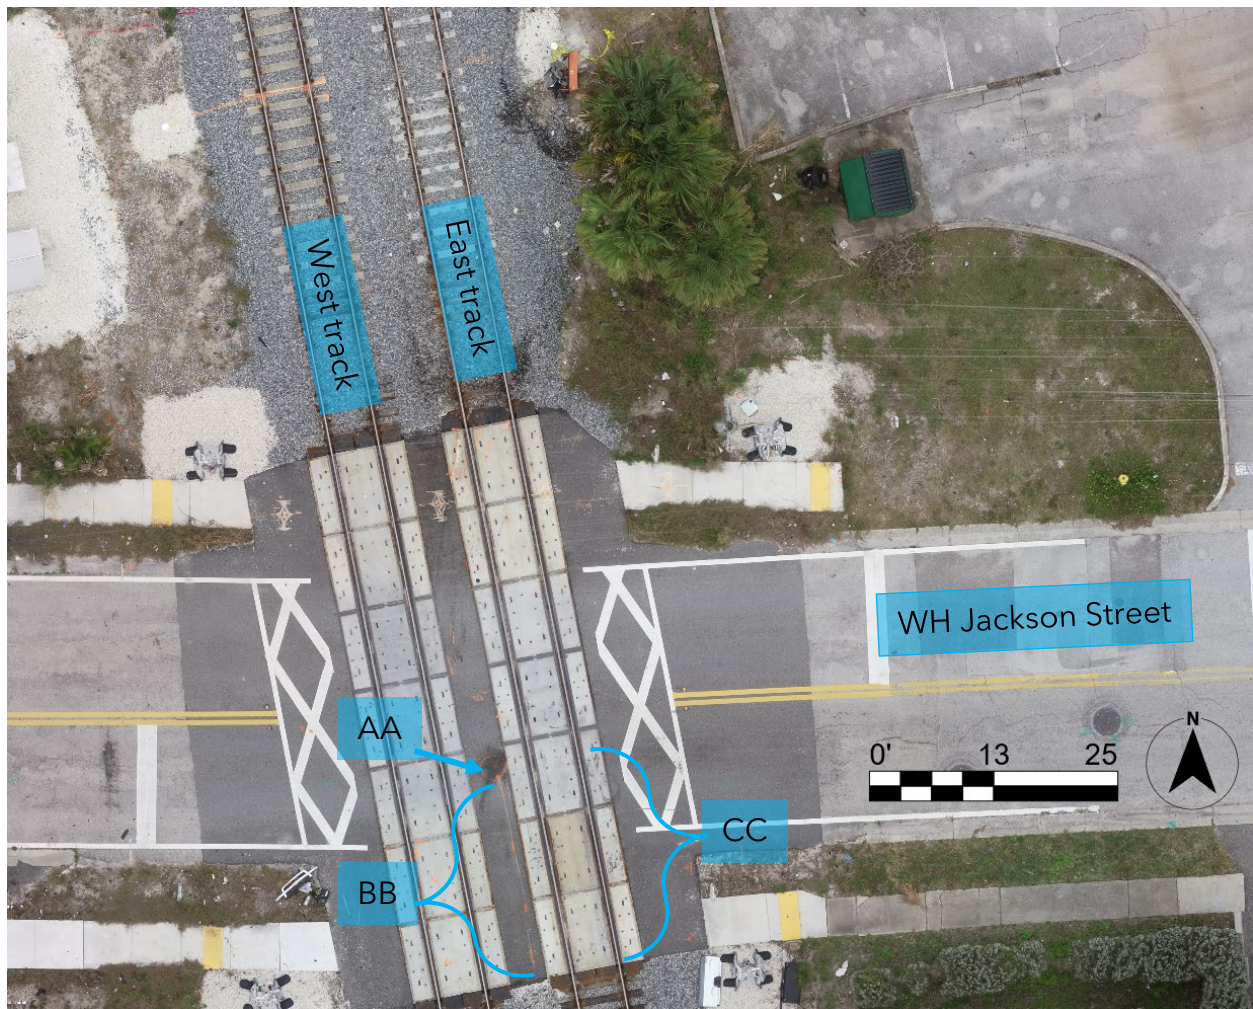
The AOI was established within the eastbound lane on the east track. Approximately 3.50 feet west of the western rail of the east track was an area of fluid (AA). Pre-collision, the vehicle was traveling westbound on WH Jackson St. and the train was traveling southbound on the east track. Scrape marks (BB) were identified beginning at the edge of the fluid, continuing south for approximately 20 feet where they terminated at the end of the asphalt. In line with the fluid, on the eastern rail of the east track, were tire friction marks. The tire friction marks traveled parallel to the scrape marks terminating at the end of the asphalt. The tire friction marks were consistent with the rear of the Chevrolet.

Post-impact, the Chevrolet remained in contact with the lead locomotive coming to rest approximately 1600 feet south of the AOI. Numerous vehicle parts and components were identified and marked with orange spray paint by MPD investigators around the grade crossing and along the post impact travel of the Chevrolet. Figure 9 below shows the described physical evidence for the 1/12/2024 collision.

**Figure 9.** Image of the orthomosaic rendered from the three-dimensional point cloud depicting 1/12/2024 physical evidence.

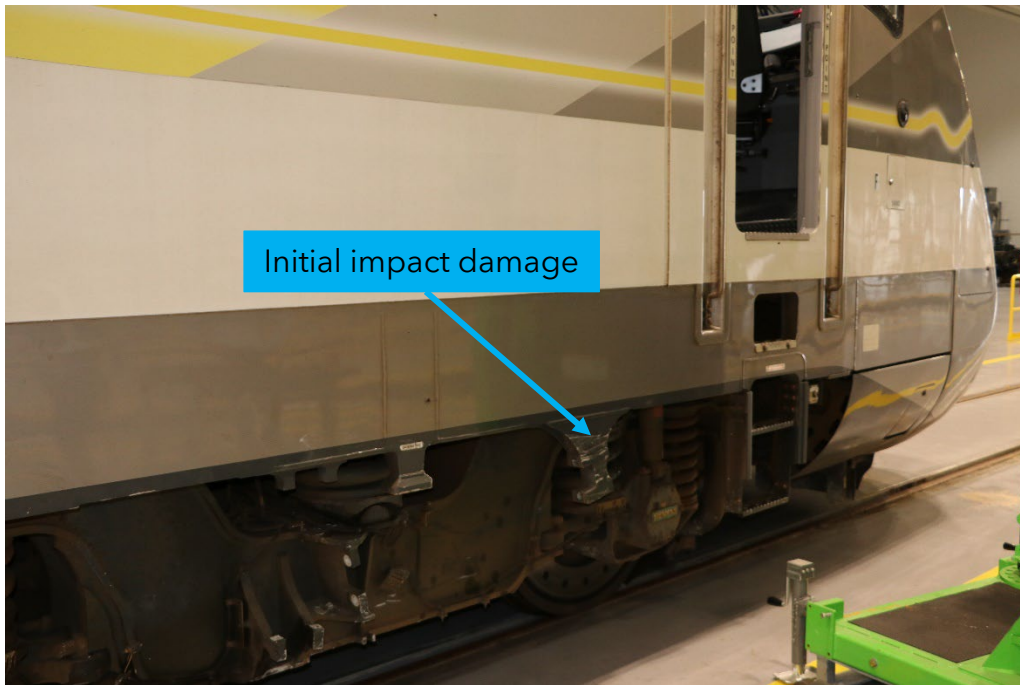
Inspection of locomotive 107 occurred on January 13, 2024. Brightline had begun repairs but stopped work upon notification that NTSB investigators wanted to conduct the inspection. The crash damage was concentrated along the right side beginning approximately 34-inches aft of the steps. Scratch and scuff marks began approximately 12-feet aft of the steps and continued rearward for about 22-feet. Figure 10 is a photograph of the right side of locomotive 107 looking forward showing the initial impact damage.

**Figure 10.** Photograph showing the damage to the right side of locomotive 107.

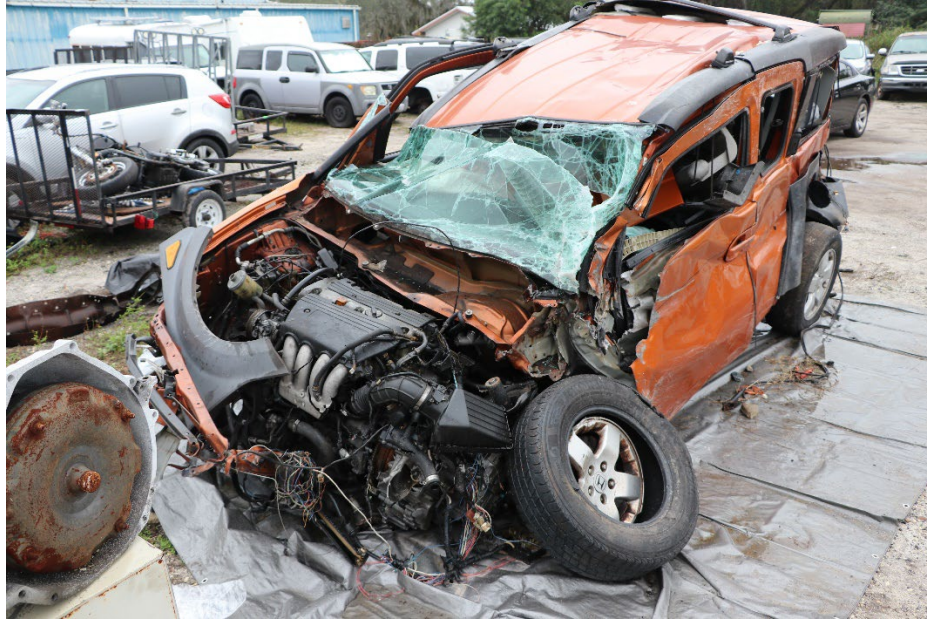
The Honda was inspected and photographed at a storage facility on January 16, 2024. The front of the vehicle; bumper cover, grille, headlights, and radiator had been torn from the vehicle along with the hood. The windshield was shattered, and the top edge of the roofline was displaced downward. Contact damage continued along the entire left side of the vehicle. There was no contact damage observed on the right side of the Honda. The right side "A" and "B" pillars had been cut during occupant extrication by first responders. Figure 11 is a photograph from the left front corner of the Honda showing the damage to the front, left side, and roof.

**Figure 11.** Photograph showing the damage to the Honda.

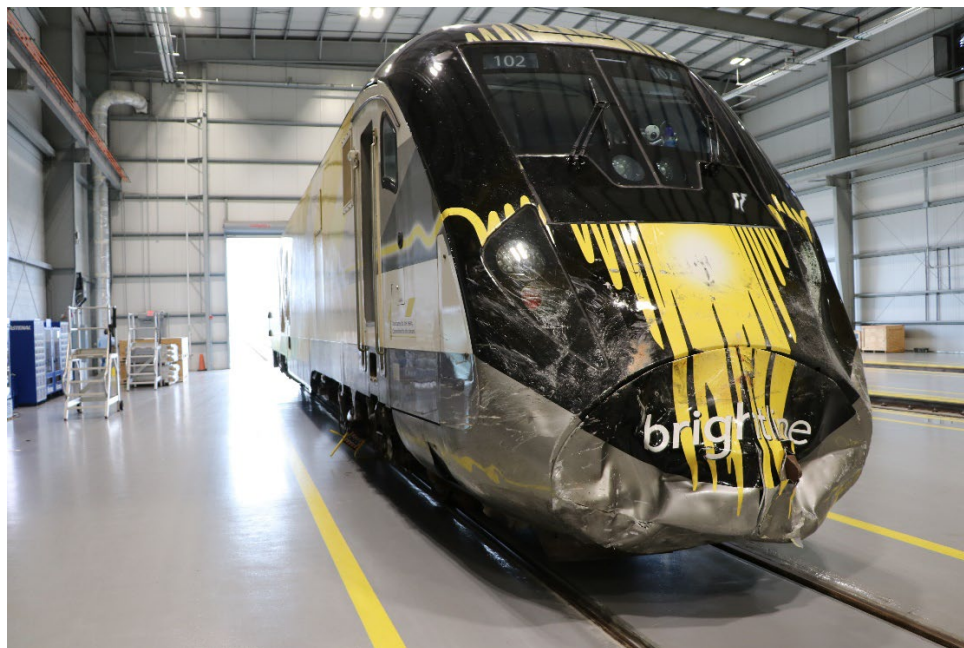
Locomotive 102 was inspected on January 13, 2024. Collision damage was concentrated to the front nose cone, and area above the nose cone. Contact damage was observed along the right and left side of the locomotive as well as damage beneath the front of the locomotive. Figure 12 is a photograph of the front and right side of locomotive.

**Figure 12.** Photograph depicting the damage to the front of locomotive 102.

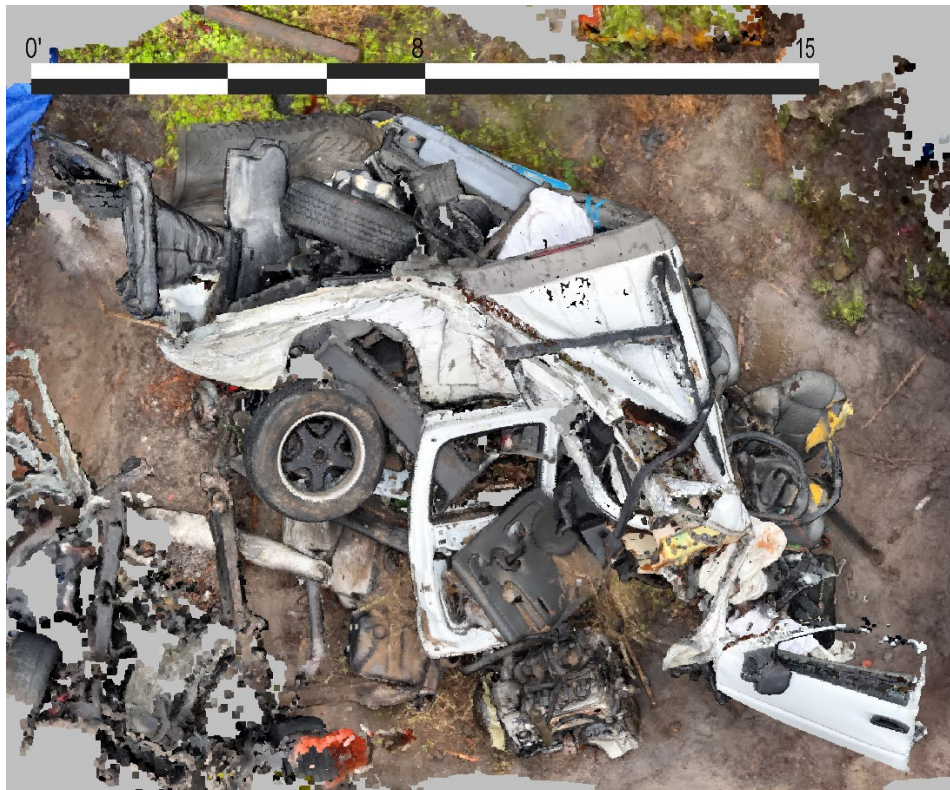
The Chevrolet had been impacted on the passenger side by the locomotive. The body had been torn from the frame. The driver's seat was displaced outward and was positioned outside the body of the vehicle. The front passenger seat was displaced inward and was atop the driver's seat. The front end of the vehicle, up to the firewall, was torn from the frame and separated from the rest of the vehicle. Figure 13 is an overhead image from the rendered three-dimensional point cloud of the damage sustained to the Chevrolet.

**Figure 13.** Overhead image of the rendered three-dimensional point cloud depicting the damage to the Chevrolet.

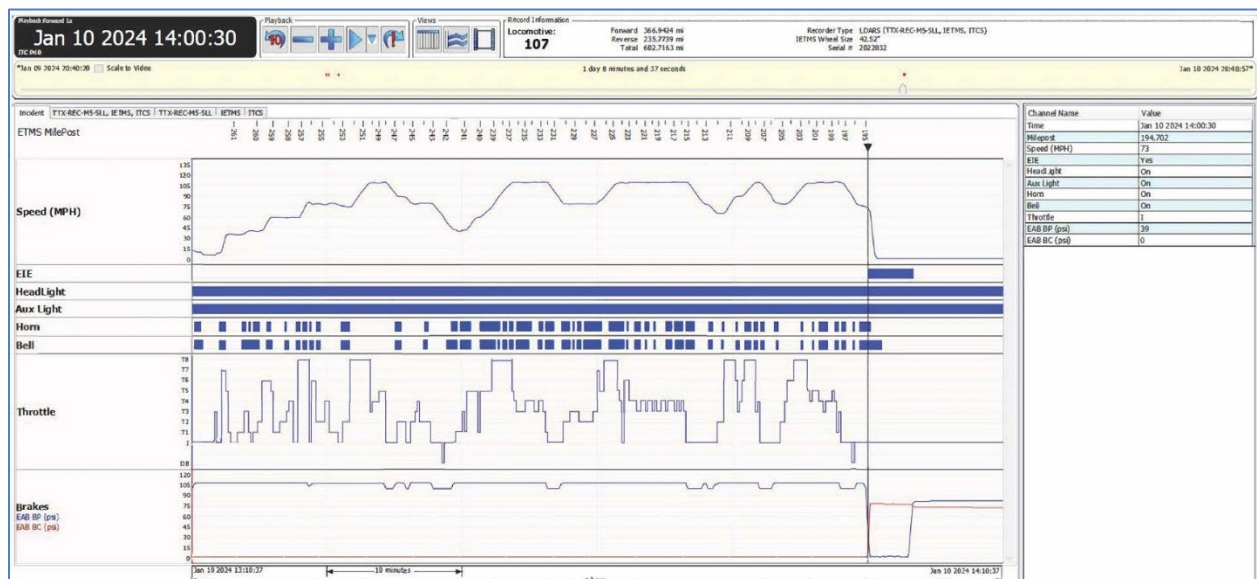
As shown in Figure 14 below, the throttle position for train BLF 107 from the January 10, 2024, accident was in idle, and it was determined that train handling was not a factor. The engineer was blowing his horn prior to placing the trains brakes into emergency.

The team noted that the engineer placed BLF 107 into emergency at 2:00:30 p.m. local time after the engineer felt something hit his train and then saw the accident in the rear-view mirror. When the train went into emergency, it was traveling at 68 MPH.

**Figure 14.** Locomotive BLF 107 ERU download.

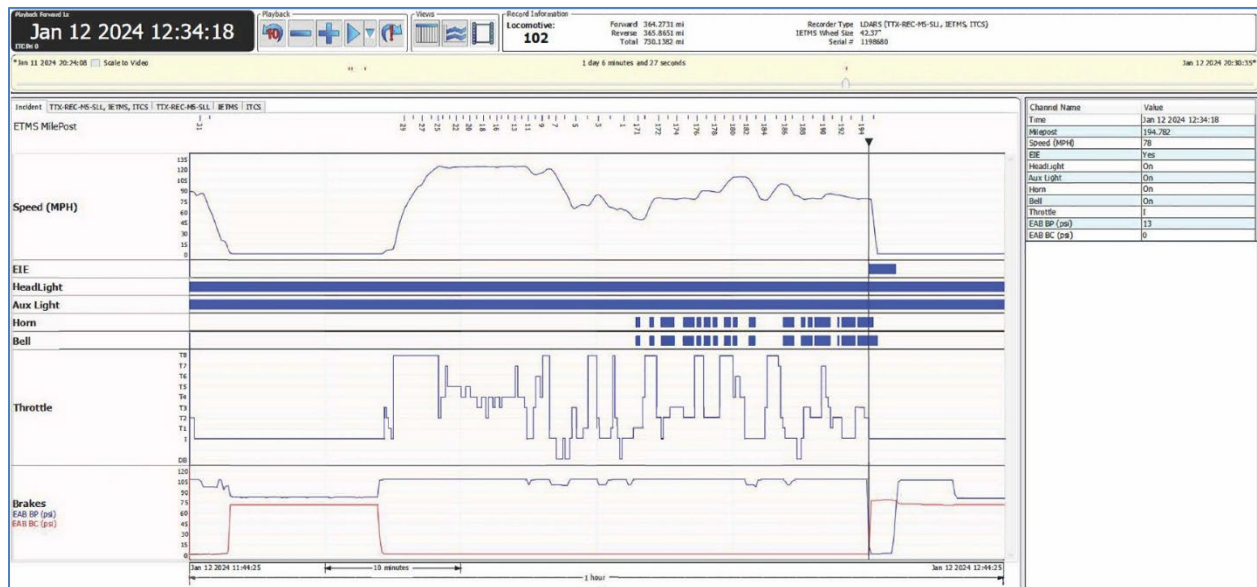
As shown in Figure 15 below, the throttle position for BLF 102 from the January 12, 2024, accident was in T2, and it was determined that train handling was not a factor. The engineer was blowing his horn prior to placing the train into emergency and continued to blow the horn for an additional 8 seconds after the train brakes emergency application.

The team noted that the engineer placed the BLF 102 into emergency at 12:50:51 p.m. local time upon impact with the highway vehicle. When the train was placed in emergency, it was traveling at 78 MPH.

**Figure 15.** Locomotive BLF 102 ERU download.

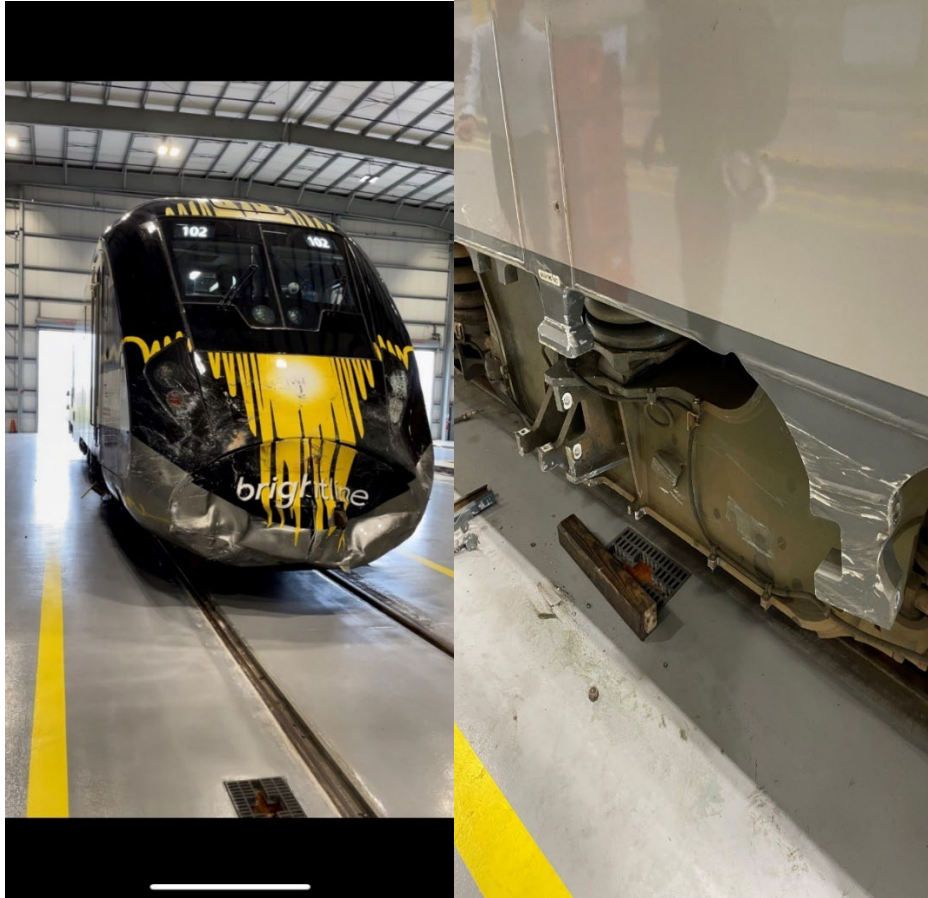
The investigation team met at the Brightline Running Repair Facility in Orlando, FL on Saturday morning, January 13, 2024, to inspect the lead locomotives, BLF 102 and BLF 107. The crash damage for both locomotives can be seen in Figure 16 below.

The inspection found no exceptions to the locomotive air brake system, head lights, locomotive horn, and the auxiliary lights functioned as designed.

**Figure 16.** Locomotive BLF 102. Left photograph depicts the front-end damage. Right photograph depicts the right-side damage on Locomotive BLF 107.
