## **NATIONAL TRANSPORTATION SAFETY BOARD**

### **Group Chairman's Factual Report**

# **TECHNICAL RECONSTRUCTION**

HWY22FH008

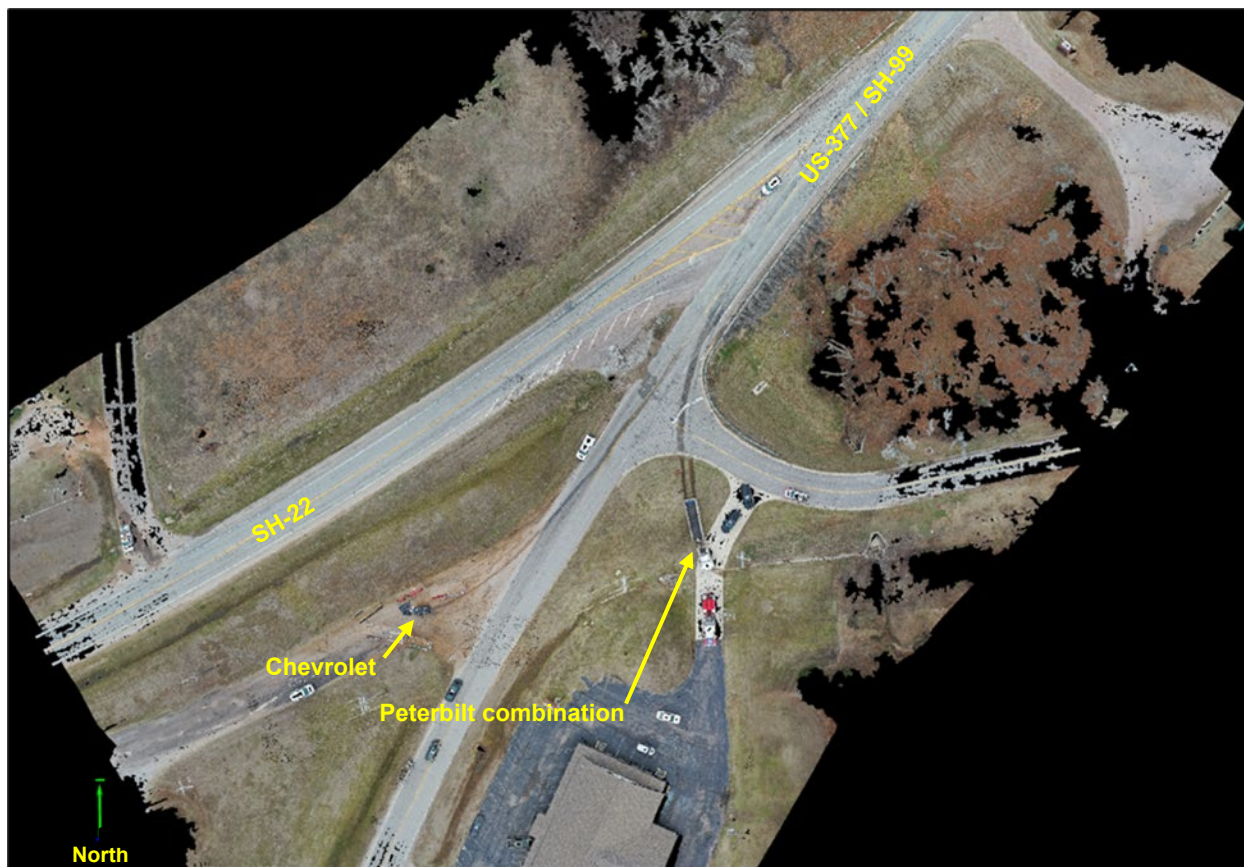
**Figure 3:** Screen capture image of the 3D point cloud rendered from the ariel photograph project depicting the roadway and vehicle positions of rest.

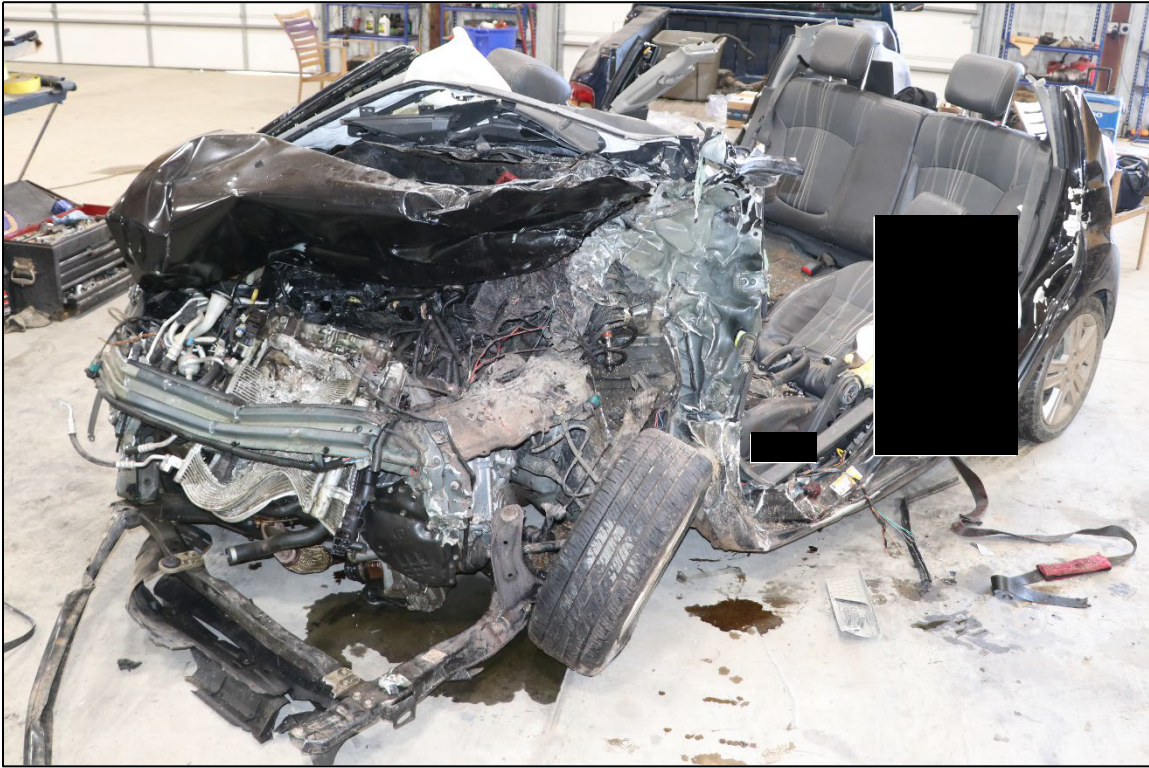
While post-collision dimensions were not provided, photographic imagery depict evidence of substantial contact damage at the driver side front of the vehicle. As depicted, evidence of direct contact encompassed the driver side front fender and A-pillar with some overlap of the left frontal surface. Similar structural displacement was observed to the driver side rocker panel. Photographs depict rearward displacement of the driver side floor pan that compromised apparent leg occupant leg room. On scene photographs depict substantial outward bowing of the driver's door.

Rearward displacement of the vehicle engine with the accompanying destruction of numerous engine compartment components were evident. The forward portion of a frontal structure identified as the engine cradle cross member protruded from the front of the vehicle. The structures above the cradle cross member, which included the engine and frontal body appeared to be displaced rearward relative to this structure. The right edge of the cradle exhibited evidence of override contact.

The passenger side front fender and body structure about the A-pillar and forward exhibited a displacement toward the driver side of the vehicle.

**Figure 4:** Post-collision photograph depicting the frontal damage exhibited by the Chevrolet. The vehicle roof and driver's side B-pillar had been removed by emergency response personnel. Source: NTSB

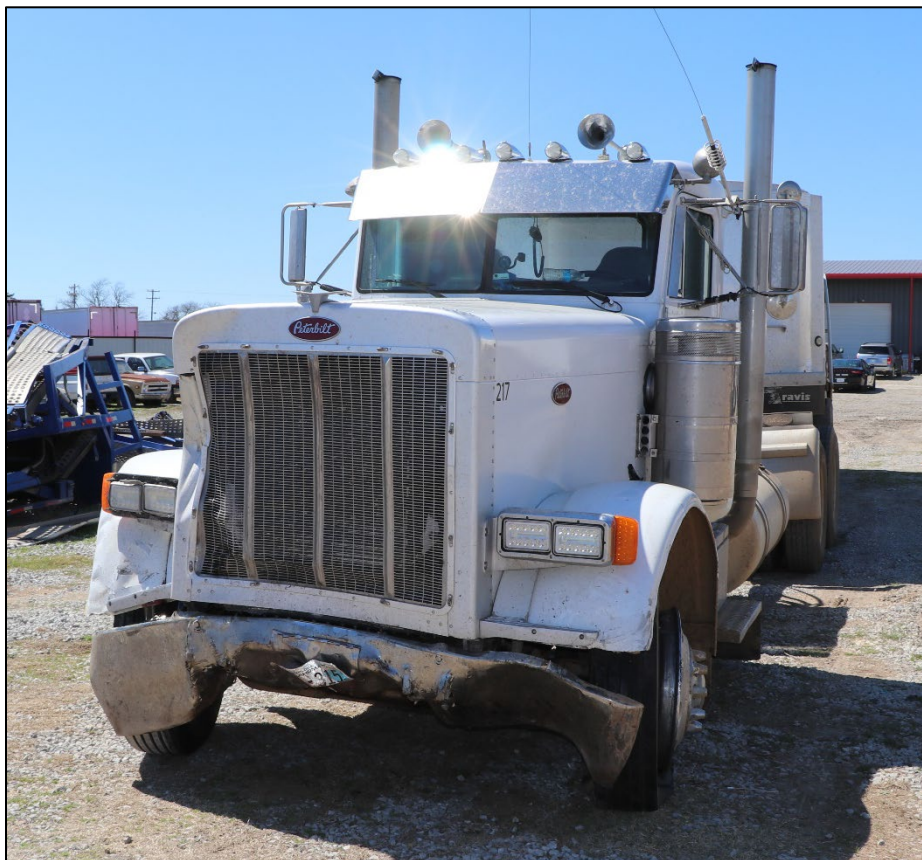
The truck tractor exhibited contact damage across the entire width of the vehicle front end, primarily at bumper height. The appearance of substantial contact deformation began near the right (passenger) side frame rail attachment point and extended laterally across the bumper face to the

left side. The contact damage created deformation to the face of bumper and displaced the lower edge (bottom) rearward. The frame attachment on the left side limited rearward displacement at that location. Additional contact damage and body deformation was observed to the right side of the hood's vertical face (just above the headlamps) and to the leading surface of the right front fender. **Figure 5** depicts a photograph of the Peterbilt post-collision.

While post-collision photographs depict the left steer axle tire as being deflated, the remaining nine tires on the Peterbilt appear intact and in operational condition.

**Figure 5:** Post-collision photograph depicting damage exhibited by the Peterbilt.  
Source: NTSB

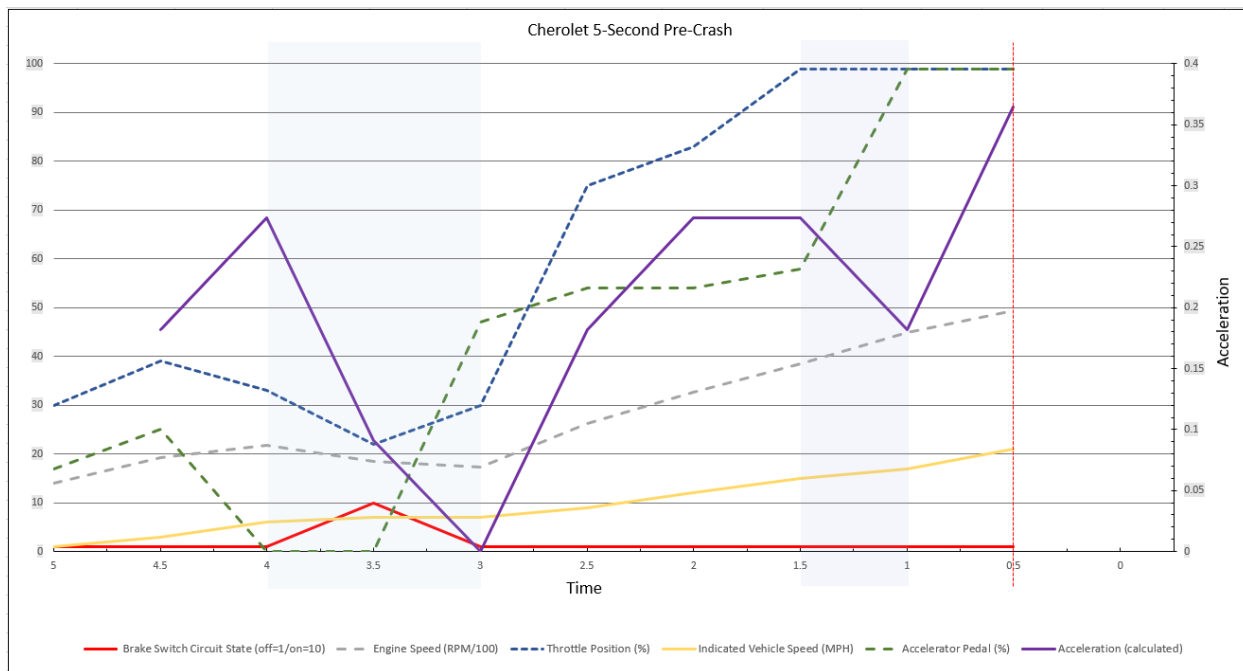
As illustrated by the precrash data, for the approximate 5 seconds before the crash the Chevrolet was in motion with only evidence of a momentary brake application at about 3.5 seconds before impact.<sup>19</sup> The data then exhibit notable changes at the 4- and 2.5-second samples. At about 4 seconds precrash, the accelerator pedal reports 0% application. This data is repeated at the 3.5 second sample concurrent with the brake application. In contrast, the 2.5 second sample depicts a sharp increase in both the accelerator pedal and engine throttle percent data. Between about 1.5 and 1.0 seconds before impact, both the accelerator pedal and engine throttle percentage depict an increase to 99%. At the final data sample, the reported vehicle speed was 21 mph. **Figure 6** provides a graphical depiction of the precrash data.

**Figure 6:** Precrash data depicted in graphical format
