FINAL REPORT

2006 REVIEW OF DEGT HARD SPOT MANAGEMENT ACTIVITIES

**DUKE ENERGY GAS TRANSMISSION
HOUSTON, TEXAS**

**CC TECHNOLOGIES, INC.
TOM A. BUBENIK
LISA A. BARKDULL
JOHN A. BEAVERS
PATRICK H. VIETH**

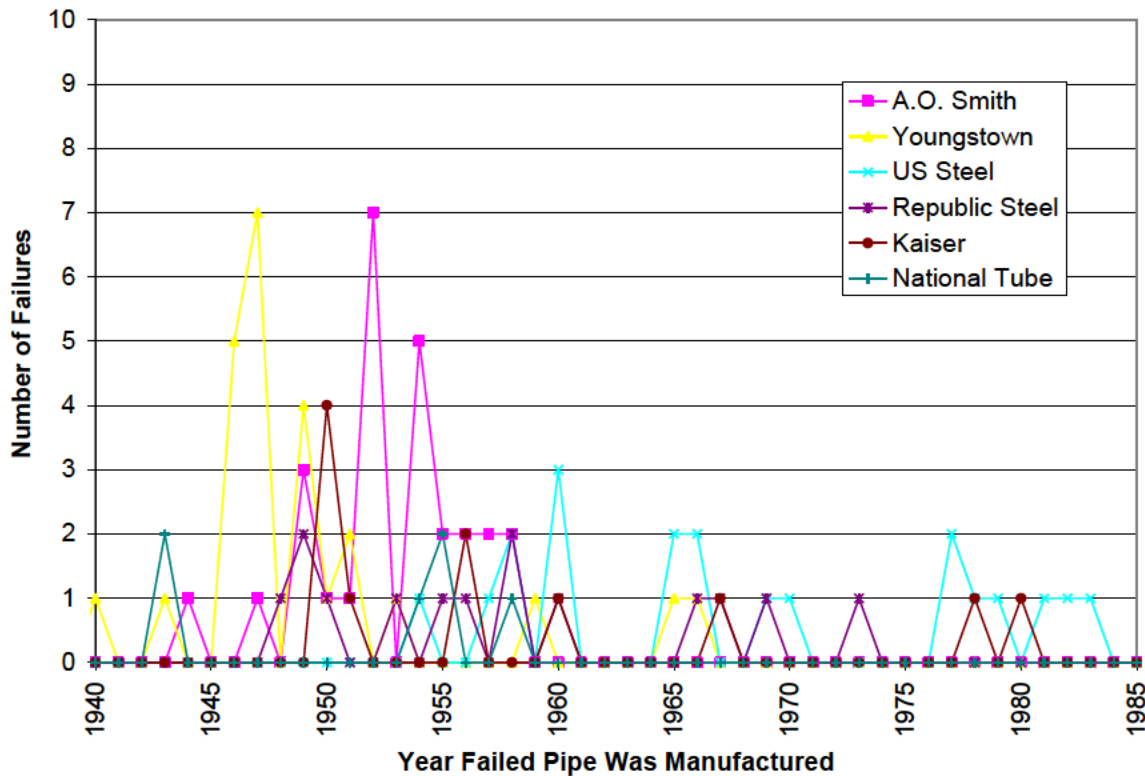
Figure 1. Number of reported failures grouped by manufacture year.

Figure 1 plots the number of failures as a function of pipe manufacturer and the year in which the failed pipe was manufactured. The figure covers the period 1940 through 1985 in order to concentrate on the most common pipe production years in which a possible hard spot failure was reported. The largest number of failures occurred on line pipe that was manufactured during the 1950s.

The number of failures attributed to any one manufacturer typically shows a peak followed by a rapid decrease to (near) zero incidents per manufacturing year. That is, the companies improved either their manufacturing processes or were successful in obtaining better base materials.

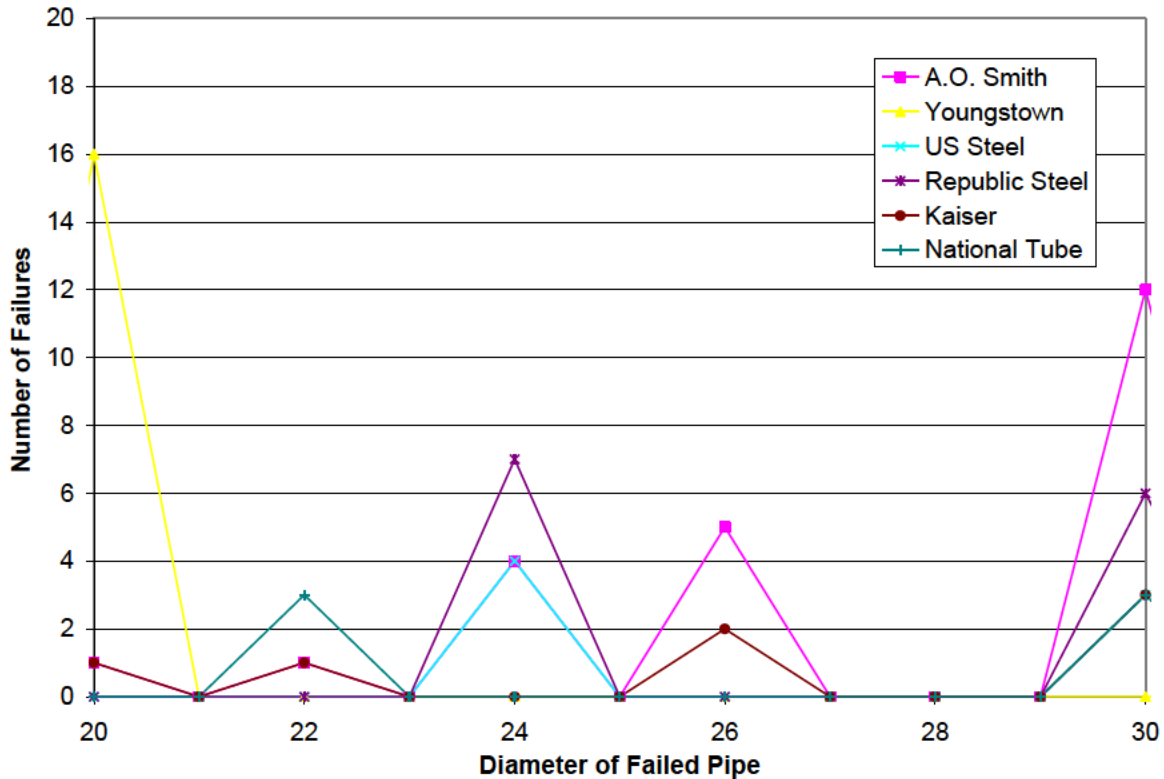
Figure 2. Number of reported failures grouped by pipe diameter.

Failed line pipe having diameters between 20 and 30 inches made up 77% of the reported data for the top six manufacturers. (Of these six manufacturers 28% of the OPS data did not include a reported diameter.) The most common diameters reported

are 30 and 24 inches. A complete breakdown by pipe diameter of failed pipe can be found in the Appendix C.

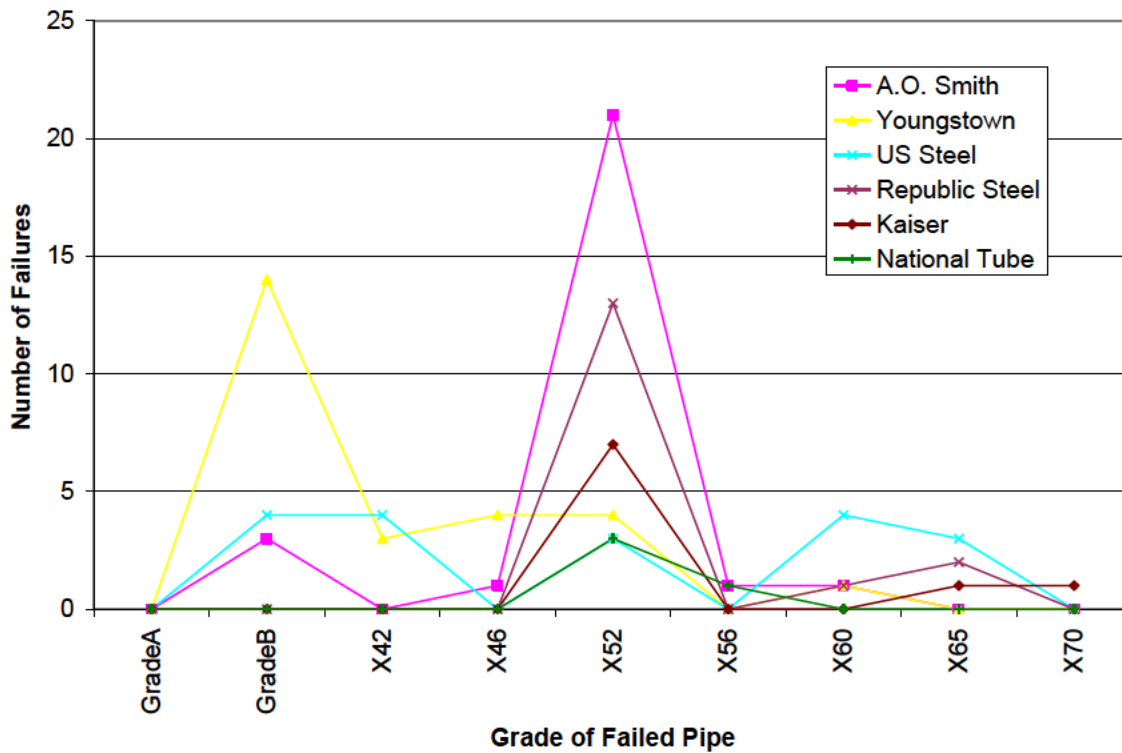
Figure 3. Number of reported failures grouped by pipe grade.

As shown in Figure 3, the most prevalent grade of failed line pipe was X52, which accounted for over 50% of all reported failures that could be attributed to hard spots. Of these, 41% were manufactured by A. O. Smith.

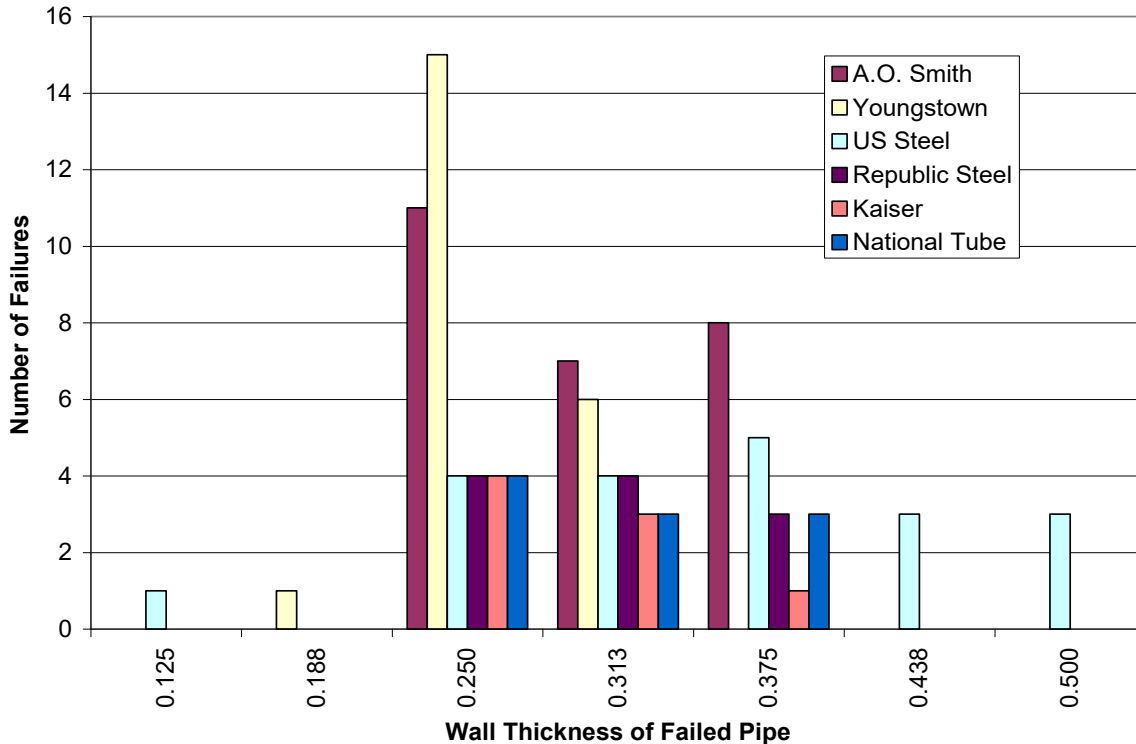
Figure 4. Number of reported failures grouped by wall thickness.

The most common wall thickness (43% of the reported data) is 0.25 inches, with Youngstown Sheet and Tube showing the highest number of failures for that wall thickness.

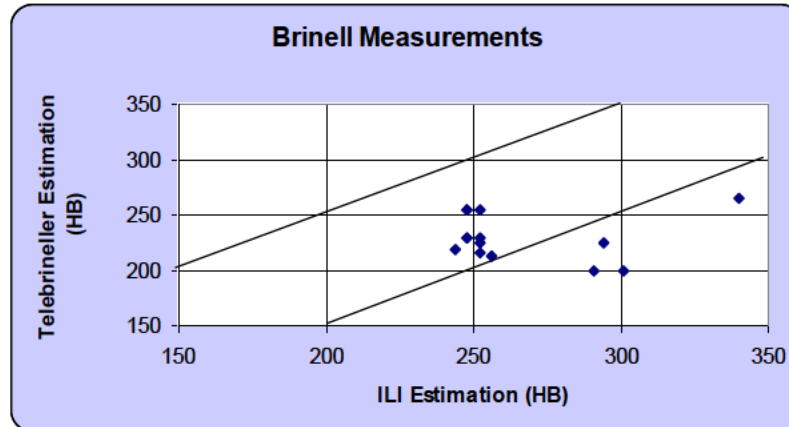
Figure 5. Unity Plot of Hardness Values.

In addition to hardness measurements, ultrasonic wall thickness measurements and magnetic particle inspections were performed at each excavation location. No evidence of laminations or cracking was found at any of the hard spot sites. The results from the 14 excavated hard spots are consistent with or more conservative than the ± 50 Brinell specification given by the inspection vendor. That is, the majority of the hardness values reported by the ILI vendor met the performance specification or were higher than measured. Figure 5 plots the results in a unity graph.

The field and laboratory program also characterized the hardness levels present on DEGT's pipeline system. The measured hardness values, while elevated, were lower than that typically associated with hydrogen embrittlement and cracking of hard spots.

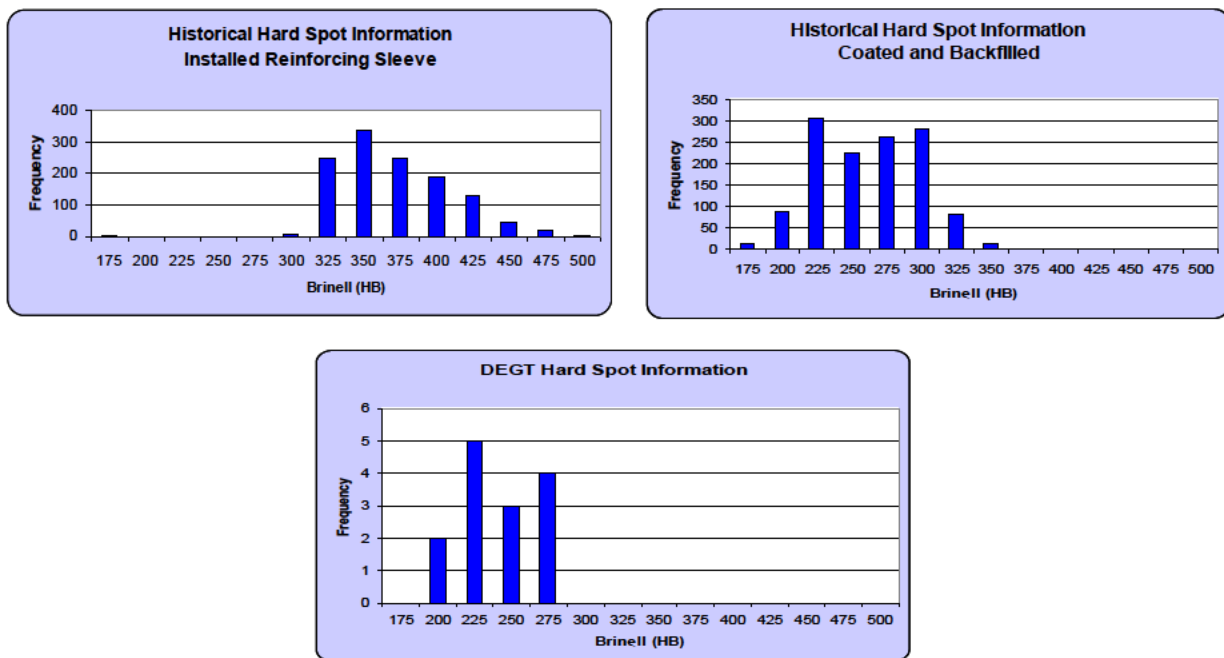
Figure E-2. Historical hard spot measures compared to Duke Energy's hard spot measures.

Appendix E includes a graphical summary of the excavation results. For the sake of comparison, Appendix E also includes hardness values from a pipeline system that has experienced hard spot failures in the past and utilized ILI technology to detect and locate hard spot anomalies. The Brinell measurements for the historical information were made with Equotip hardness testers. It can be seen in Figure E-2 that the hardness measurements DEGT have found in their pipeline system are similar to historical hardness measurements associated with re-coats and appear much lower than the hardness measurements for hard spots that required reinforcing sleeves.
