**METALLURGICAL ASSESMENT OF OWINGSVILLE LINE 15
FOR HARD SPOTS**

NOVEMBER 10, 2004

**PREPARED BY:
Gary Vervake
Sr. Metallurgical Engineer
Metallurgical Services & QA**

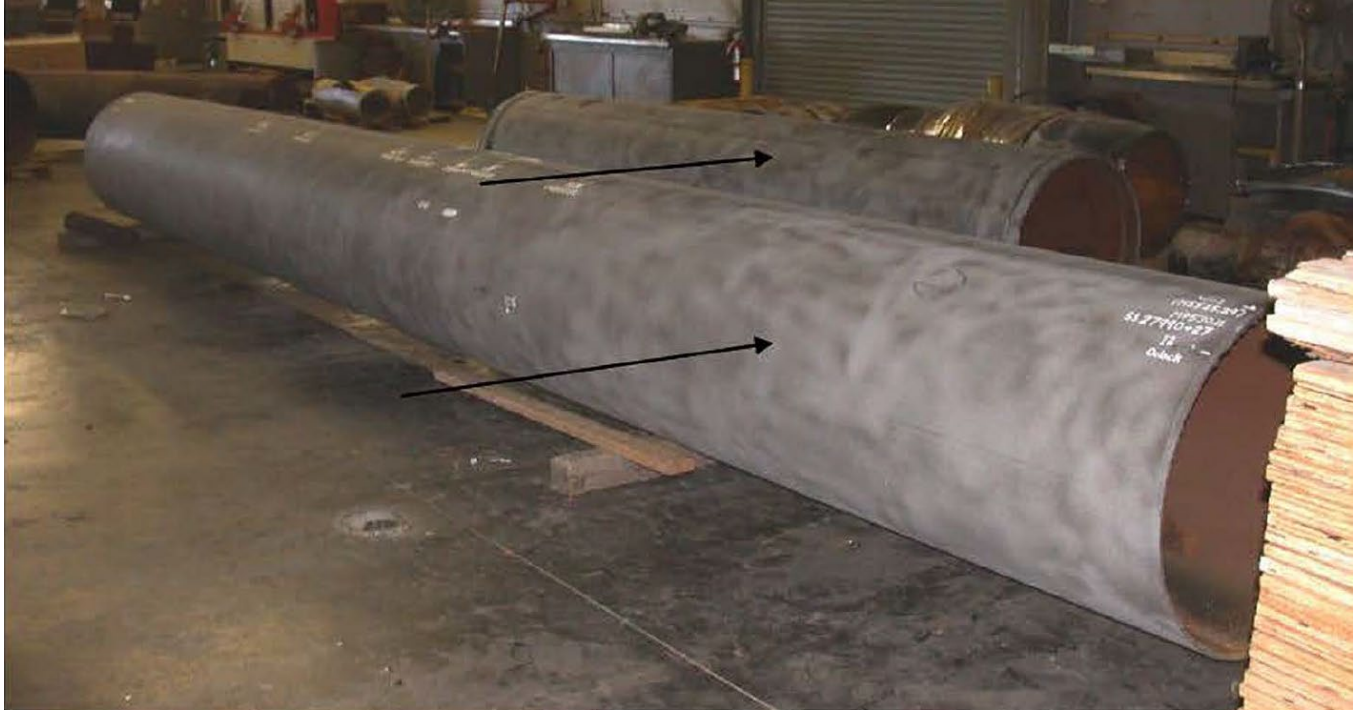
The two pipe samples removed from Owingsville Line 15 are shown in Figure 3. Field personnel had identified each sample by paint marking the mile post, station number, and

Figure 3. The sections of pipe removed from service from Owingsville Line 15 for assessment of hard spots.

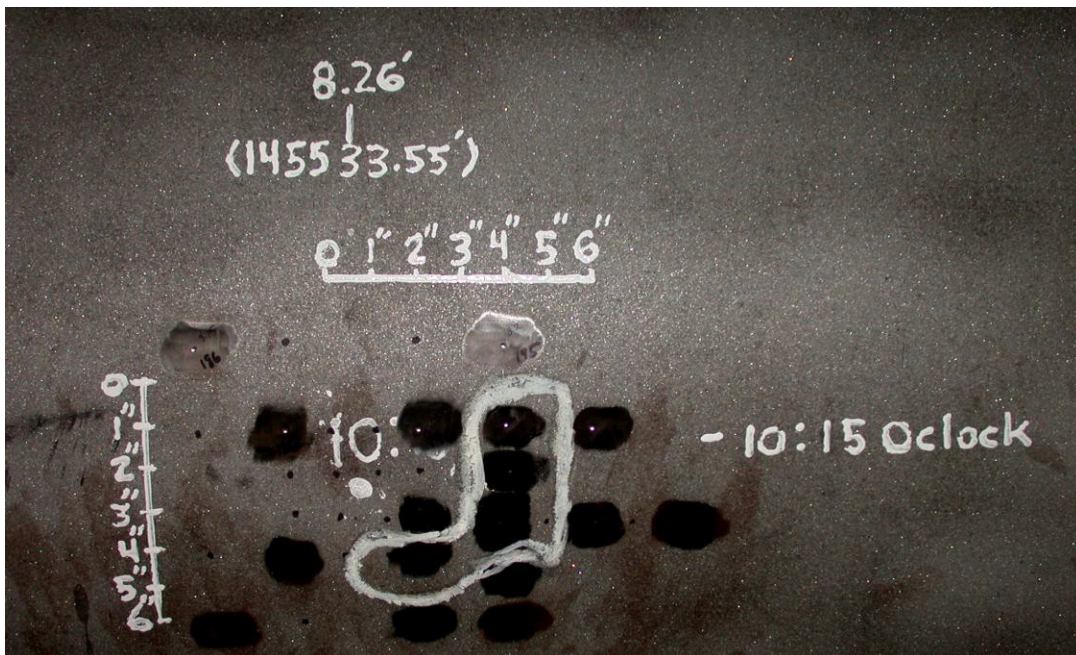
The third hard spot metallographically examined had a pearlitic microstructure, consistent with the normal pipe body. The Vickers microhardness of this region was also consistent with the pipe body. It was concluded that the ILI tool provided a false positive hard spot indication for this anomaly.

- Vickers Microhardness Testing - Vickers microhardness testing was performed in accordance with ASTM E92 requirements. Vickers tests involved a small diamond penetrator that relied on optical evaluation of the indentation were also performed on metallographic cross sections of selected areas in three hard spots. Vickers microhardness data provided the most reliable method for assessing the actual hardness properties of the steel at the selected locations. The testing was performed on metallographic cross sections from hard spots “A”, “C” and “H”. The Vickers hardness, or actual steel, properties for hard spots “C” and “H” were found to be in close agreement with the Telebrineller, ILI and Microdur data. Hard spot “A” properties as established by Vickers testing was in close agreement with the Microdur data, but not with the ILI and Telebrineller data. This indicated that hard spot “A” was a false positive indication.

- Hard Spot “A”– Seven metallographic cross sections from the region were prepared for metallographic examination. Four of the sections were removed from Telebrineller test

locations indicating the presence of a hard spot, and the remaining three were removed from outside the hard spot region. All of the metallographic cross sections had a pearlitic microstructure, indicative of typical pipeline steel. See Figure 12. The microstructure was free of features that would indicate the presence of a hard spot. The Vickers hardness properties for each of these mounts were consistent with the pipe body properties.

Figure 6. A view of hard spot region "A". The boundary of the hard spot indicates the region with hardness greater than 200 Brinell as determined by Telebrineller hardness testing.

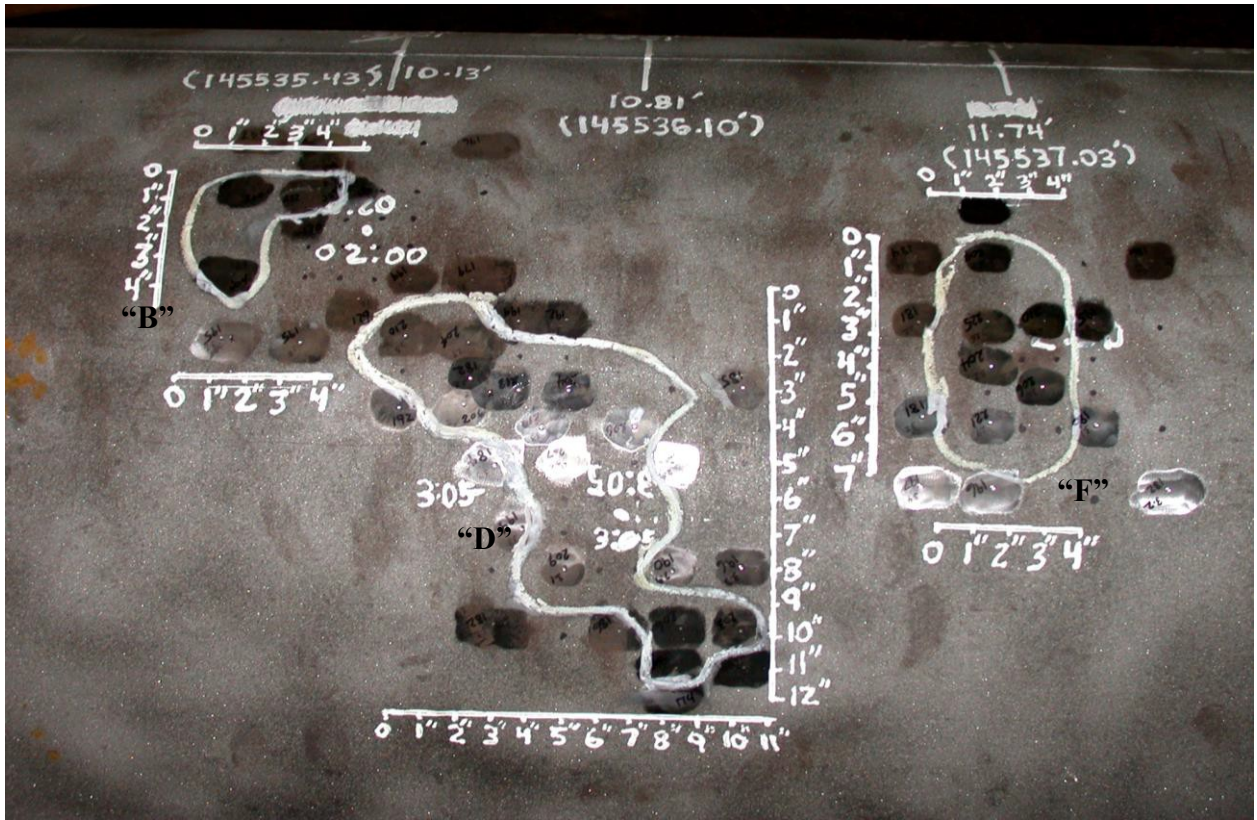
Figure 7. A view of hard spot regions "B", "D", and "F".

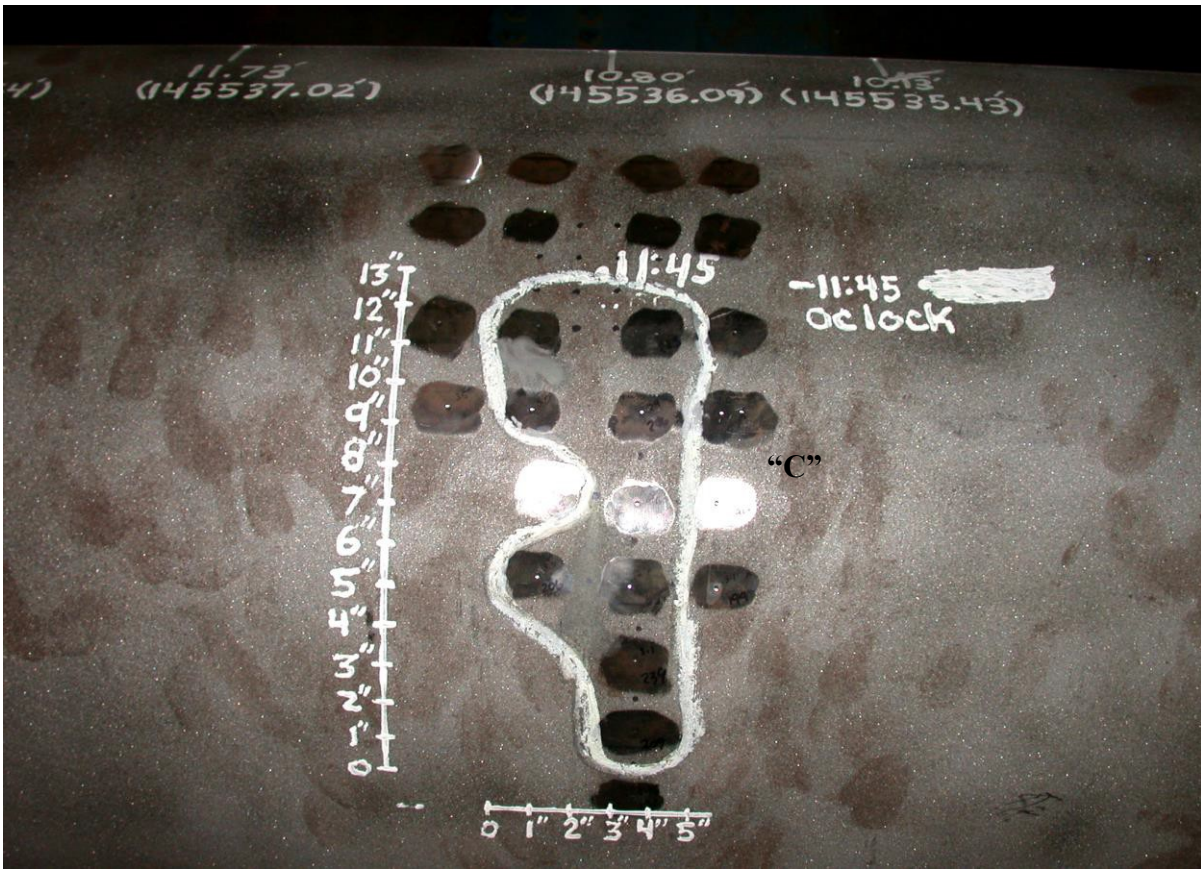
- Hard Spot at “C” – Nine metallographic cross sections from the region were prepared for metallographic examination. Six of the sections were removed from Telebrineller test locations indicating the presence of a hard spot, and the remaining three were removed from outside the hard spot region. The metallographic cross sections from within the hard spot region had a bainitic/martensitic microstructure indicative of quenched and hardened steel. See Figure 13. The cross sections outside of the hard spot region had pearlitic microstructure, indicative of typical pipeline steel. In each case, the microstructure was consistent with the Vickers properties for each of the mounts.

Dry magnetic particle inspection was performed on the hard spot “C”. MT was performed at this location because the ILI and field hardness testing had determined that this region had the highest hardness properties (252 to 260 BHN). Although the hardness properties were well below the 300 BHN criteria in the assessment protocol, the inspection was performed in order to verify that cracking was not present. No evidence of cracking was detected during MT inspection, and as a result, it was concluded that hydrogen induced cracking was not an integrity threat at each of the hard spot locations.

Figure 8. A view of hard spot region "C".

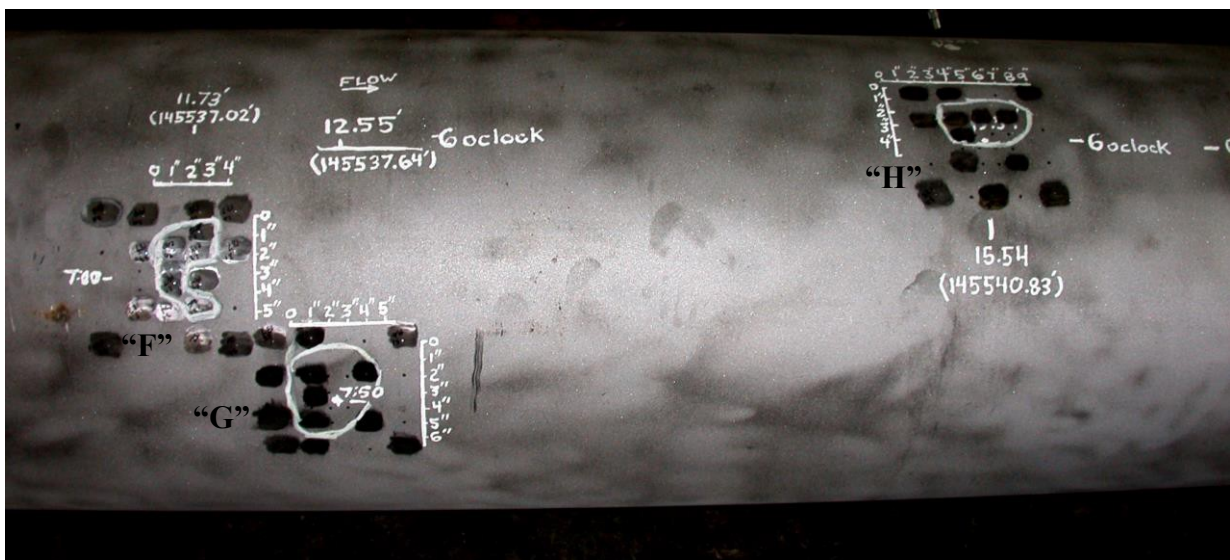
- Hard Spot at “H” – Six metallographic cross sections were removed from Telebrineller test locations indicating the presence of a hard spot. These metallographic cross sections had bainitic/martensitic microstructures indicative of quenched and hardened steel. See Figure 14. The Vickers hardness properties for each of these mounts were found to be relatively high when compared to the normal pipe body hardness.

Figure 9. A view of hard spot regions "E", "G", and "H".

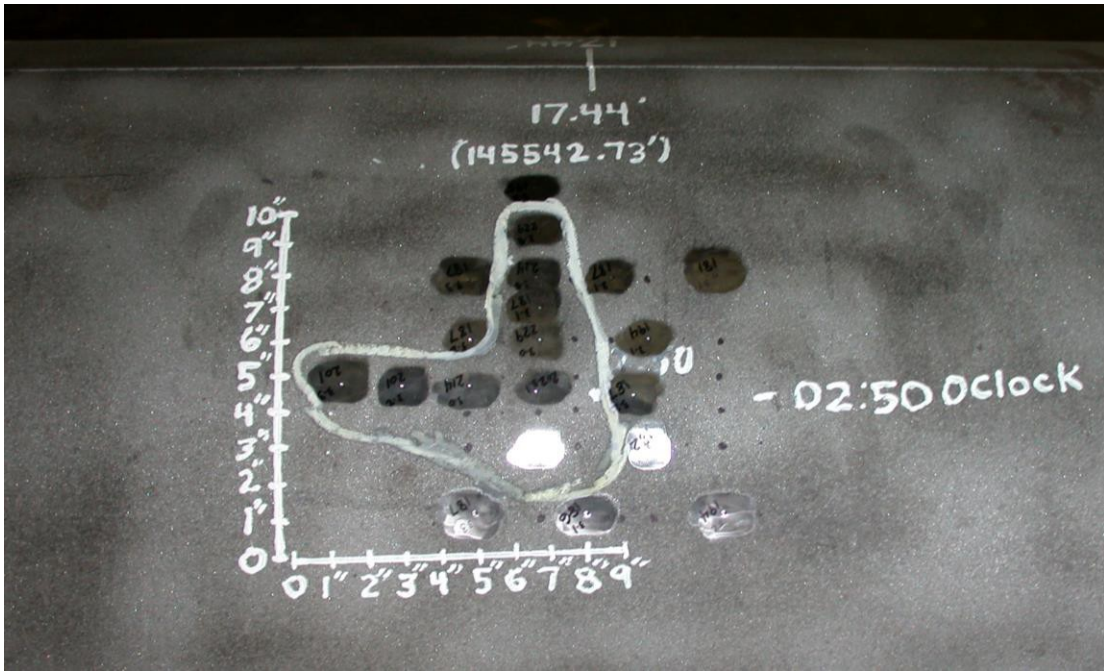
Figure 10. A view of hard spot region "I".

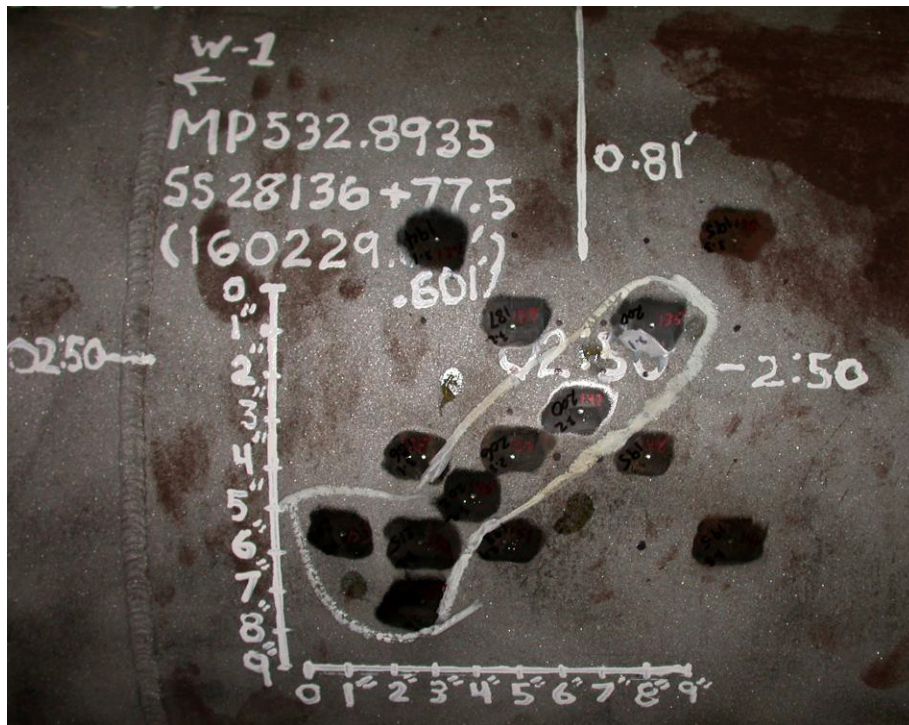
Figure 11. A view of hard spot region "J".

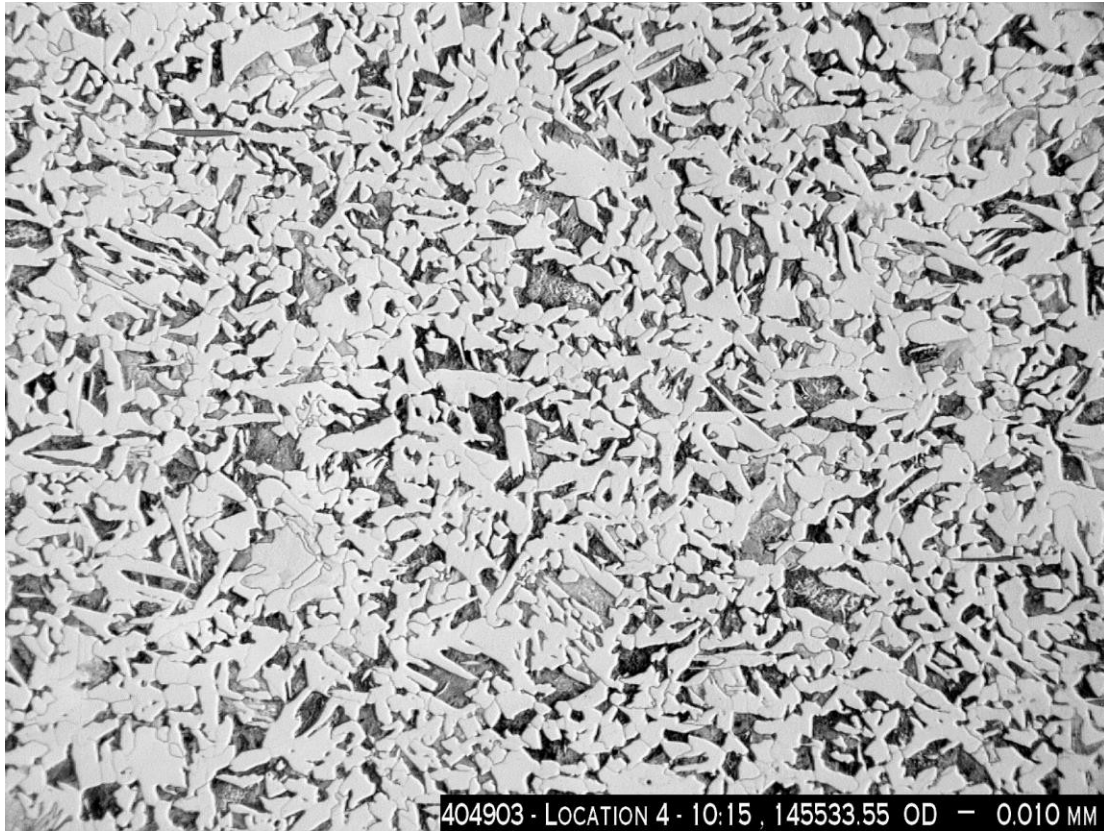
Figure 12. A view of the microstructure at a location within the “hard spot” region of sample “A”. The microstructure consists of islands of pearlite (dark regions) in a ferrite matrix (light regions). This is typical for all of the samples from hard spot region “A”, and is consistent with a normal pipeline steel microstructure. This location had an ILI estimated hardness of 248 Brinell, a Telebrineller hardness reading of 247 Brinell, a Microdur reading of 142 Brinell, and an actual hardness value of 156 Brinell as determined by Vickers testing. The microstructure and microstructure indicate that this region was a false positive hard spot indication.

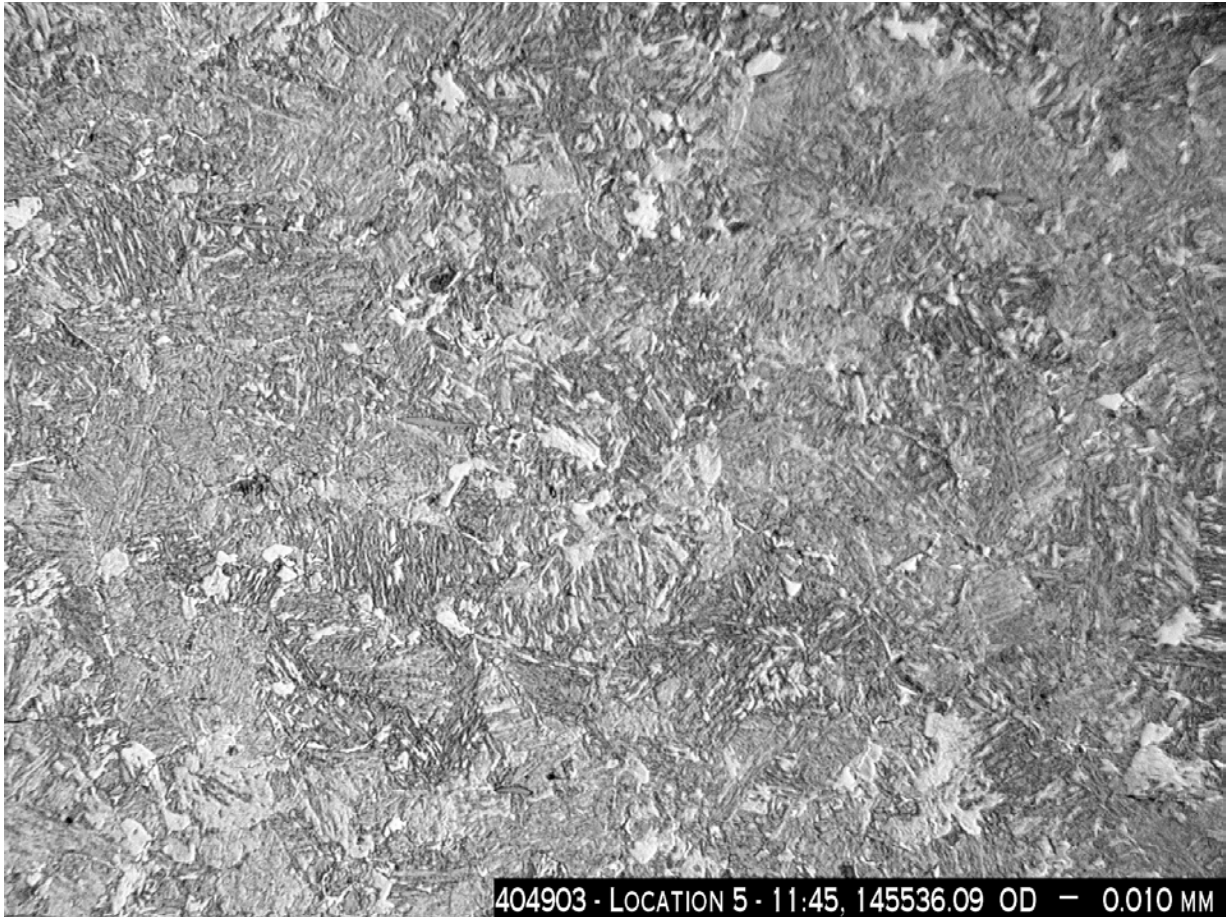
Figure 13. A view of the microstructure at a location within the hard spot “C”. This microstructure was classified as bainitic/martensitic, and is consistent with quenched and hardened steel. The microstructure shown was typical of the microstructures observed in the hard spot region. This location had an ILI estimated hardness of 252 Brinell, a Telebrineller hardness reading of 255 Brinell, a Microdur reading of 253 Brinell, and an actual hardness value of 255 Brinell as determined by Vickers testing.

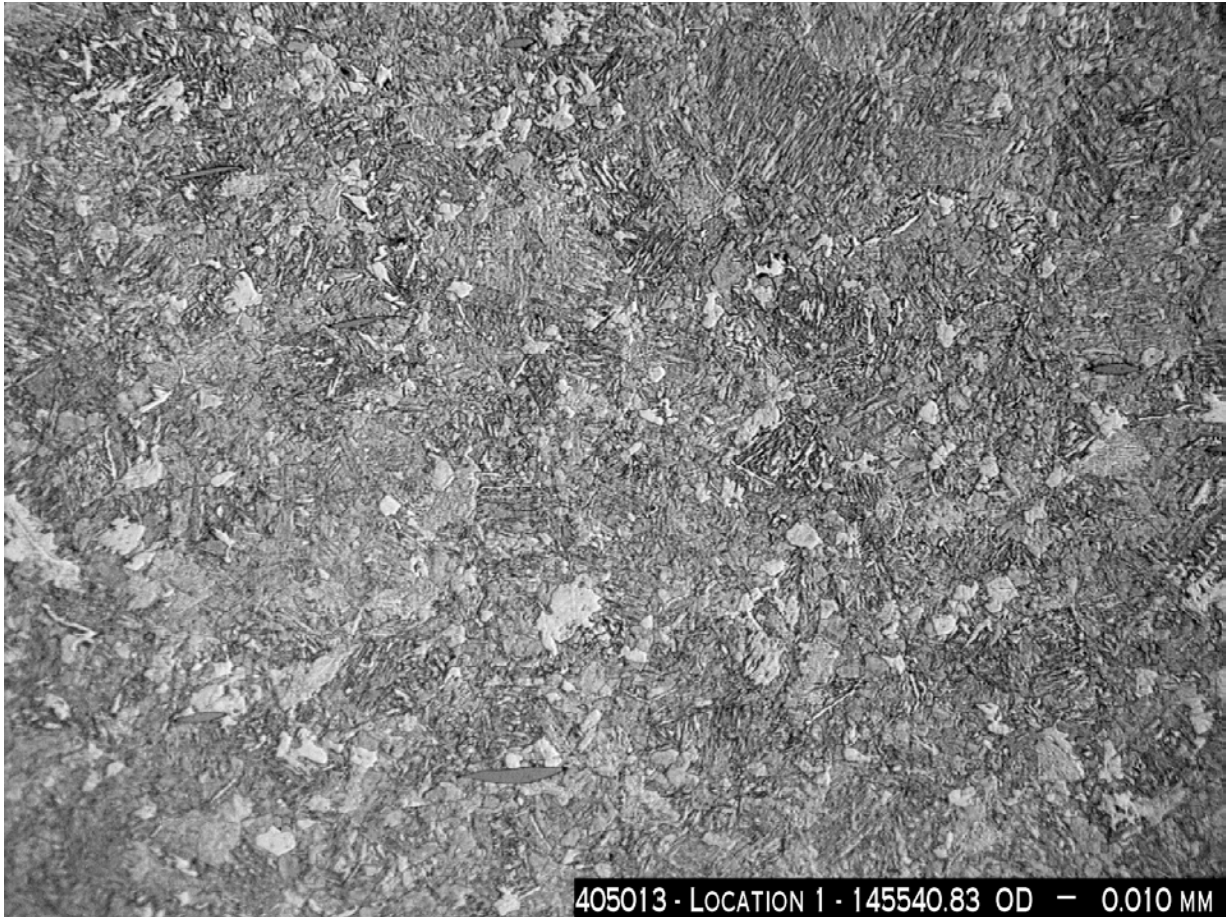
Figure 14. A view of the microstructure in hard spot “H”. This microstructure was classified as bainitic/martensitic, and is consistent with quenched and hardened steel. The microstructure shown was typical of the microstructures observed in the hard spot region. This location had an ILI estimated hardness of 248 Brinell, a Telebrineller hardness reading of 229 Brinell, a Microdur reading of 236 Brinell, and an actual hardness value of 223 Brinell as determined by Vickers testing.
