### Federal Railroad Administration Tank Car Damage Assessment Form

Reporting Marks	UTLX 665072		Car Location City/State	Reed Point, MT
Date inspected	6/28/23	Railroad	MRL	DOT Specification
Last Contained	UN3257		Was product released?	Yes
(Jacket thickness)	Jacket 1196	Non-jacketed	Does car contain product	Yes
Car builder	Union Tank	Stub Sill Design	UTLZBG	Built Date 6/1/01
Capacity (GAL)	23,590		LD Limit (LB)	190,800

Tank car breached and was located in the river.

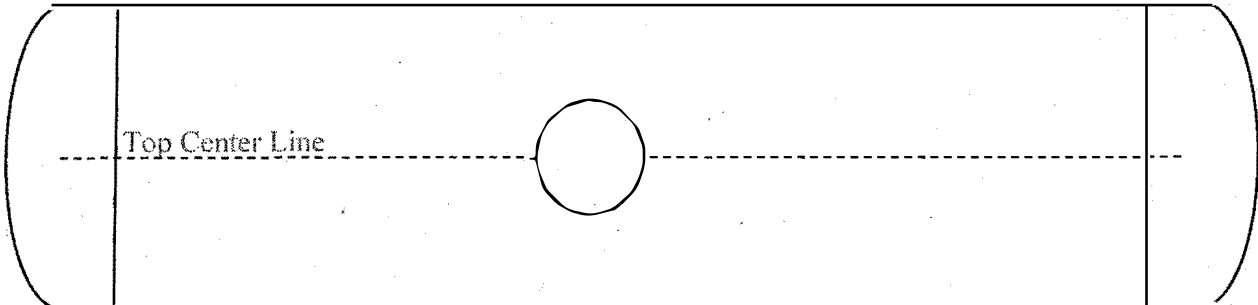
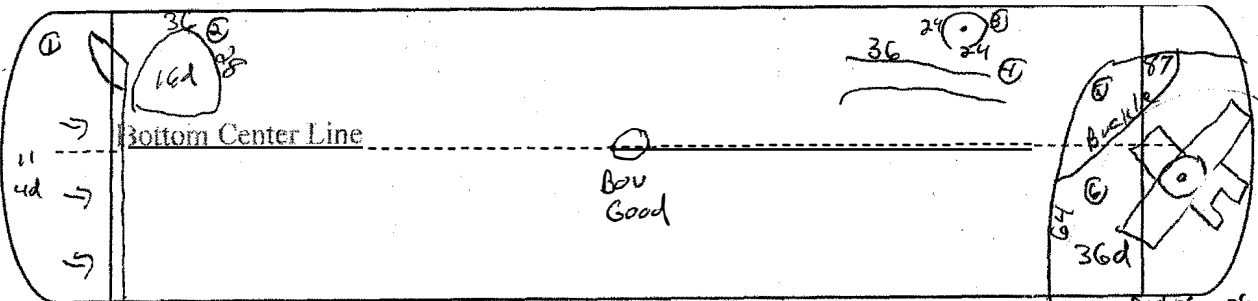
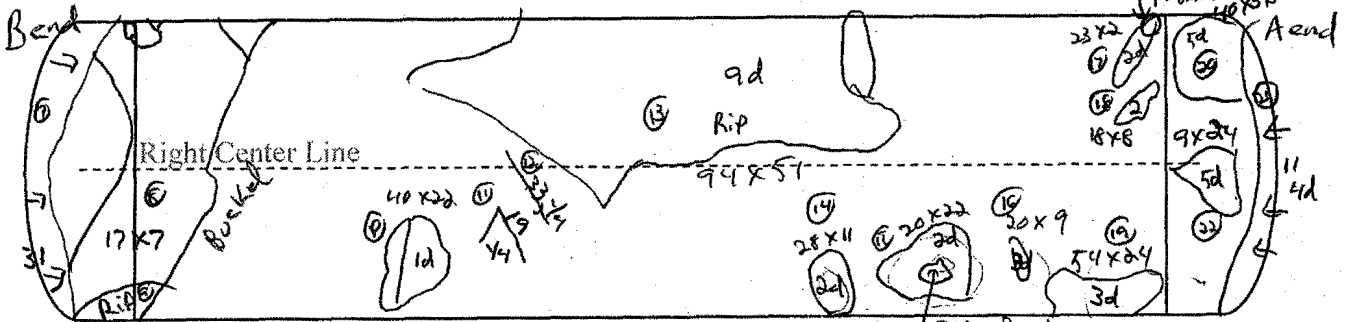
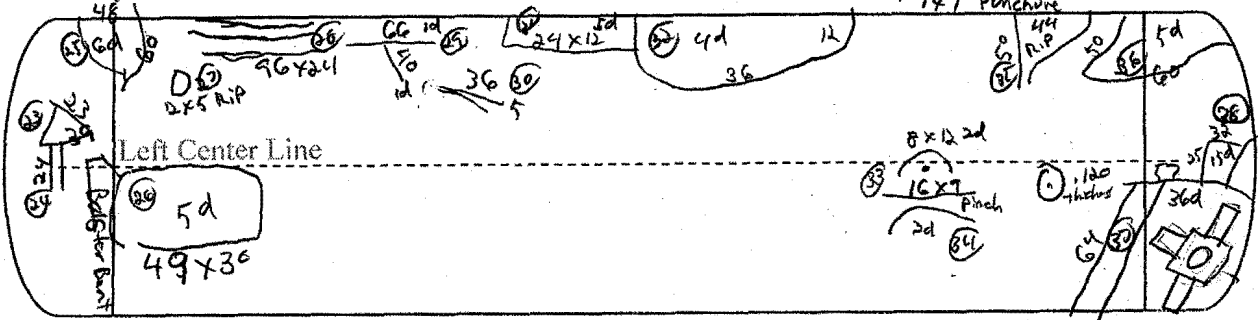
Indicate number on figures below within damaged areas. (sketched in by inspector)

1.	Affected?	Jacket/Tank	Location?	Bottom A End	Dimensions:	Length	Width	Depth	11
-	Defect type?	Dent/breach	Shape?	Circle	Possible Cause?	Derailment/bridge failure/ head impact			
2	Affected?	Jacket	Location?	Bottom A End	Dimensions:	Length 36	Width 16	Depth 28

-	Defect type?	Dent	Shape?	Oval	Possible Cause?	Derailment/bridge failure			
3	Affected?	Jacket	Location?	Bottom B end	Dimensions:	Length 24	Width 24	Depth 2

-	Defect type?	Dent	Shape?	Semicircle	Possible Cause?	Derailment/bridge failure			
4	Affected?	Jacket	Location?	Bottom B end	Dimensions:	Length 36	Width 9	Depth 3

-	Defect type?	Scrape	Shape?	lines	Possible Cause?	Derailment/bridge failure			
5	Affected?	Jacket/Tank	Location?	Bottom B end	Dimensions:	Length 87	Width 64	Depth 36

-	Defect type?	Buckle	Shape?	Semicircle	Possible Cause?	Derailment/bridge failure			
6	Affected?	Jacket/Tank	Location?	Bottom B end	Dimensions:	Length 87	Width 64	Depth 36

-	Defect type?	Buckle	Shape?	Semicircle	Possible Cause?	Derailment/bridge failure			
7	Affected?	Jacket/Tank	Location?	Right B end	Dimensions:	Length 31	Width 96	Depth 31

-	Defect type?	Buckle	Shape?	Semicircle	Possible Cause?	Derailment/bridge failure			
8	Affected?	Jacket/Tank	Location?	Right B end	Dimensions:	Length 17	Width 96	Depth

-	Defect type?		Shape?	rectangle	Possible Cause?	Derailment/bridge failure

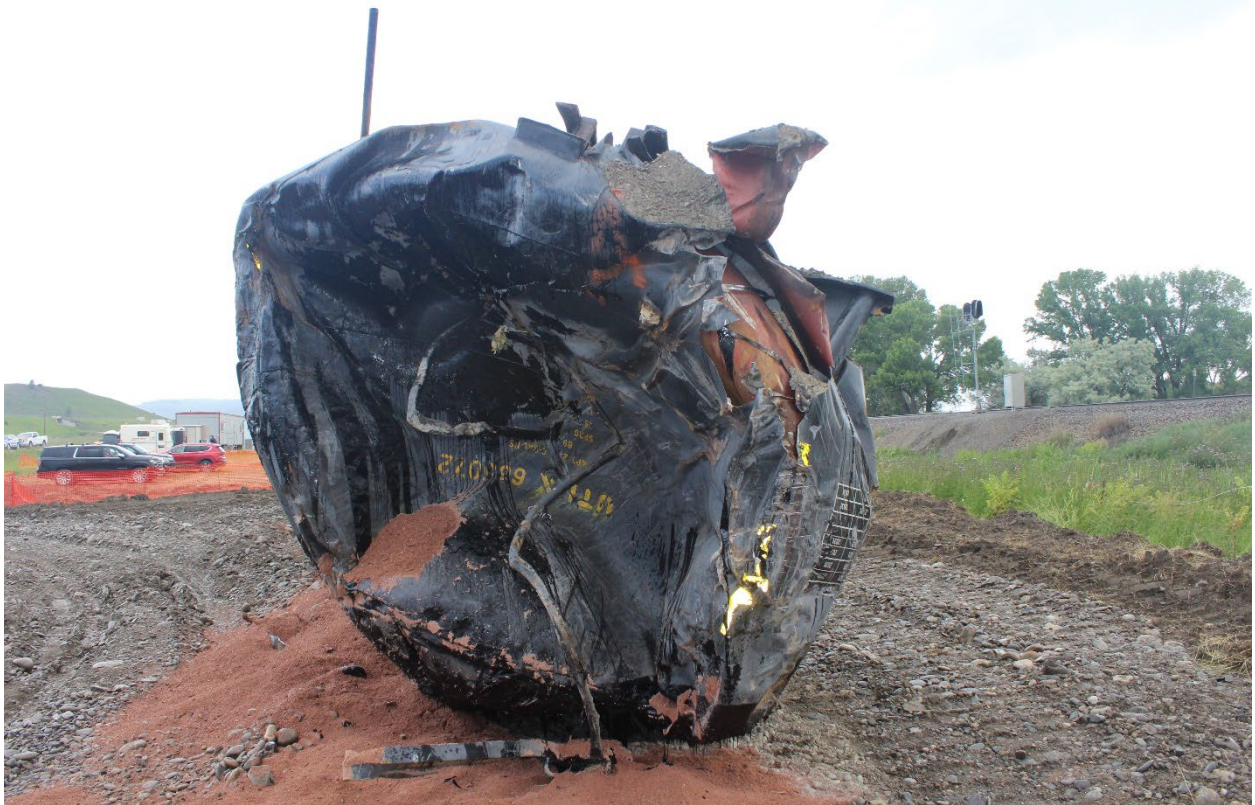
UTLX 665072 tank car is upside down this is the B end.

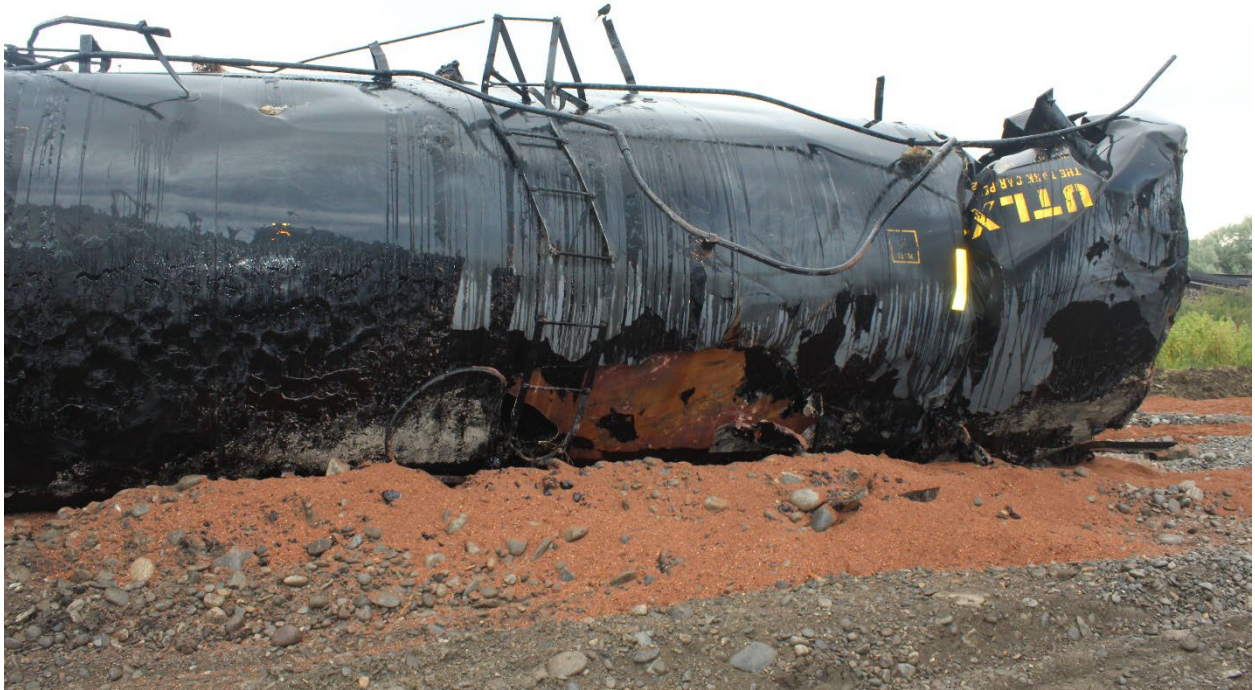
UTLX 665072 right side and B end.

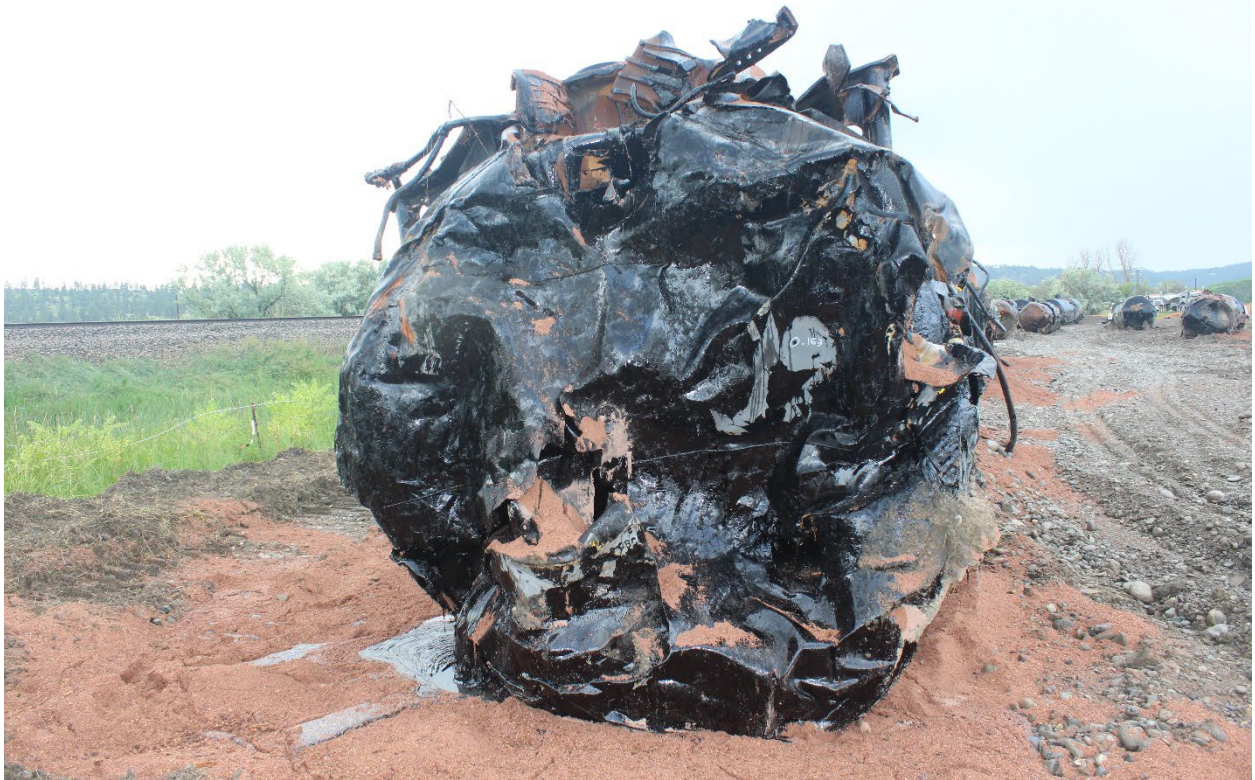
UTLX 665072 A end.

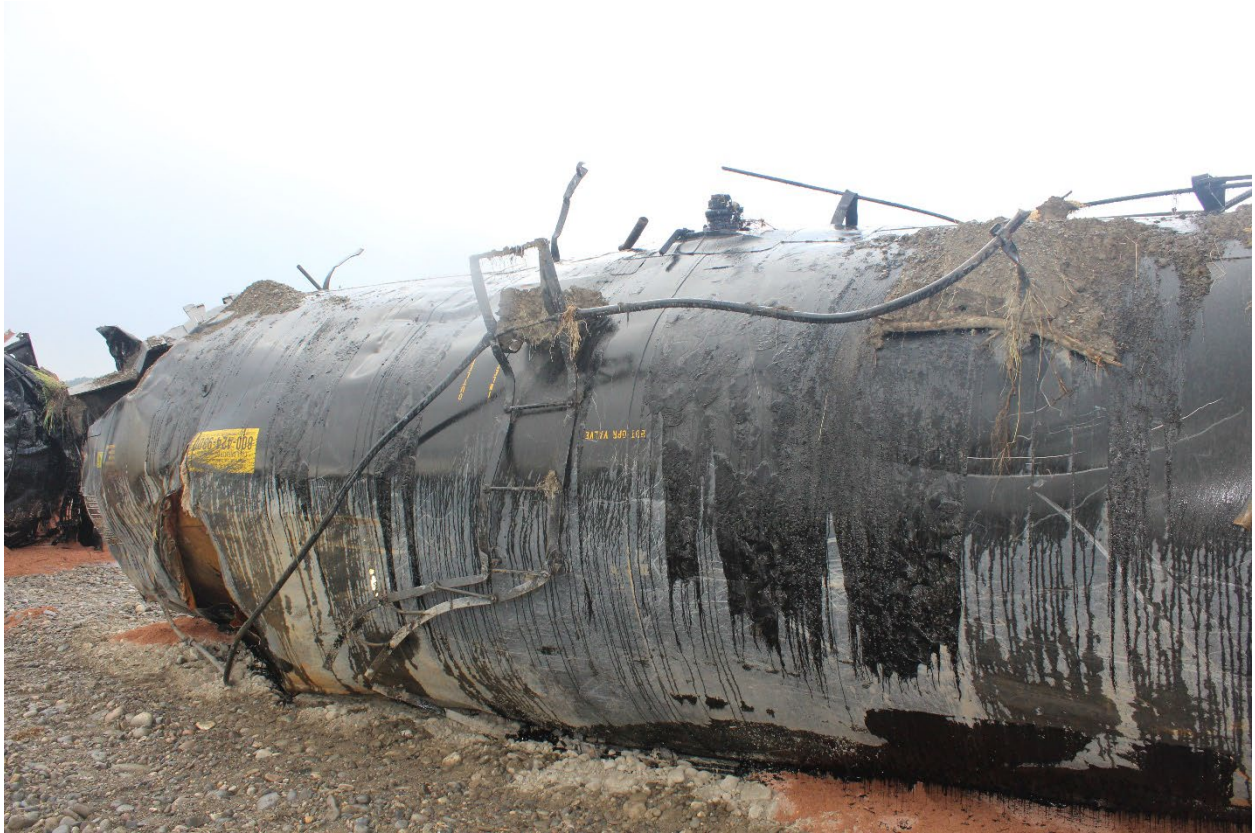
UTLX 665072 left side.

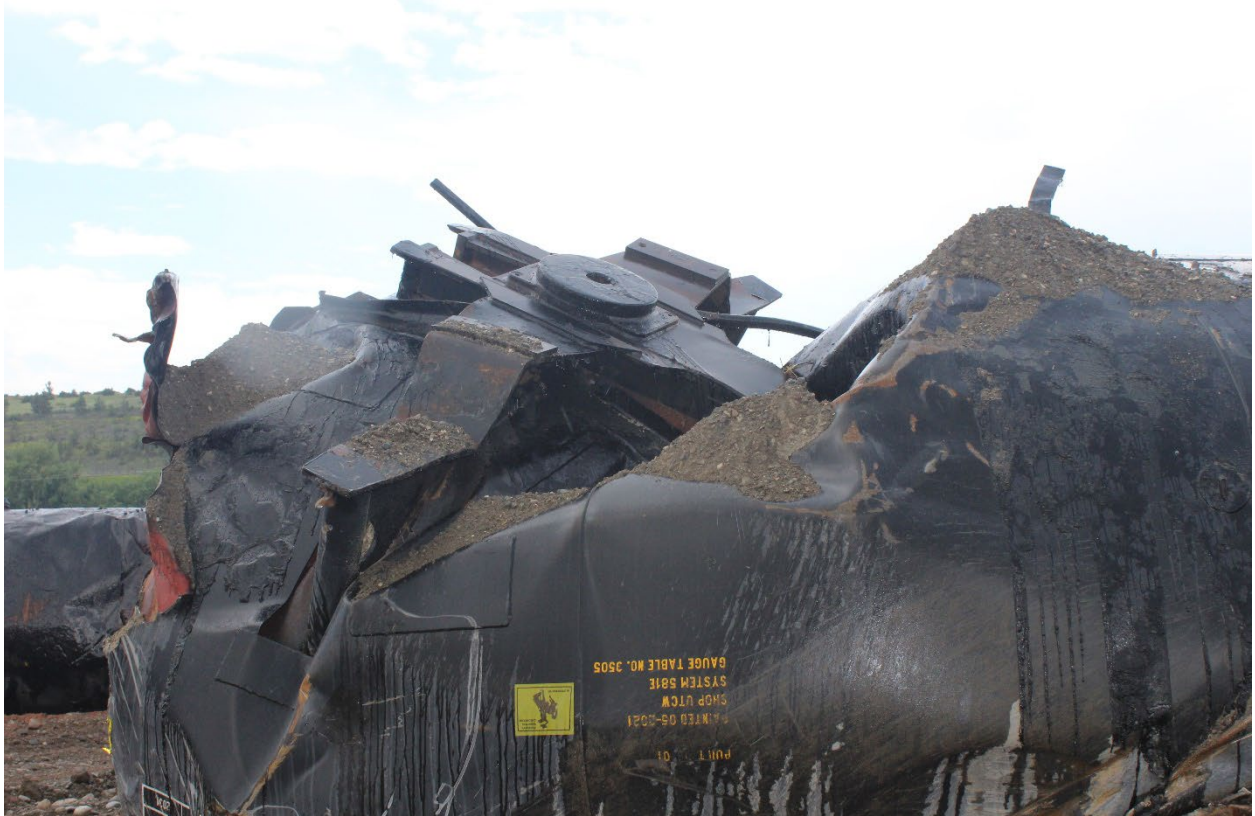
UTLX 665072 left side near B end.
