Federal Railroad Administration  
Tank Car Damage Assessment Form

| Reporting Marks | UTLX 644827 | | Car Location City/State | Reed Point, MT | |
| Date inspected | 7/6/23 | Railroad | MRL | DOT Specification | 111A100W1 |

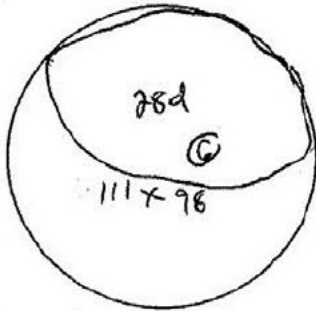
| 6. | Affected? | Jacket | Location? | A Head | Dimensions: | Length | 111 | Width | 98 | Depth | 28 |
| - | Defect type? | Dent | Shape? | Circle | Possible Cause? | Derailment/Bridge collapse | | | | | |

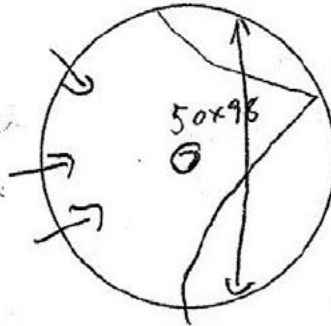
| 7. | Affected? | Jacket | Location? | B Head | Dimensions: | Length | 50 | Width | 98 | Depth | |
| - | Defect type? | Dent | Shape? | Triangle | Possible Cause? | Derailment/Bridge collapse | | | | | |

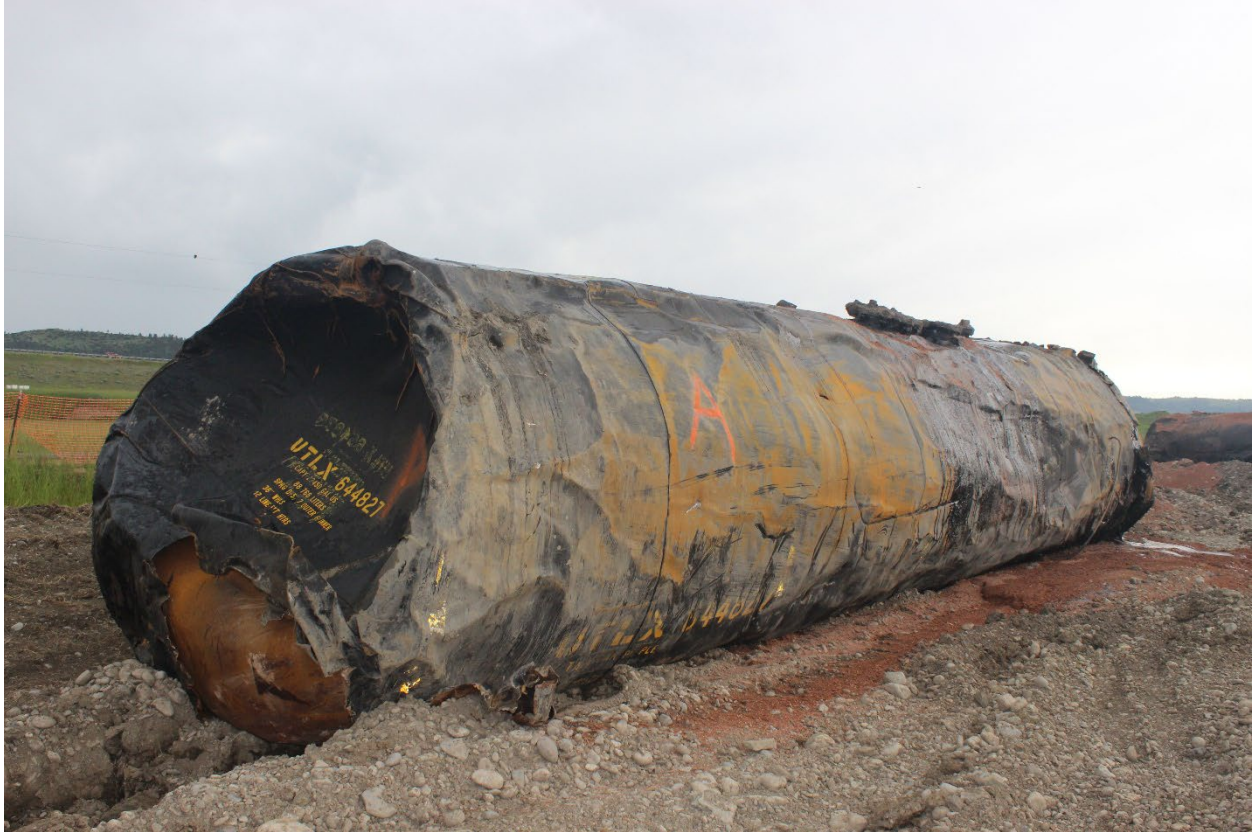
Tank punctured on left side towards B head.  
Jacket missing of left side, B head and A head.

UTLX 644827 A end and left side.

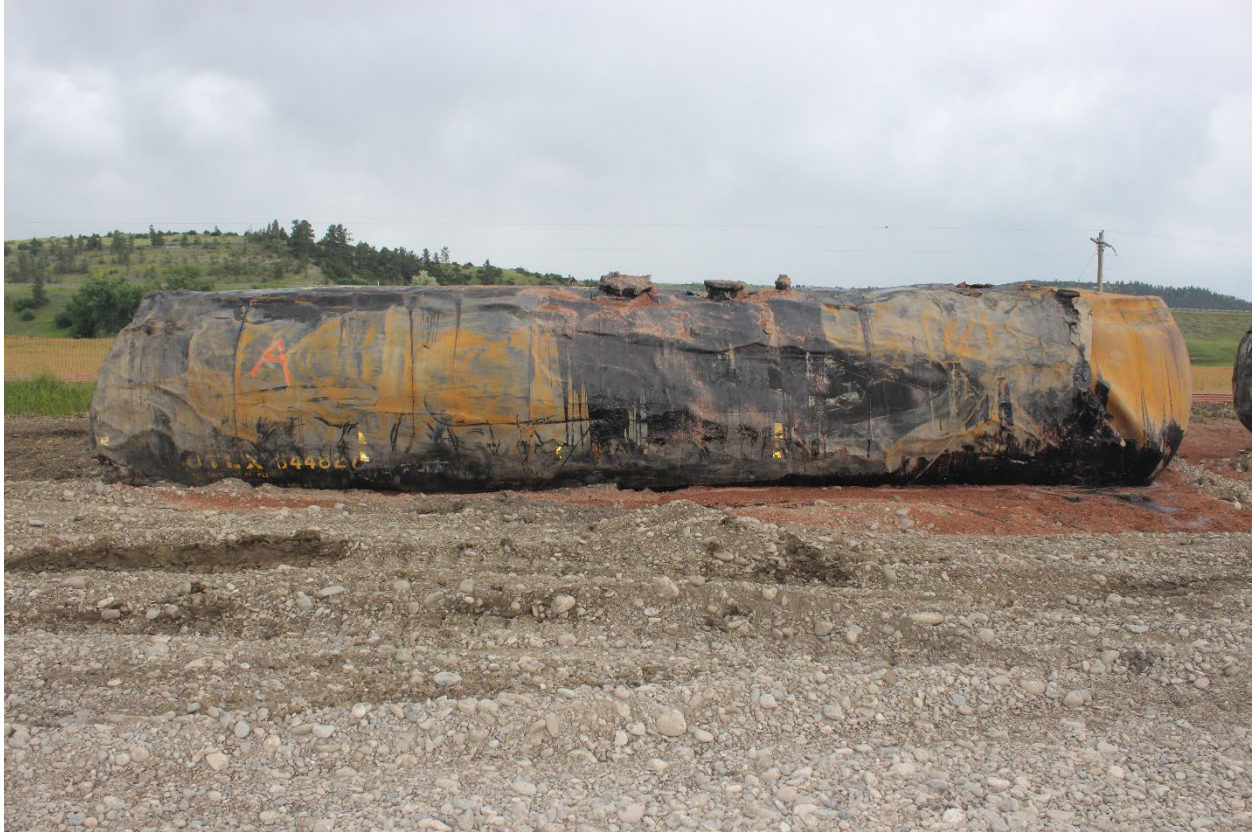
UTLX 644827 left side.

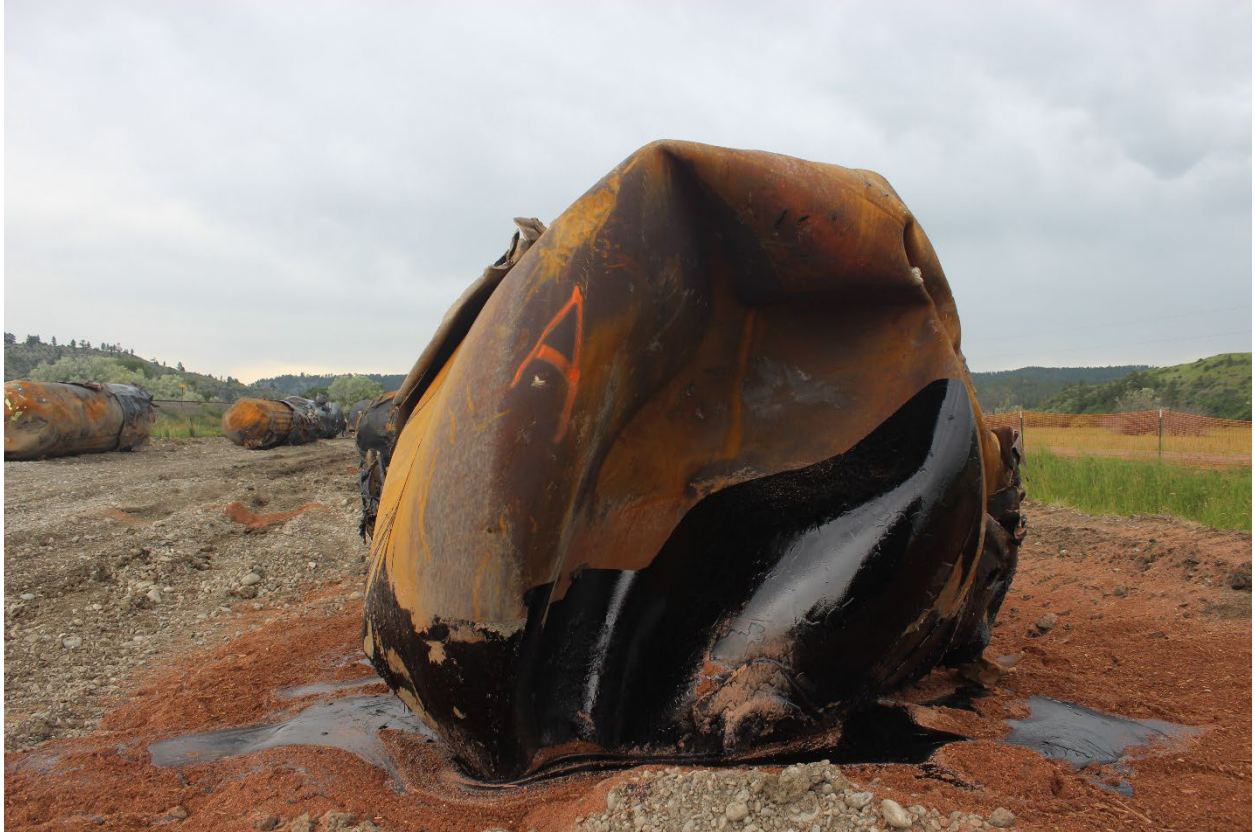
UTLX 644827 B end. The spray-painted A identifies asphalt cars to recovery workers.

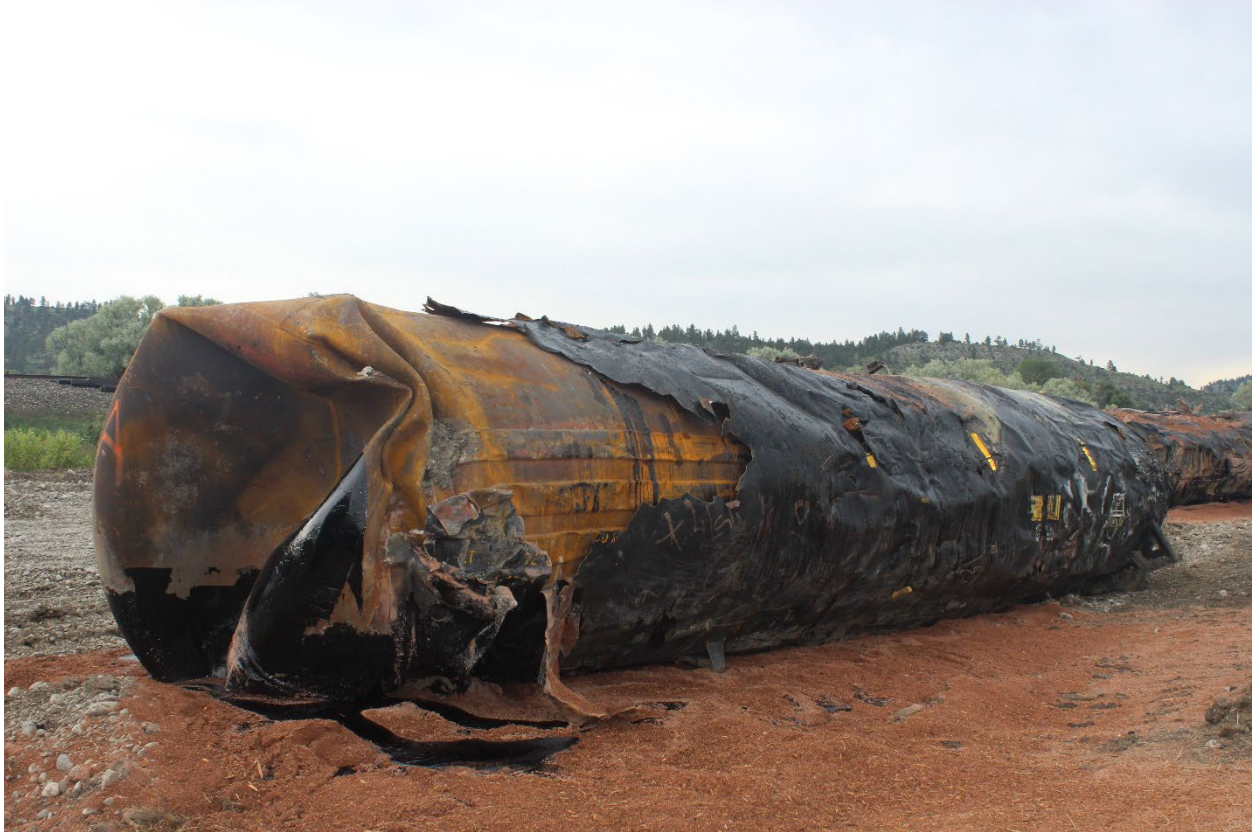
| 1. | Affected? | Jacket | Location? | Rt Cent | Dimensions: | Length | 182 | Width | 46 | Depth | 5 |
| - | Defect type? | Dent | Shape? | Oval | Possible Cause? | Derailment/Bridge collapse | | | | | |

UTLX 644827 right side.
