Federal Railroad Administration  
Tank Car Damage Assessment Form

Reporting Marks	UTLY 641341		Car Location City/State	Reed point, Montana	
Date inspected	6/27/83	Railroad	MAL	DOT Specification	111A 100W3
Last Contained	UN3257 Class 9		Was product released?	Yes	
(Jacket thickness)	Jacket 0.1192	Non-jacketed	Does car contain product	Yes	
Car builder	Union Tank	Stub Sill Design	UTL2BN	Built Date	7/1/1989
Capacity (GAL)	23508		LD Limit (LB)	190500

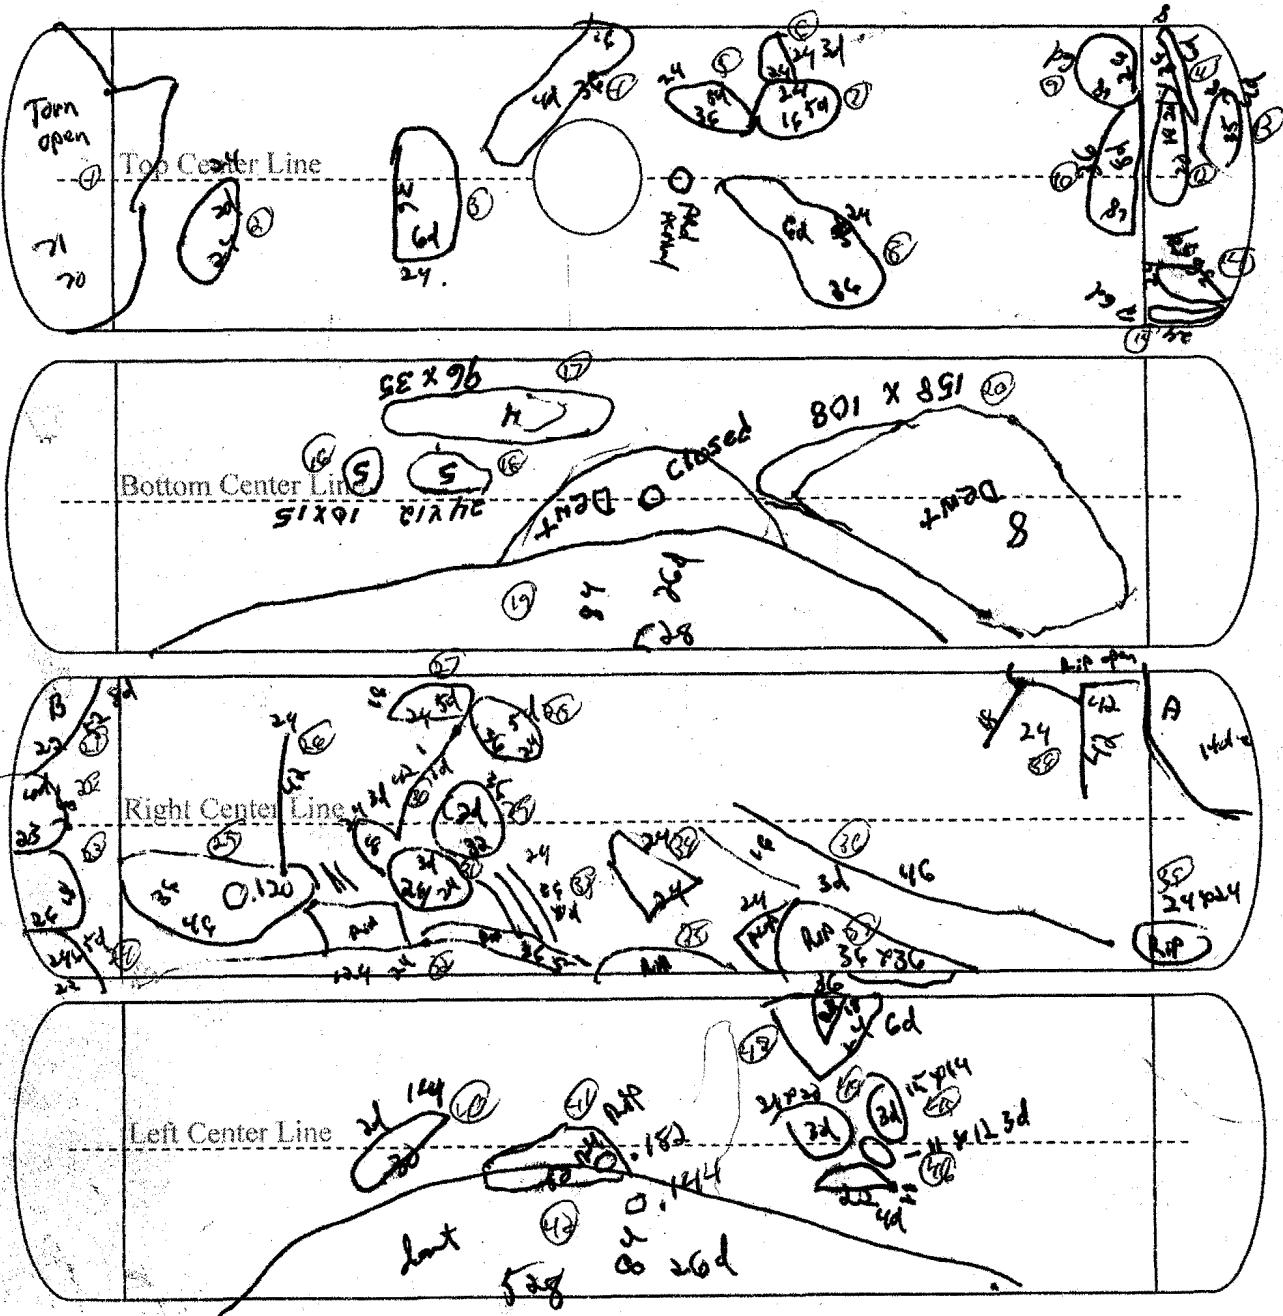
A-END

1.	Affected?	Jacket/Tank	Location?	Top A End	Dimensions:	Length	71	Width	70	Depth	
-	Defect type?	Breach	Shape?	Oval	Possible Cause?	Derailment into river.

2.	Affected?	Jacket/Tank	Location?	Top A End	Dimensions:	Length	24	Width	24	Depth	2
-	Defect type?	Dent	Shape?	Oval	Possible Cause?	Derailment into river.					
3	Affected?	Jacket/Tank	Location?	Top Center	Dimensions:	Length	36	Width	24	Depth	6

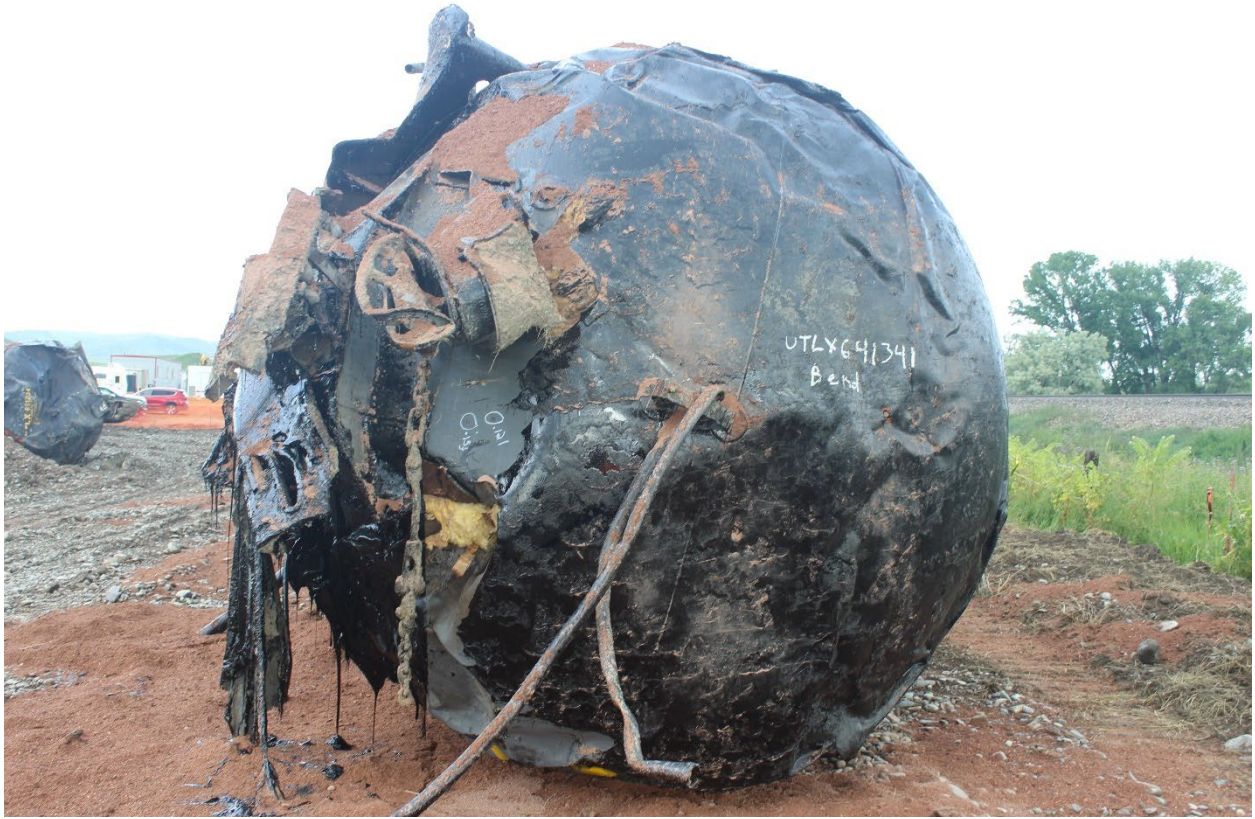
UTLX 641341 B end.

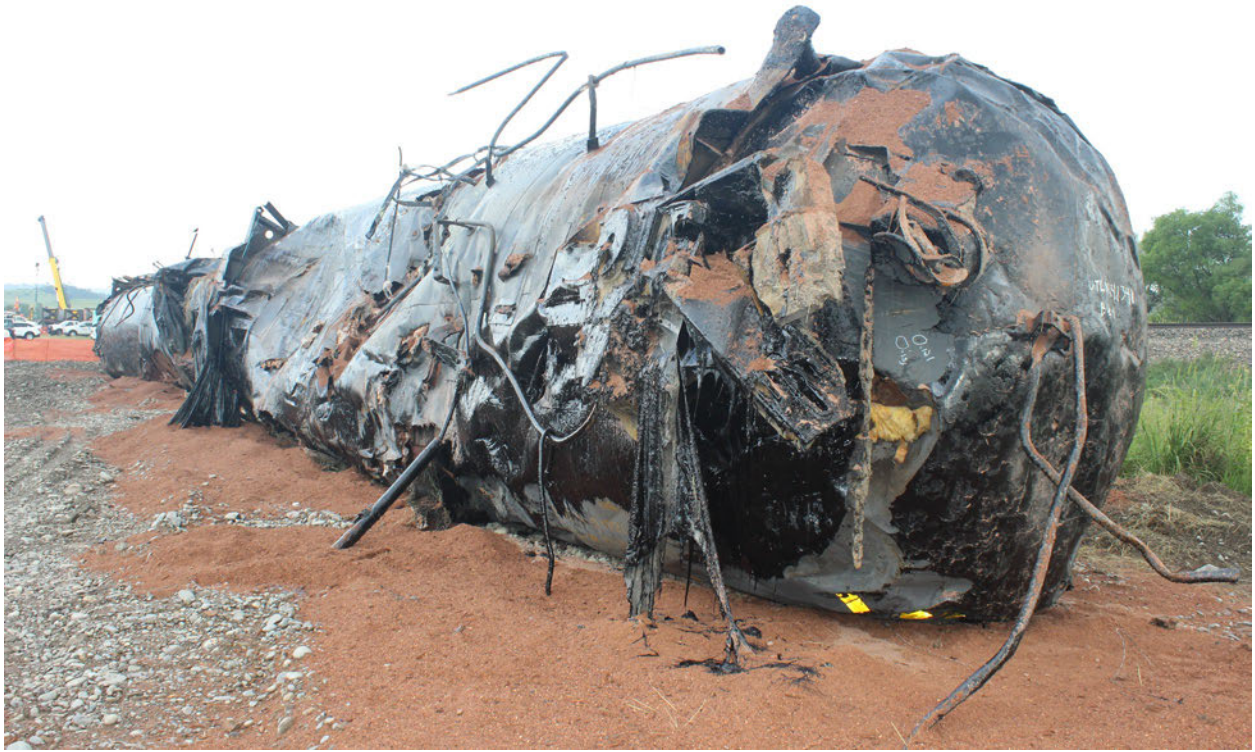
UTLX 641341 bottom of tank car and B end.

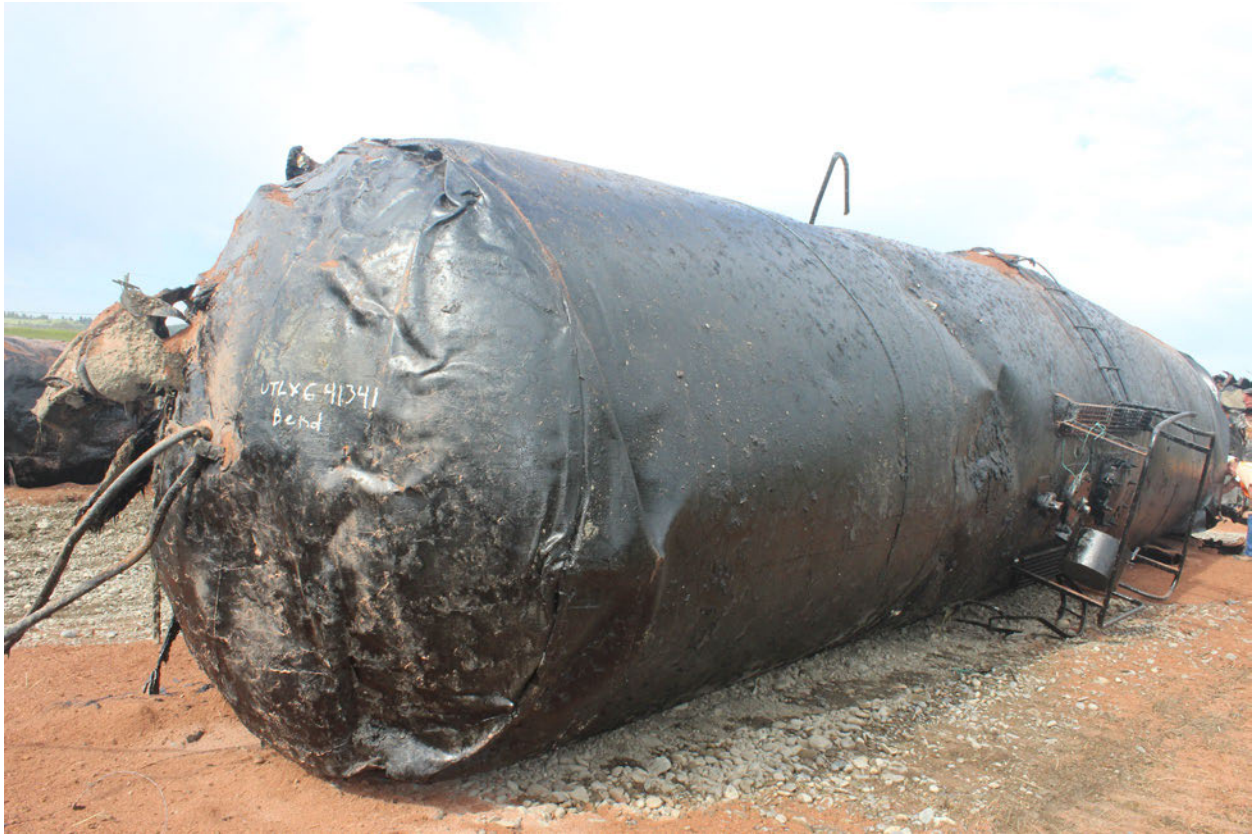
UTLX 641341 top of tank car and B end.

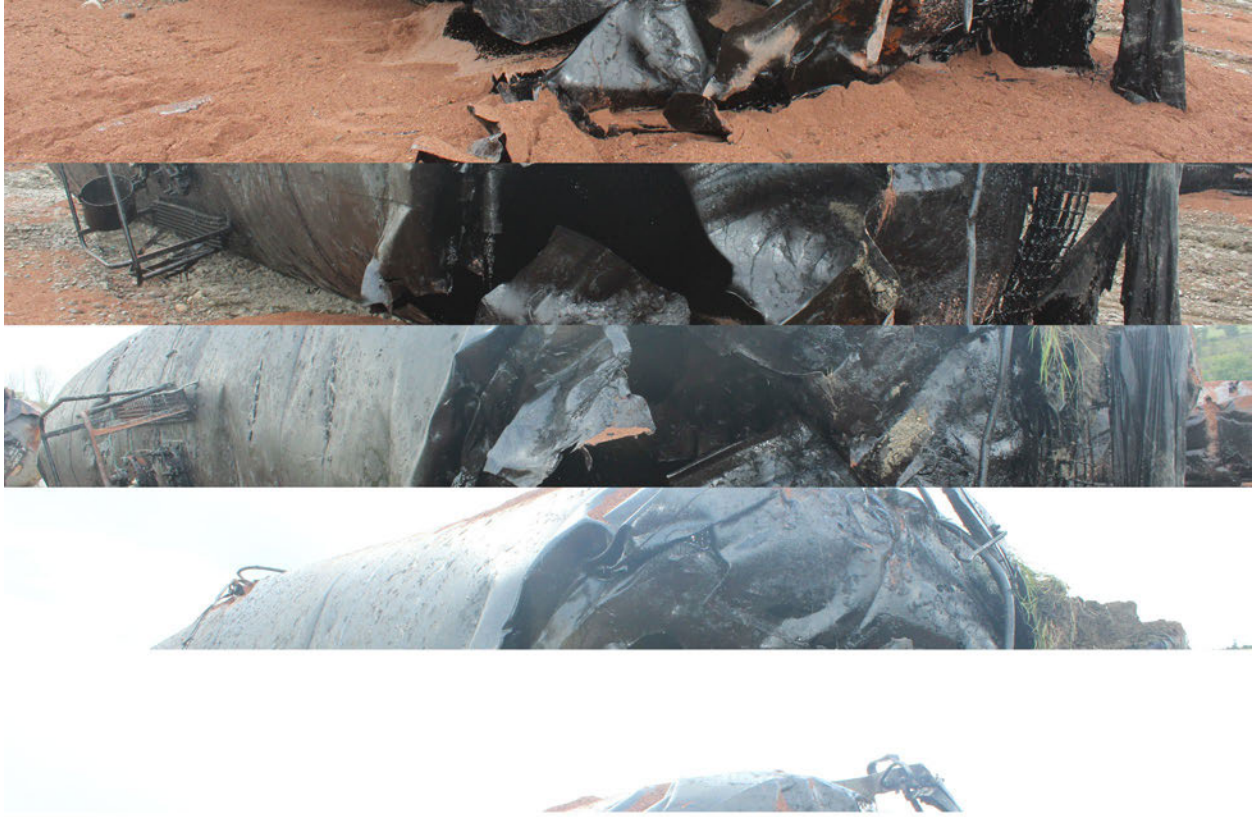
Bottom outlet valve sheared off. A head breached. Tank car dropped 12-17 feet with bridge collapse onto the top of tank car pile in river.

UTLX 641341 A end.

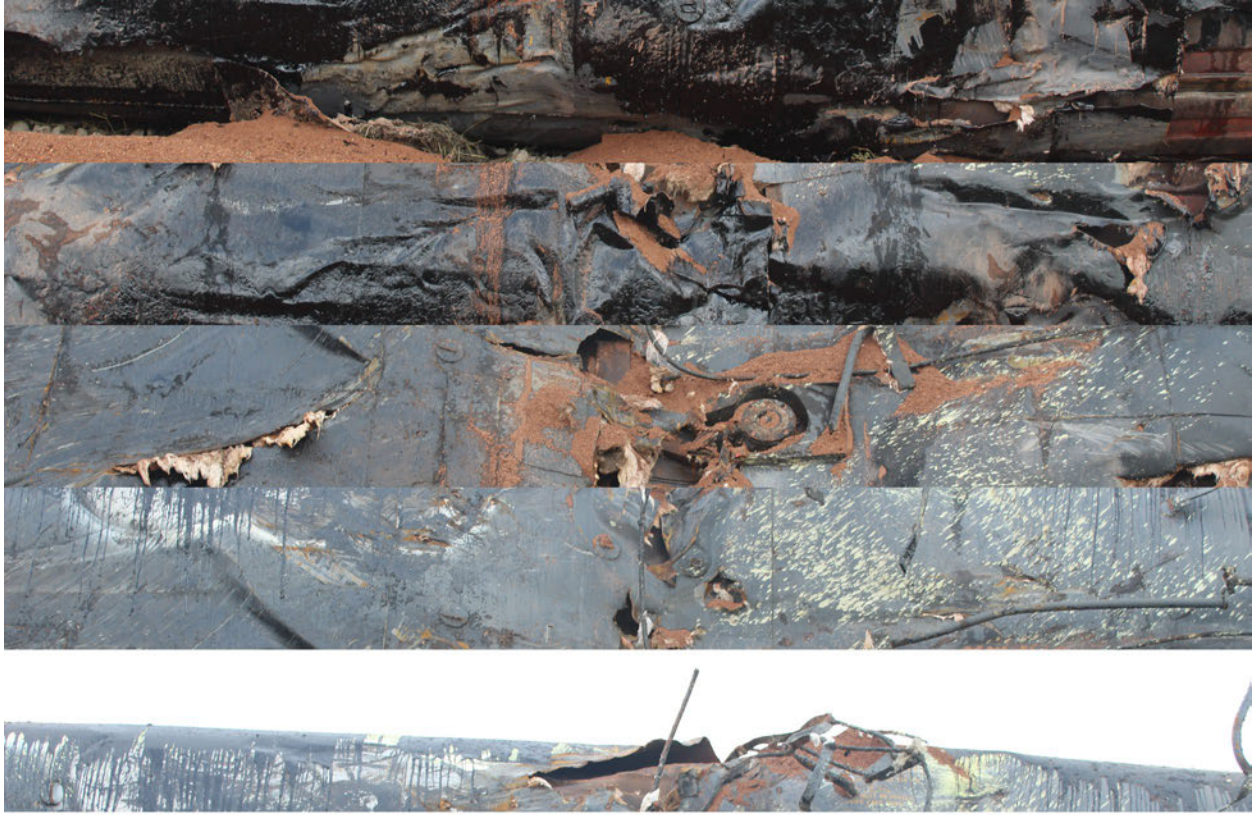
UTLX 641341 bottom outlet valve sheared off.
