Federal Railroad Administration Tank Car Damage Assessment Form

Reporting Marks	GATX 69298		Car Location City/State	Reed Point, Montana
Date inspected	6/29/23	Railroad	MRL	DOT Specification
	UN2448		Was product released?	Yes
(Jacket thickness)	Jacket 0.1196	Non-jacketed	Does car contain product	Yes
Car builder	TILX	Stub Sill Design	Built Date	12/1/1990
Capacity (GAL)	13,856		LD Limit (LB)	20,300

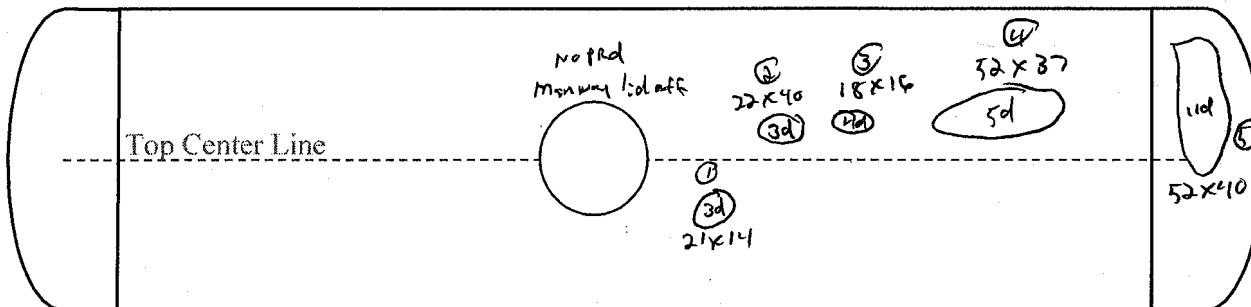
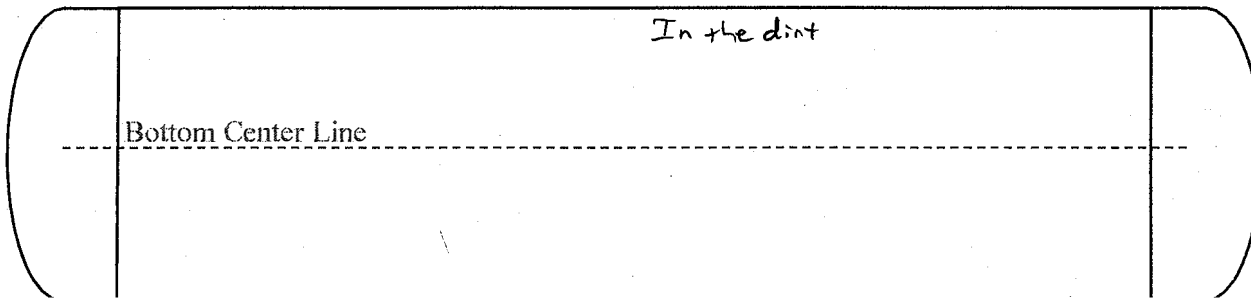
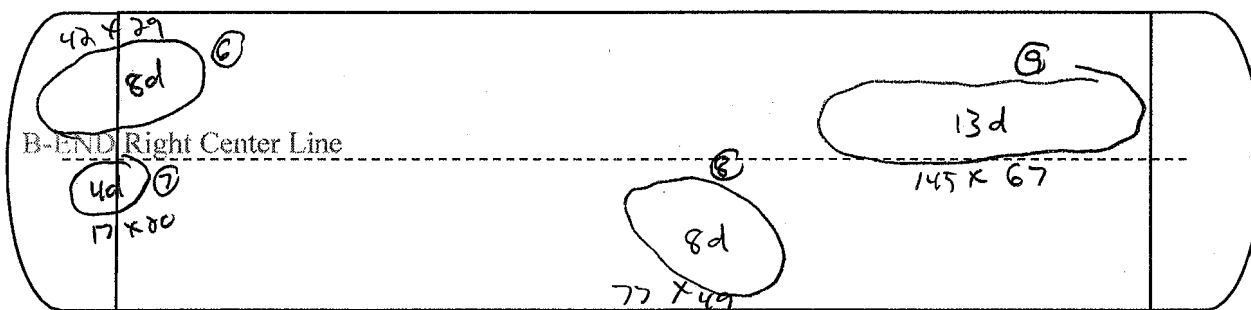
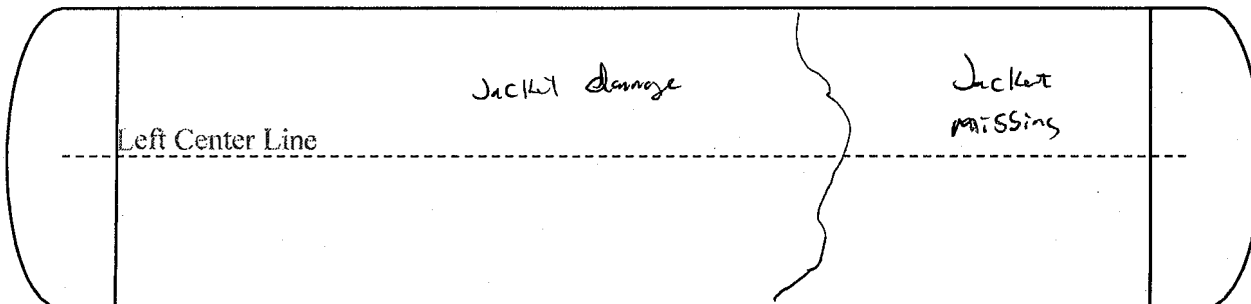
1	Affected?	Tank	Location?	Top, Middle	Dimensions:	Length	21	Width		Depth	3
-	Defect type?	Dent	Shape?	Circle	Possible Cause?	Derailment off a bridge into river.					
2	Affected?	Tank	Location?	Top, Middle	Dimensions:	Length	22	Width	40	Depth	3

-	Defect type?	Dent	Shape?	Circle	Possible Cause?	Derailment off a bridge into river.					
3	Affected?	Tank	Location?	Top, Middle	Dimensions:	Length	18	Width	16	Depth	4

-	Defect type?	Dent	Shape?	Circle	Possible Cause?	Derailment off a bridge into river.					
4	Affected?	Tank	Location?	Top, Middle	Dimensions:	Length	52	Width	37	Depth	5

-	Defect type?	Dent	Shape?	Oval	Possible Cause?	Derailment off a bridge into river.					
5	Affected?	Tank	Location?	Top, B end	Dimensions:	Length	52	Width	40	Depth	11

-	Defect type?	Dent	Shape?	Oval	Possible Cause?	Derailment off a bridge into river.					
6	Affected?	Tank	Location?	Right, B end	Dimensions:	Length	42	Width	29	Depth	8

-	Defect type?	Dent	Shape?	Oval	Possible Cause?	Derailment off a bridge into river.					
7	Affected?	Tank	Location?	Right, B end	Dimensions:	Length	17	Width	20	Depth	4

-	Defect type?	Dent	Shape?	Oval	Possible Cause?	Derailment off a bridge into river.					
8	Affected?	Tank	Location?	Right, Middle	Dimensions:	Length	77	Width	49	Depth	8

-	Defect type?	Dent	Shape?	Oval	Possible Cause?	Derailment off a bridge into river.					
9	Affected?	Tank	Location?	Right, A end	Dimensions:	Length	145	Width	67	Depth	13

-	Defect type?	Dent	Shape?	Oval	Possible Cause?	Derailment off a bridge into river.					
10	Affected?	Tank	Location?	B Head	Dimensions:	Length	56	Width	30	Depth	7

-	Defect type?	Dent	Shape?	Circle	Possible Cause?	Derailment off a bridge into river.					
11	Affected?	Tank	Location?	B Head	Dimensions:	Length	9	Width	6	Depth	2

-	Defect type?	Dent	Shape?	Oval	Possible Cause?	Derailment off a bridge into river.					
12	Affected?	Tank	Location?	A Head	Dimensions:	Length	54	Width	15	Depth	16

-	Defect type?	Puncture	Shape?	Oval	Possible Cause?	Derailment off a bridge into river.					
13	Affected?	Tank	Location?	A Head	Dimensions:	Length	75	Width	67	Depth	16

-	Defect type?	Dent	Shape?	Oval	Possible Cause?	Derailment off a bridge into river.					
14	Affected?	Tank	Location?	A Head	Dimensions:	Length	37	Width	37	Depth	9

-	Defect type?	Dent	Shape?	Circle	Possible Cause?	Derailment off a bridge into river.

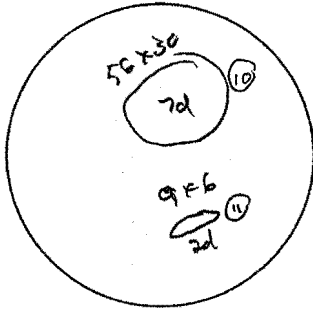
B-Head

A Head puncture with 1/4 of jacket material missing. B head dented with no jacket.

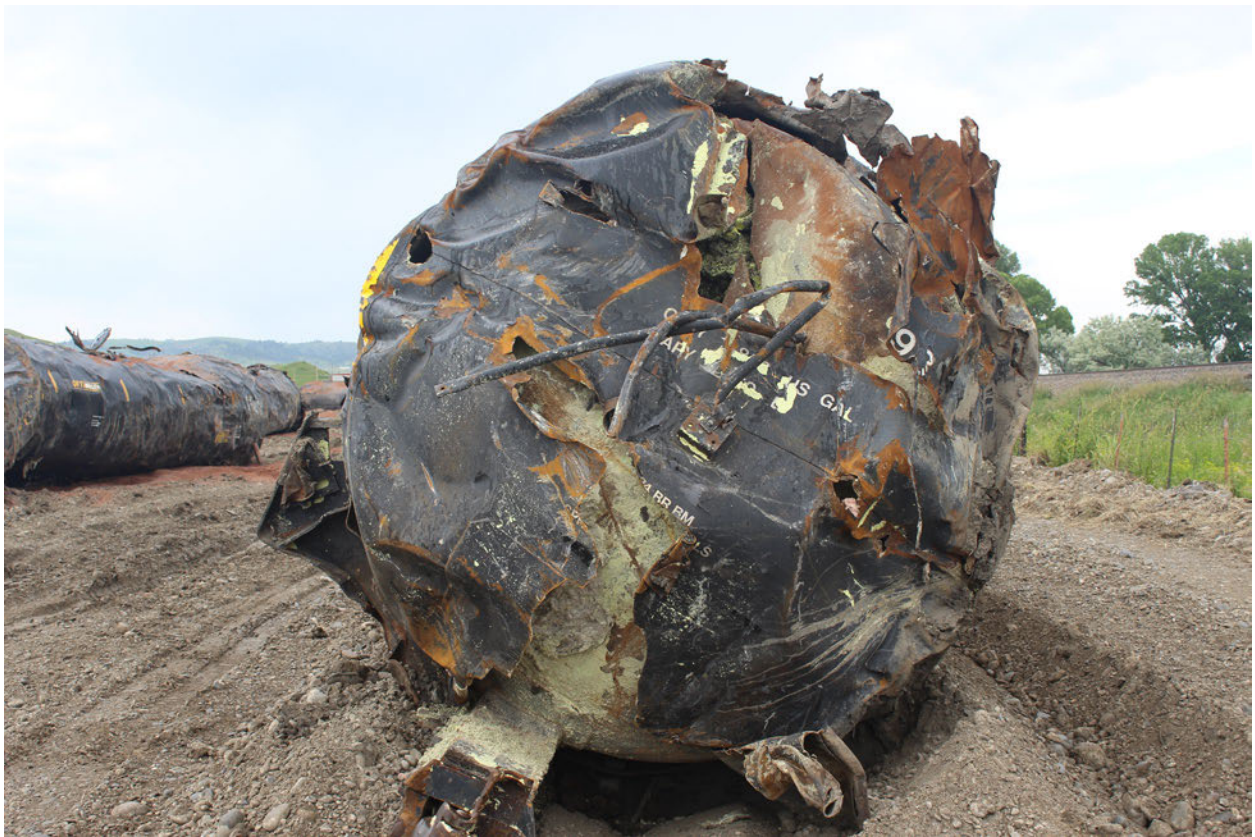
GATX 69298 A end.

Jacket ripped off from the middle of the tank car to the B head. A head puncture, manway cover missing which released hazmat into the environment. Bottom outlet valve handle securement structure was missing and valve was partway open but the bottom outlet valve was intact. Tank car recovered from the river due to derailment/bridge collapse.
