Federal Railroad Administration Tank Car Damage Assessment Form

| Reporting Marks | CGTX 13864 | | Car Location City/State | Reed Point, Montana | |
| Date inspected | 6/29/23 | Railroad | MRL | DOT Specification | DOT 111AL00W1 |

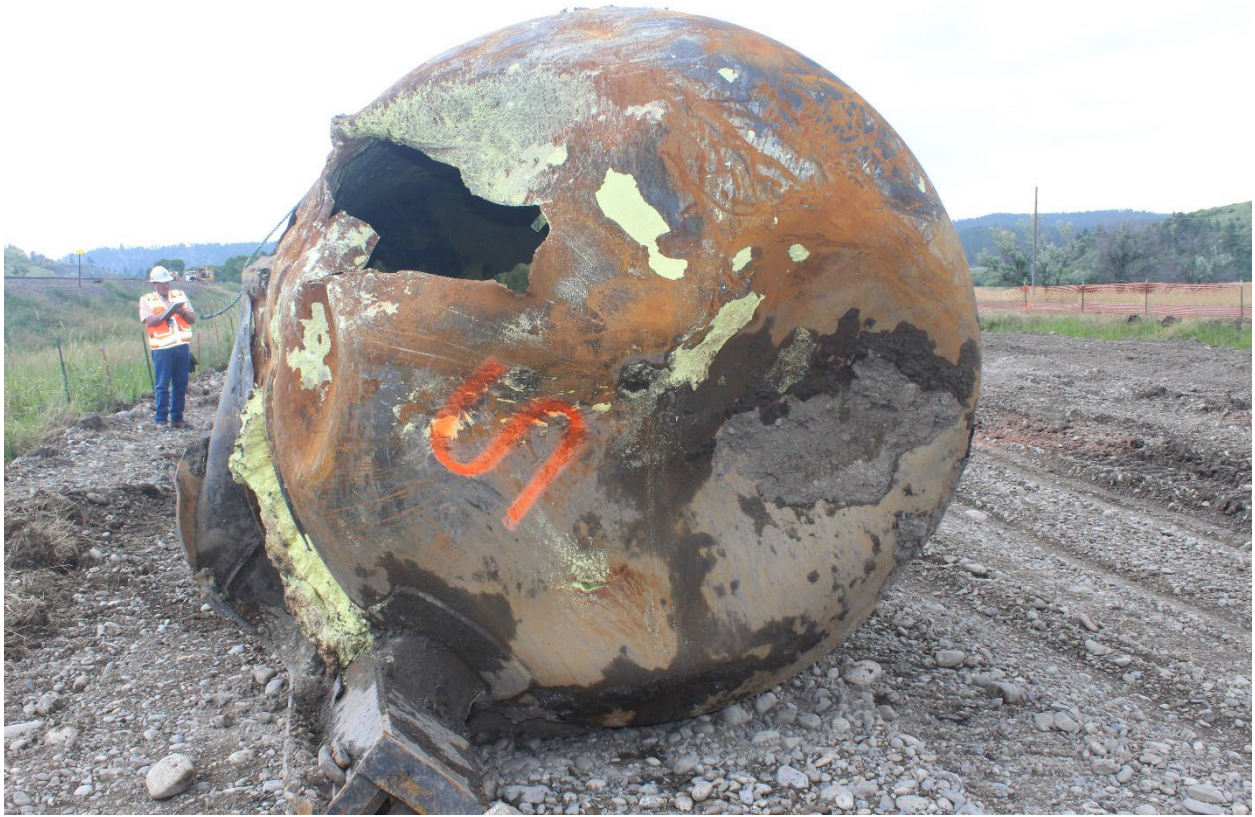
Manway and PRD missing. A head punctured.

CGTX 13864 A end.

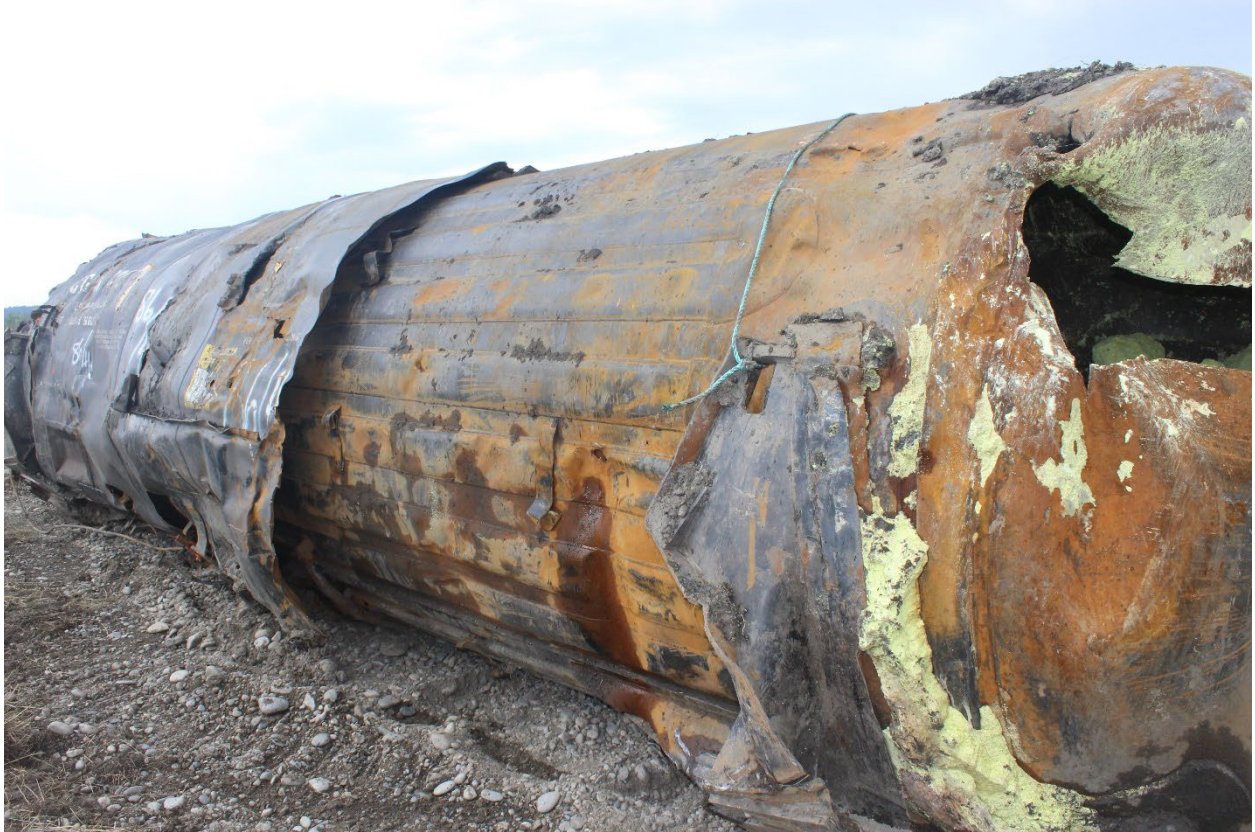
CGTX 13864 right side, A end.

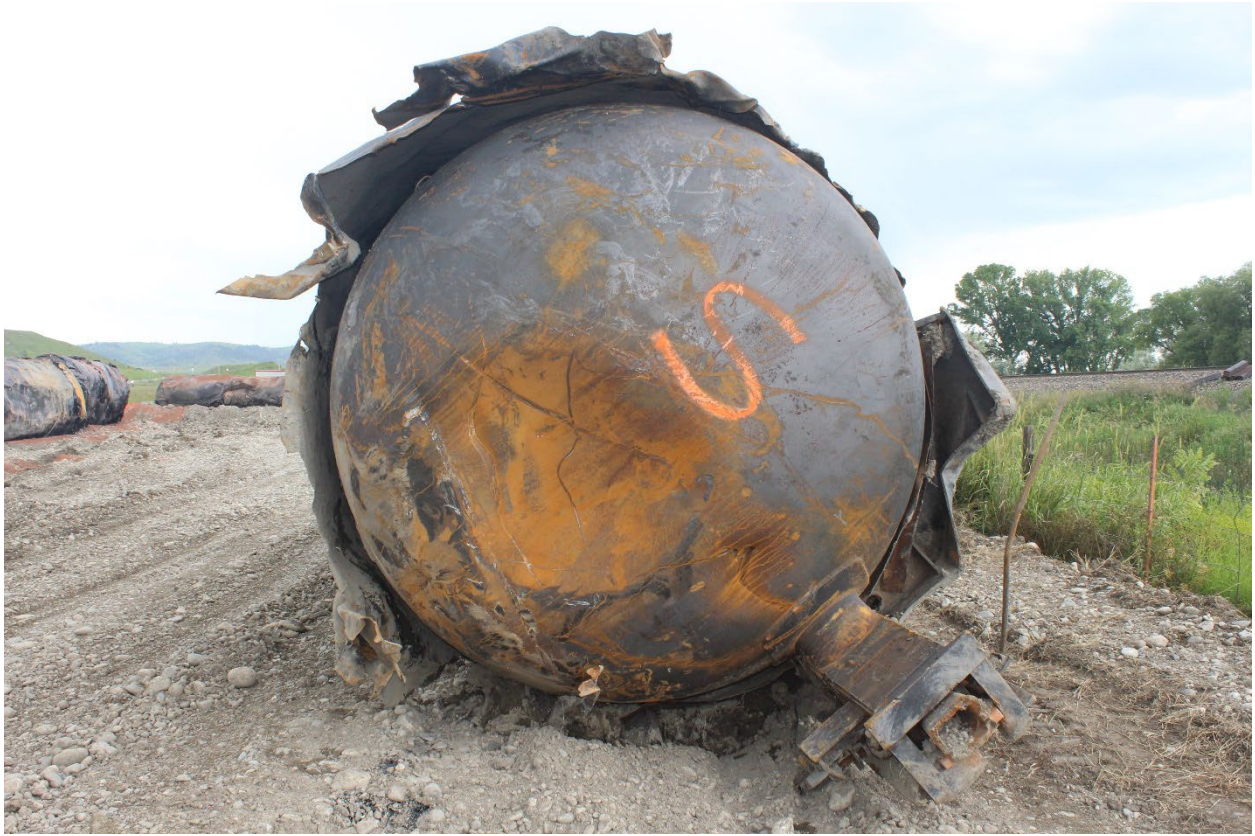
Jacket ripped off A head to the middle of the left side and on the B head. Bottom outlet valve handle sheared off.

CGTX 13864 B end.

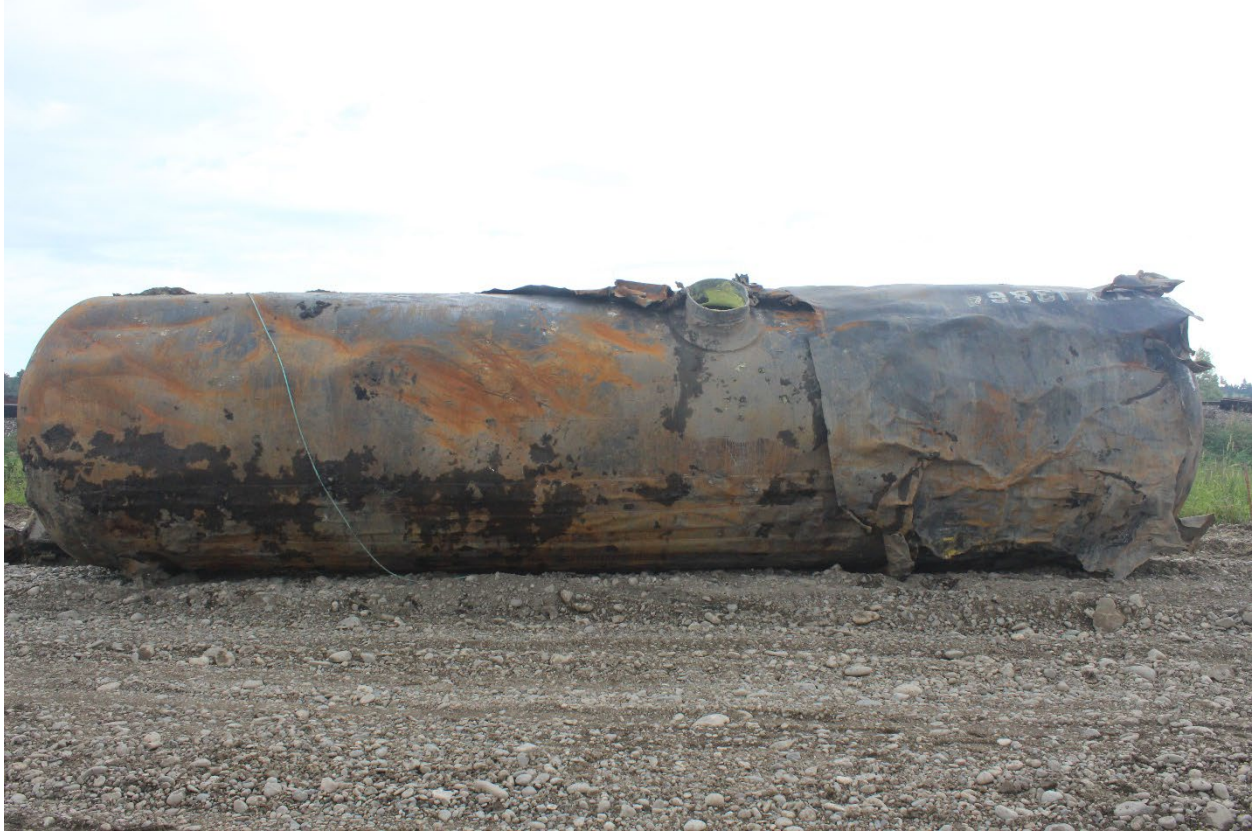
CGTX 13864 left side.
