NTSB Questions DR 129:

Revised and Supplemental Response:

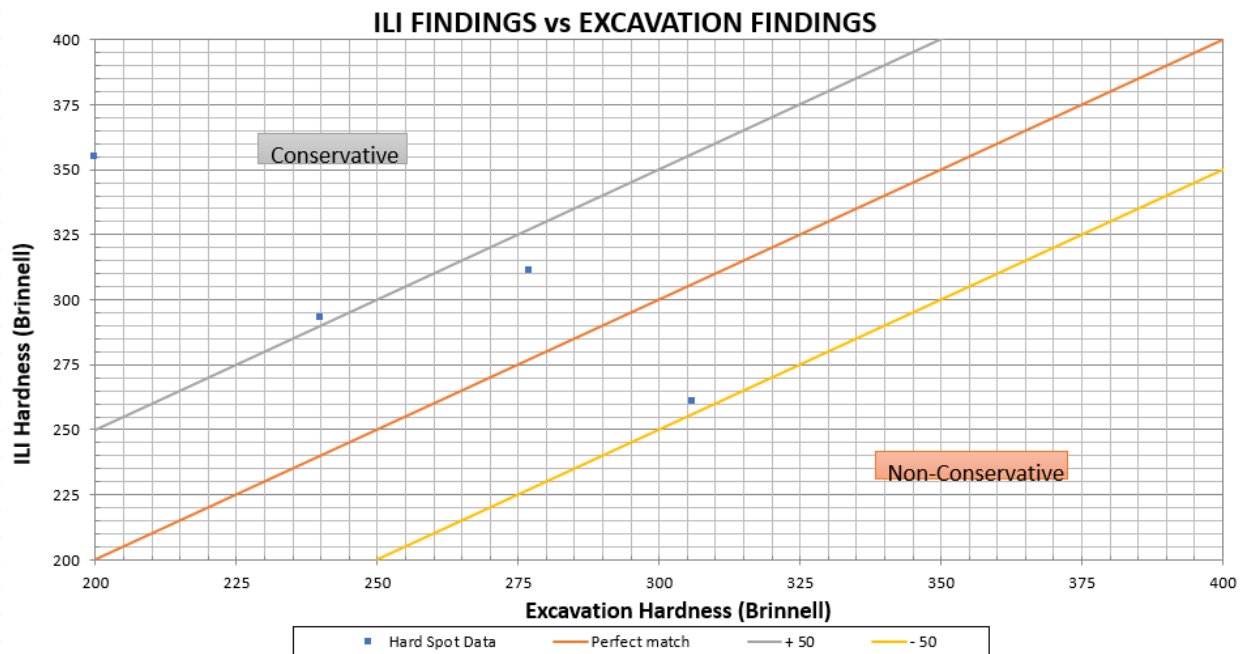
- A unity plot of the excavation results was generated in 2019 after the incident, and is provided below for the comparison of ILI and excavation findings in 2011:

Note: The ILI reported hardness for WC 244877.9 was 355 HB, and the excavation maximum hardness was 160 HB. For Unity plot purposes an excavation hardness of 200 HB was used due to graphing issues.

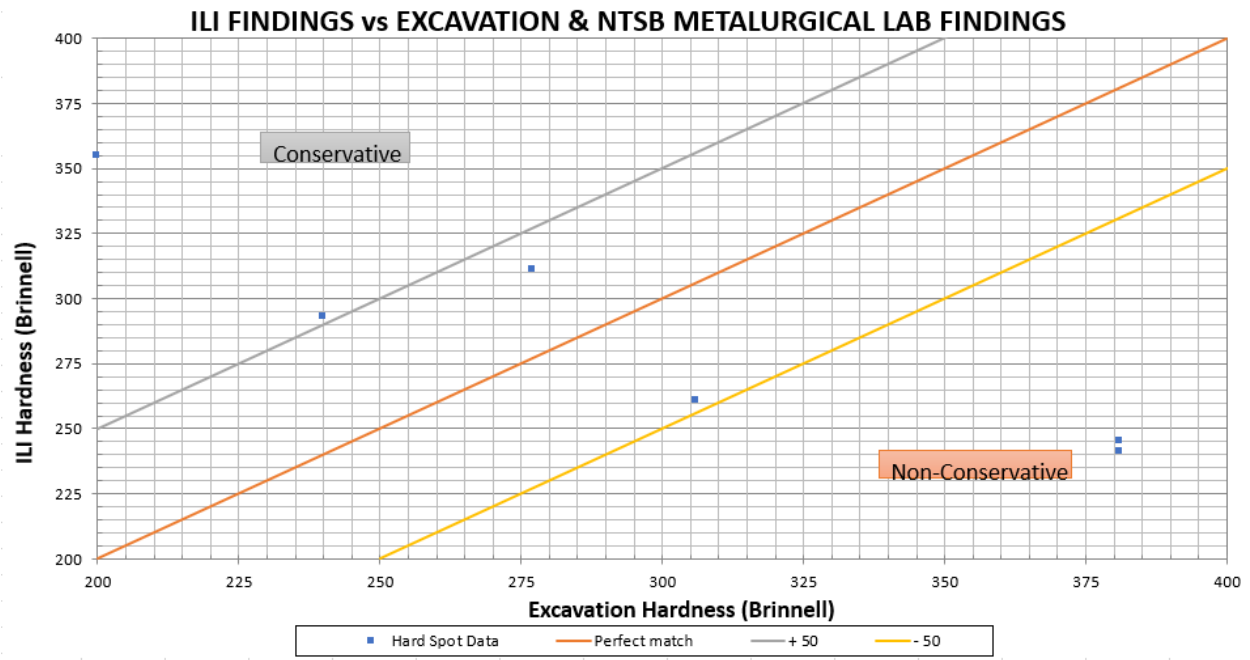
The updated unity plot after the incident is provided below:

The two non-conservative data points represent the Lincoln County incident origin hard spot. The ILI reported possible hard spot at WC 376895.967 was investigated with polishing and etching at the reported location, however no hard spot was found. It is represented in the table as 0 for metallurgical lab hardness; however the value 0 is not within the scale boundaries of the unity plot.

- Enbridge has requested additional testing of 6 hard spots (between WC 376895.508 and 376903.633) on the incident site samples at NTSB metallurgical lab in order to further assess the remaining possible hard spots identified by the ILI vendor during the re-analysis of the 2011 ILI data. The possible hard spot at WC 376911.425 is at NTSB facilities, however the sample was on a spool in the crater and was subjected to the effects of prolonged heat exposure. Testing of these data points would provide additional hardness values for the unity plot.
