July 14, 2020, Rev. 2

**NTSB Questions DR 130:**

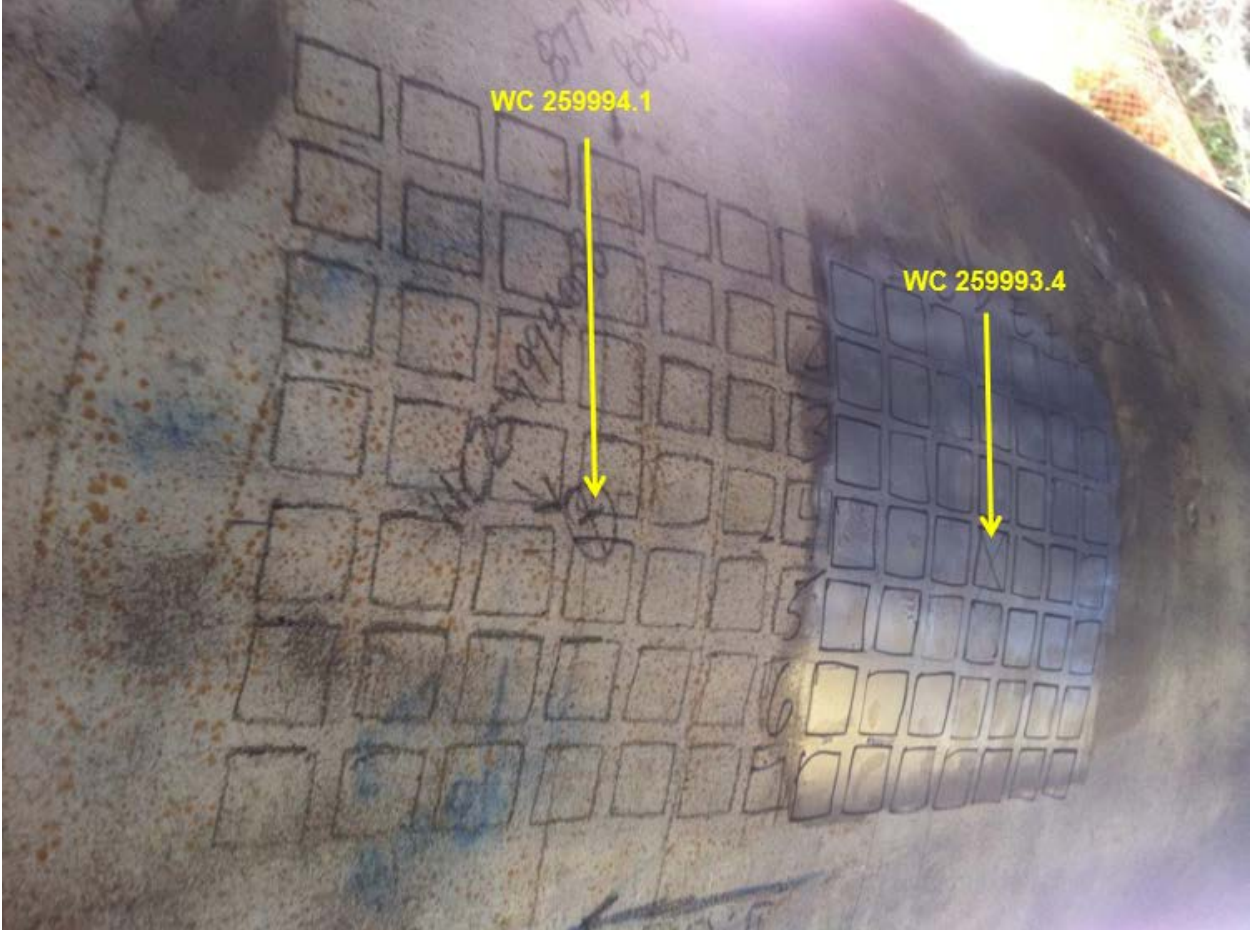
- WC 259994.1 (2011 Reported ILI 261 HB, Excavation 306 HB) – The hard spot at WC 259994.1 was approximately 7" from the ILI reported hard spot at WC 259993.4. See image below. The maximum hardness measured at the excavation for WC 259994.1 was 306 HB, and the maximum hardness for WC 259993.4 was 277 HB as shown in the Table below. The excavation measured hardness at WC 259994.1 (277 HB) was in the non-conservative region, but within the tolerance (+/- 50 HB) of the ILI tool. The field hardness for WC 259994.1 closely matched the estimated hardness for WC 259993.4. Similarly, the excavation measured hardness at WC 259993.4 (277 HB) closely aligned with the ILI estimated hardness (261 HB) for WC 259994.1. Both hard spots were repaired with a Type-B sleeve with welded ends.

Hard spot test grid for ILI excavation at WC 259994.1 (pre-polish) and WC 259993.4 (post-polish).
