7/22/2020

David Wayne  
Hooks  
Memorial  
Airport

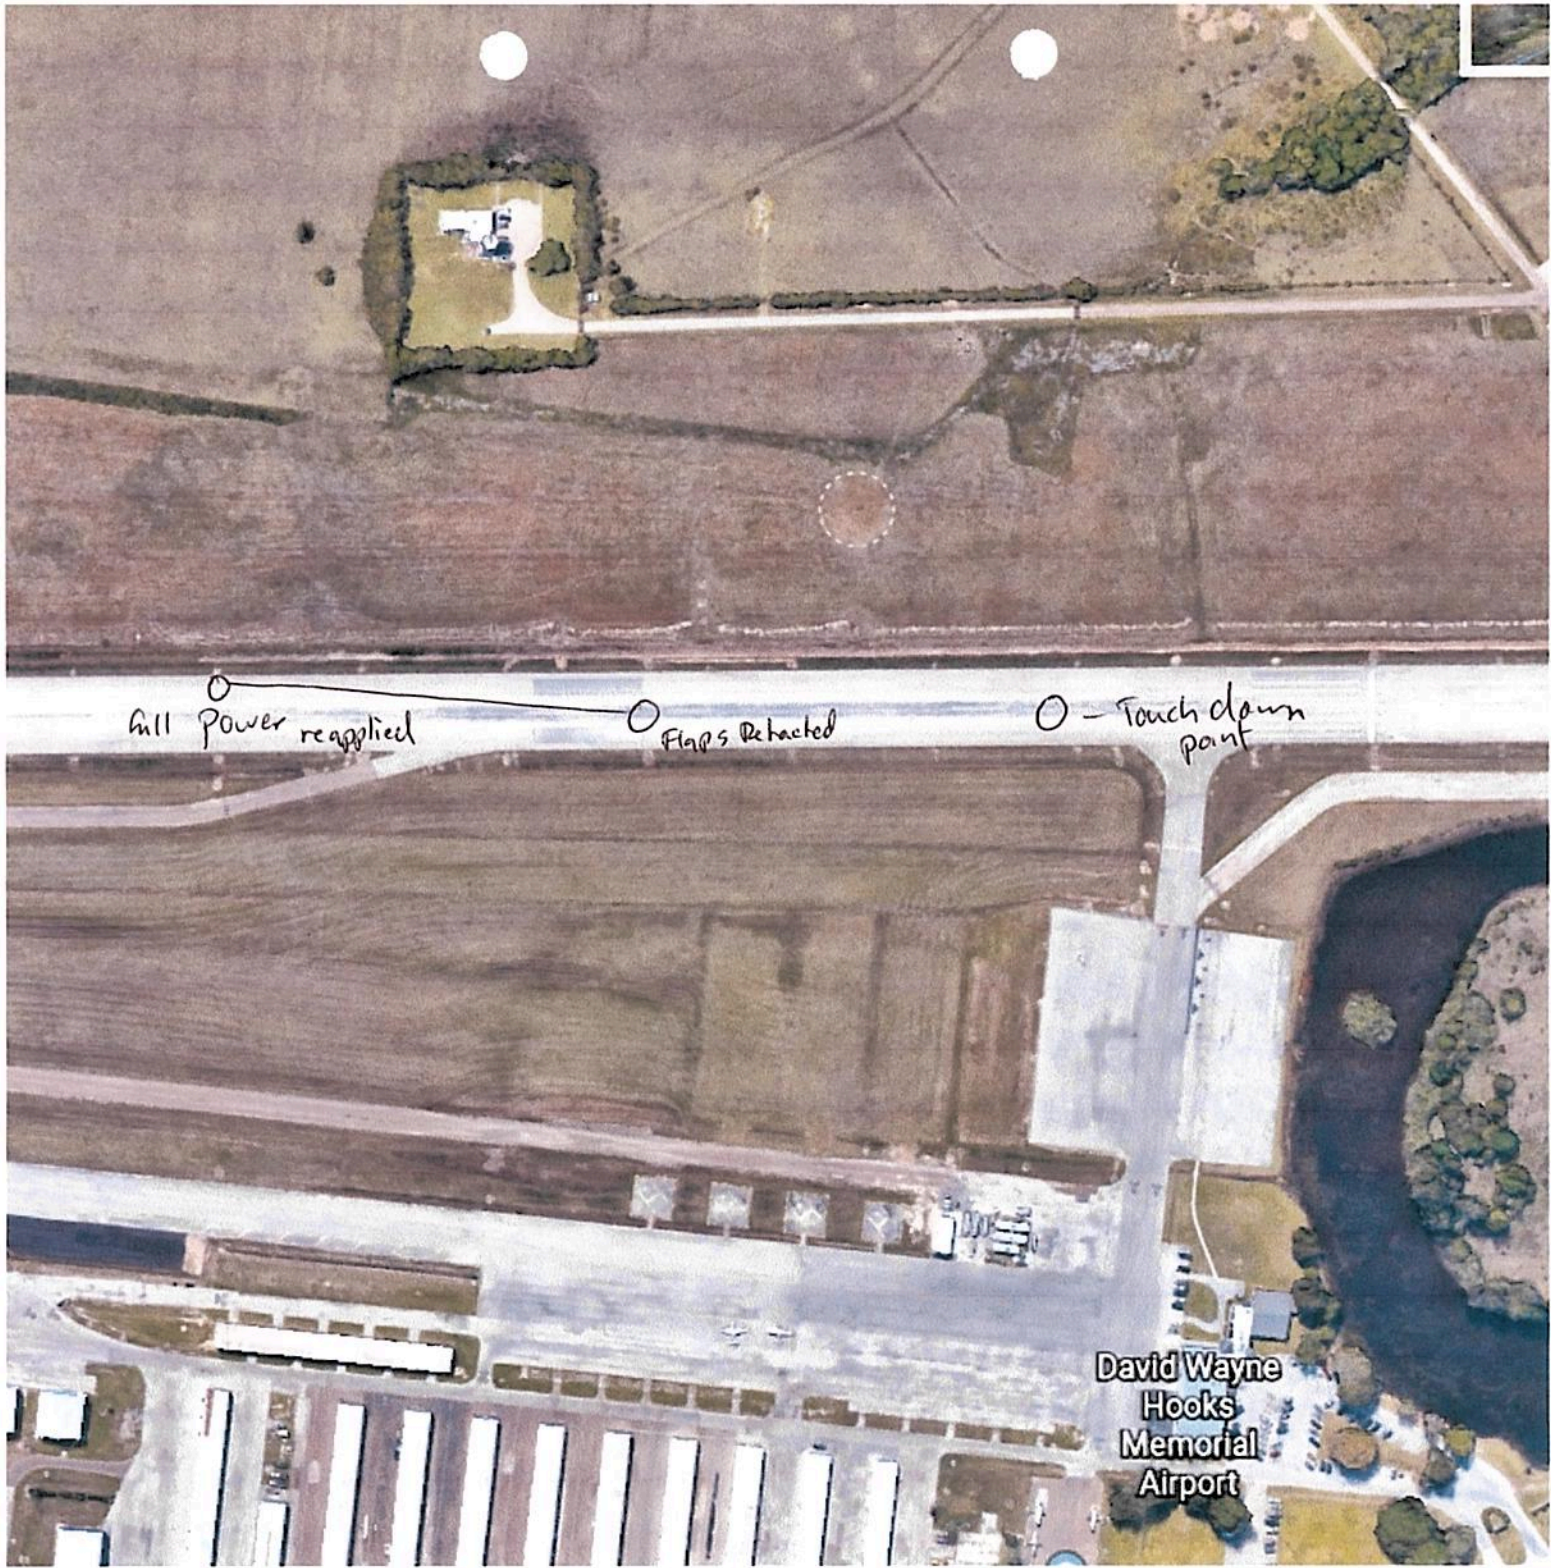
Full Power reappplied

Flaps Retracted

Touch down point

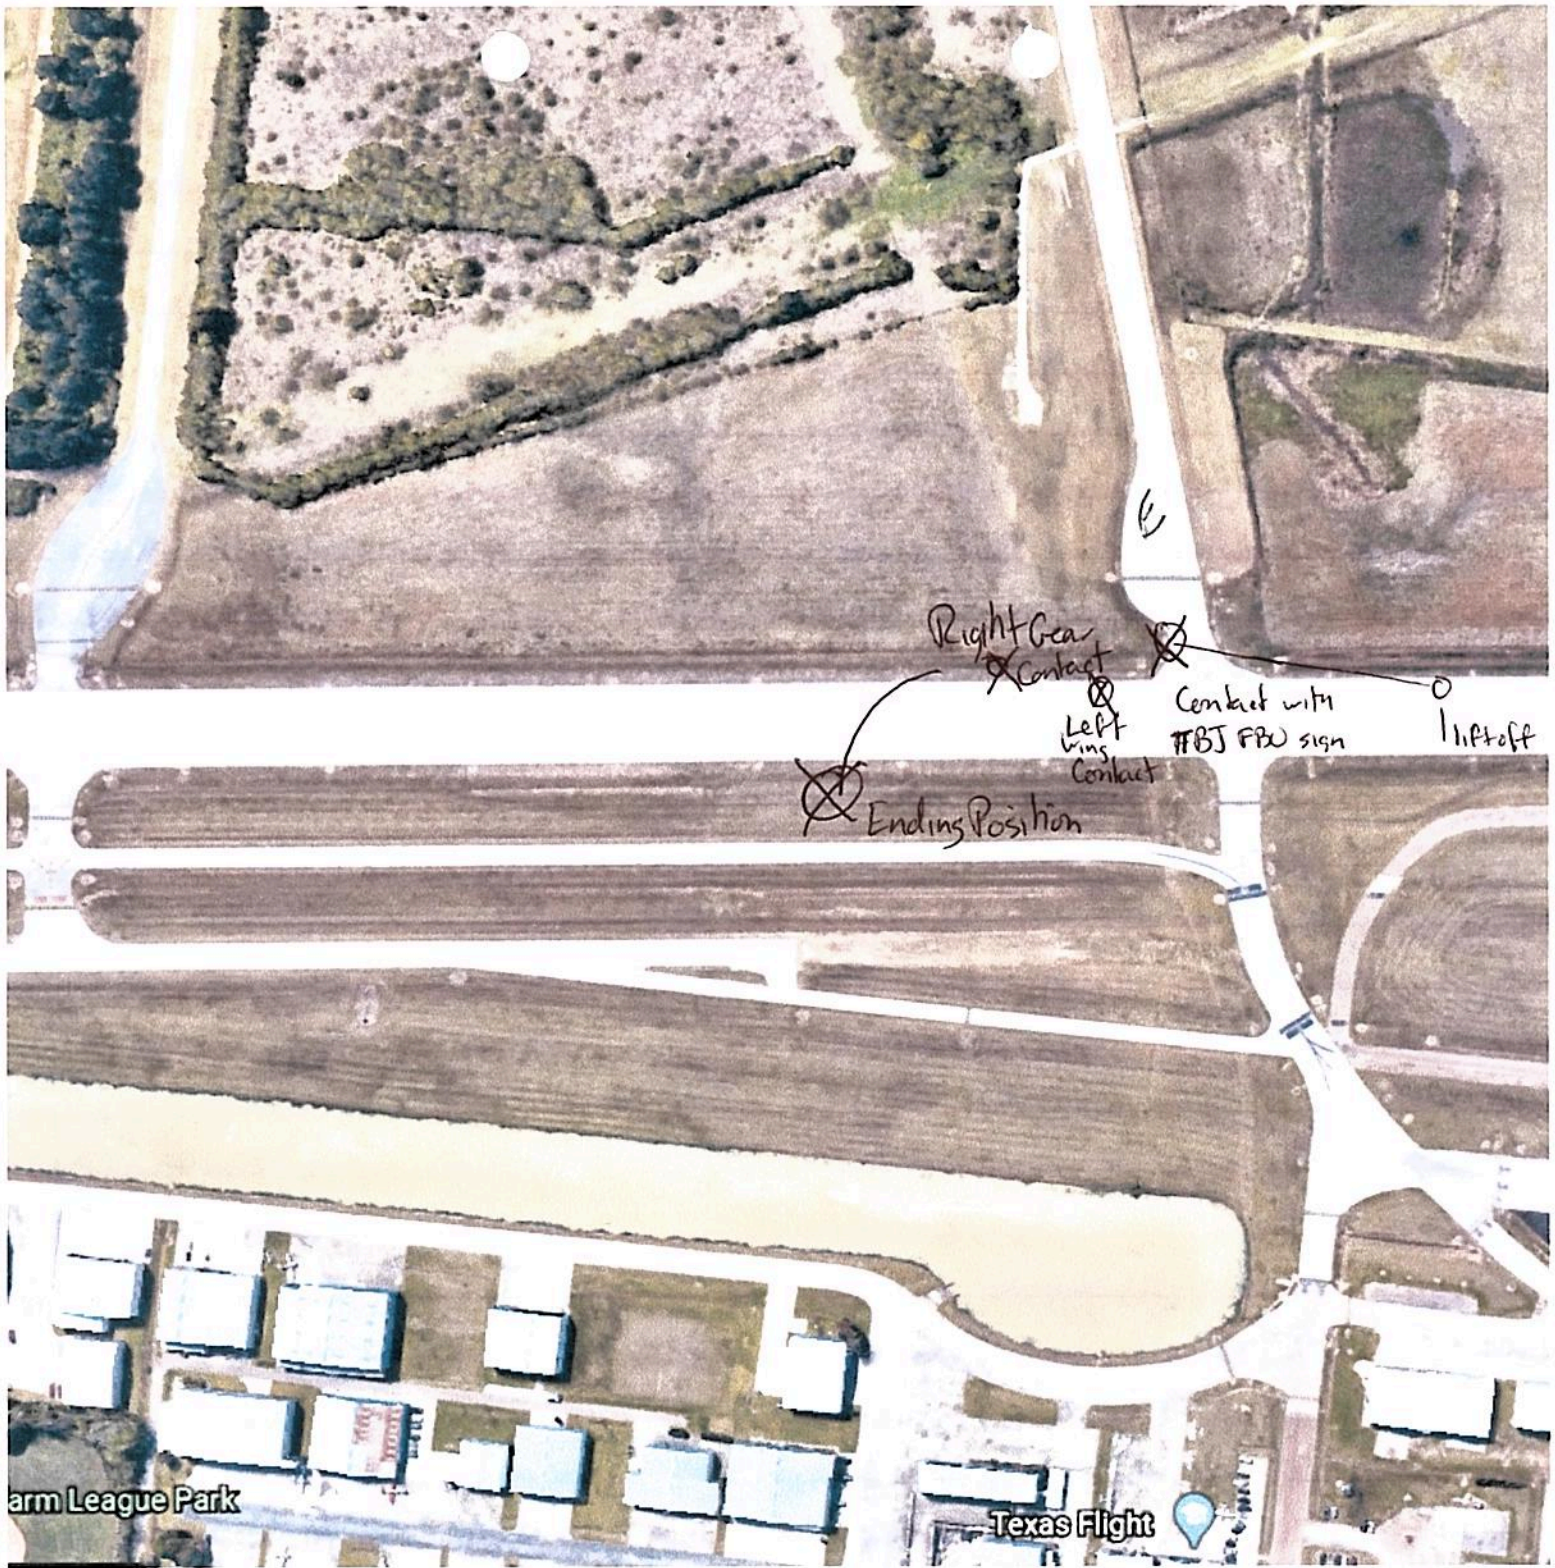
Right Gear  
Contact

Left  
Wing  
Contact

Ending Position

Contact with  
TFBJ FBU sign
