**Photo 1 – N9325H, an Aeronca L-16A (7BCM), in a pasture after a forced landing following a total loss of engine power (FAA photo)**

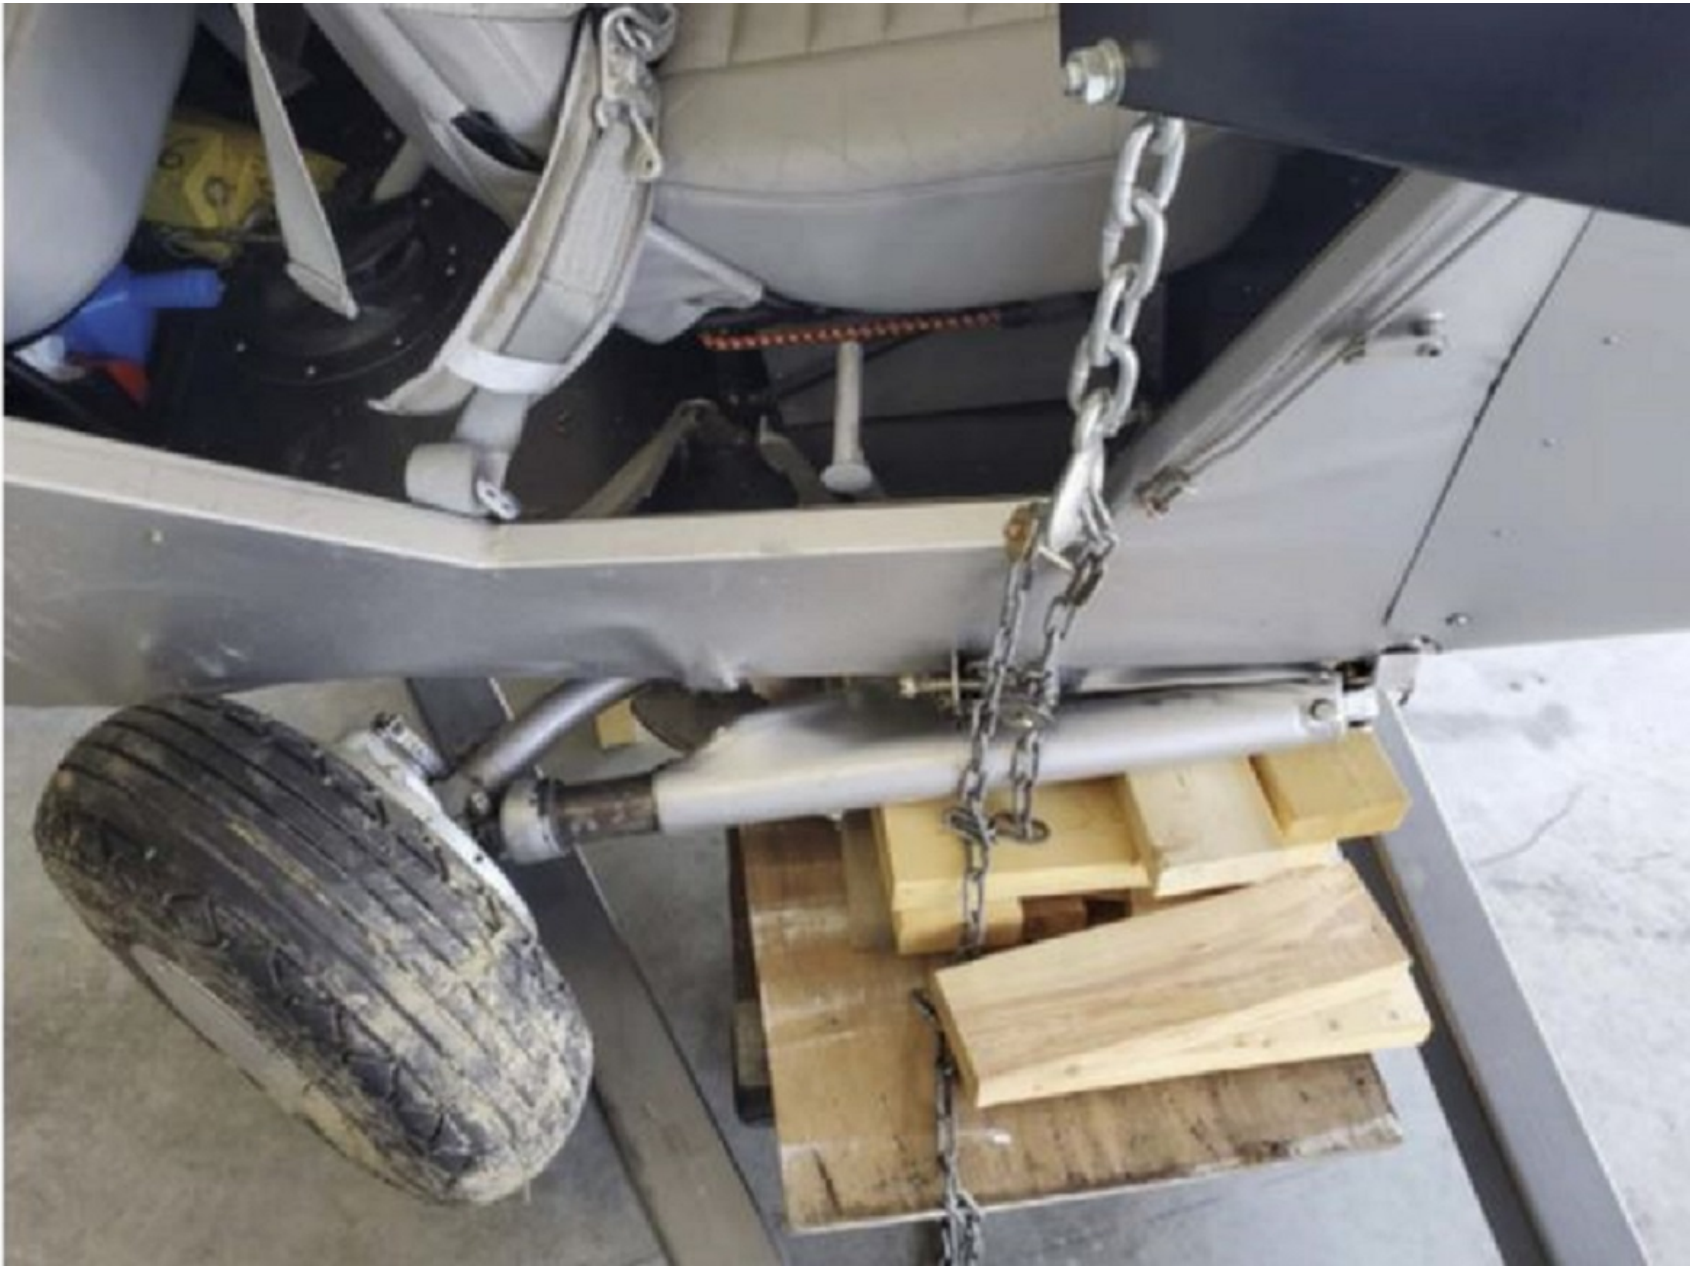
**Photo 2 - Buckled right main landing gear (FAA photo)**

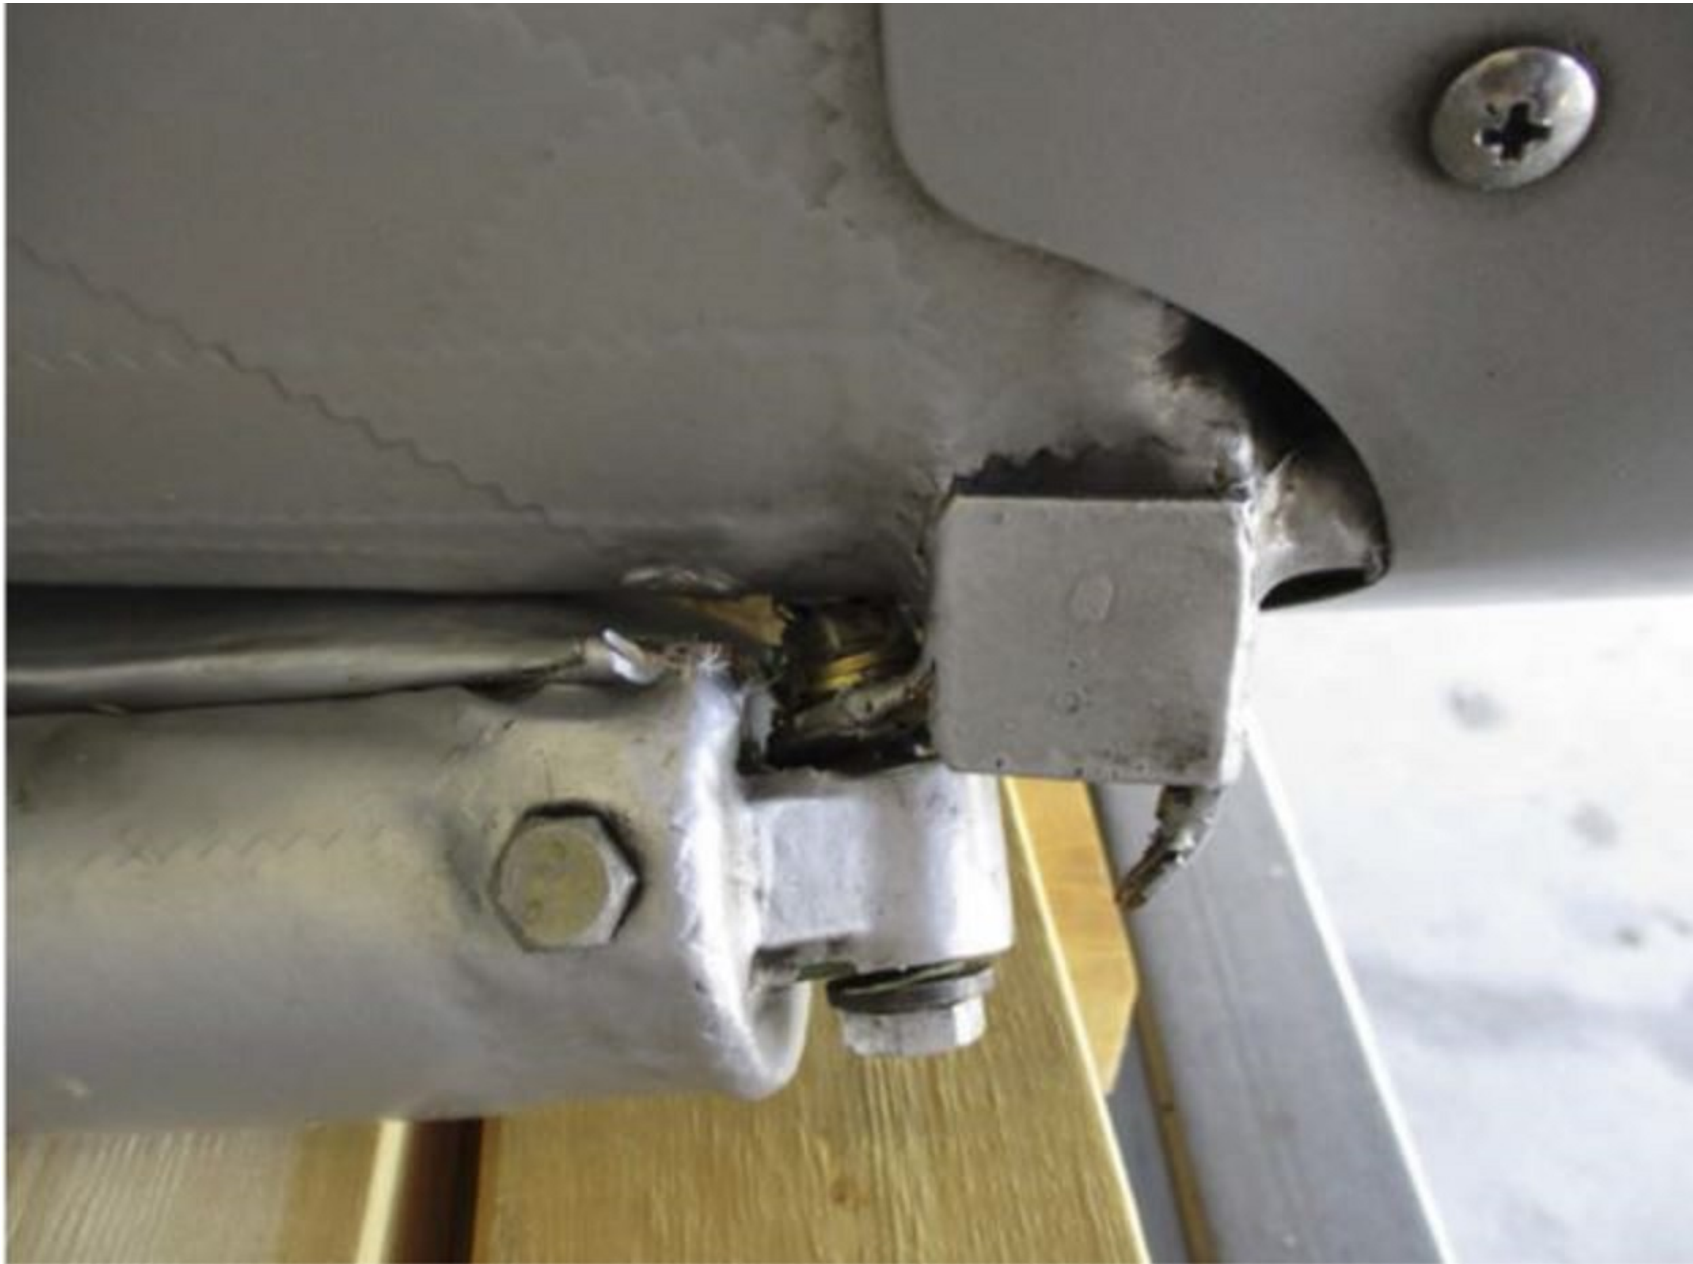
**Photo 3 – Close-up view of right main landing gear failure point (FAA photo)**

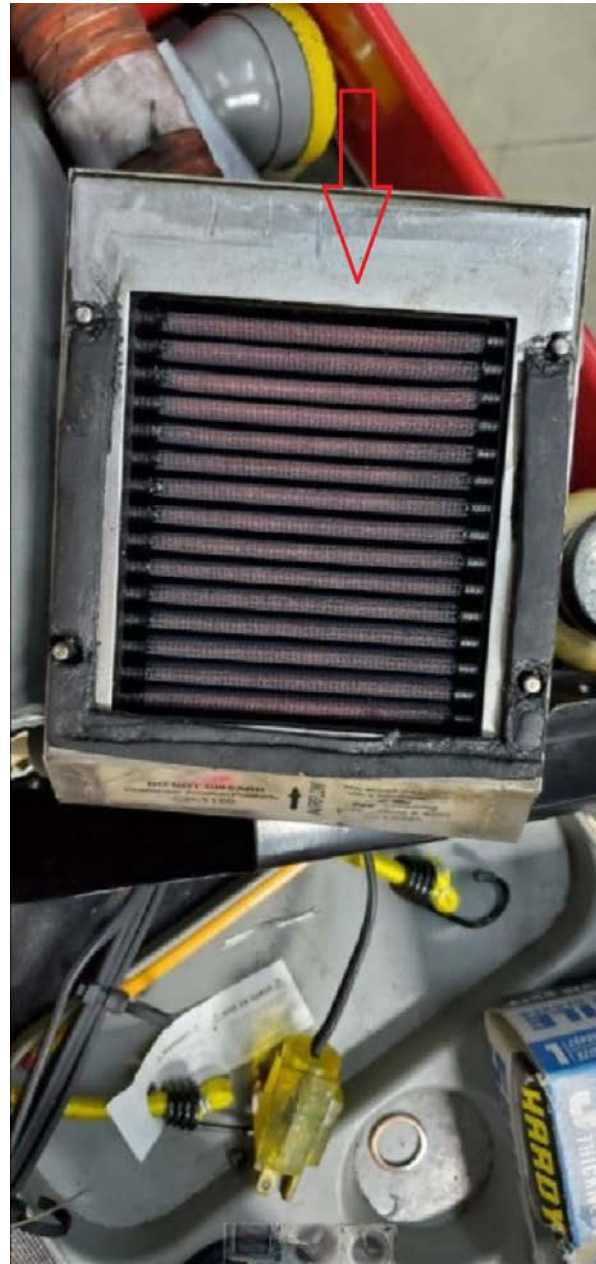
**Photo 4 - The condition of the air filter gasket as found by the mechanic. Note the gasket seal is missing from the top of the air filter (arrow) (Chuck Potts photo)**

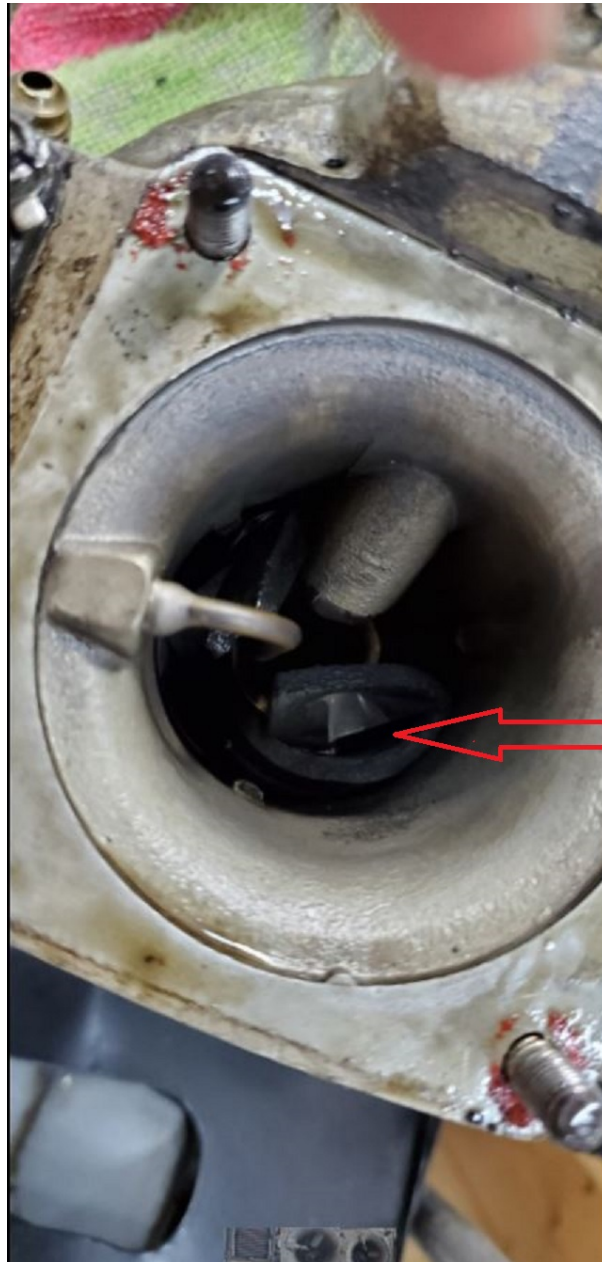
**Photo 5 - The carburetor intake. Note the strip of air filter gasket lodged in the throat (arrow) (Chuck Potts photo)**

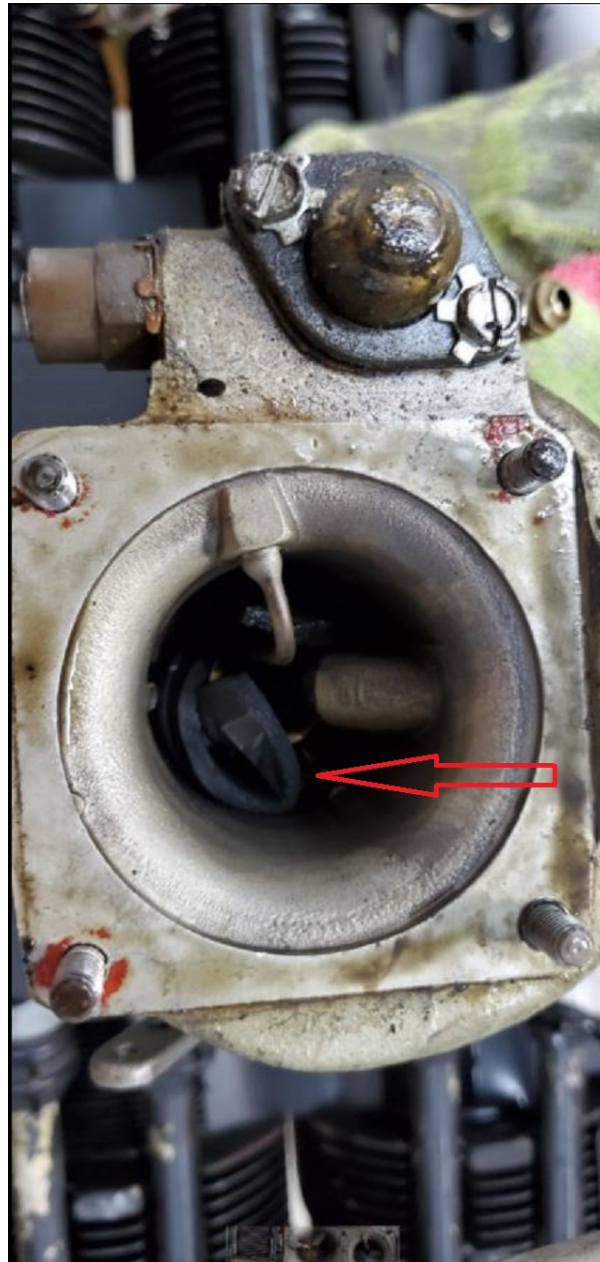
**Photo 6 - Another view of the carburetor intake with a strip of air filter gasket lodged in the throat (arrow) (Chuck Potts photo)**
