# National Transportation Safety Board

HWY23FH008

## **CONSOLIDATED FACTUAL REPORT**

Goodyear, Arizona Group Chair's Factual Report

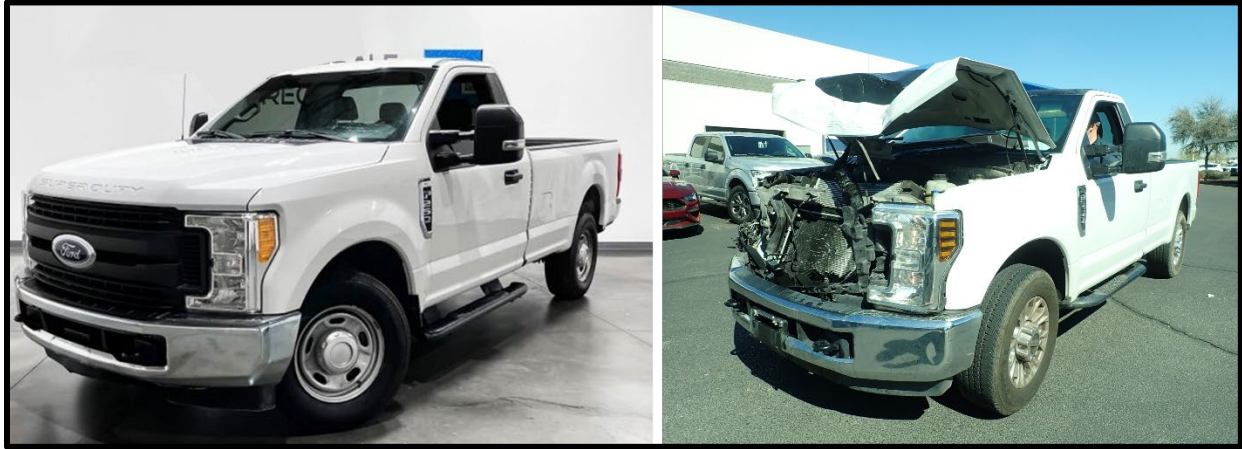
**Figure 14: Left-front view of the subject pickup with exemplar.**

Damage to the front of the vehicle was above the bumper and into the radiator and right front headlamp, as shown in Figure 14 with exemplar. The undamaged exemplar is displayed on the left, and the subject vehicle after the accident is indicated on the right. The grille was separated from the vehicle in an intact piece. The peak static crush was approximately 18 inches at the front of the hood line. Figure 15 demonstrates the severe hood buckling in the subject pickup compared to an undamaged exemplar. The peak vertical deformation was approximately in the same horizontal plane as the roof line. As shown in Figure 16, the passenger side mirror was separated from the door; however, the support struts remained intact and retracted against the side of the pickup. The insert in Figure 16 shows the undamaged exemplar

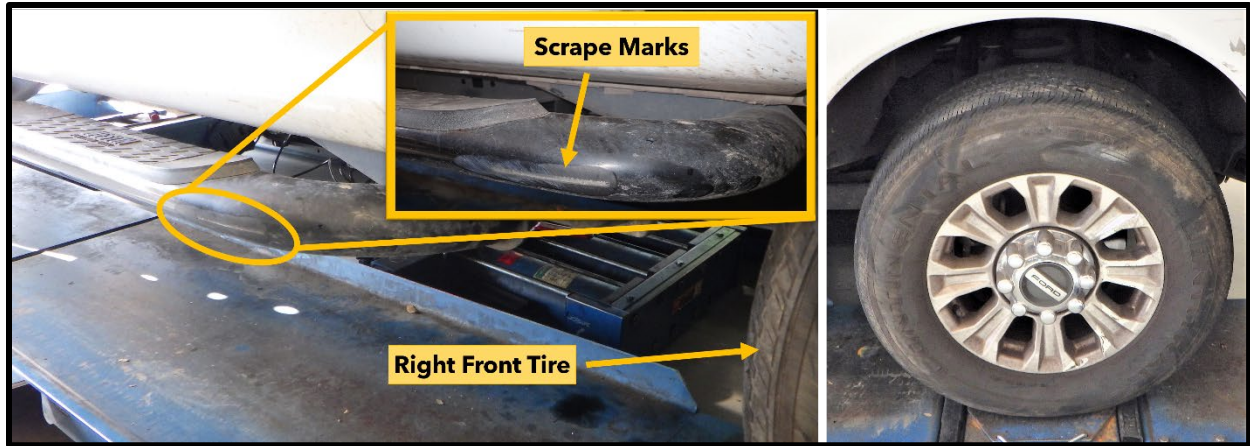
**Figure 17: Damage to right side of subject pickup.**

from a similar perspective. Other notable exterior damage included scrapes along the front of the right-side step bar and scuff marks on the outer sidewall of the right front tire (Figure 17).

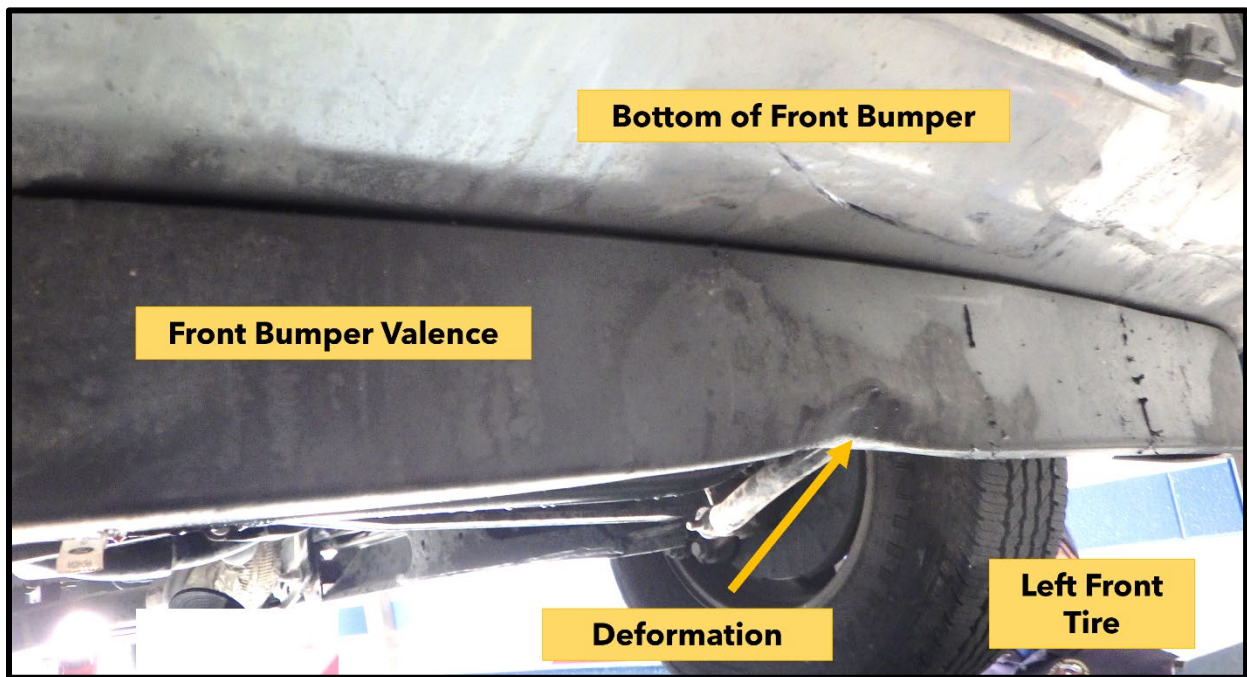
**Figure 18: Subject pickup bumper valance.**

No significant damage was observed to the frame of the subject pickup. The front bumper valance had some deformation near the middle consistent with impact to a narrow-width object (Figure 18). Evidence consistent with biological material was found on the muffler, bottom of the gas tank, right rear shock, and the spare tire mounted to the rear undercarriage.

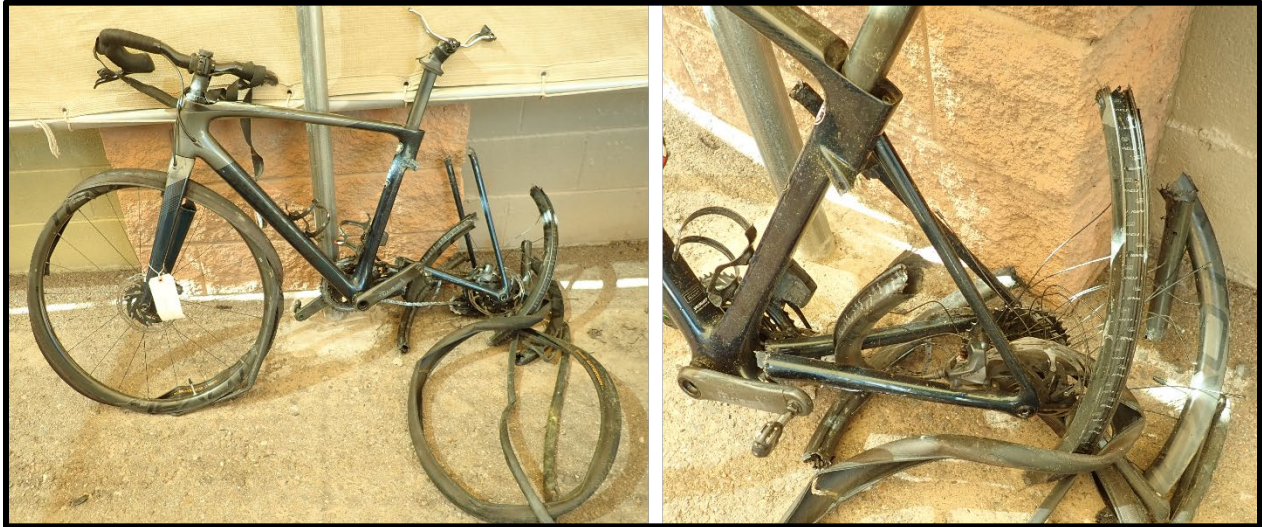
**Figure 21: Inspection photos of Specialized Tarmac Disc Sport bicycle.**

<b>Brand</b>	Specialized
<b>Model</b>	Tarmac Disc Sport
<b>Serial Number</b>	WSBC604205272P
<b>Owner</b>	B01
<b>Rear reflector/light present</b>	None were present during the inspection.
<b>Seat height from the ground</b>	Not measured
<b>Notes</b>	Both sides of the fork were fractured; the seat was missing; the rear triangle <sup>35</sup> was separated at seat stays and chain stays. The rear rim was broken into several pieces.

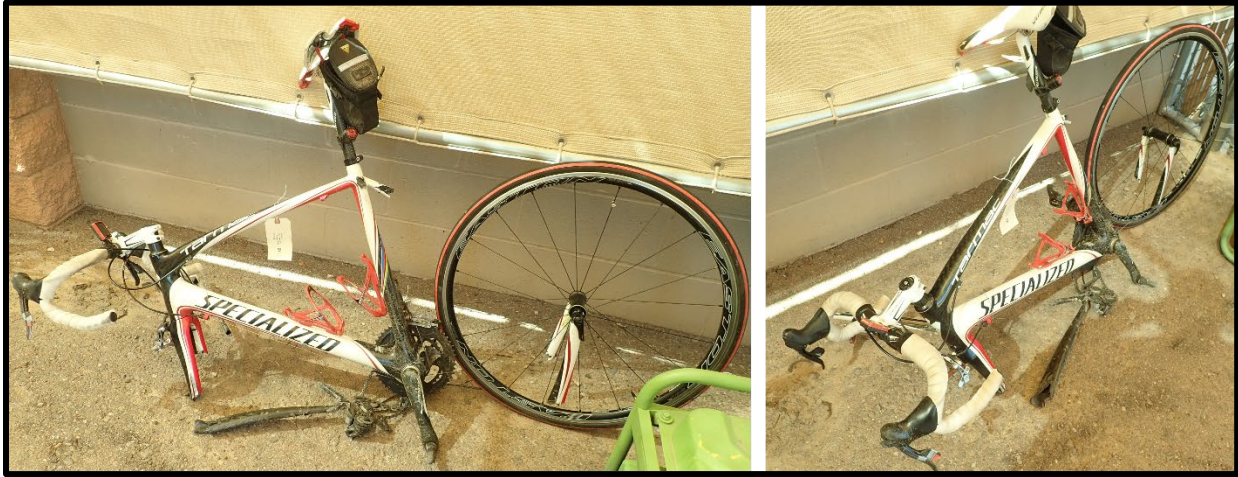
Figure 22: Inspection photos of Specialized Tarmac bicycle.

<b>Brand</b>	Specialized
<b>Model</b>	Tarmac
<b>Serial Number</b>	WUD094023020E
<b>Owner</b>	B02
<b>Rear reflector/light present</b>	Rear light
<b>Seat height from the ground</b>	Not measured
<b>Notes</b>	The rear tire separated from the chain stays and seat stays; the lower half of the front fork fractured on both sides and detached from the bike along with the front tire.

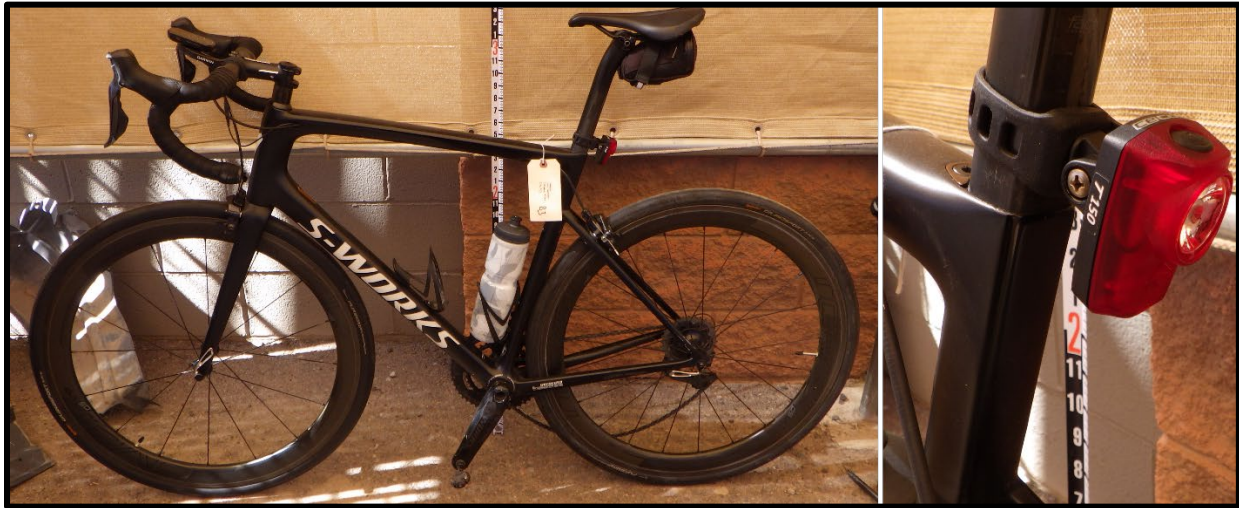
Figure 23: Inspection photos of Specialized 2018 S-Works Tarmac bicycle.

<b>Brand</b>	Specialized
<b>Model</b>	2018 S-Works Tarmac
<b>Serial Number</b>	WSBC604263539N
<b>Owner</b>	B03
<b>Rear reflector/light present</b>	Ceco T150 light
<b>Seat height from the ground</b>	103 cm
<b>Notes</b>	The front and rear tires rotated freely—no damage to the frame was observed.

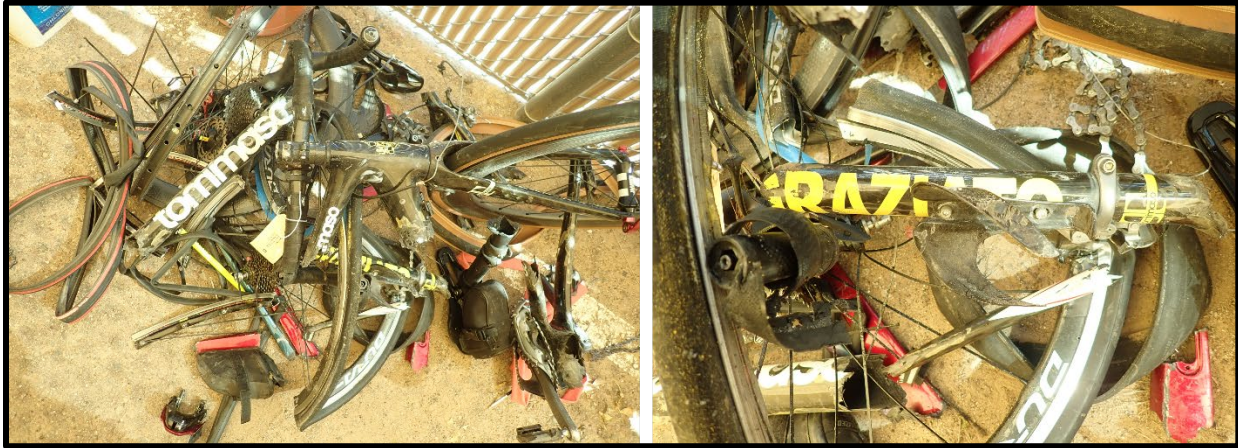
**Figure 27: Inspection photos of Tommaso Aggraziato bicycle.**

<b>Brand</b>	Tommaso
<b>Model</b>	Aggraziato
<b>Serial Number</b>	EM11D0506
<b>Owner</b>	B07
<b>Rear reflector/light present</b>	None found
<b>Seat height from the ground</b>	Not measured
<b>Notes</b>	Extensive damage

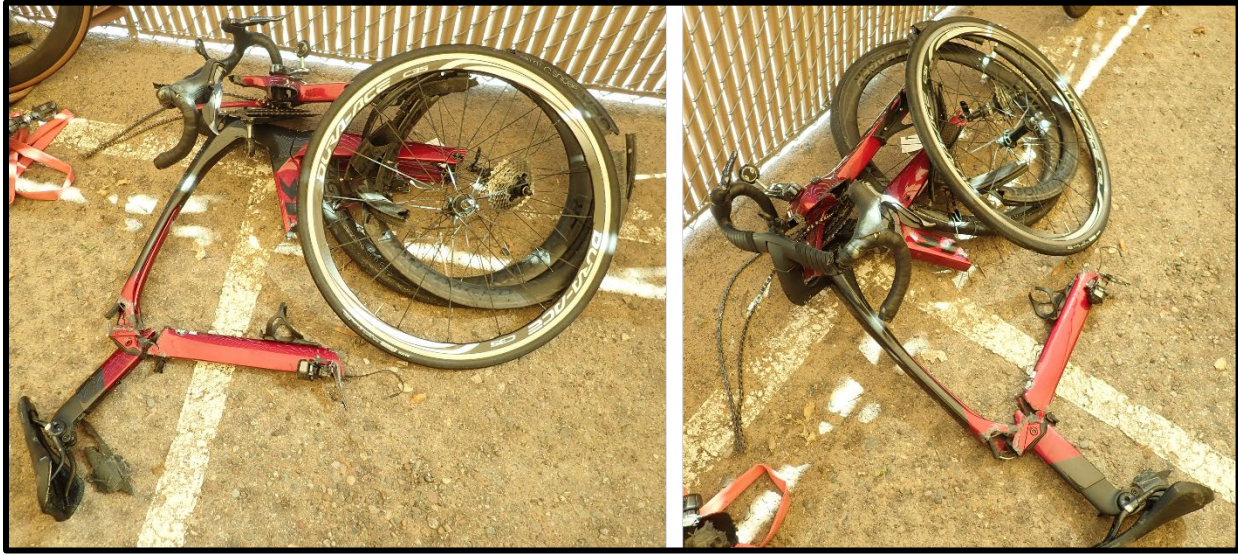
Figure 28: Inspection photos of Trek Madone bicycle.

<b>Brand</b>	Trek
<b>Model</b>	Madone
<b>Serial Number</b>	WTU0202QU0364T
<b>Owner</b>	B08
<b>Rear reflector/light present</b>	None were present during the inspection.
<b>Seat height from the ground</b>	Not measured
<b>Notes</b>	Down tube fractured and missing; chain stays and seat stays missing; seat tube post fractured near seat post.

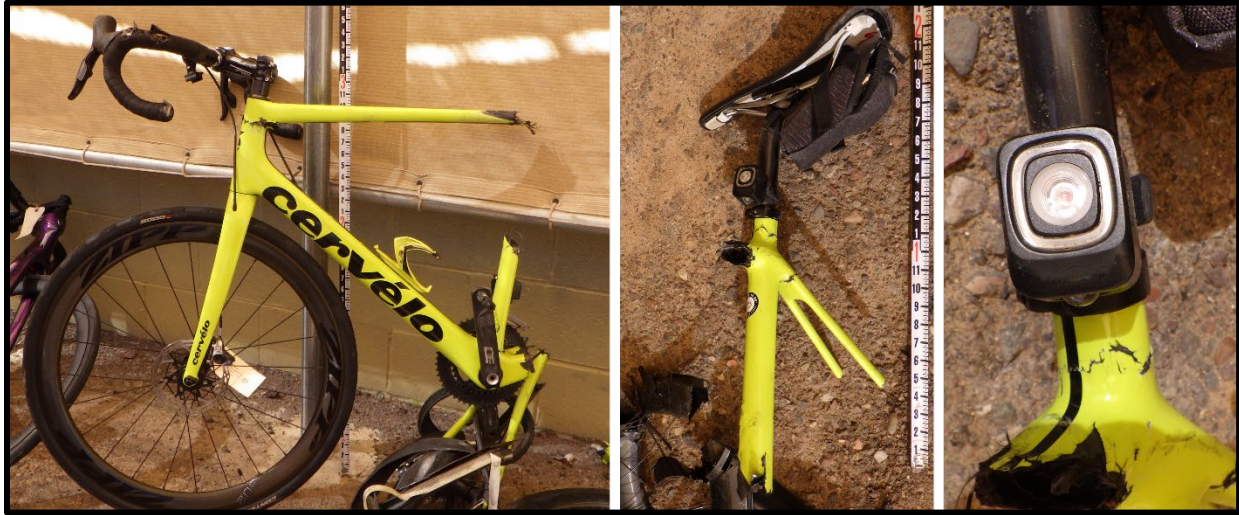
Figure 30: Inspection photos of Cervelo R3 bicycle.

<b>Brand</b>	Cervelo
<b>Model</b>	R3
<b>Serial Number</b>	SNR3F17L00228
<b>Owner</b>	B10
<b>Rear reflector/light present</b>	Magicshine rear light
<b>Seat height from the ground</b>	Not measured
<b>Notes</b>	The upper seat tube was separated from the top tube, and the rear seat stays were fractured; the Rear wheel was broken and separated from the seat stays and chain stays.

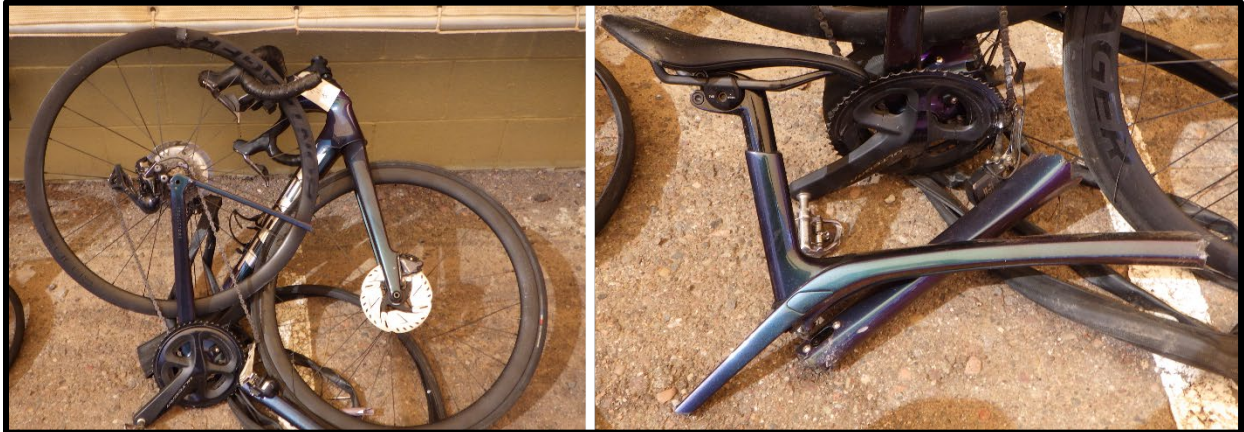
Figure 31: Inspection photos of Trek Domane SLR7 bicycle.

<b>Brand</b>	Trek
<b>Model</b>	Domane SLR7
<b>Serial Number</b>	WTU347QU0226R
<b>Owner</b>	B11
<b>Rear reflector/light present</b>	None were present during the inspection.
<b>Seat height from the ground</b>	Not measured
<b>Notes</b>	Fractured top tube, seat post, and half of the seat stay; Fractured chain stays, and half of the seat stay from the bottom bracket shell. <sup>36</sup>

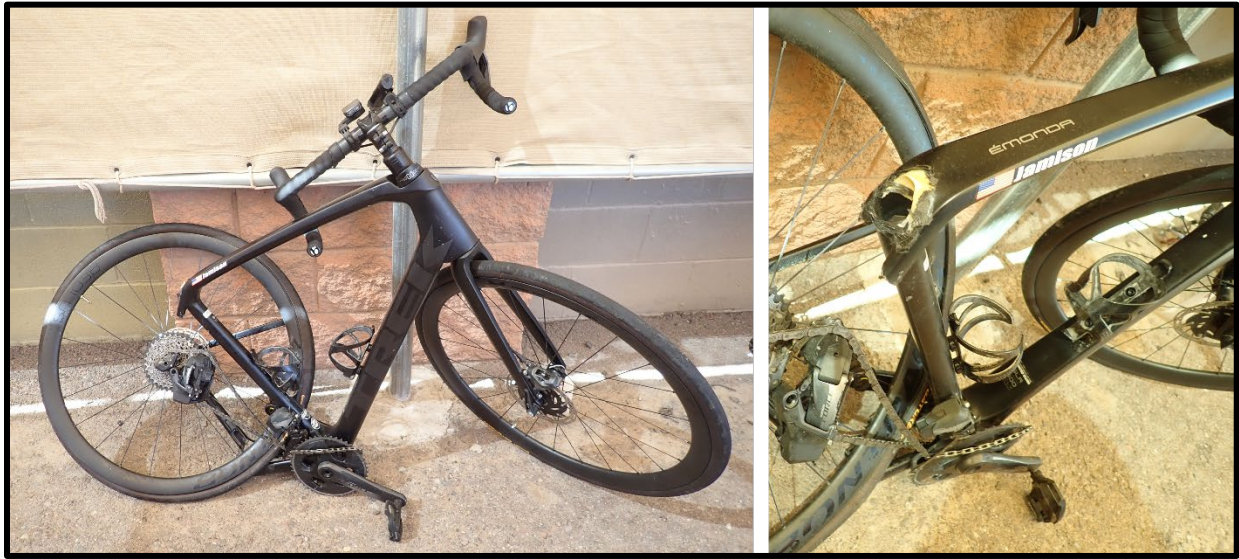
**Figure 32: Inspection photos of Trek Emonda SLR bicycle.**

<b>Brand</b>	Trek
<b>Model</b>	Emonda SLR
<b>Serial Number</b>	WTU217T0023R
<b>Owner</b>	B12
<b>The rear reflector/light present</b>	Not found during the inspection
<b>Seat height from the ground</b>	Not measured
<b>Notes</b>	The seat post separated from the seat tube; the Rear wheel detached from the bottom bracket shell at the chain stays, and the seat post at the seat stays.

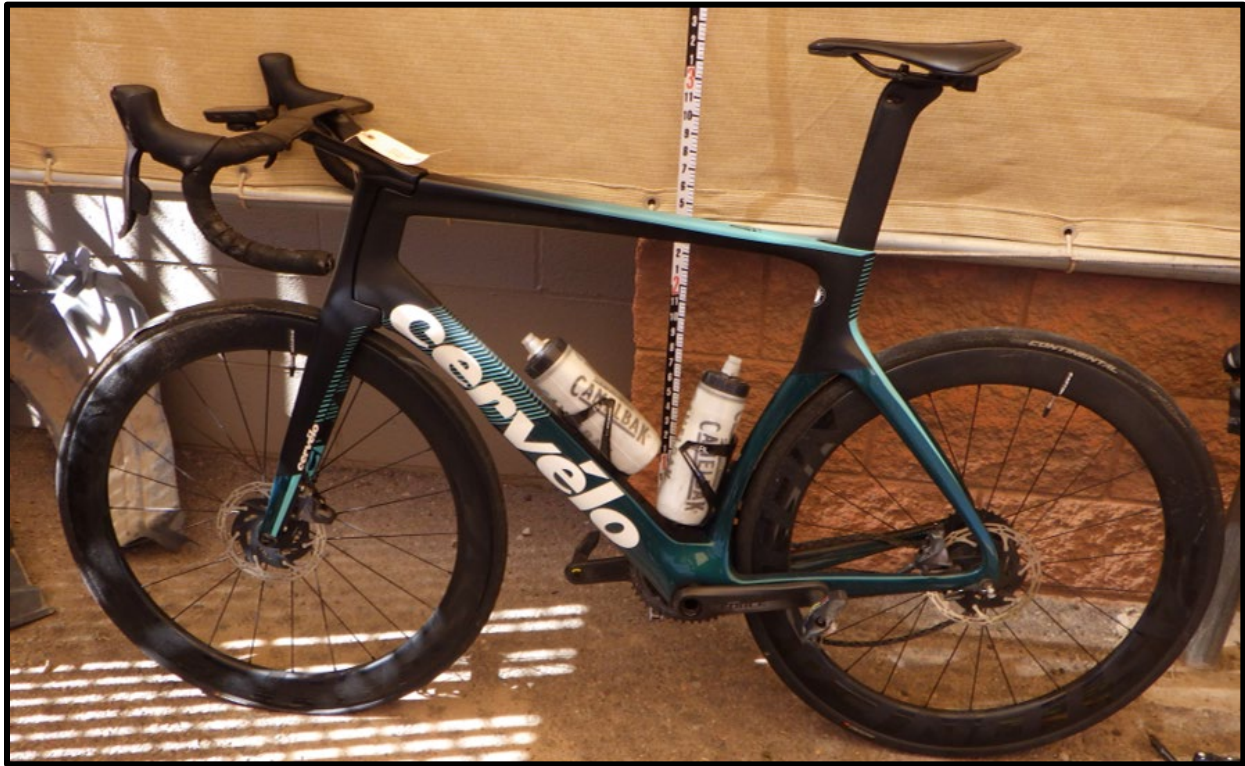
**Figure 35: Inspection photo of Cervelo S5 bicycle.**

<b>Brand</b>	Cervelo
<b>Model</b>	S5
<b>Serial Number</b>	S5E19E00083
<b>Owner</b>	B16
<b>Rear reflector/light present</b>	Not found during the inspection
<b>Seat height from the ground</b>	101 cm
<b>Notes</b>	Both tires rotated freely The front tire was punctured and torn on the sidewall

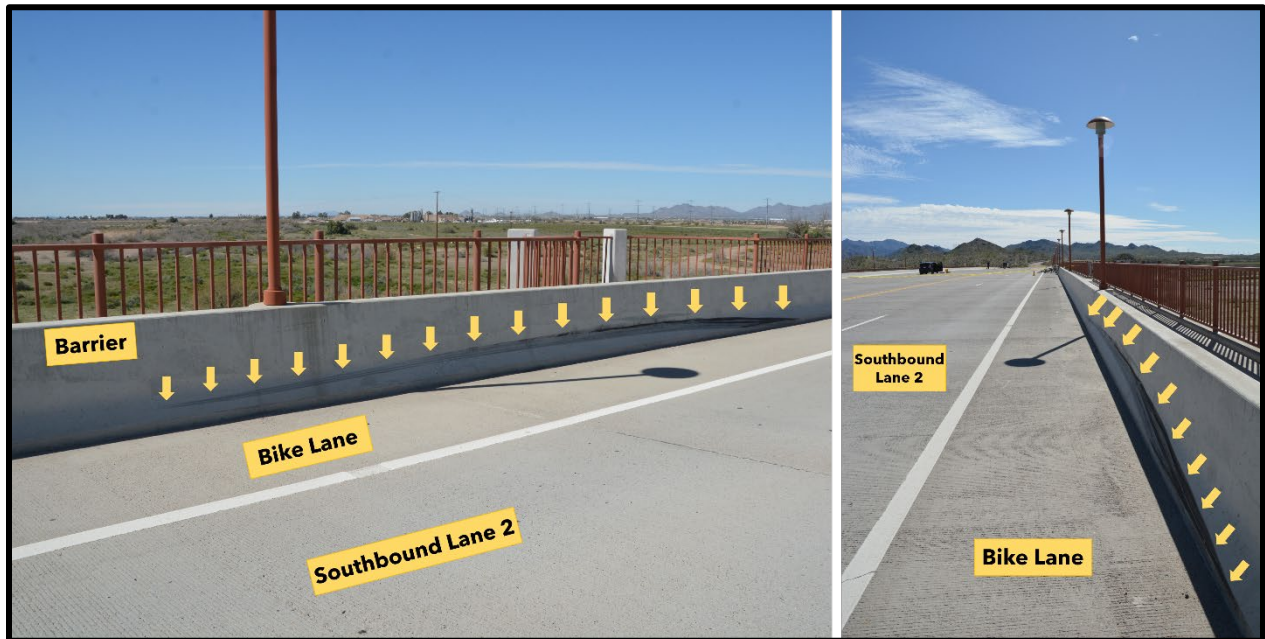
**Figure 37: Friction mark on the barrier.**

A scaled diagram was created from the total station data provided by the GPD. The following information and measurements were determined by reviewing GPD and NTSB investigators' scene photographs and the scaled diagram. The pickup had been traveling southbound on South Cotton Lane. The first physical evidence area documented was on the vertical portion of the concrete barrier along the southbound roadway. The tire friction mark was about 749-feet south of the bridge's beginning and about 597-feet north of the pickup's final rest. The friction mark (Figure 37) measured approximately 33.5-feet in length and arced upward from the bottom of the barrier to just above the break-point<sup>38</sup> of the barrier and back downwards. The friction mark began dark and transitioned lighter as the mark continued south along the barrier. As stated, the pickup was at final rest 597-feet from the initial tire mark. It stopped facing south within the median.
