National Transportation Safety Board

FACTUAL REPORT OF INVESTIGATION - HAMDEN, CONNECTICUT
HWY22FH011

REPORT OF INVESTIGATION

July 12, 2023

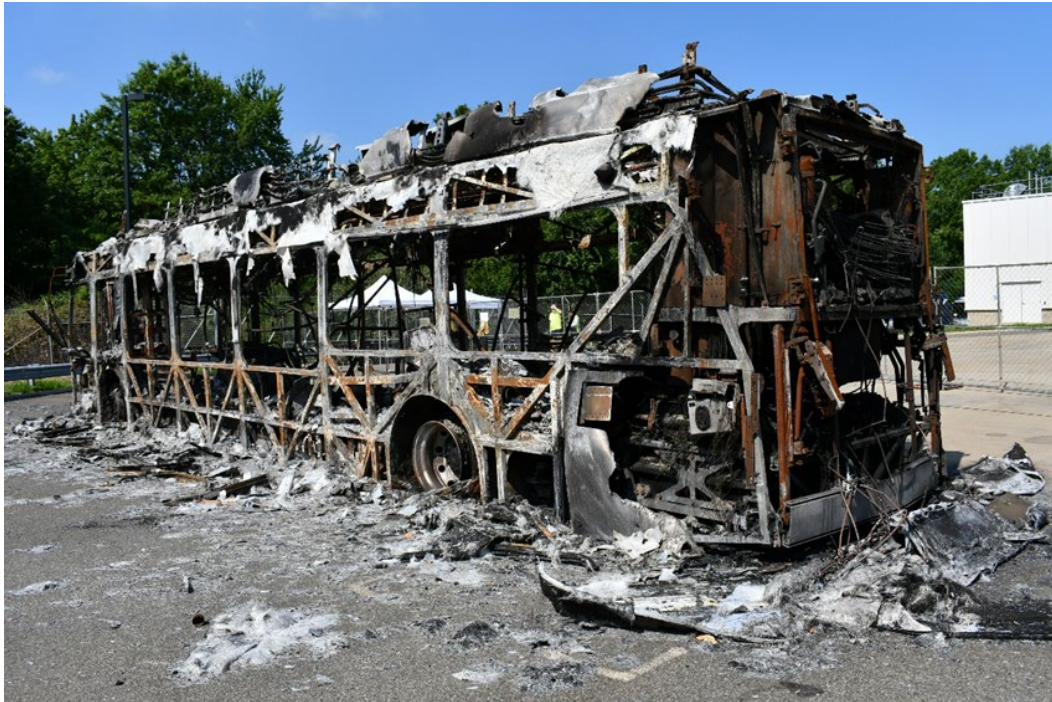
The BETB sustained severe fire damage to all areas of the bus. All windows were missing, and the fiberglass cladding was consumed, exposing the steel frame of the bus. All tires were consumed leaving only the wheels. At the rear of the bus, the upper fiberglass door covering the heating and cooling (HVAC) system and the lower door covering the rear battery storage area were consumed, exposing the remnants of both the HVAC system and the batteries. **Figure 1** shows an exemplar bus and **Figure 2** shows the post-fire bus.

Figure 2: Burned New Flyer Xcelsior as viewed from the left rear corner.

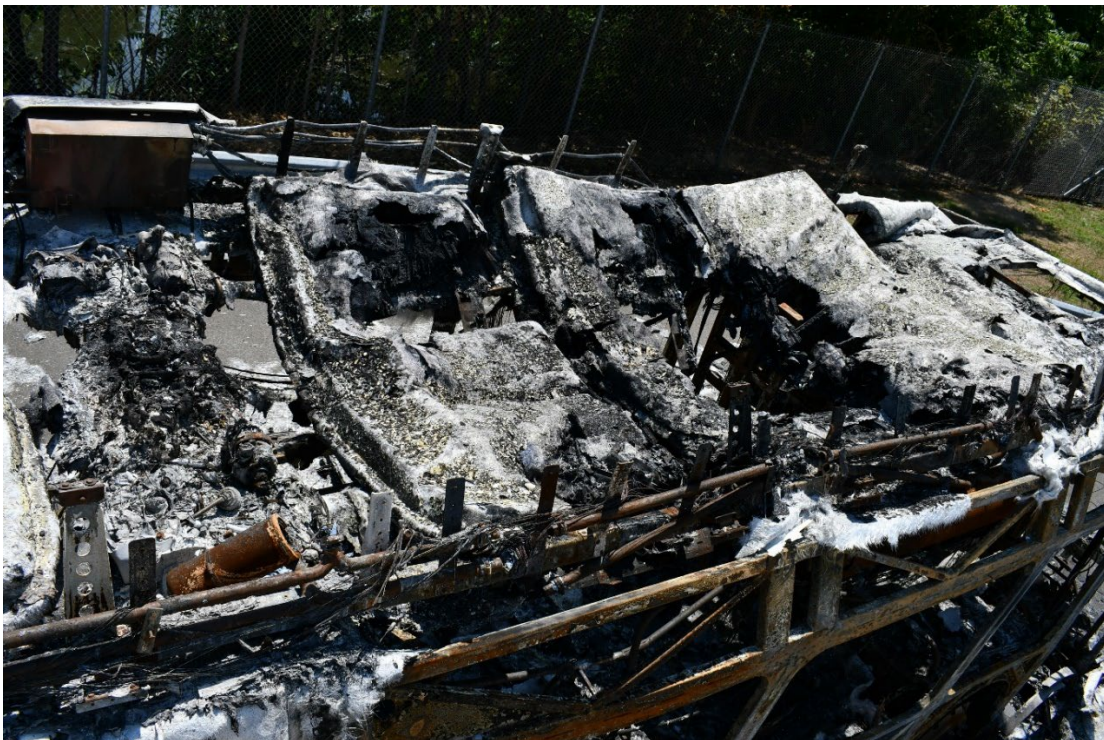
All six fiber-reinforced composite ESS enclosures on the bus were partially or fully consumed in the fire, exposing some of the individual battery packs within. Two of the four ESS enclosures on the roof partially collapsed into the interior of the bus. The two partially consumed ESS enclosures on the rear of the bus remained in their steel mounting bracket. **Figure 3** shows the roof mounted ESS storage enclosures on an exemplar bus. **Figure 4** shows the same enclosures on the involved BETB post-fire. **Figure 5** shows the rear mounted ESS enclosures on the exemplar bus and **figure 6** shows the fire damaged rear enclosures.

Figure 4: Post-fire rooftop energy storage enclosures

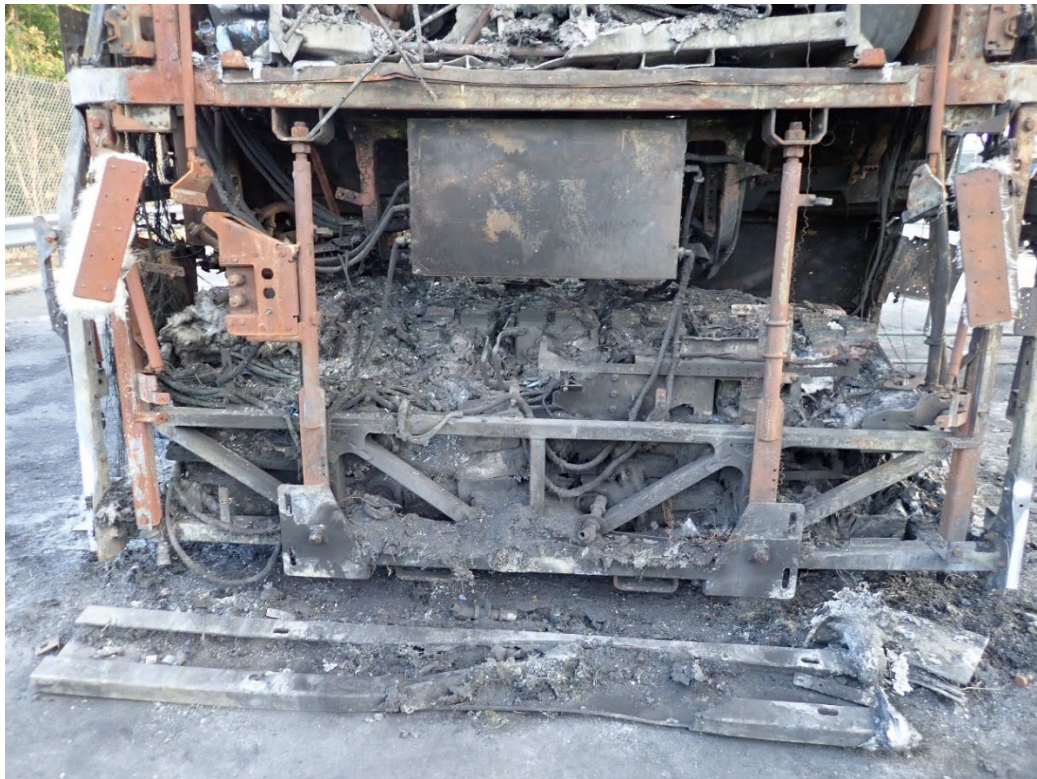
Figure 6: Post-fire rear mounted energy storage enclosures

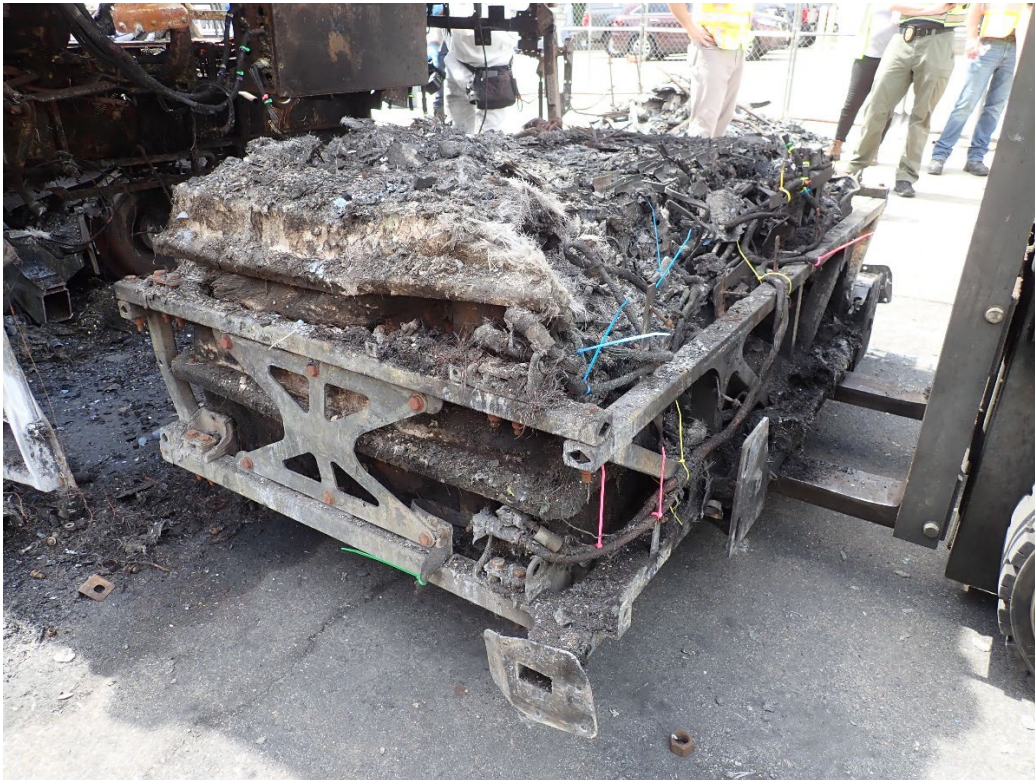
Post-fire, the bus remained in the parking lot of the Hamden CT Transit facility. On August 22, 2022, the rear ESS mounting bracket was exposed by removing the remaining fiberglass and door frames. The entire steel bracket containing both ESS's was then cut away from the frame of the bus and removed using a forklift. **Figure 7** shows the bracket containing the rear ESS containers upon removal from the bus.

Figure 7: Rear mounted ESS bracket after removal

On October 25 - 27, 2022 a laboratory examination of the rear batteries was conducted. This examination, along with additional testing and inspections indicated evidence of water or coolant damage in the ESS enclosure. After this laboratory examination was completed, the root cause investigation was transferred by the CSP Fire and Explosion Unit to New Flyer and Xalt for continued analysis.
