NATIONAL TRANSPORTATION SAFETY BOARD

MATERIALS LABORATORY FACTUAL REPORT

Report No. 21-084

Place : Greenville, Alabama
Date : June 1, 2021
Vehicle : Multiple commercial and passenger vehicles (See Section C)
NTSB No. : HWY21MH009
Investigator : Dennis Collins OHS-IIC

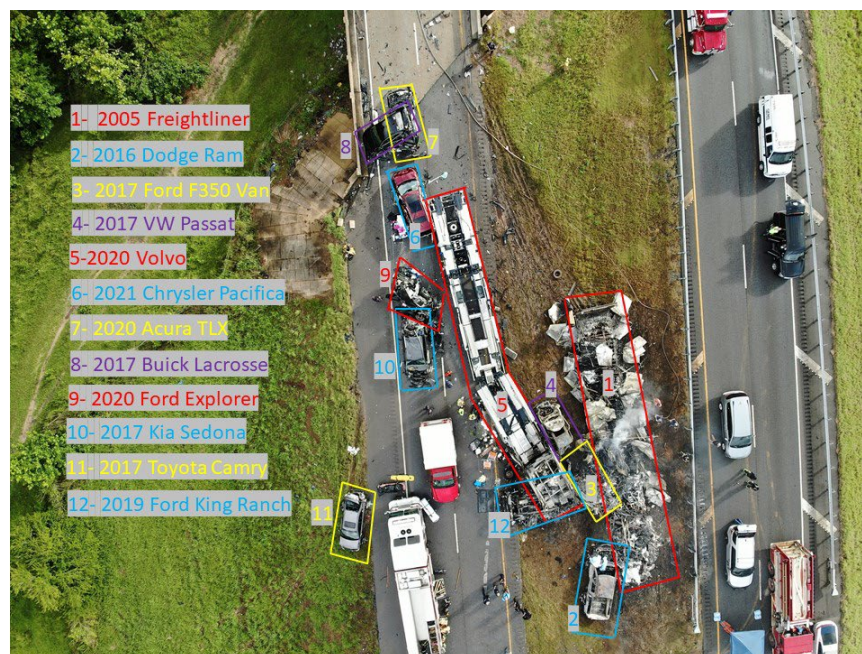
For a summary of the events with regards to the crash, refer to the Crash Summary Report. An aerial photograph of all involved vehicles in the final resting position is shown in Figure 1. The fire involved vehicles are labeled in the photograph as Vehicle 1, 2, 3, 4, 5 and 12.

Figure 1. Aerial view of final rest positions of involved vehicles.

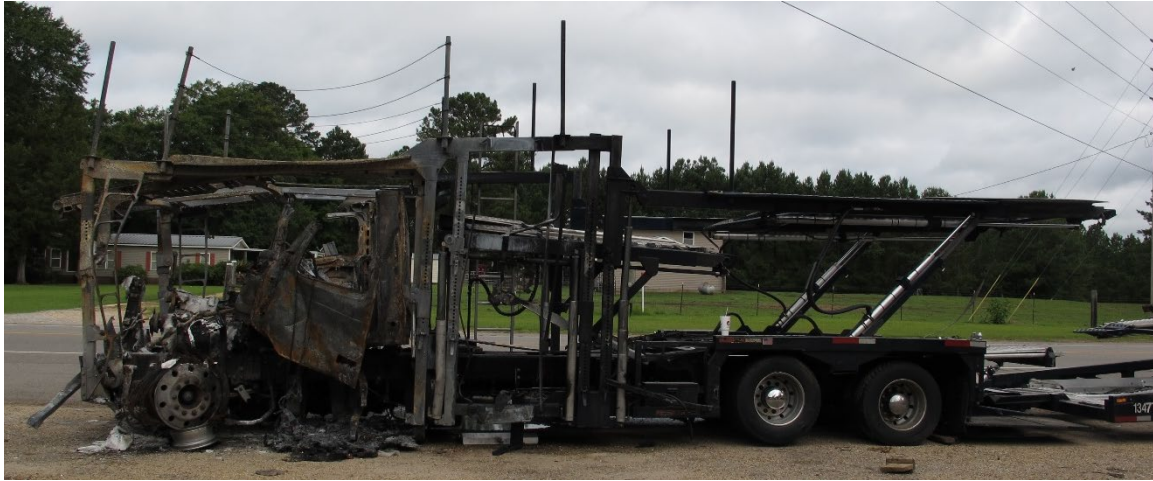
The tractor body sustained extensive impact and fire/heat related damage. The tractor body exhibited warpage and discoloration consistent with exposure to heat/fire and most polymeric and non-ferrous components were melted or missing. A section of the trailer was still attached to the tractor. The remaining section exhibited thermal related discoloration and warpage and was heavily sooted. A photograph of the tractor with the attached trailer section is shown in Figure 2. One aluminum fuel tank, located on the right side of the tractor, was intact as shown in Figure 3. The front of the tank was sooted and exhibited some thermal related discoloration. The forward wall of the tank had a small dent with a hole present. The fuel tank located on the left side of the vehicle was missing, presumed destroyed in the fire, with only the mounting straps still present. The section of trailer located behind the tractor had some thermal discoloration and sooting but was otherwise intact as shown in Figure 4.

Figure 2. 2020 Volvo VAH Truck-Tractor.

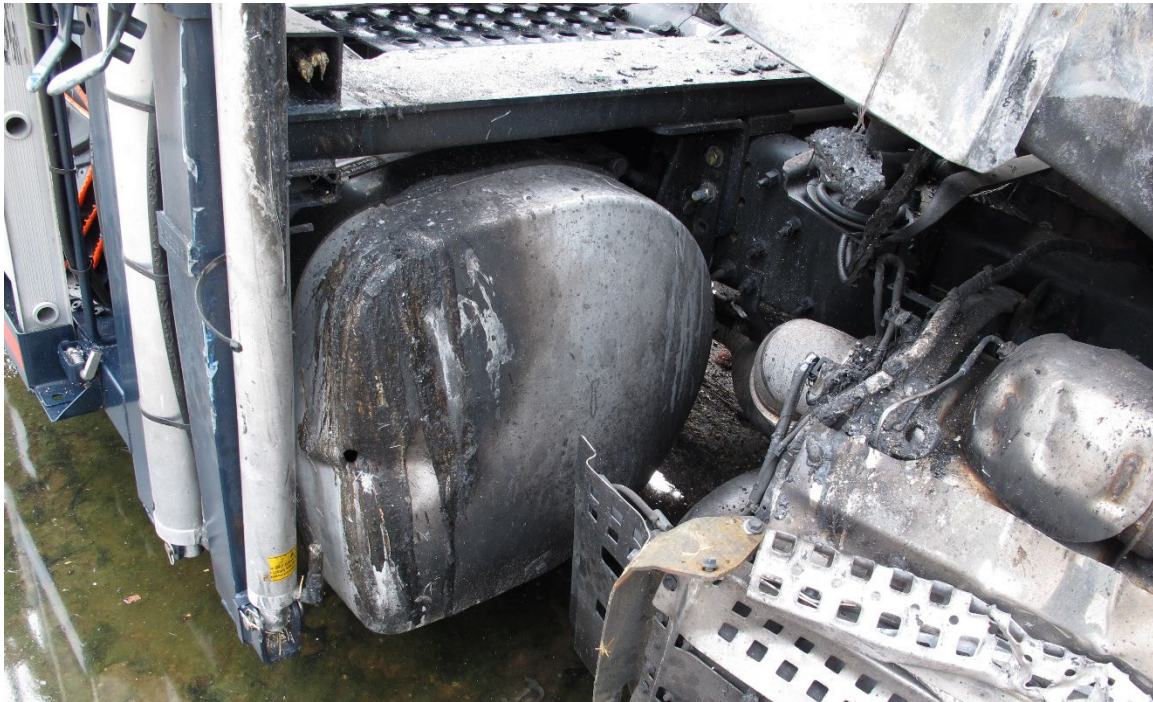
Figure 3. Intact Fuel Tank.

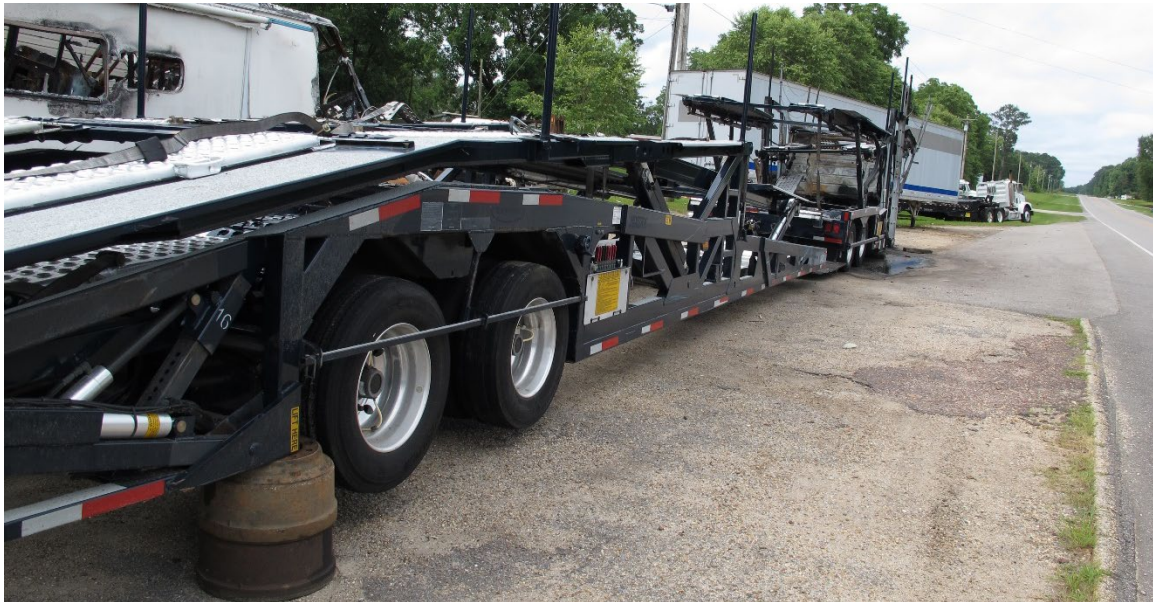
Figure 4. Car Trailer.

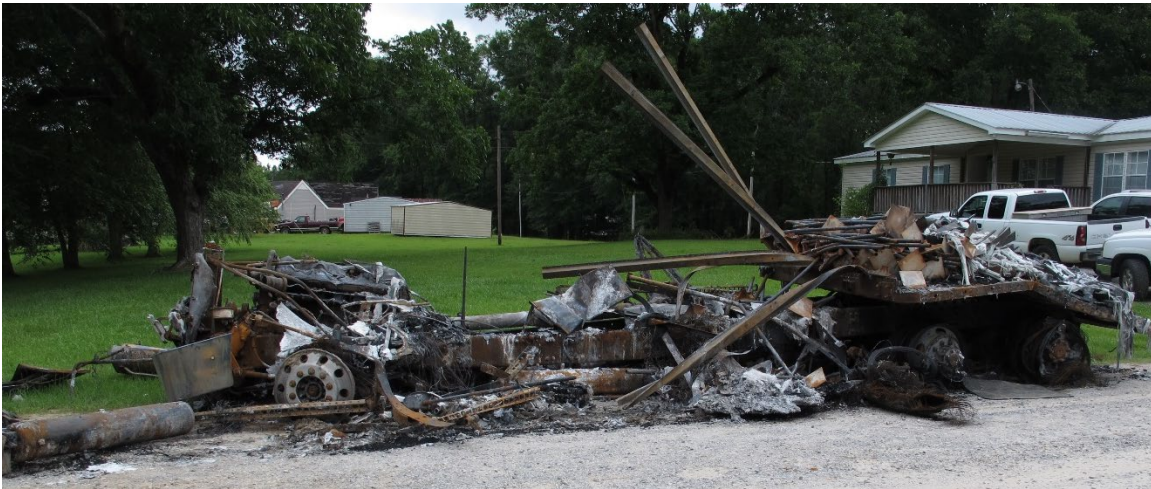
The tractor body sustained extensive fire/heat related damage. The tractor body and trailer were mostly consumed in the fire with only ferrous-based metallic components remaining. The tractor is shown in Figure 5 and the trailer in Figure 6.

Figure 5. Freightliner CST120 tractor.

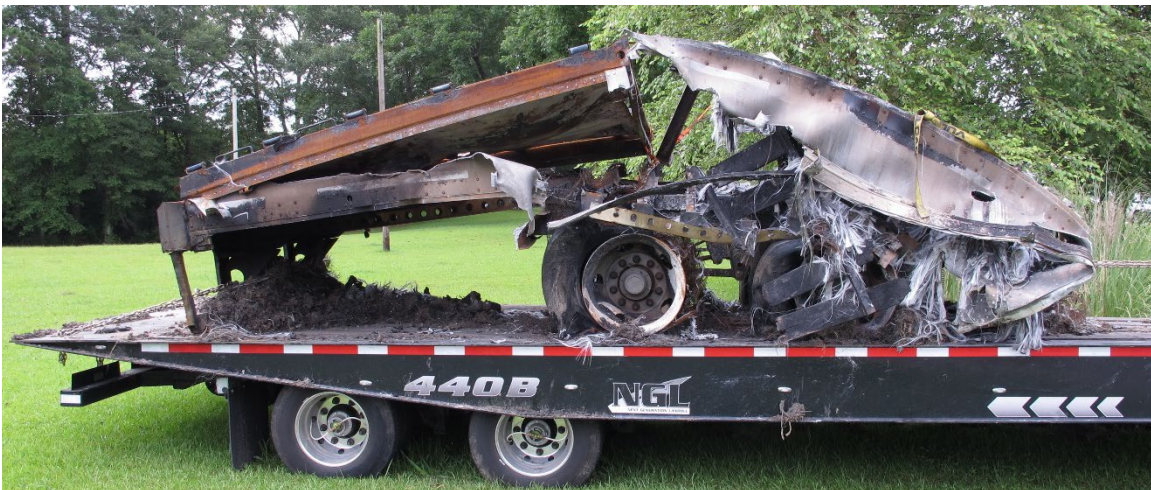
Figure 6. Wabash National Trailer.

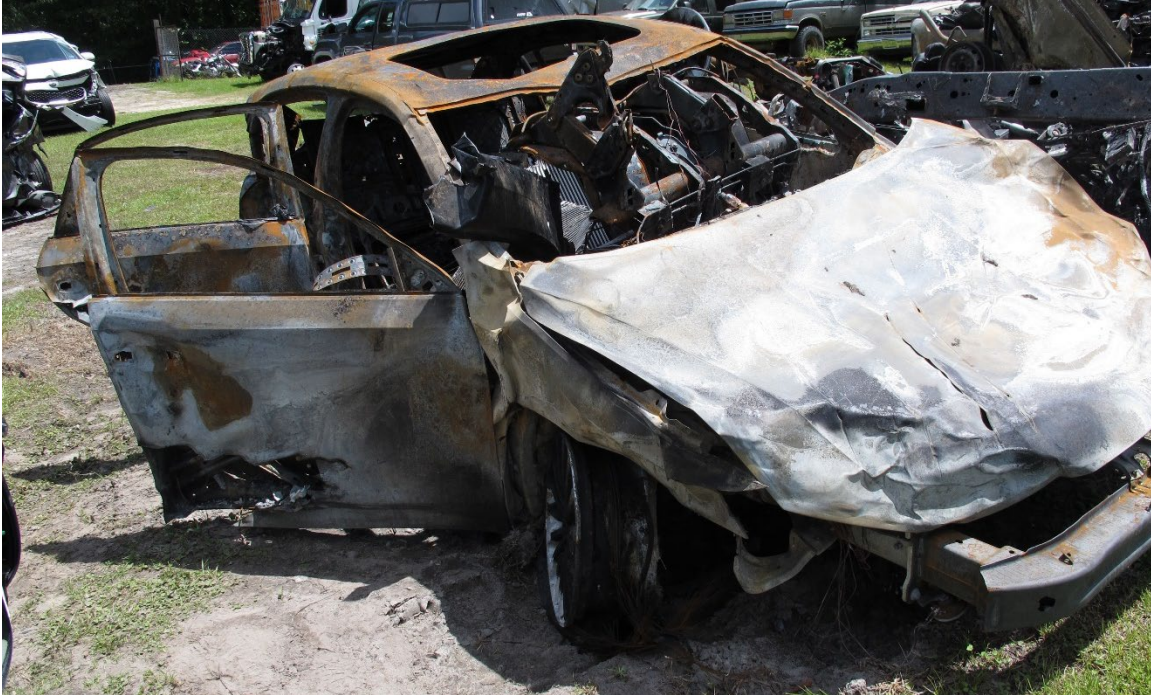
The passenger car sustained extensive impact and fire/heat related damage. The car body exhibited warpage and discoloration consistent with exposure to heat/fire and most polymeric and non-ferrous components were melted or missing. There were several dents and tears in the body consistent with impact. The interior exhibited similar fire related damage. The

fuel tank was missing and presumed destroyed in the fire. The passenger car is shown in figure 7.

Figure 7. 2017 VW Passat.

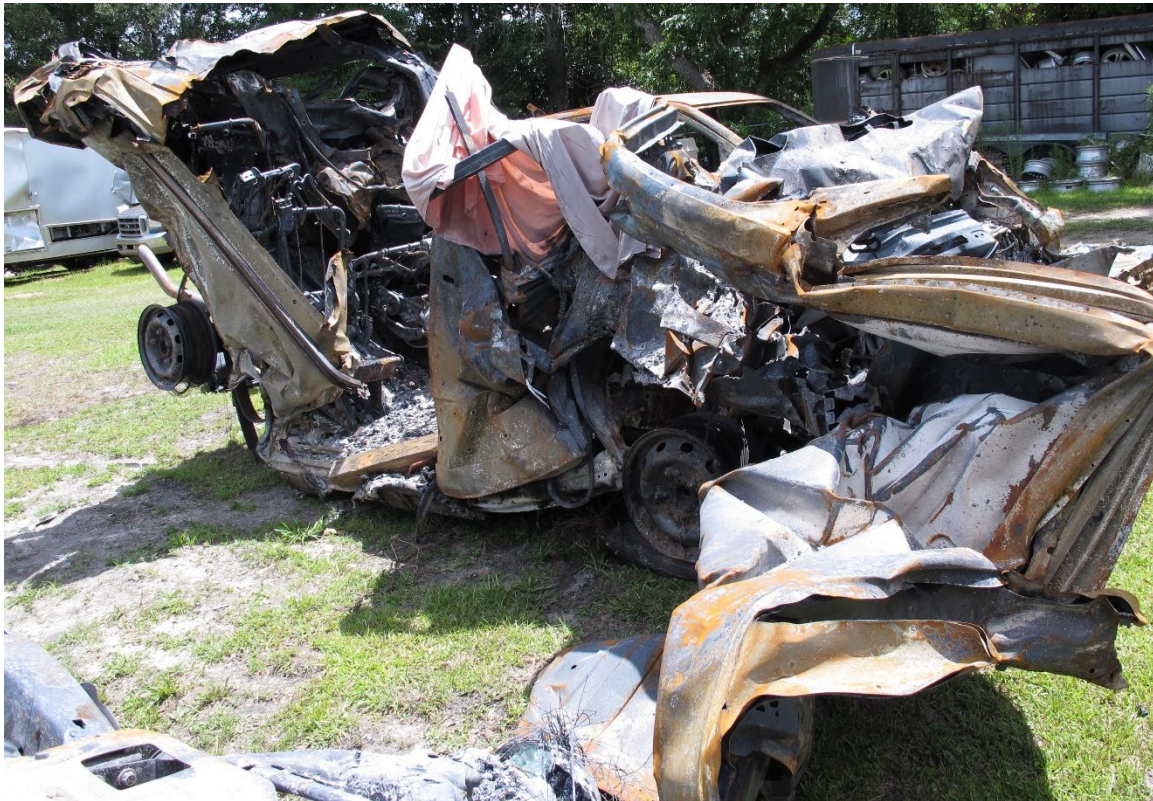
The van sustained extensive impact and fire/heat related damage. The body exhibited warpage and discoloration consistent with exposure to heat/fire and most polymeric and non-ferrous components were melted or missing. The rear portion of the van was significantly deformed upwards from its original position. There were two separations of the body panels at the floor level where the rear section was bent upwards. Sections of the drive shaft were visible through the floor of the passenger compartment. The roof was removed during the emergency response. The interior exhibited significant fire related damage. The fuel tank was missing and presumed destroyed in the fire. The van is shown in figure 8.

Figure 8. 2017 Ford Transit Passenger Van.

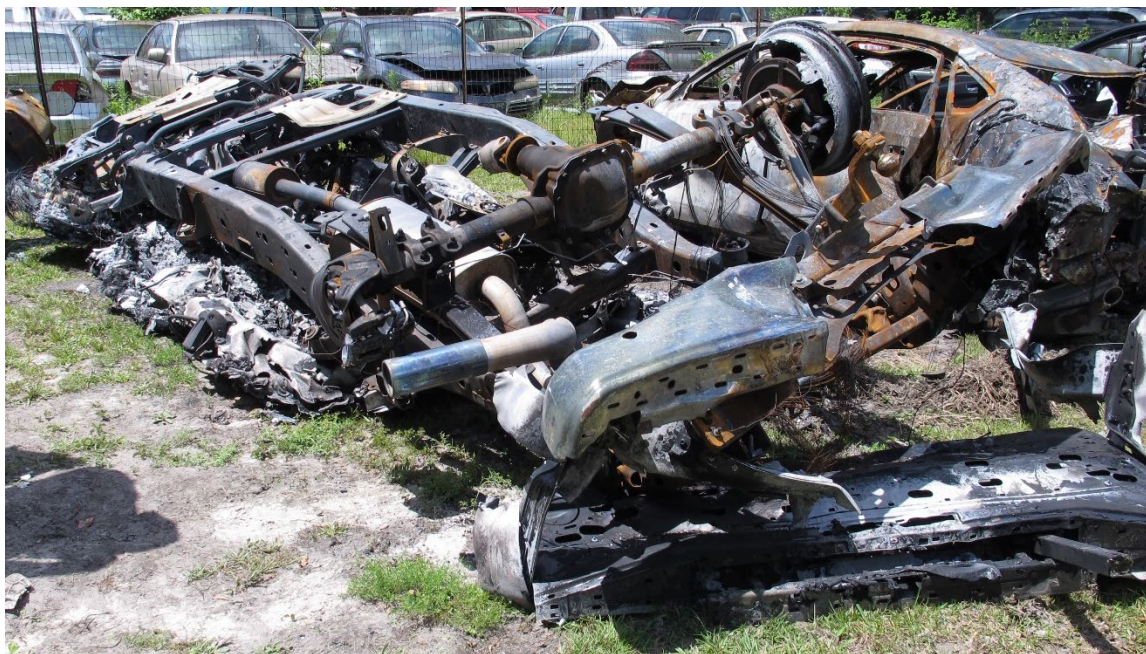
When examined, the truck was found in an inverted position. The remaining body of the cab and bed had collapsed. The truck sustained extensive fire/heat related damage. The body exhibited warpage and discoloration consistent with exposure to heat/fire and most polymeric and non-ferrous components were melted or missing. The interior exhibited similar fire related damage. The fuel tank was missing and presumed destroyed in the fire. The truck is shown in Figure 9.

Figure 9. Ford F150 King Ranch Pickup Truck.

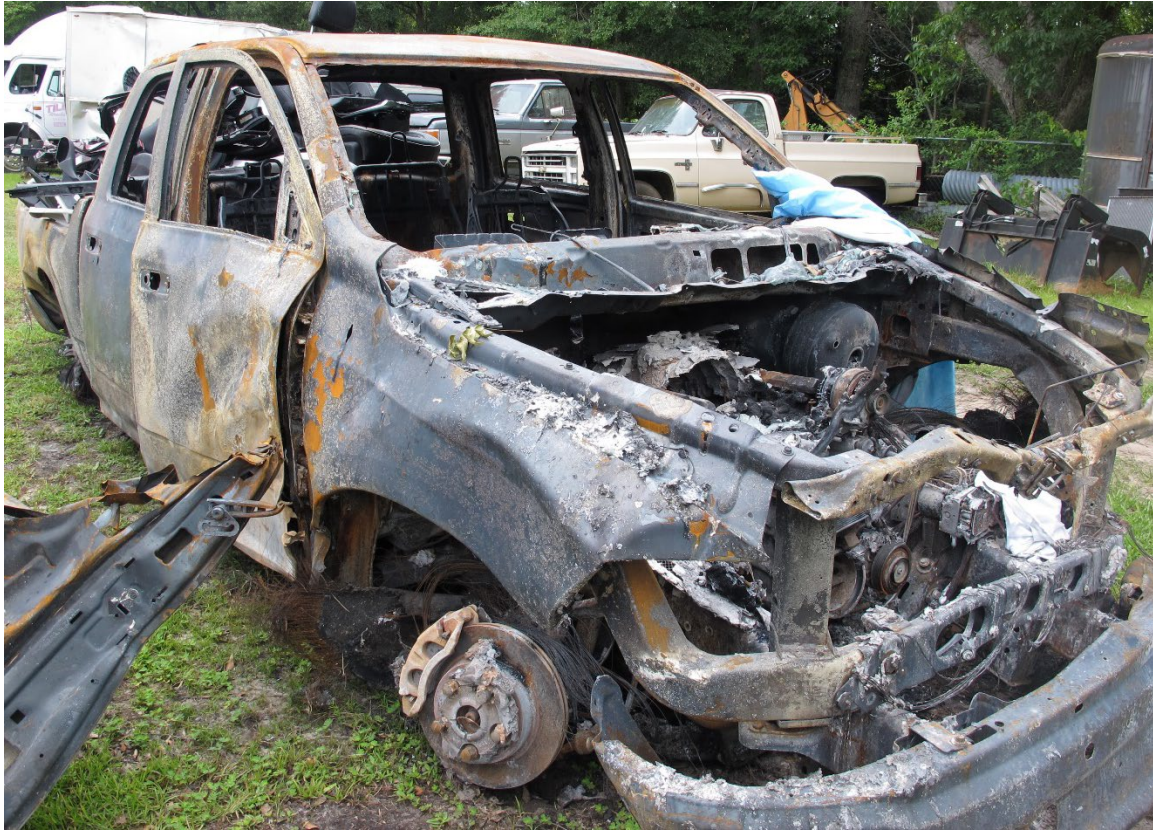
The pickup sustained impact and extensive fire/heat related damage. The body exhibited warpage and discoloration consistent with exposure to heat/fire and most polymeric and non-ferrous components were melted or missing. There were several dents and tears in the body consistent with impact. The interior exhibited similar fire related damage. The fuel tank was missing and presumed destroyed in the fire. The truck is shown in figure 10.

Figure 10. Ram 1500 Pickup Truck.
