**NATIONAL TRANSPORTATION SAFETY BOARD
OFFICE OF HIGHWAY SAFETY
WASHINGTON, D.C.**

**SURVIVAL FACTORS GROUP CHAIRMAN'S
FACTUAL REPORT**

NORTH LAS VEGAS, NEVADA – HWY22FH004

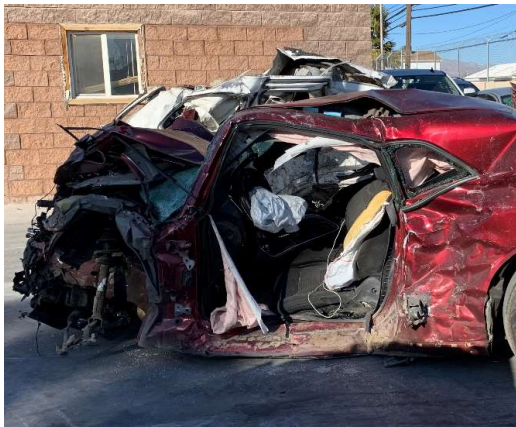
The 2018 Dodge Challenger had Vehicle Identification Number (VIN): 2C3CDZAG6JHXXXXXX.¹ The Dodge Challenger sustained severe impact to the front of the vehicle, with additional impact damage present on the left side and rear. Both left and right front doors were removed (by responders). The left window glass was shattered, while the right window glass was intact.

Figure 1. Driver's side of Dodge Challenger

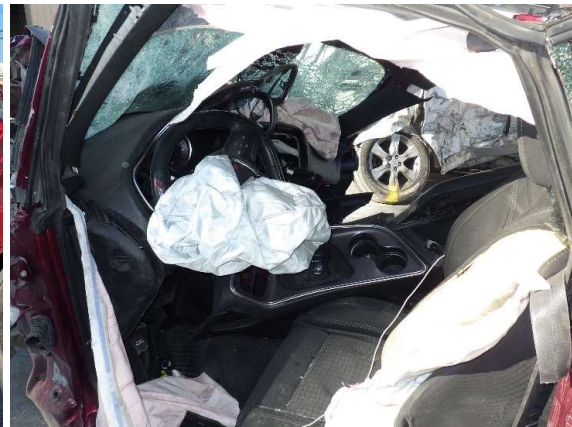
The steering wheel, side curtain, and side torso airbags deployed in the crash. No blood was found on the airbags. The steering column was displaced left and forward, with the steering rim also deformed inwards towards the hub. The bottom of the steering rim was fractured. The seatbelt was cut (by responders) and the connector was in the buckle at the time of inspection. The floor and footwell were deformed upward and were in contact with the bottom of the seat pan. The seat pan was deformed by the rocker panel and the seat back was twisted slightly inboard. There was blood present on the front upper quadrant of the driver's door. The center console was displaced leftward due to removal of the vehicle's Event Data Recorder (EDR).

Figure 2. Driver's side occupant compartment

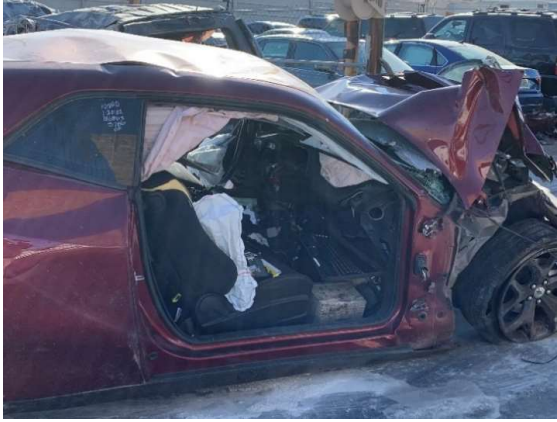
Figure 3. Passenger's side of Dodge Challenger

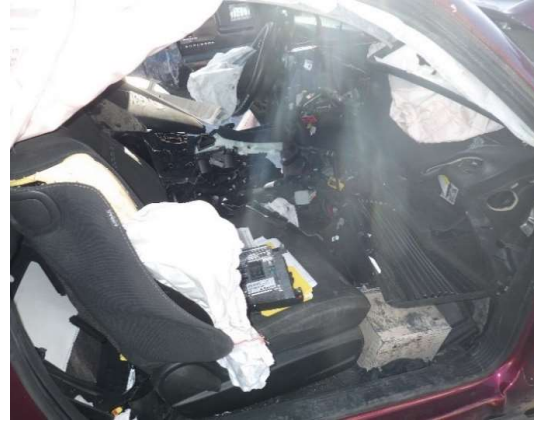
The frontal, side curtain and side torso airbags deployed in the crash. No blood was found on the airbags. The seatbelt was unbuckled and found in the stowed position. The belt was locked. There were no significant intrusions in the passenger occupant space and the seat appeared undamaged.

Figure 4. Passenger's side occupant compartment

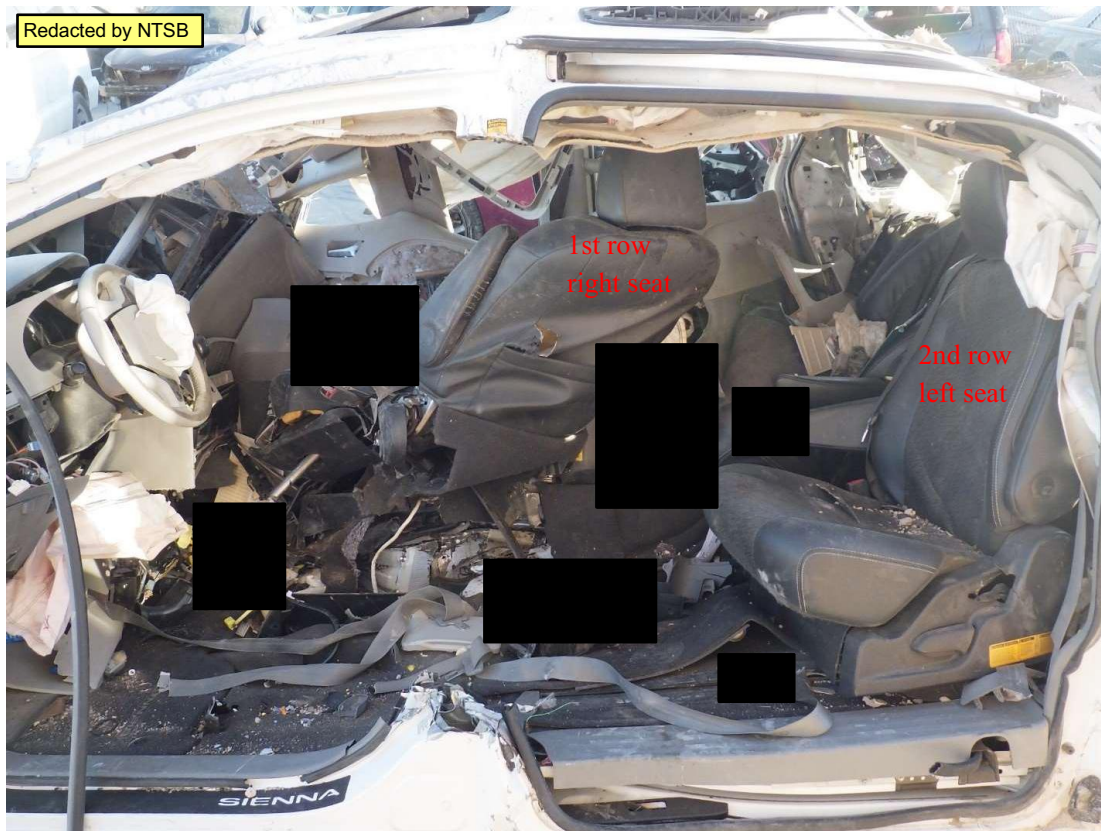
The 2013 Toyota Sienna had VIN: 5TDXK3DC4DSXXXXX. The Sienna sustained a severe right side impact resulting in complete loss of occupant survival space for the right front passenger. There was also significant vertical crush, in the area of the third row, from the rollover.

The steering wheel, knee bolster and side curtain airbags deployed in the crash. The driver's seat was removed from the vehicle at time of inspection. The belt was cut (by responders) and the plastic push button on the buckle was broken.

Figure 5. Occupant compartment for first and second row of Sienna.

The front, knee bolster, side curtain and side torso airbags deployed in the crash. Blood was present on the side airbag. The seatbelt was cut (by responders) and the connector was still engaged in the buckle. The plastic push button on the buckle was broken and the buckle was not functional. The right front seat was significantly displaced to the left and twisted clockwise. The passenger occupant space was completely lost due to severe intrusion.

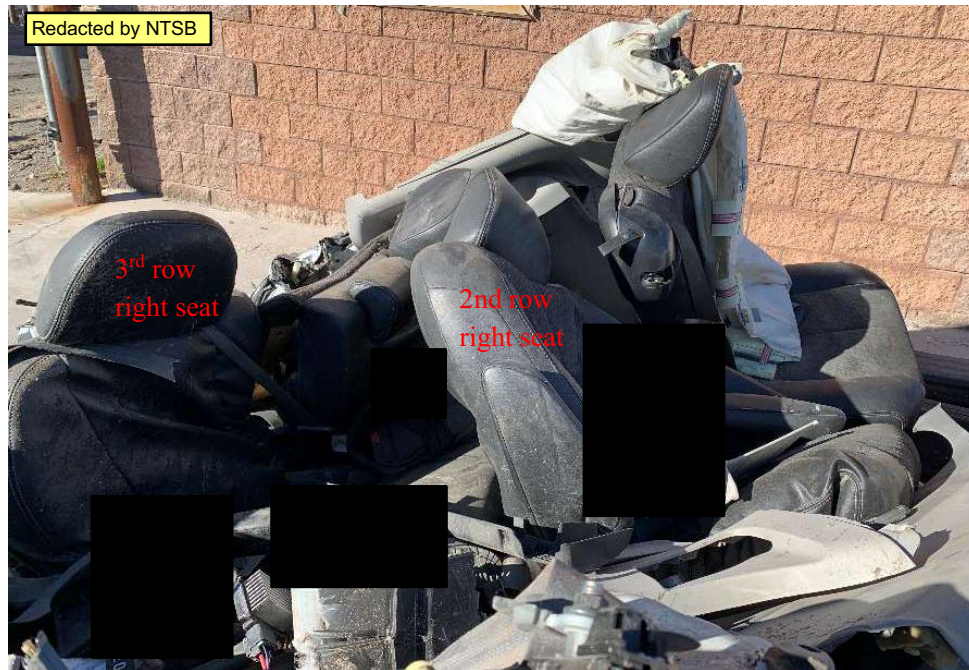
Inspection of the third-row seating area was initially obscured due to severe vertical roof deformation. It was observed that all three seatbelts were unbuckled at the time of inspection. The left seatbelt was entrapped in the wreckage.

At the request of the NTSB investigators, the North Las Vegas Fire Department removed the roof of the vehicle. The third-row seats had significant loss of occupant space due to severe intrusion from the rear, pushing the left and middle third-row seats forward and to the right. The row 3 seat pan was also displaced upwards.

Figure 6. Third-row occupant compartment in Sienna, viewed after removal of the vehicle roof.
