National Transportation Safety Board

HWY23FH013

HIGHWAY FACTORS-TECHNICAL RECONSTRUCTION

Group Chair's Factual Report

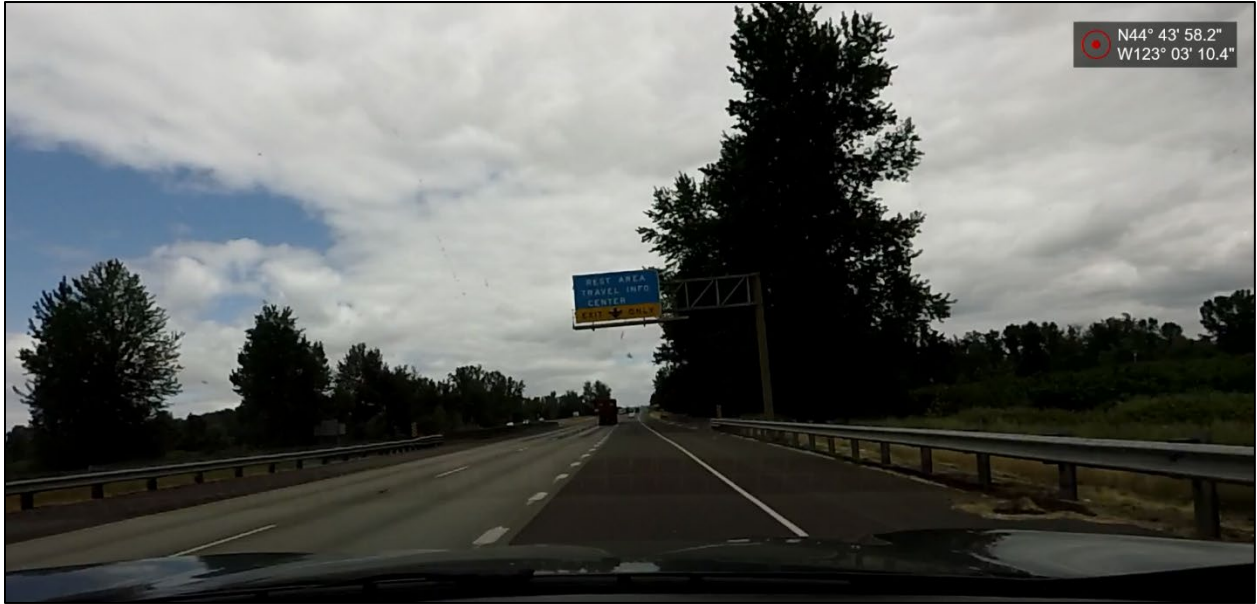
Two overhead cantilever supported signs designate the far-right lane as an exit only lane for the rest area. The blue informational service signs state “rest area travel info center” also display a yellow “exit only” panel. The first sign is located about 1,980 feet south of pavement striping gore area where the exit ramp diverges from the highway mainline and the second about 170 feet past the gore. **Figures 3** and **4** depict the rest area exit-only signage observed during the site examination.

Figure 3: Cantilever supported informational service sign stating "rest area travel info center" with a yellow "exit only" panel located about 1980 feet south of the ramp gore.

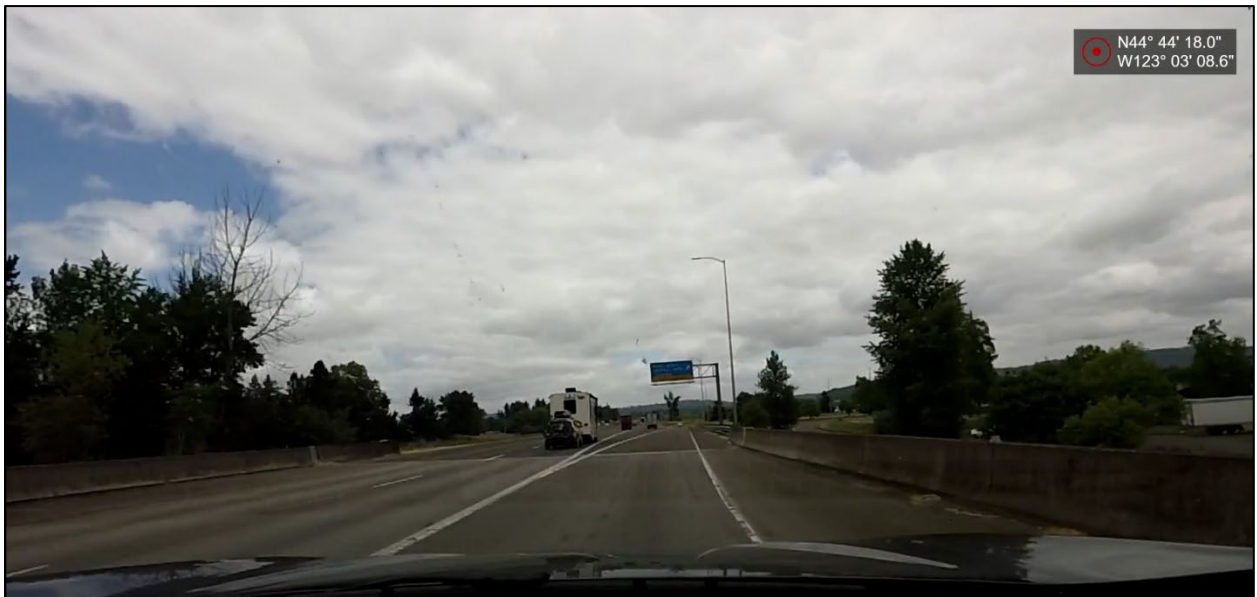
Figure 4: Cantilever supported informational service sign stating "rest area travel info center" with a yellow "exit only" panel located about 170 feet past the ramp gore.

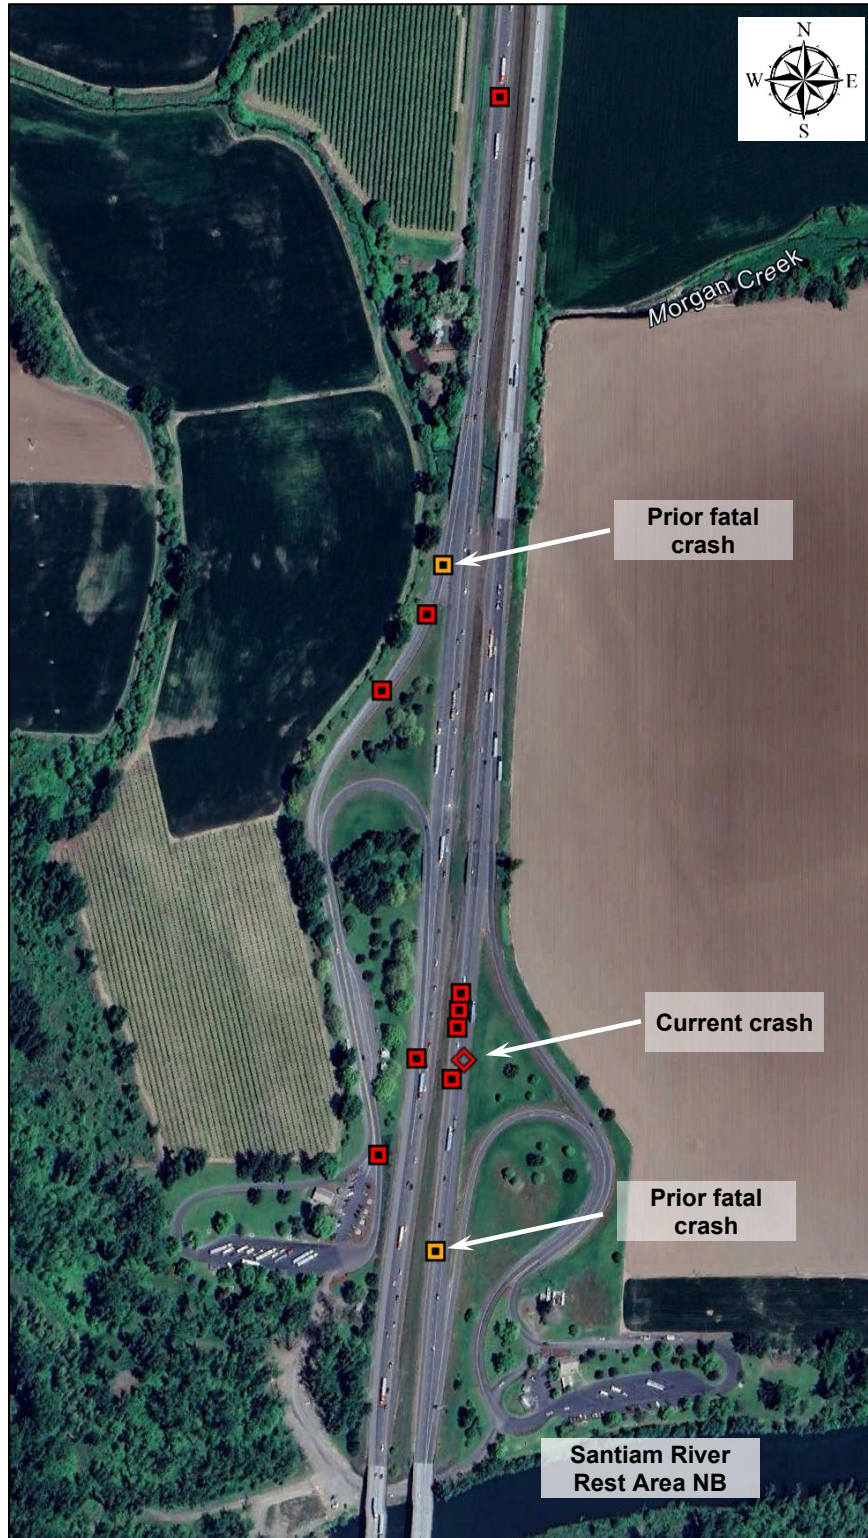
The five-year crash data revealed 11 occurrences classified as involving a parked combination vehicle. The two fatal crashes that occurred in 2017 involved fatal injury to the striking passenger vehicle drivers. For the other crashes, two crashes involved minor injuries, four crashes involved possible injury and three crashes reported no injuries. For each crash, the striking vehicle driver was identified as “at-fault”. Of the eleven crashes only one occurred during wet weather and all but three occurred during hours of darkness.

Crash reports for six of the 11 crashes were available for additional review. One crash involved a combination vehicle striking another combination vehicle, otherwise the crashes involved passenger type vehicles striking the stopped combination vehicle. Causation factors included - a passenger vehicle losing control while traveling at high speed, a passenger vehicle driver suffering a medical condition, a passenger vehicle driver falling asleep, a hit and run collision and one collision where an errant tire bounced off a parked combination vehicle and struck the passenger vehicle. Three previous crashes involving a parked combination vehicle appeared in proximity to the

Figure 5: Google Earth image modified to depict approximate locations of the previous parked combination vehicle crashes as referenced by reported geographic position data. (Note that positions are approximate and imprecise to identify details such as lane position.)

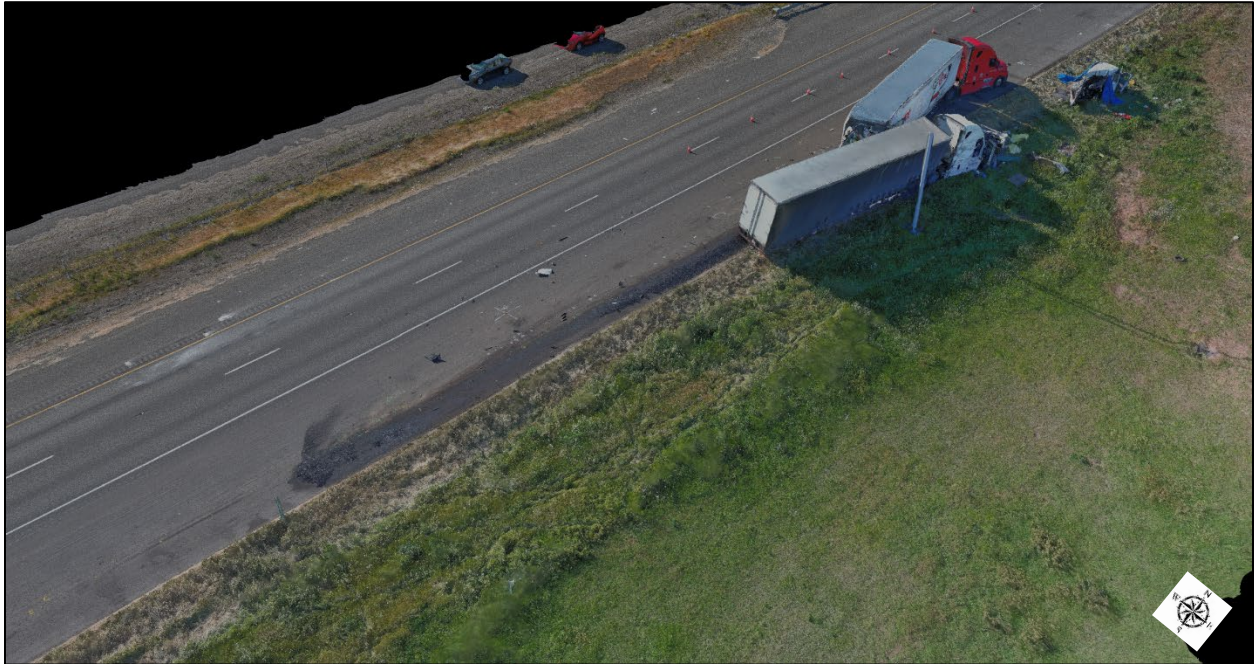
Figure 6: Screen capture of 3D point cloud created from the OSP sUAS aerial photographs depicting vehicle positions of rest following the collision.

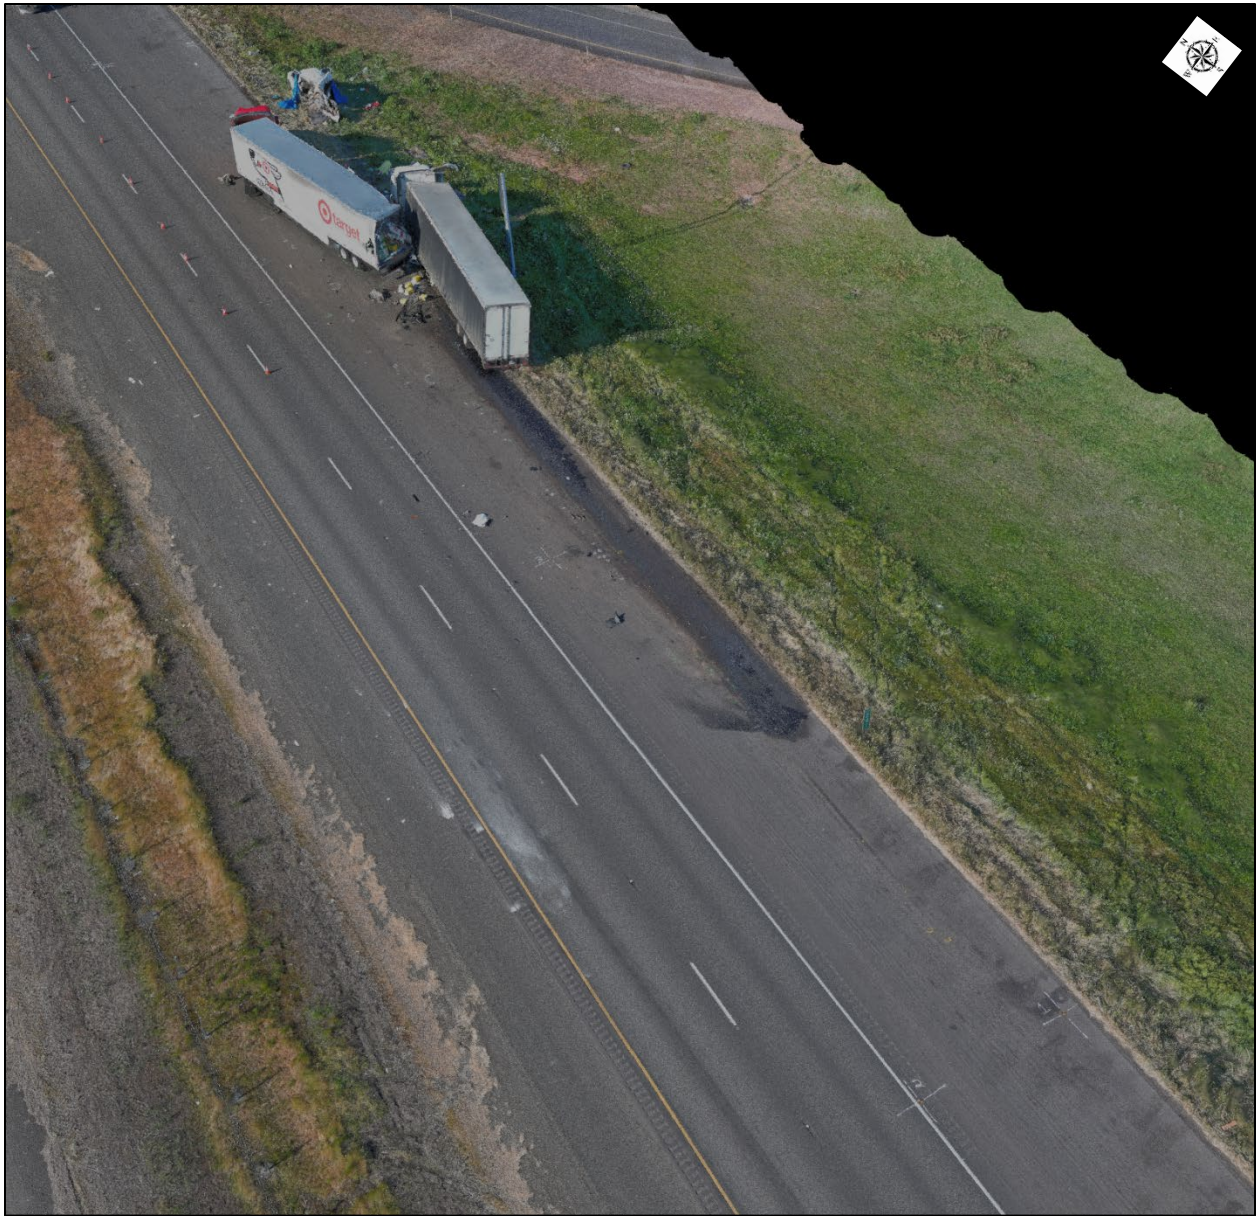
Figure 7: Screen capture of 3D point cloud created from the OSP sUAS aerial photographs depicting vehicle positions of rest following the collision.

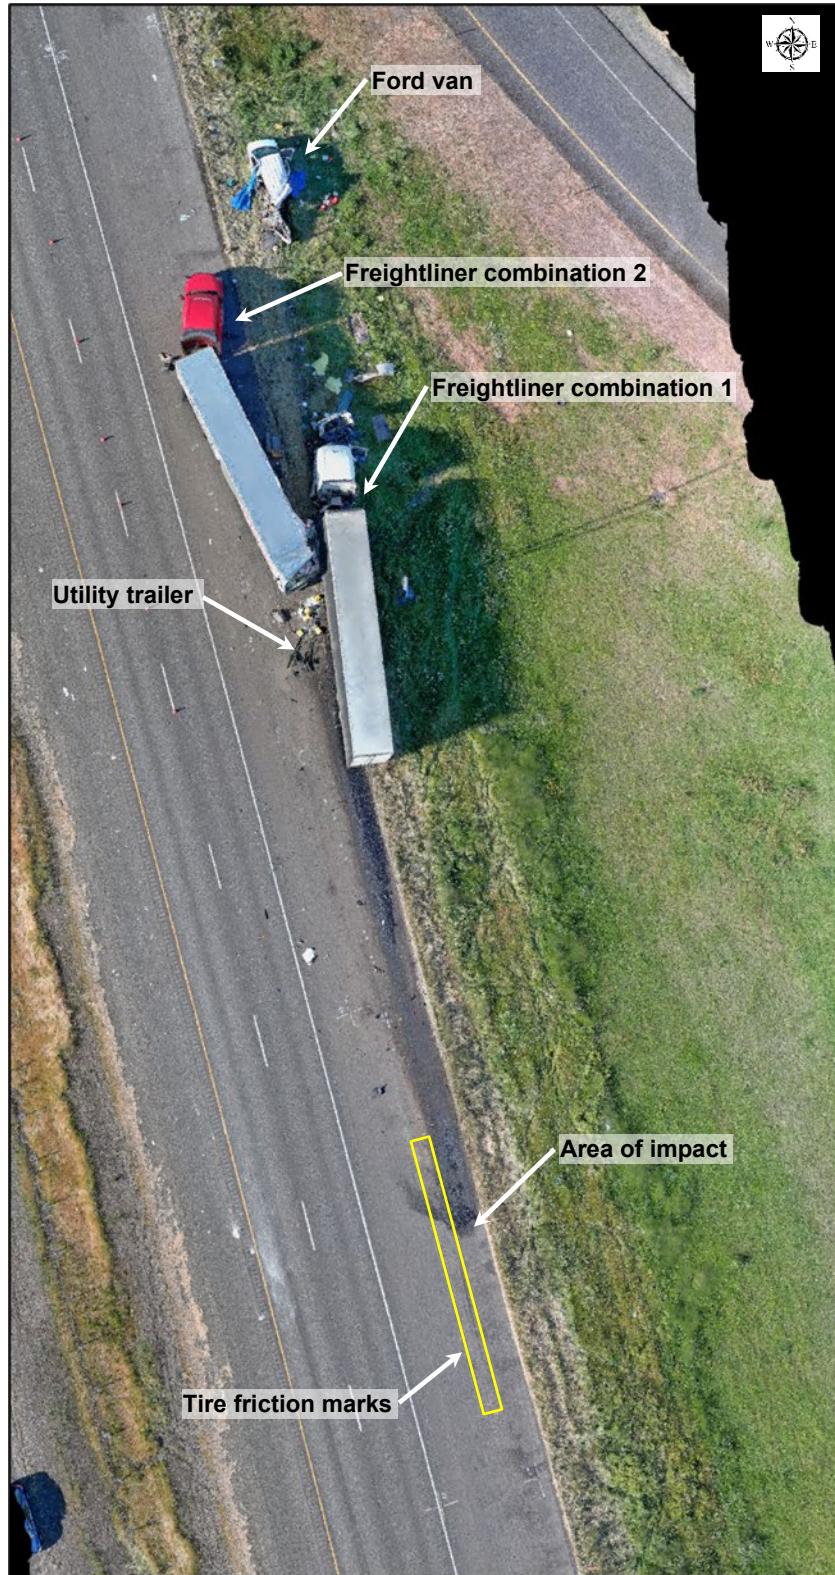
At final rest, the Ford van was oriented northward parallel to the roadway and about 16 feet off the pavement on the right roadside. The van was positioned about 241 feet north of the onset of the fluid debris or the approximate area of impact. Remnants of the light duty utility trailer, primarily the perimeter frame and axle, that had been coupled to the Ford were located on the shoulder about 127 feet north of the area of impact and 15 feet behind the second Freightliner combination.

Freightliner combination 1 was also facing northward but was angled at about eight degrees toward the roadside and was mostly off the pavement. The truck tractor was completely off the pavement onto the roadside while the driver-side wheels of the semitrailer remained on the pavement. The front of the truck tractor was about 175 feet north of the area of impact.

Freightliner 2 remained on the shoulder and was basically oriented northward. The truck tractor and semitrailer were skewed with the semitrailer angled slightly toward the travel lanes while the truck tractor was angled toward the roadside. The front of the combination vehicle was positioned about 214 feet north of the approximate area of impact.

Figure 8: Orthomosaic image of post-collision vehicle orientation and positions of rest created from the Pix4DMapper photogrammetry project using OSP sUAS photographs.

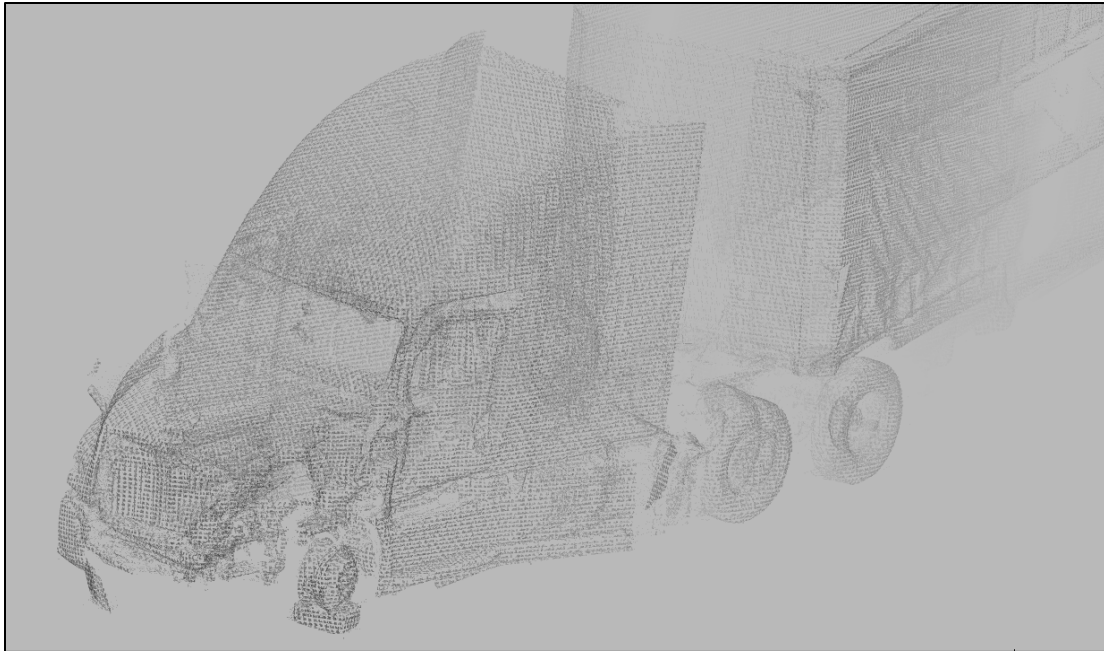
The striking unit was identified as a 2018 Freightliner Cascadia truck tractor coupled with a 53-foot Utility curtainside semitrailer.^{19,20} The truck tractor exhibited contact damage at the front of the Truck tractor that encompassed about two-thirds of the vehicle width extending inboard about 74-76 inches from the driver's side edge. Contact damage extended along the driver's side of the truck tractor encompassing the hood, front fender and wheel and trailing aft ward to include damage and displacement of the driver's door. Contact damage extended vertically at the A-pillar and leading edge of the driver's door to a height of about 7.5 feet. Rearward of the sleeper, contact damage was observed to the outer driver's side drive wheels. The trailing drive axle (axle 3) was displaced due to broken suspension components. Apparent biological material was observed along the entire length of the truck tractor driver's side with heavier deposits rearward of the cab door. The engine oil pan was fractured and the lower half missing.

The semitrailer exhibited contact damage at the driver's side front corner. Evidence of contact extended the full vertical height of the semitrailer. An apparent fragment from the Freightliner 2 semitrailer was embedded in the upper corner structure. Some minor damage was observed to lower portions of the curtain sidewall along the driver's side between the front corner and the landing gear. Apparent biological material was spread along the driver's side of head wall. **Figure 9** depicts a screen capture image of the truck tractor 3D point cloud rendered from scanning of the Freightliner combination.

Figure 9: Screen capture image of the Freightliner combination 3D point cloud created from 3D scanning. (Rendered in greyscale to obscure visible biological material on the vehicle.)

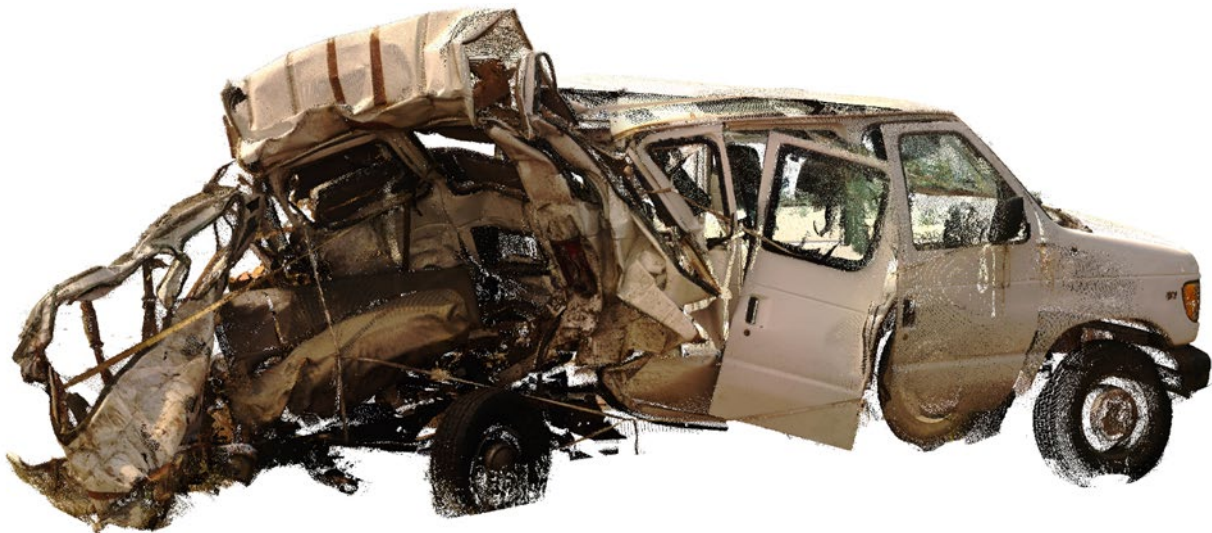
The Ford exhibited catastrophic impact damage at the rear and driver-side of the vehicle. Impact at the rear of the van exhibited a slight offset toward the passenger side and resulted in at least 81 inches of forward intrusion that extended to about the C-pillar. Damage extended vertically to approximately 7.5 feet, which was consistent with the vertical damage height to the Freightliner 1 truck tractor. Damage at the rear exhibited an override of the vehicle frame. The driver's side of the Ford displayed substantial damage characteristic of a sideswipe contact that resulted in the sidewall separating from the vehicle and being folded rearward exposing the vehicle interior. Contact at the driver's side originated around the B-pillar. The front and passenger side of the vehicle exhibited no evidence of contact damage.

Figure 10: Screen capture image of the Ford van 3D point cloud created from 3D scanning.

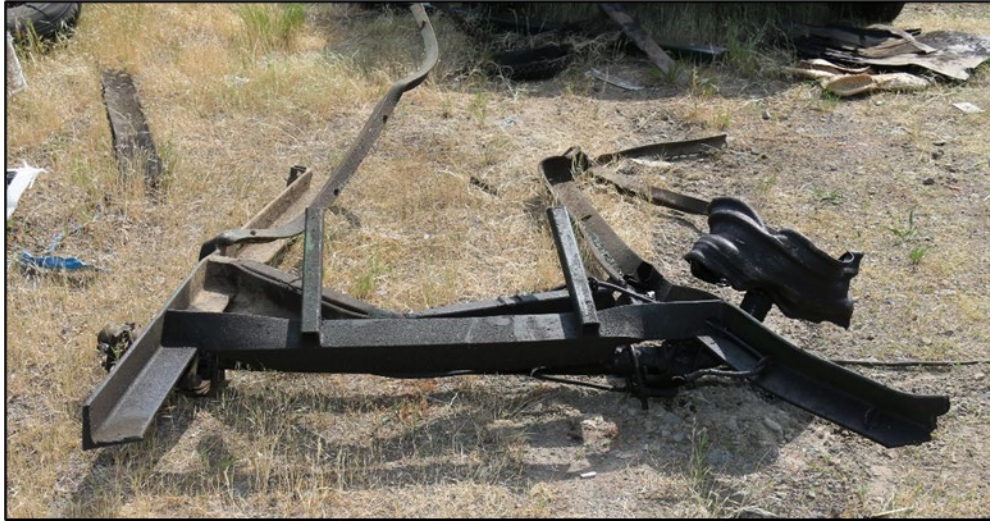
The utility trailer was destroyed in the collision. The two primary longitudinal frame rails remained attached to the axle but exhibited substantial deformation. Other components of the trailer were displaced, deformed or otherwise unrecovered. The remnants exhibited evidence of having been overridden. Neither the trailer make, model nor the original dimensions could be discerned from the debris. Similar single-axle utility trailers tend to have nominal dimensions of 136 inches in length, 68.5 inches in width and a deck height of 25 inches.

Figure 11: Photograph depicting the remnants of the utility trailer towed by the Ford van.
