National Transportation Safety Board

HWY23FH013

SURVIVAL FACTORS AND HUMAN PERFORMANCE

Group Chair's Factual Report

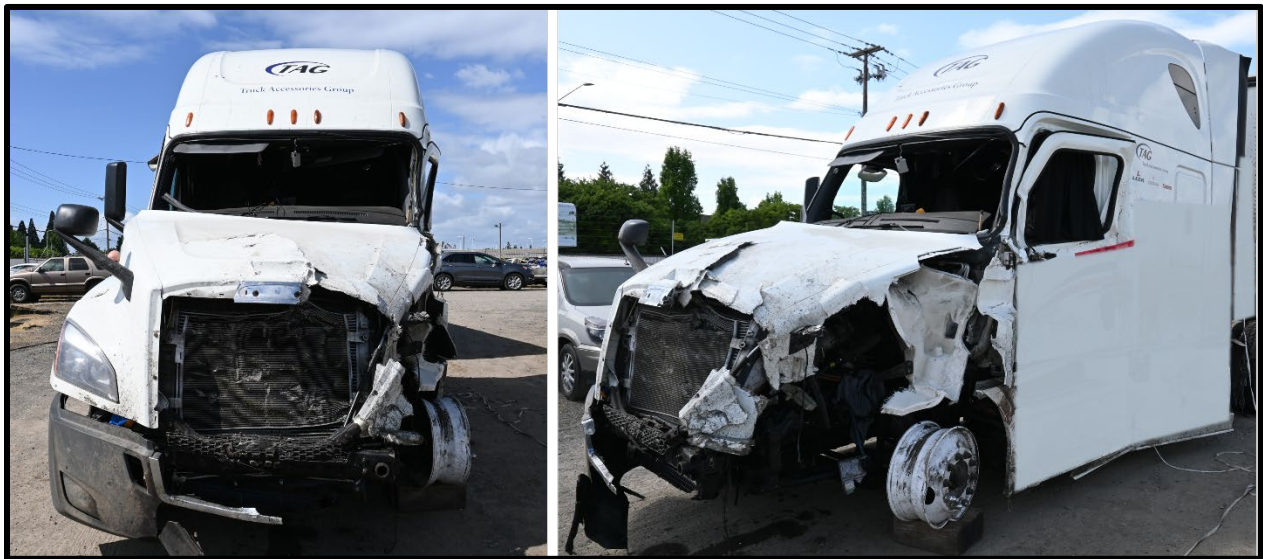
The 2018 Freightliner Cascadia Truck (2018 truck) and trailer were inspected on May 22, 2023, at Wiltse's Towing on 3118 Cherry Ave NE, Salem, OR. An interior inspection was limited to a visual inspection from outside the vehicle due to concerns with the DA's office. Photographs of the 2018 truck are shown in Figure 1 (the lower part of the left side of the cab and the lower part of the left door have been redacted). Damage to the truck was primarily to the front, left front engine compartment, axle-1-left tire and wheel assembly, and driver's side door.

Figure 1: 2018 truck exterior.

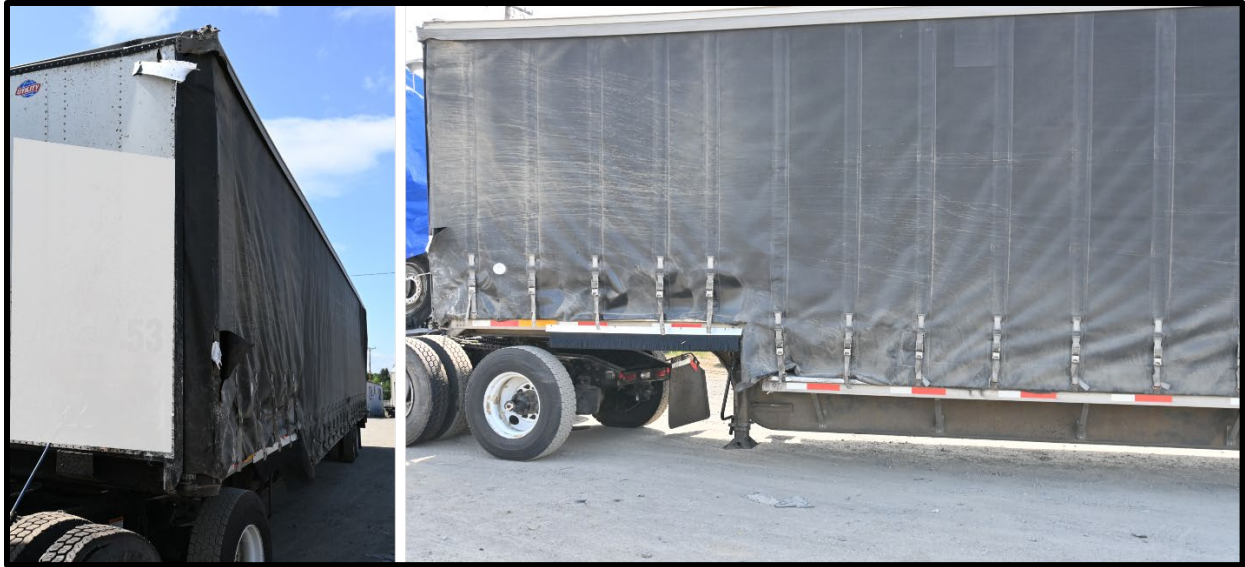
The 2014 Utility Softside Dry Van Trailer had minor damage to the front left side of the trailer (Figure 2). The lower two-thirds of the front surface of the trailer is redacted in the photograph. Please refer to the *Technical Reconstruction Factual Report* in the docket for this investigation for information on the exterior damage.

Figure 2: 2014 trailer.

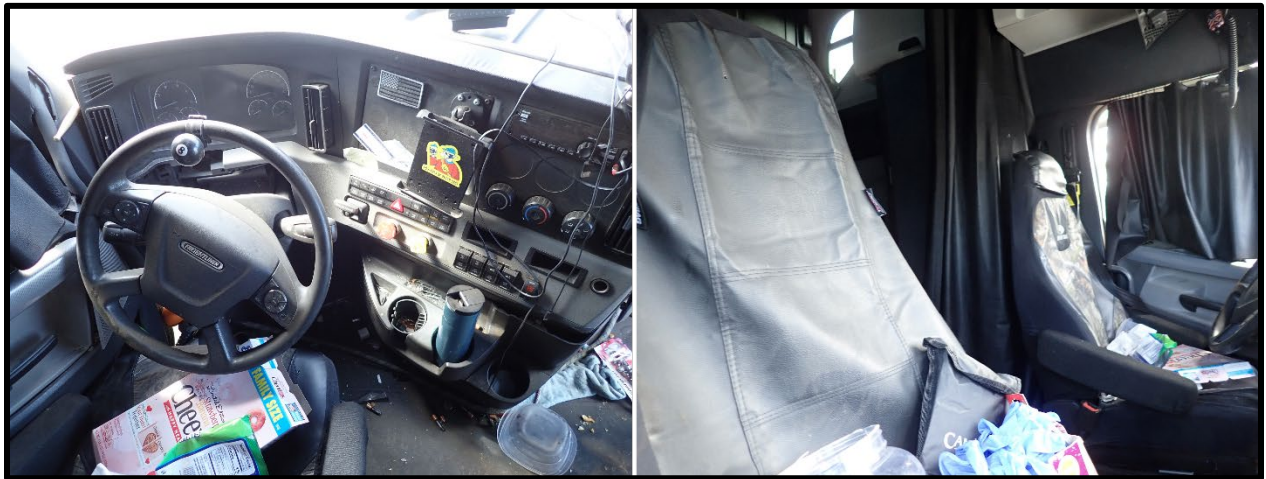
An internal inspection of the 2018 truck was conducted on June 2, 2023, by OSP and observed by the NTSB. An inspection of the driver's seatbelt indicated no signs of loading. Items associated with drug use were recovered inside the vehicle and documented by OSP. The electronic control modules (ECM) were removed and secured by OSP for download. Photos of the 2018 truck's interior are shown in Figure 3.

Figure 3: 2018 truck interior.

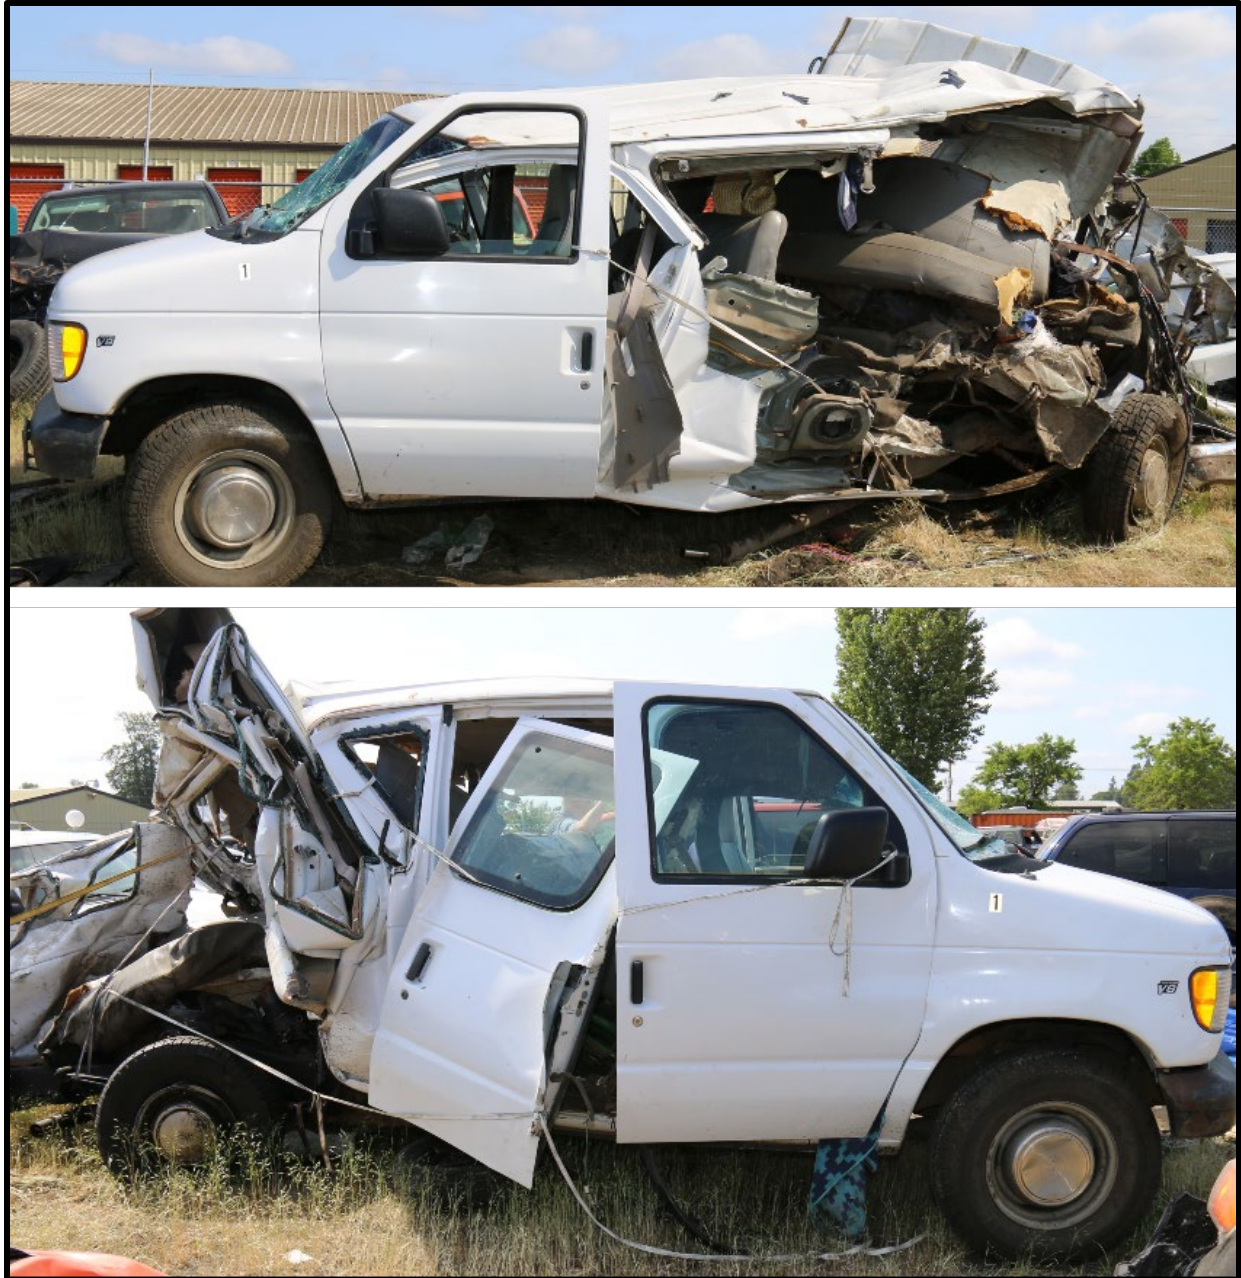
Inspection photographs of the van are shown in Figure 4. There was extensive damage to the vehicle. The rear floor pan and body were separated from the chassis. There was significant vehicle deformation between the outer surface of the vehicle body at the bottom of the right rear door and the back surface of the chassis. The body of the van was crushed to approximately the mid-point of the rear side door on the right side of the vehicle. The pillar supporting the door was buckled towards the front of the vehicle. The rear axle was separated and displaced from the vehicle frame. Severe buckling of the roof and separation from the roof rails were observed near the back of the vehicle. The damaged section of the roof extended well above its original plane. The exterior body on the left side of the van was torn from the roof rails and lower frame and peeled rearward from the B-pillar to the left rear pillar. This created a large ejection port for the rear passengers. The left A-pillar was bent downwards, starting just above the bottom of the windshield. The left B-pillar buckled rearward at the mid-point of the pillar. A partial tear was at the top of the left B-pillar at the roof rail. The left front corner of the roof was intact with the roof rail and was depressed downward with the top of the A- and B-pillars. Please refer to the *Technical Reconstruction Factual Report* in the docket for this investigation for information on the exterior damage.

Figure 4: Van exterior photos

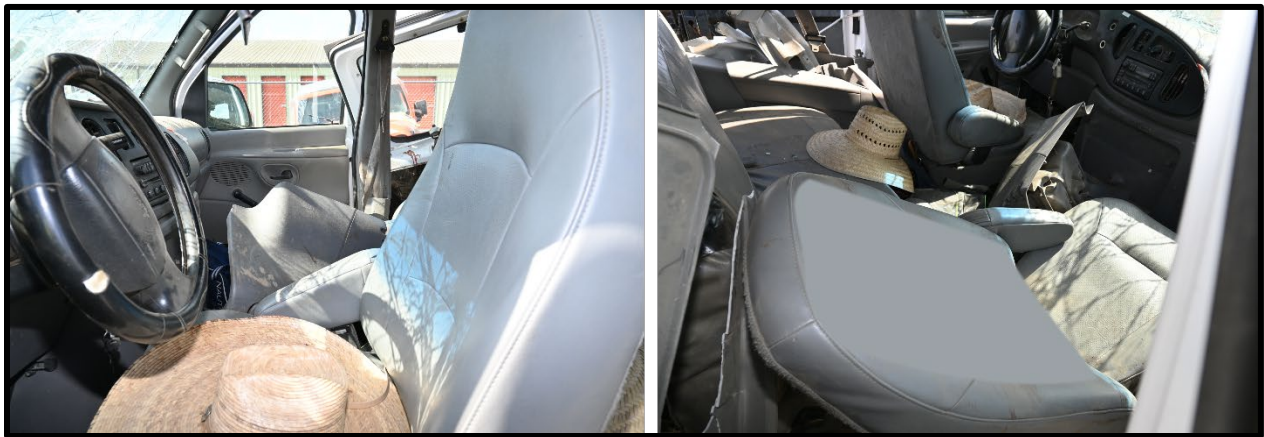
was just above the top of the Row 1 seat back. Additionally, the left half of the Row 4 bench was angled backward about its vertical axis and conformed with the intruded rear surface of the van. The left outboard surface of the seat cushion was torn off and missing. Rows 3 and 4 were missing and found outside the van post-crash. The Row 1 bench seat appeared connected to the vehicle's floor pan. However, the mounts could not be inspected due to limitations from the DA. The Row 1 seat was intact, with slight forward displacement of the right side of the seat. The Row 1 seat belt tongue and latch plates were not on the seat pan but on the vehicle's floor. The right front passenger bucket seat was reclined at least 45 degrees and nearly in contact with the seat back of the Row 1 seat. Pictures from the vehicle interior are shown in Figure 5 and Figure 6 (images were redacted).

Figure 5: Van front seats (driver left, passenger right).

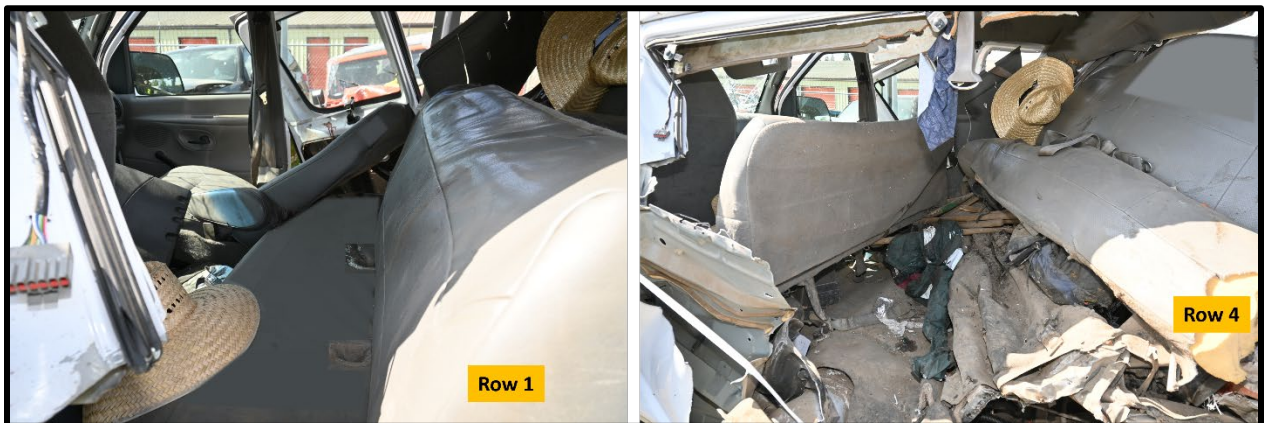
The van had front bucket seats with integral head restraints and four rows of bench seats.⁴ The vehicle was equipped with lap/shoulder belts at all the outboard seating positions and lap belts for the inboard seat positions. The van's rear occupant compartment had little survivable space rearward of Row 1. The area between Row 1 and Row 4 nearly collapsed on the right side of the vehicle. The vehicle's floor was crumpled and elevated in the back such that the seating surface of the Row 4 bench

Figure 6: Van Row 1 (left) and Row 4 (right) bench seats.

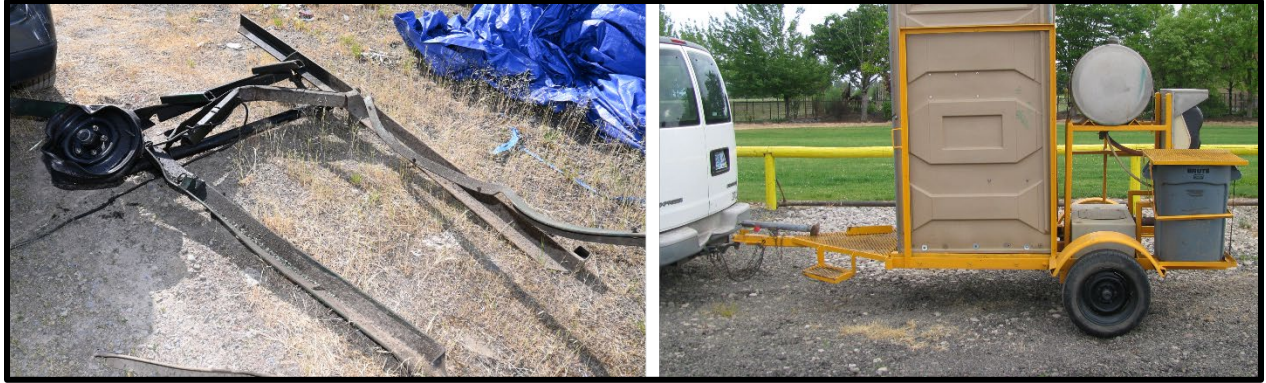
The utility trailer was destroyed in the crash. Photos of the remaining trailer frame and exemplar are given in Figure 7.

Figure 7: Van utility trailer (post-crash left and exemplar on right)

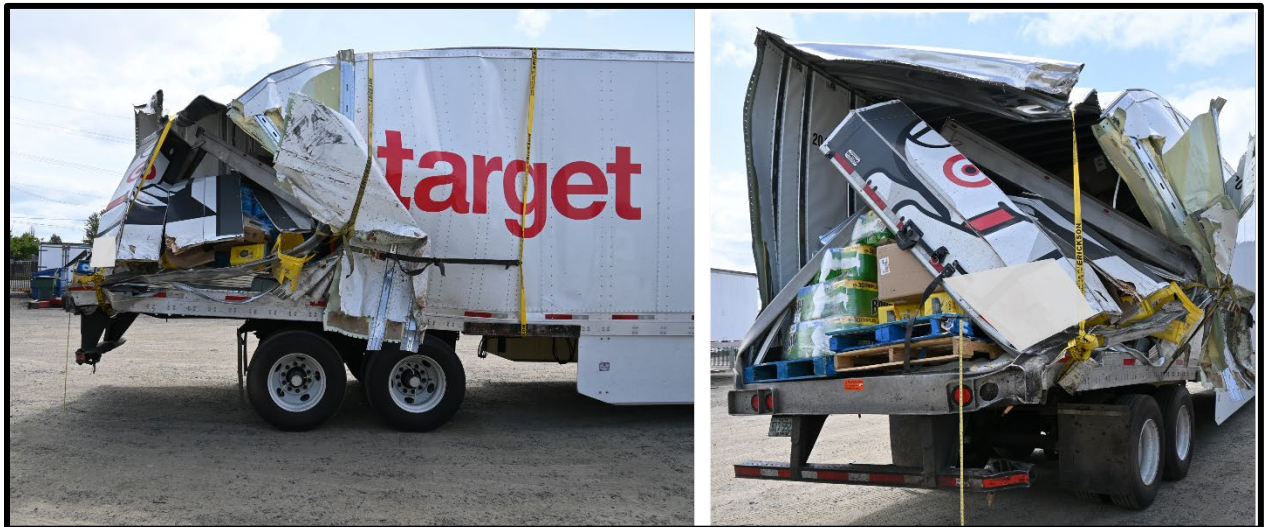
An external inspection of the 2023 Freightliner Cascadia (2023 truck) and the 2023 Utility Dry Van trailer was conducted on May 22, 2023, at AA Auto Wrecking and Towing at 260 E. Queen Ave, Albany, OR. Photographs of the trailer are shown in Figure 8. The 2023 truck had no evidence of damage. The bottom right corner of the trailer was redacted in the photos. The roll-up rear door was separated from the trailer, and the right upper corner of the roof was unsupported and displaced downwards. The right corner of the bumper was displaced forward by approximately ten inches. The Mansfield bar was also displaced forward on the right edge. The trailer's exterior was torn and peeled forward on the right side up to the middle of the rear axle. Please refer to the *Technical Reconstruction Factual Report* in the docket for this investigation for information on the exterior damage.

Figure 8: Dry van trailer from the 2023 truck

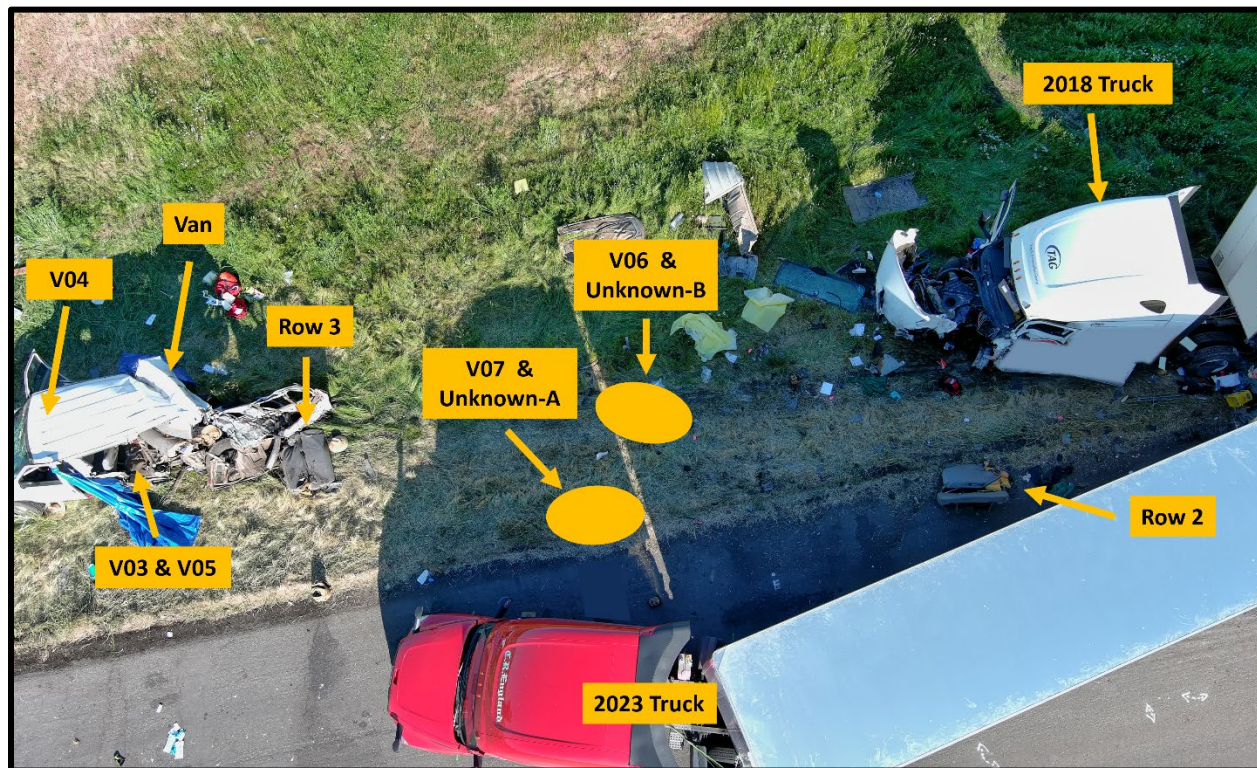
The final rest locations of the fatal occupants are shown in Figure 10. Note that the positions of V02 and V08 could not be determined.

Figure 10: Positions of fatal occupants
(Photo source OSP)
