**NATIONAL TRANSPORTATION SAFETY BOARD  
OFFICE OF HIGHWAY SAFETY  
WASHINGTON, D.C.**

**HIGHWAY FACTORS GROUP CHAIRMAN'S  
FACTUAL REPORT**

**GREENVILLE, ALABAMA – HWY21MH009**

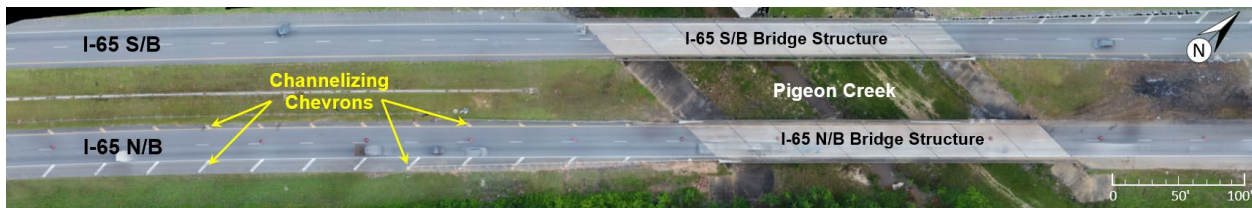
**Figure 2:** Orthomosaic Aerial Image of Crash Location

The collision occurred in the northbound travel lanes of Interstate Highway 65 (I-65), at mile marker 138.18 near the north end of the northbound bridge structure over Pigeon Creek near Greenville, Butler County, Alabama. The crash location, shown in **Figure 1**, was located approximately 8.8-miles north-northeast of the City of Greenville, Alabama. An annotated orthomosaic aerial image of the crash location is shown in **Figure 2**.<sup>1</sup>

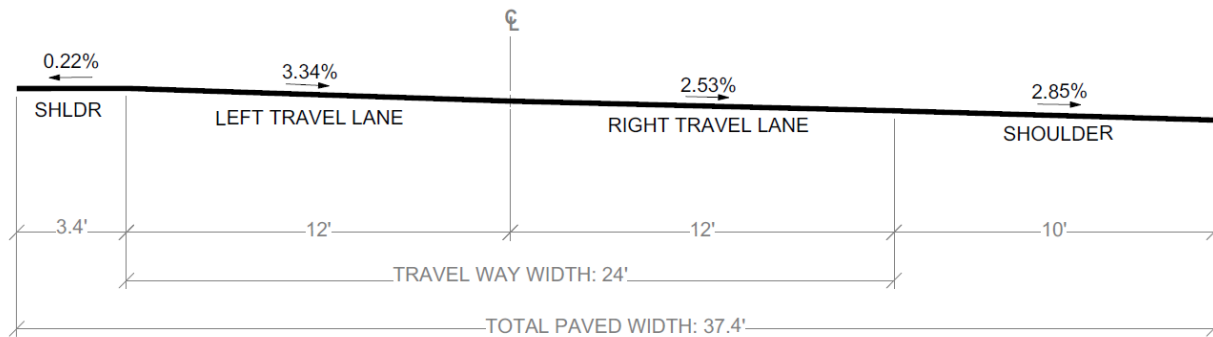
**Figure 3:** Roadway Cross-Section for I-65 Northbound Near Milepost 138.055, Approximately 680-feet South of Bridge Structure (source: NTSB, based on ALDOT data)

Due to the combined horizontal and vertical geometry of the roadway in this area, the grades and cross-slopes for the northbound lanes and shoulders were obtained from ALDOT in the form of roadway cross-section drawings. Roadway cross-sections were provided corresponding to locations approximately every 100-feet beginning 2,000-feet prior to the south end of the northbound bridge structure and ending 2,000-feet beyond the north end of the northbound bridge structure, for a total of 47 diagrams.<sup>10</sup> Pavement cross-slopes and other dimensional data for three locations along the northbound lanes of I-65 have been reproduced from the data provided by ALDOT and are shown in **Figures 3** thru **5**. **Figure 3** shows the cross-slopes of the northbound roadway approximately 680-feet south of the south end of the northbound bridge structure, or approximately 95-feet south of the beginning of the channelizing chevron pattern on the left and right shoulders of the northbound roadway south of the bridge structure. **Figure 4** shows an approximate cross-section of the northbound bridge deck as well as the average cross-slopes of the northbound roadway on the bridge.<sup>11</sup> **Figure 5** shows the cross-slopes of the northbound roadway approximately 250-feet north of the north end of the bridge structure. In the area of the crash, I-65 had a posted speed limit of 70 miles per hour (mph) for both travel directions.

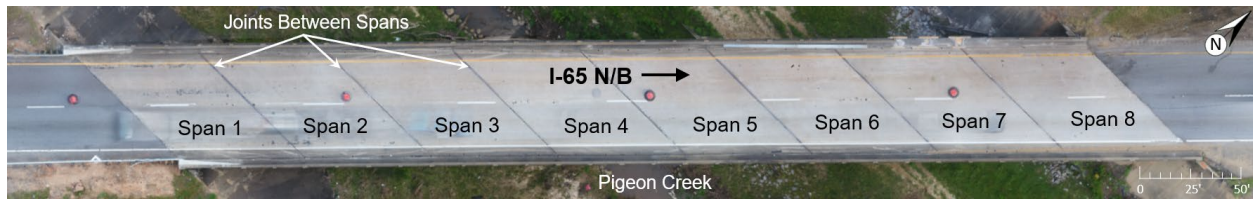
**Figure 6:** Orthomosaic Aerial Image of I-65 Northbound Bridge Structure

On June 25, 2021, and July 8, 2021, the ALDOT conducted testing to determine the pavement texture depth of the I-65 northbound travel lanes in the area of the collision.<sup>15</sup> Testing was performed in both the left and right travel lanes beginning about 250-feet south of the south end of the northbound bridge structure and ending about 250-feet north of the north end of the bridge structure. For the purposes of the testing, each travel lane within the test area was broken into 14 segments with multiple tests being conducted in each segment. The overall average mean texture depth (MTD) results for the travel lane wheelpaths are summarized in **Table 1**. For reference, an orthomosaic aerial image of the northbound bridge structure with the bridge spans labeled is shown in **Figure 6**.

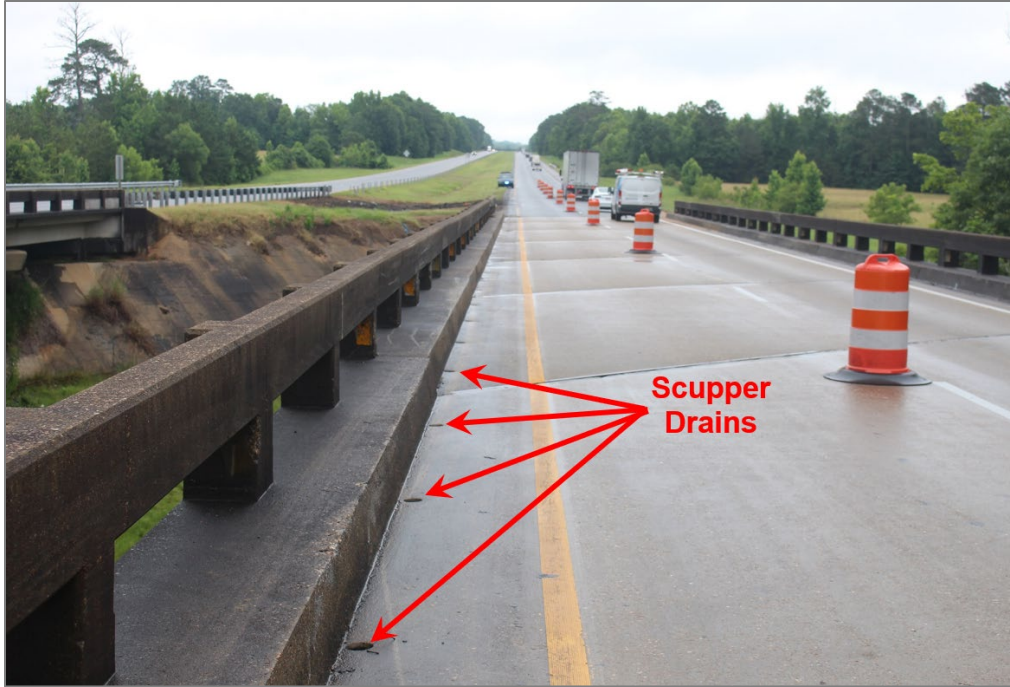
**Figure 7:** Scupper Drains through Bridge Deck

Drainage appliances were present on the bridge deck and in the median in the general vicinity of the crash location. Three-inch-diameter circular scupper drains were located on both the left and right sides of both bridge decks, within the paved shoulders and adjacent to the curbs.<sup>16</sup> There were 24 scupper drains regularly spaced along each curb on the interior six of the eight bridge spans making up each bridge structure, for a total of 48 scupper drains per bridge structure. The reinforced concrete bridge decks were designed and constructed with a 2.25-inch parabolic crown to channel rainwater to the scupper drains. The scupper drains were examined by NTSB investigators, and all of them were found to be clear of any debris. Several scupper drains are shown in **Figure 7**.<sup>17</sup>
