# National Transportation Safety Board

CEN23FA046

## **ACCIDENT FLIGHT DATA SUMMARY**

Location: Wonder Lake, Illinois  
Date: November 25, 2022  
Time: 1615 central standard time (2215 UTC)  
Airplane: Extra EA 300/LC; Registration No. N361LX

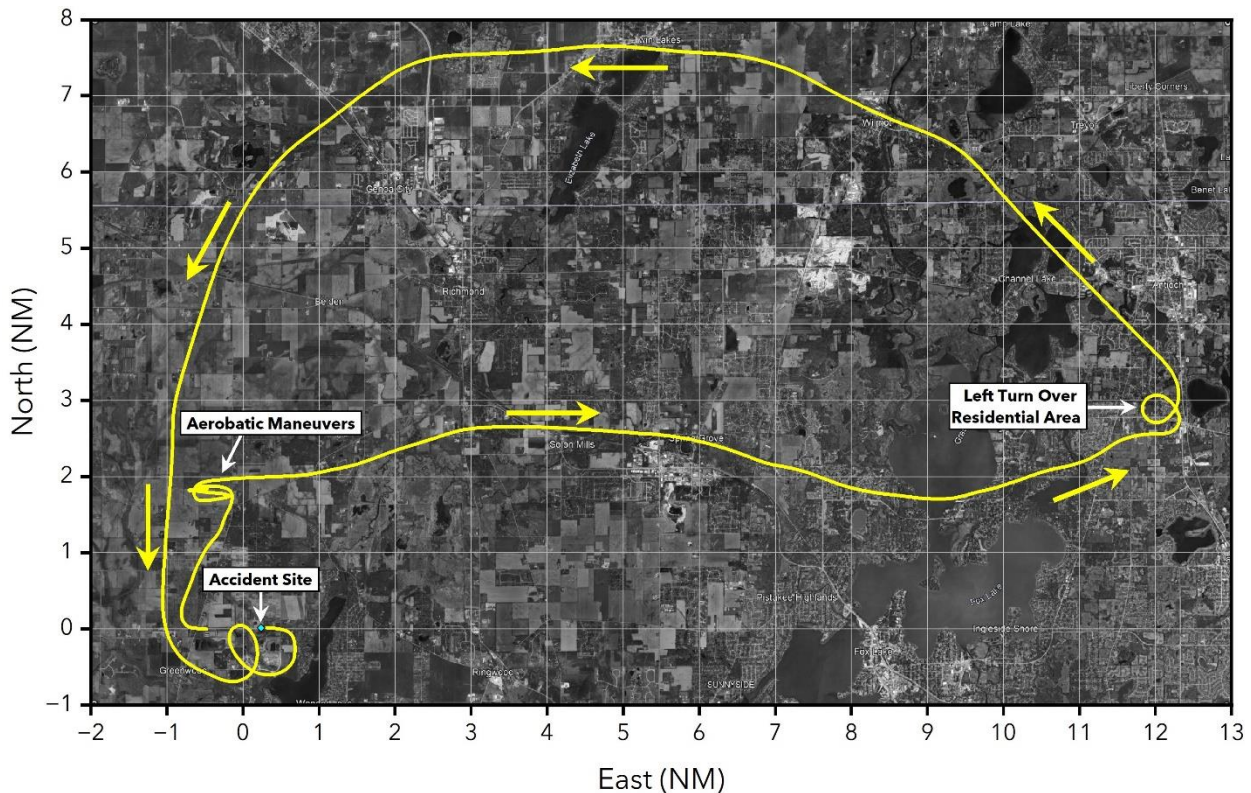
**Figure 1.** Plot of the airplane ground track for accident flight.

A review of Federal Aviation Administration (FAA) automatic dependent surveillance-broadcast (ADS-B) data indicated that at 1558, the airplane departed runway 27 at Galt Field Airport (10C), Wonder Lake, Illinois, and then entered a climbing right turn toward north and 3,000 ft mean sea level (msl), as depicted in Figure 1. Between 1559:15 and 1600:30, the airplane completed at least two aerobatic maneuvers about 1.8 nautical miles (nm) north-northwest of 10C. Following the aerobatic maneuvers, the airplane flew east toward Antioch, Illinois. About 1605, the airplane entered a left 360° turn over a residential area located about 1.8 nm south of downtown Antioch, Illinois. The airplane's altitude during the 360° turn was about 1,250 ft above ground level (agl). Following the 360° turn, the airplane turned northwest and climbed to about 2,700 ft msl. At 1608:30, the airplane turned west and descended to 2,400 ft msl. At 1610, about 1.7 nm north of Genoa City, Wisconsin, the airplane turned south and continued toward 10C.

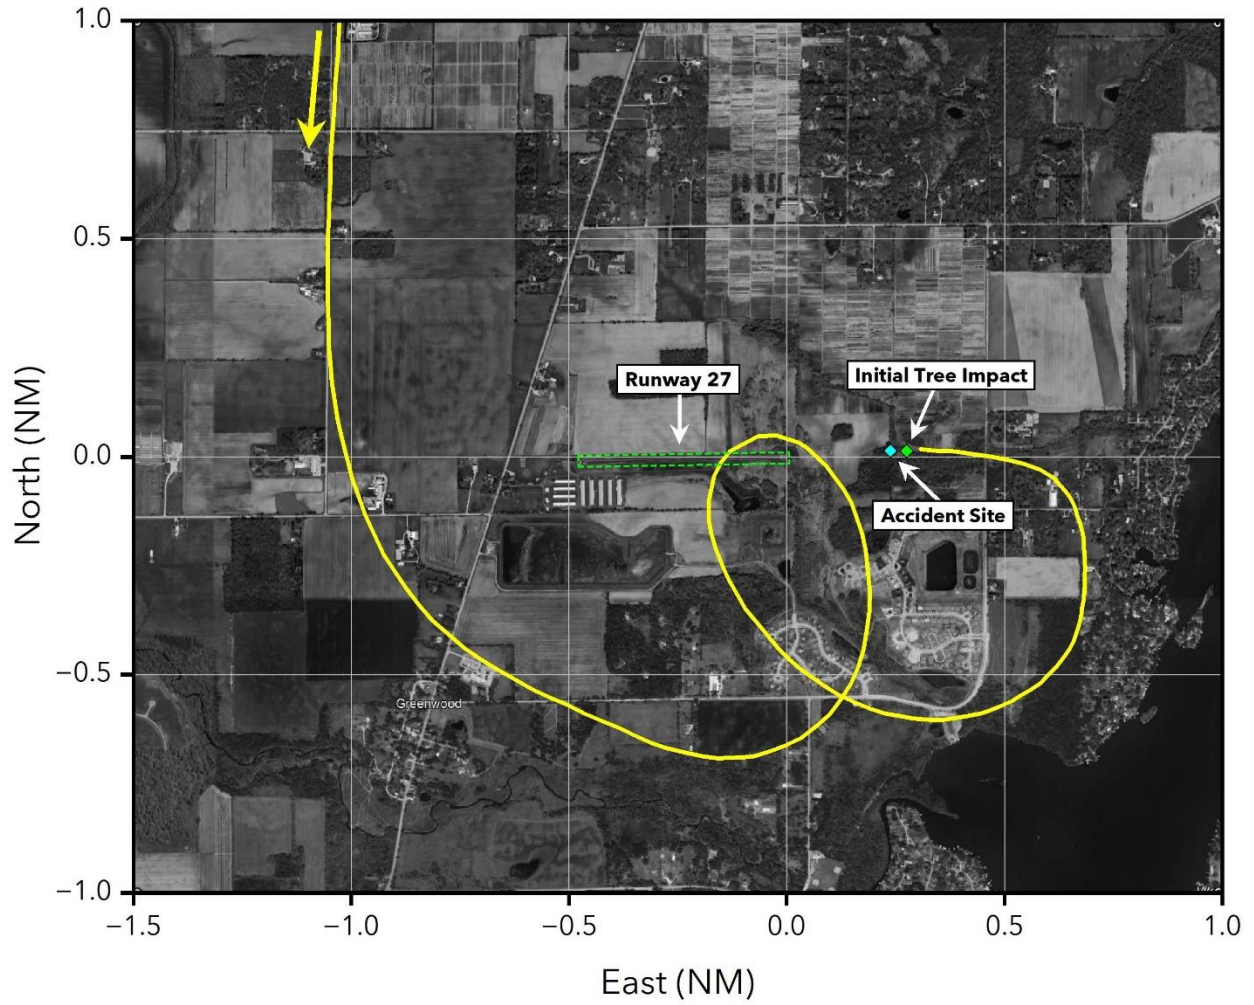
**Figure 2.** Plot of the airplane ground track while in traffic pattern.

At 1613:12, the airplane entered the traffic pattern at 10C while on a left crosswind for runway 27, as depicted in Figure 2. The airplane was decelerating through 160 knots calibrated airspeed (KCAS) as it entered the traffic pattern, as shown in Figure 3. Between 1613:45 and 1614:30, the airplane made a 360° left turn while abeam the runway 27 threshold. The airplane's altitude was about 1,800 ft msl (950 ft agl) during the 360° turn. After the 360° turn, the airplane entered a descending left base turn toward runway 27. During the descending turn, the airplane briefly decelerated to 70 KCAS and achieved a maximum descent rate of about 1,700 feet per minute (fpm). At 1615:23, the final ADS-B data point was recorded about 0.31 nm from the runway 27 threshold. At that time, the airplane was at 922 ft msl, 84 KCAS, descending about 900 fpm. The airplane had a 270.5° true heading, 2.7° left-wing-down roll, and -6.4° flight path angle, as shown in Figure 4. The airplane subsequently descended into

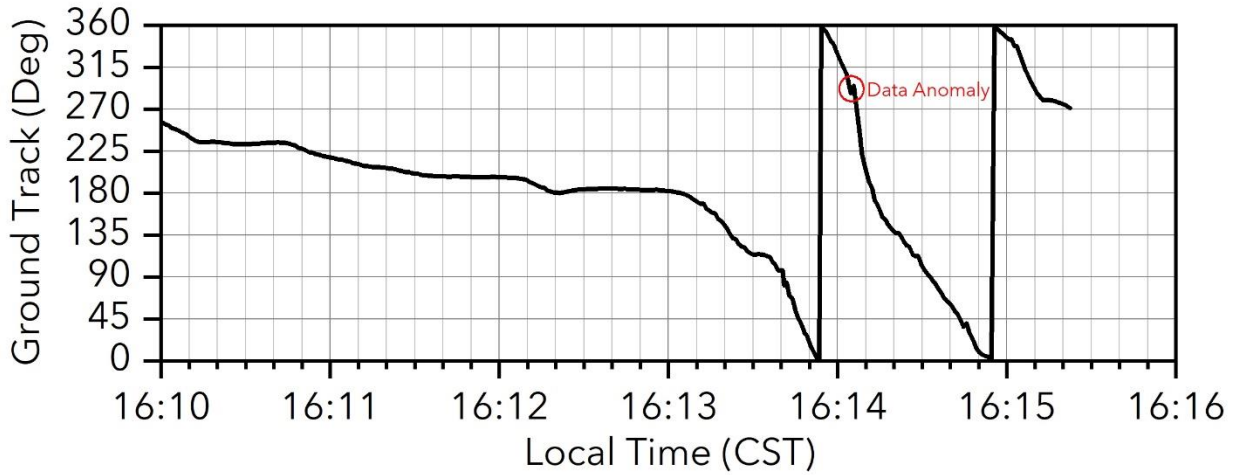
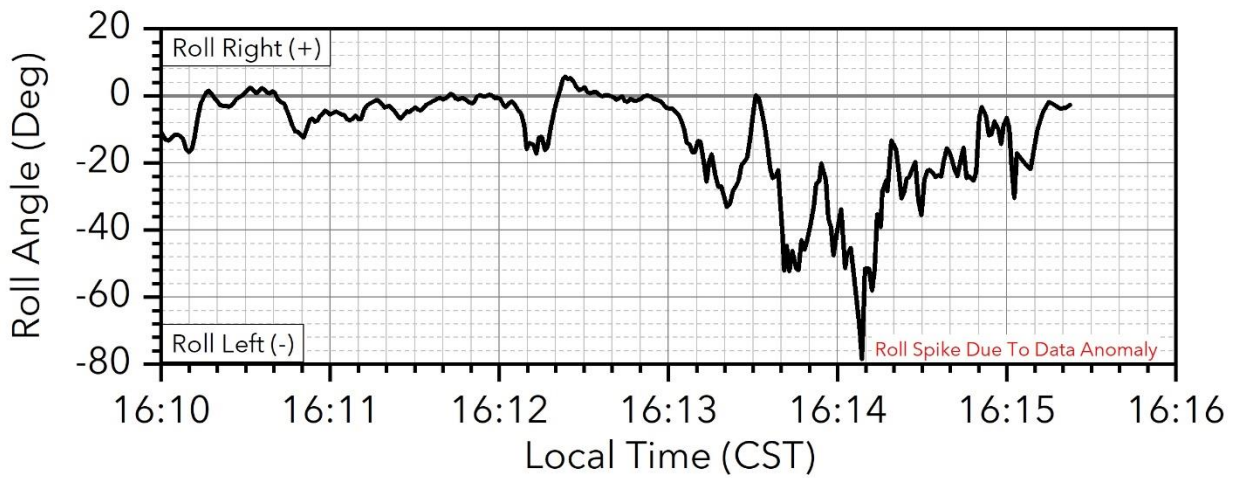
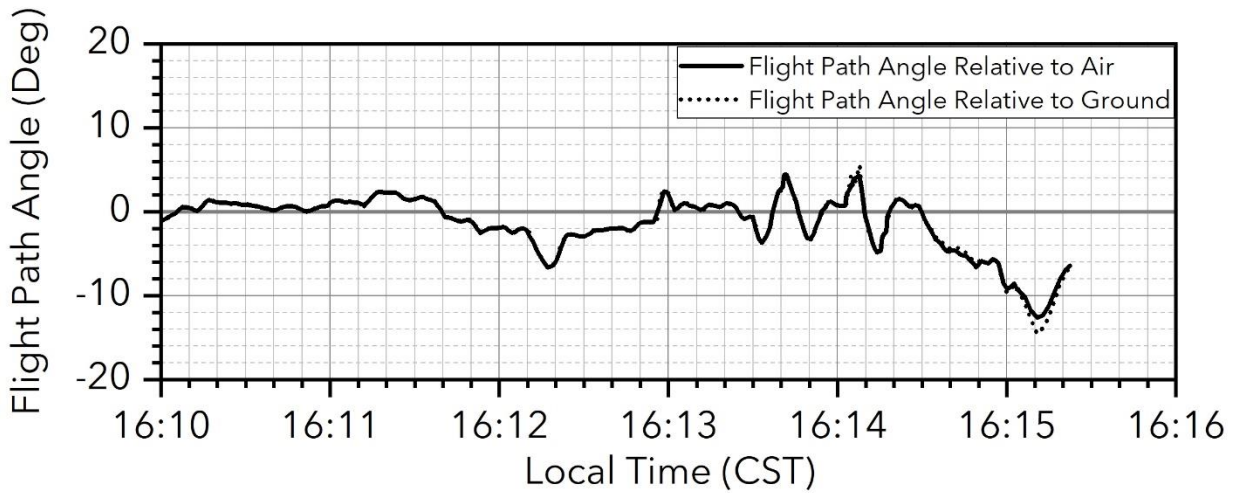
**Figure 4.** Plot of airplane ground track, roll angle, and flight path angle.

trees about 0.28 nm from the runway 27 threshold. The airplane then continued a west trajectory before coming to rest about 0.24 nm from the runway 27 threshold.

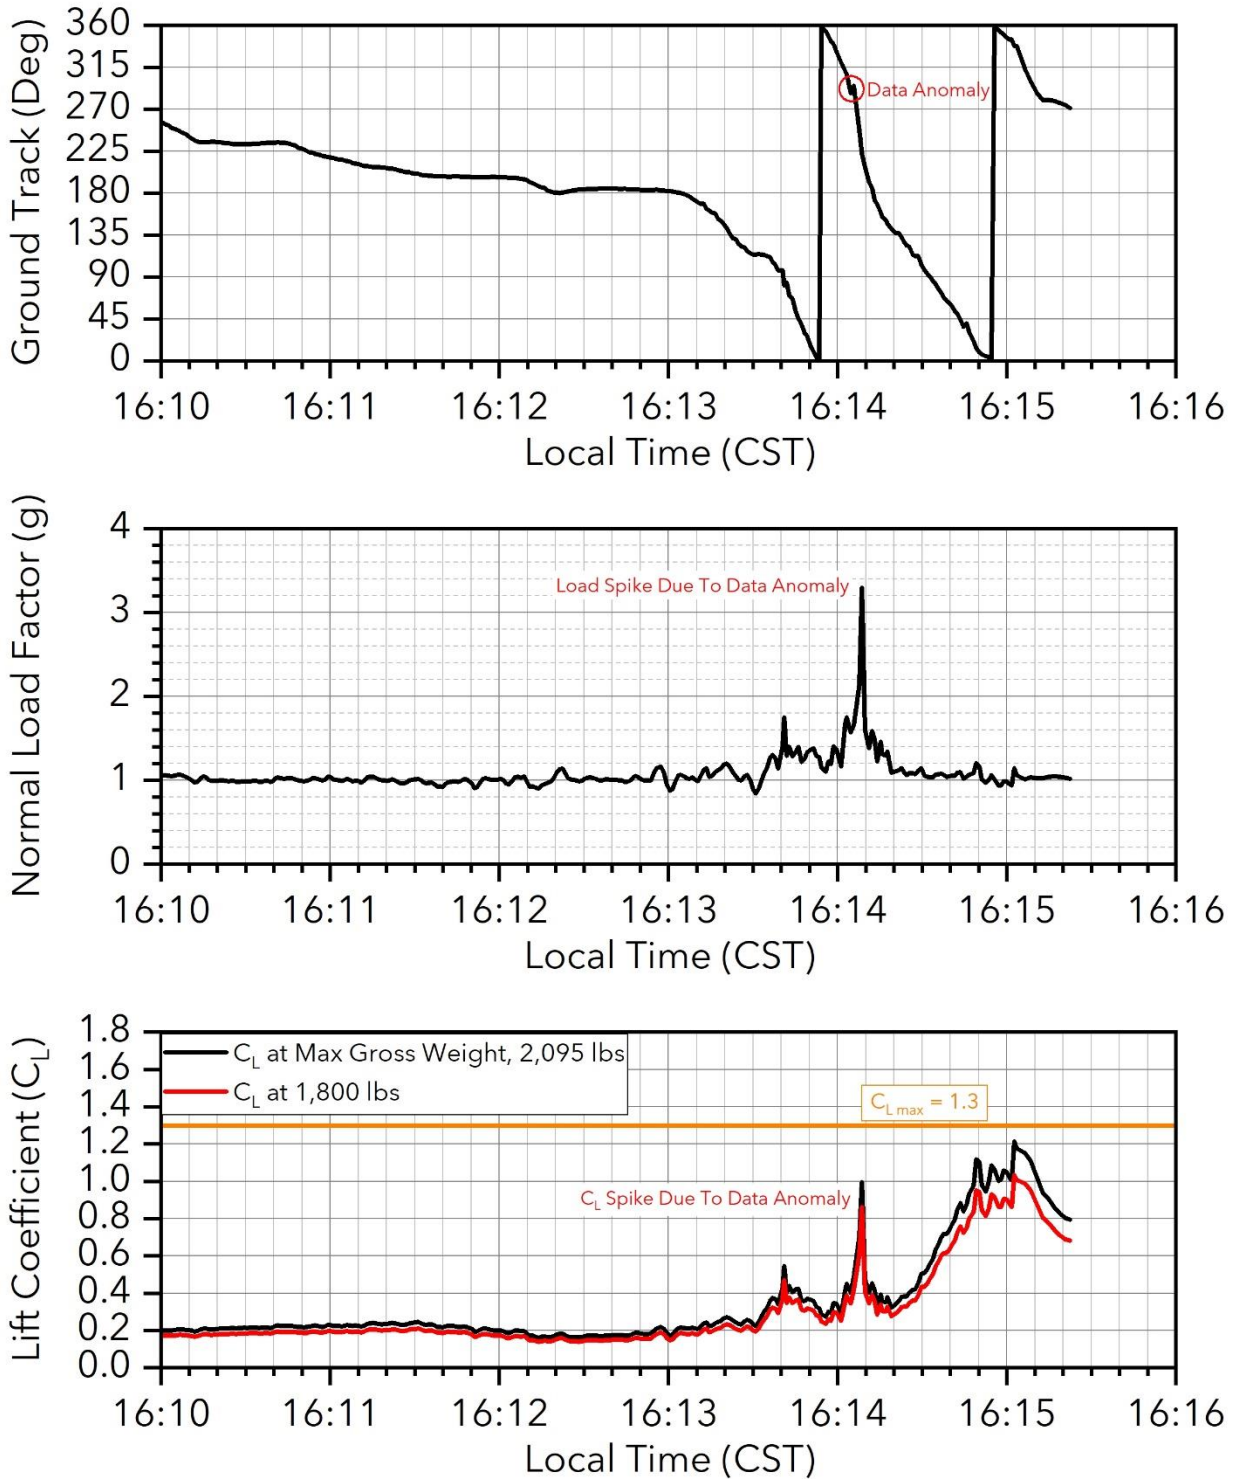
**Figure 5.** Plot of airplane ground track, normal load factor, and lift coefficient.

According to the Extra EA 300/LC Pilot Operating Handbook (POH), at the airplane's maximum gross weight of 2,095 lbs, the wings-level aerodynamic stall speed is 64 KIAS. The wings-level aerodynamic stall speed is 59 KIAS at 1,800 lbs gross weight. Performance calculations based on the recorded ADS-B data indicated that the airplane did not exceed the airplane's maximum lift coefficient ( $C_{Lmax} = 1.3$ ) while in the descending left turn toward the runway, as shown in Figure 5.

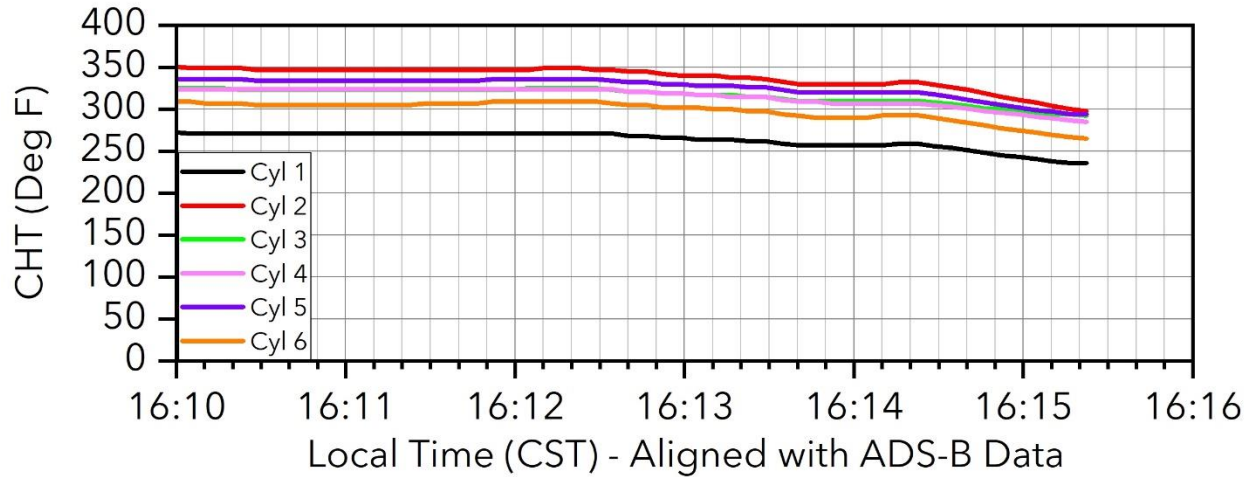
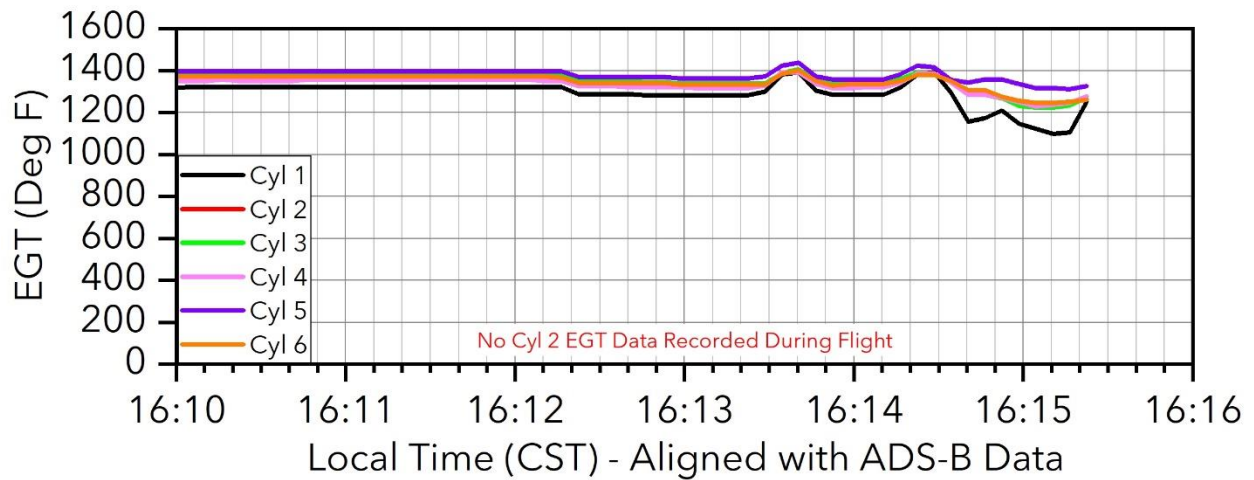
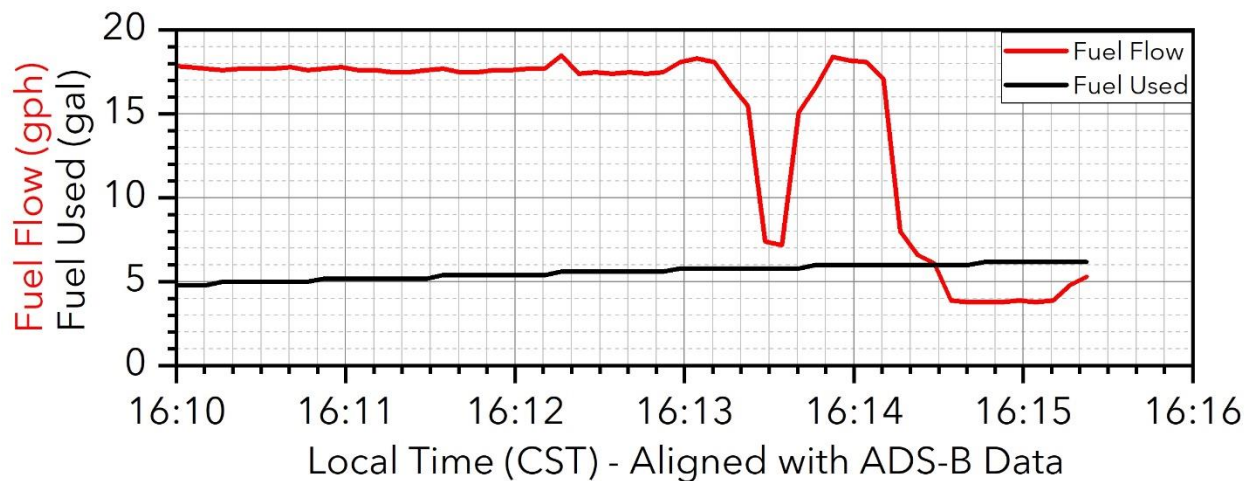
**Figure 6.** Plot of engine CHT, EGT, fuel flow, and total fuel used.

A review of downloaded engine monitor data confirmed that the engine was operating at the time of the accident. The engine's cylinder head temperatures (CHT), exhaust gas temperatures (EGT), fuel flow, and total fuel used are depicted in Figure 6. The engine monitor did not record exhaust gas temperature for cylinder No. 2 during the accident flight or the previous flight flown on November 23, 2022. According to the engine monitor, 6.2 gallons of fuel was used between engine startup and the interruption of electrical power to the engine monitor during impact.
