**National Transportation Safety Board
Office of Railroad, Pipeline and Hazardous Materials Investigations
Washington, DC 20594**

Mechanical and Engineering Group Factual Report

**Railroad Employee Fatality
BNSF Railway Globeville Yard
Denver, Colorado
February 9, 2022**

RRD22FR006

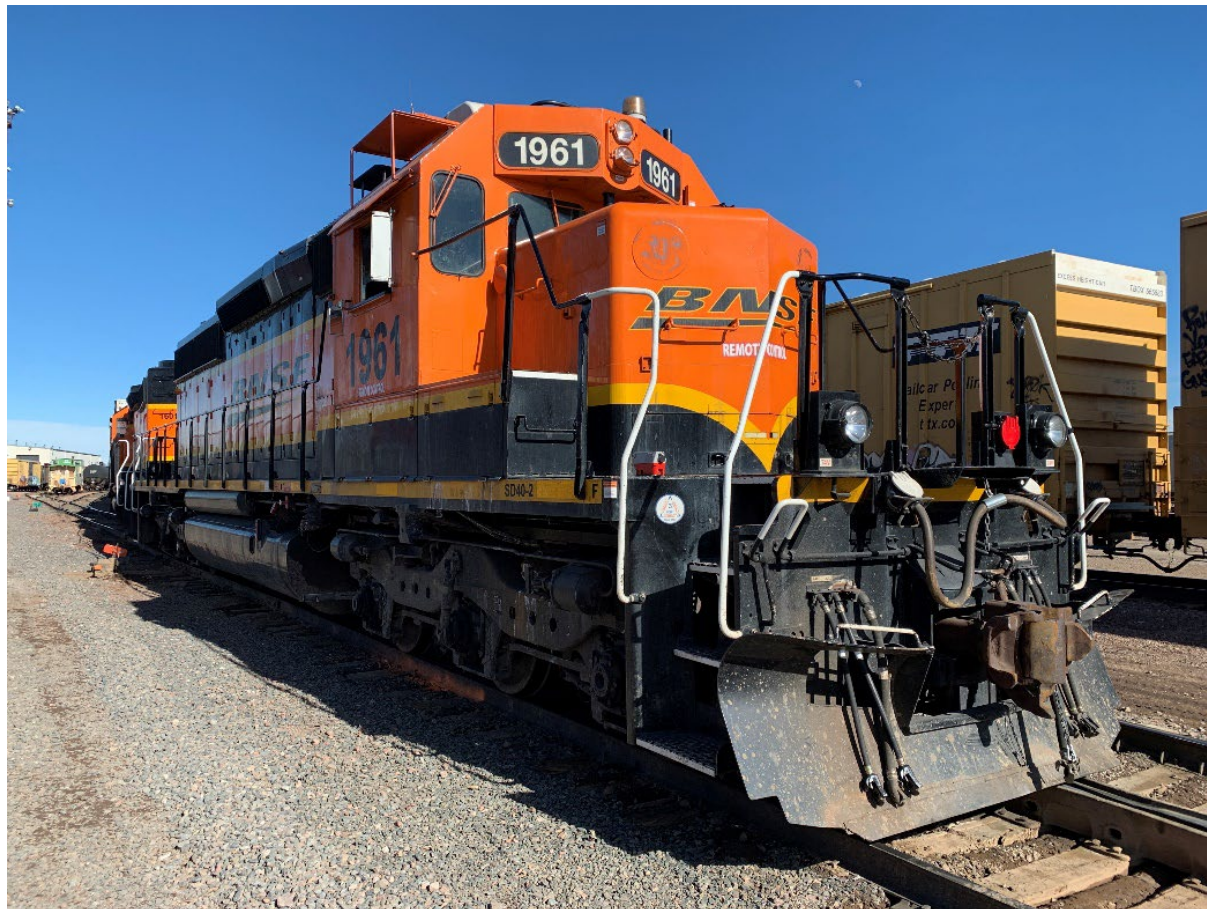
Figure 1. BNSF 1961 Final Resting Positions Post-Accident

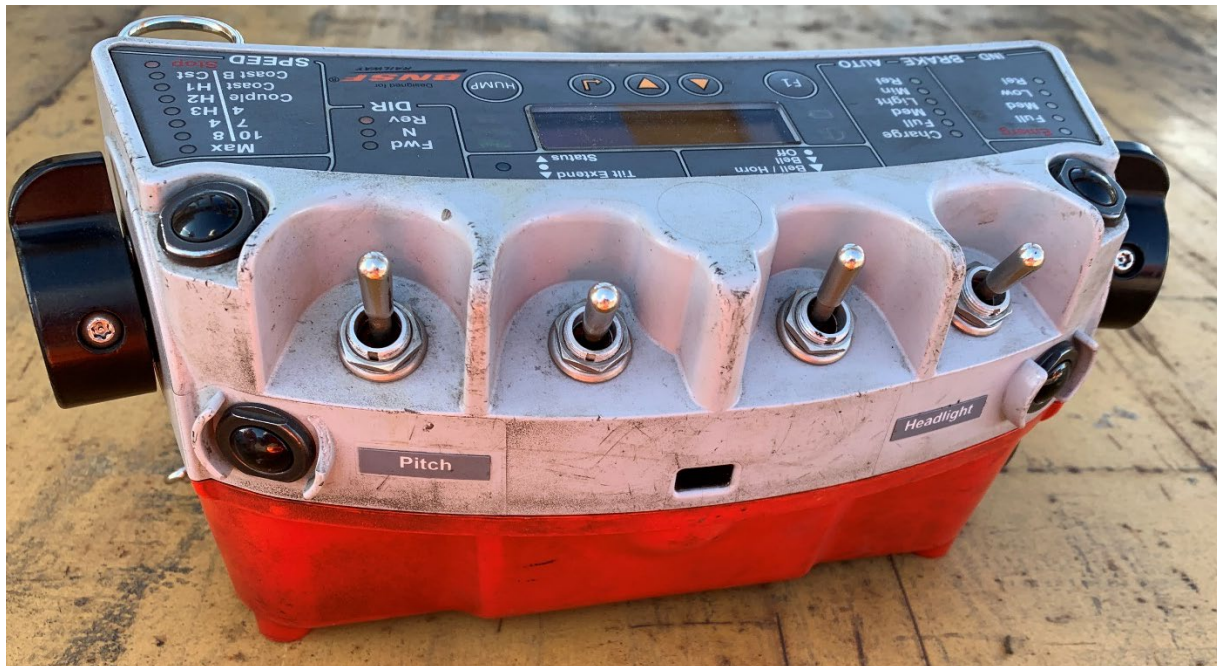
Figure 2. The Switchman Foreman (b) OCU from the accident consist.

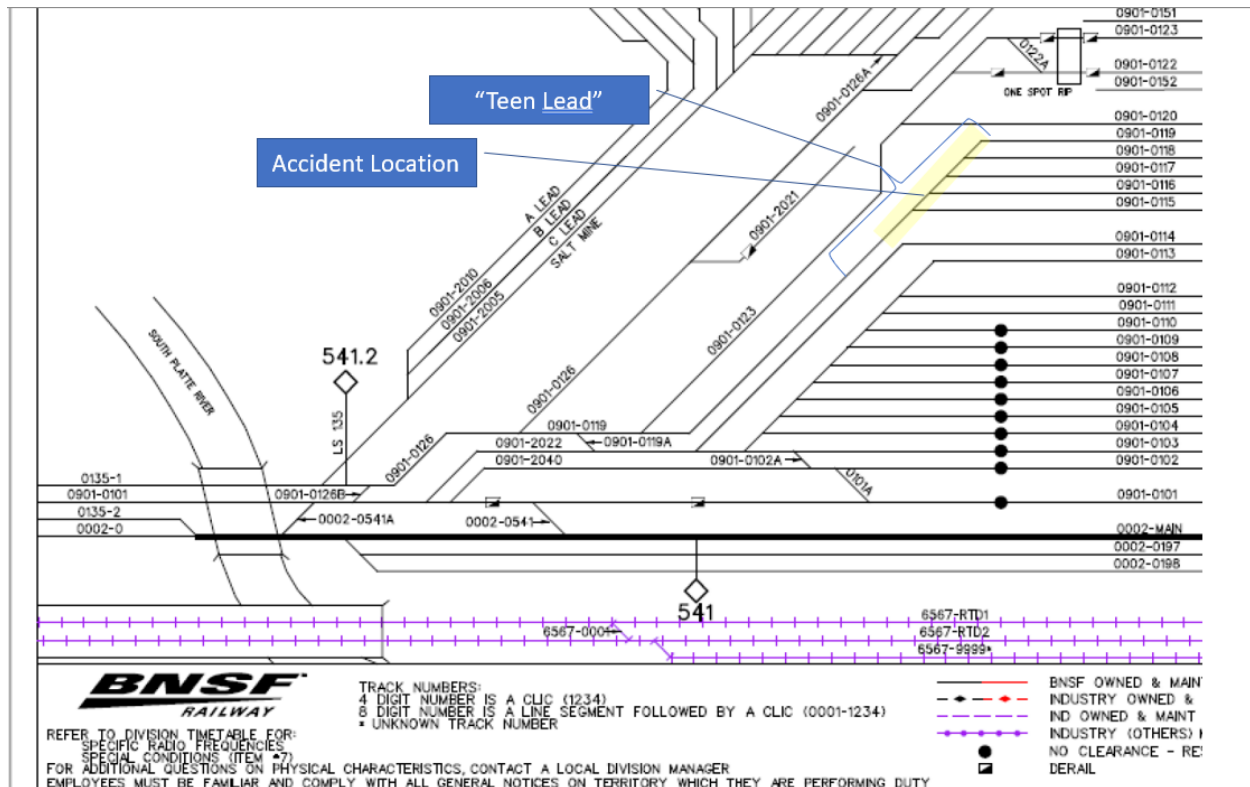
The Globeville Yard at the "Teen Lead" between Switch Numbers 15 and 16 is made up of jointed 112 pound rail dated 1945. Anchor pattern is every tie and missing anchors intermitted. Tie plates are double shouldered with standard BNSF spiking pattern with cut style 6 inch spikes. Plates are worn with spikes intermitted high. Crossties are a mix of hard and soft wooden switch ties. Tie condition is marginal. Ballast condition is made of 3/4 inch yard ballast. Sub-grade is soft with one defective ballast condition noted at a joint ahead of No. 16 switch. Switches in the area of concern are No. 9 turnouts, with hand throw (Racor 22P) Switch Stands, 16 foot 6 inch standard switch points and self-guarded frogs.

Figure 3. BNSF Globeville Yard

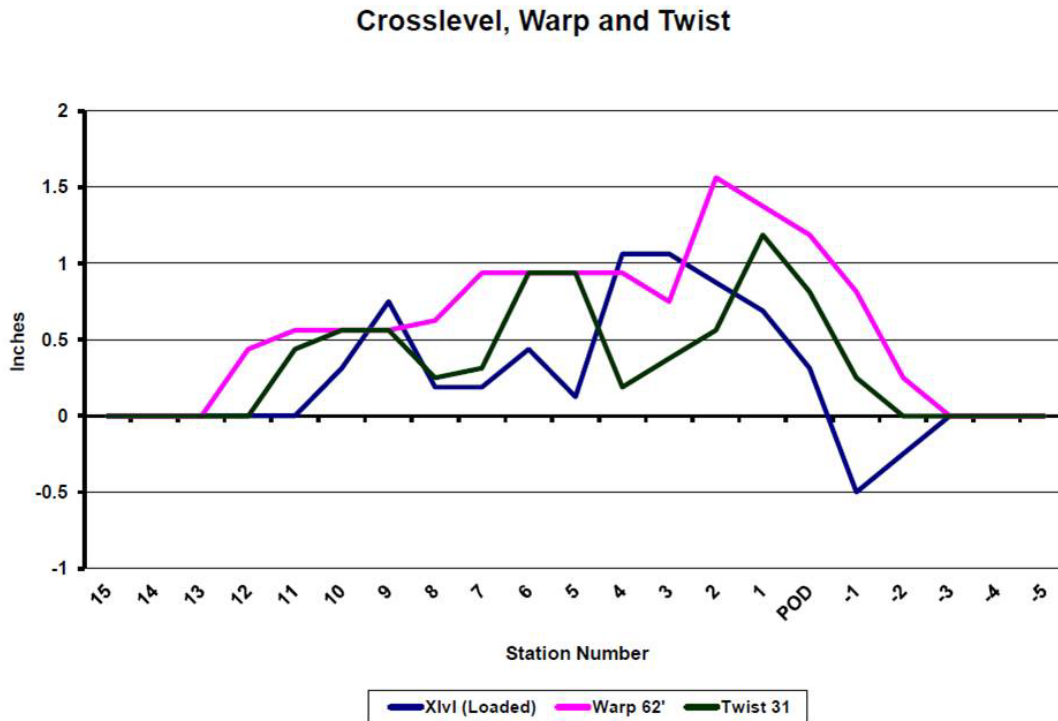
- Highest Warp measurement is 1 - 9/16 inches. The upper limit for Class I track is 3 inches.
- Highest X Level measurement is 1 - 11/16 inches. The upper limit for Class I track is 3 inches.
- Highest Profile measurement is 1 - 3/4 inches humped. The upper limit for Class I track is 3 inches.
- Highest Gage measurement is 57 - 5/8 inches. The upper limit for Class I track is 58 inches.

During the investigation, FRA Inspectors documented 4 non-class specific defects and 3 operating defects. They filed no violations and found no class specific defects. The non-class specific defects included ballast failing to restrain the track which allowed for 1 - 11/16 inches of crosslevel with evidence of entrapped water; a broken switch plate; improper fit between switch point and stock rail, and insufficient fasteners to effectively maintain gage allowing for 57- 5/8 inches of gage⁶. The operating defects were 3 occurrences of failure to ensure a switch is latched when not in use⁷.

Figure 4. Chart of crosslevel, warp and twist 5 stations past the incident location (marked as "POD") and 15 stations prior to the incident location. Note: For Class 1 track, the maximum allowable warp is 3-inches.

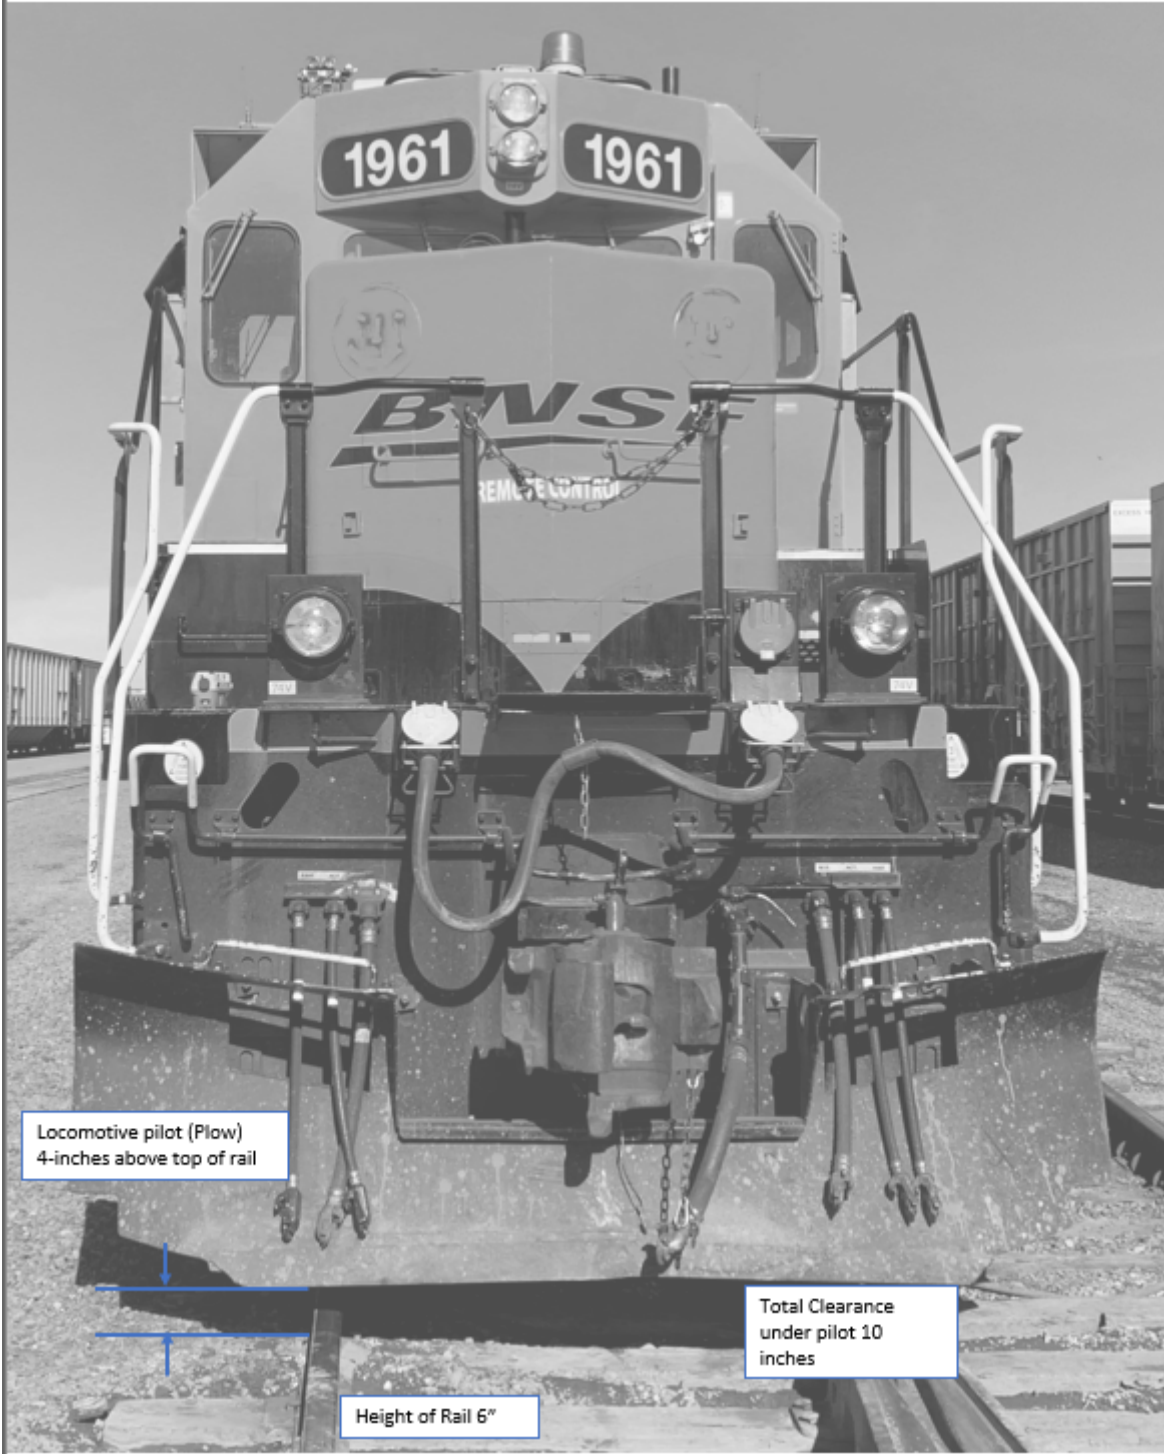
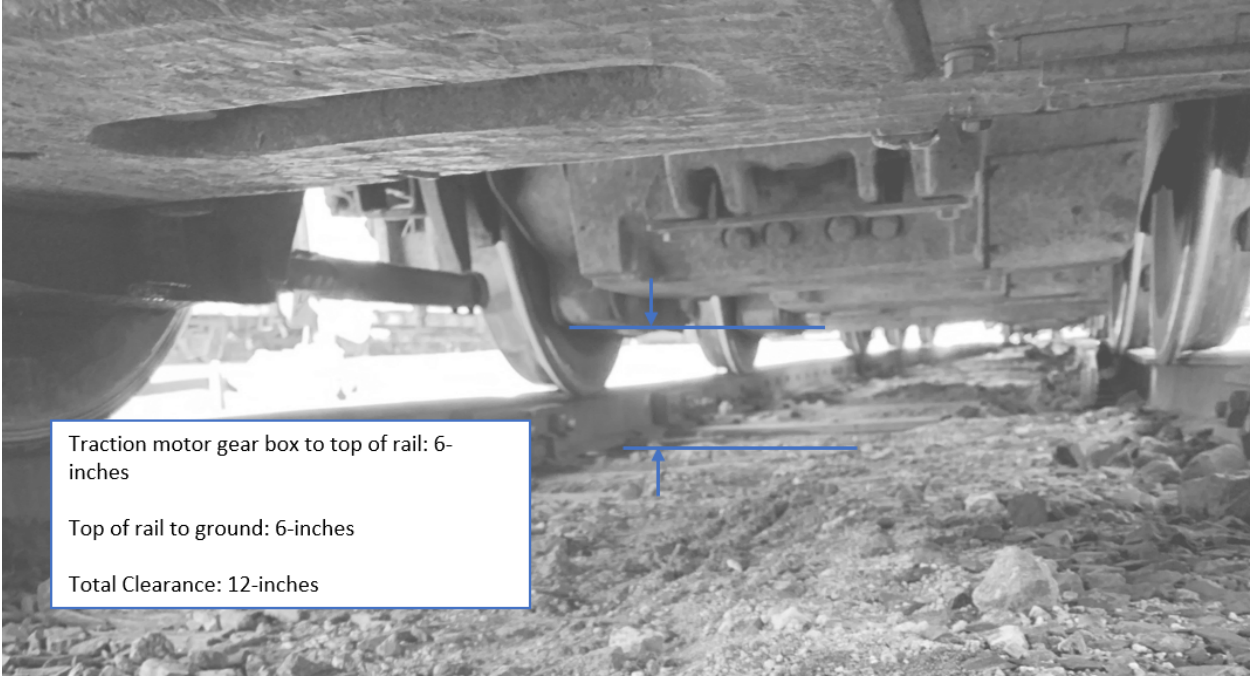
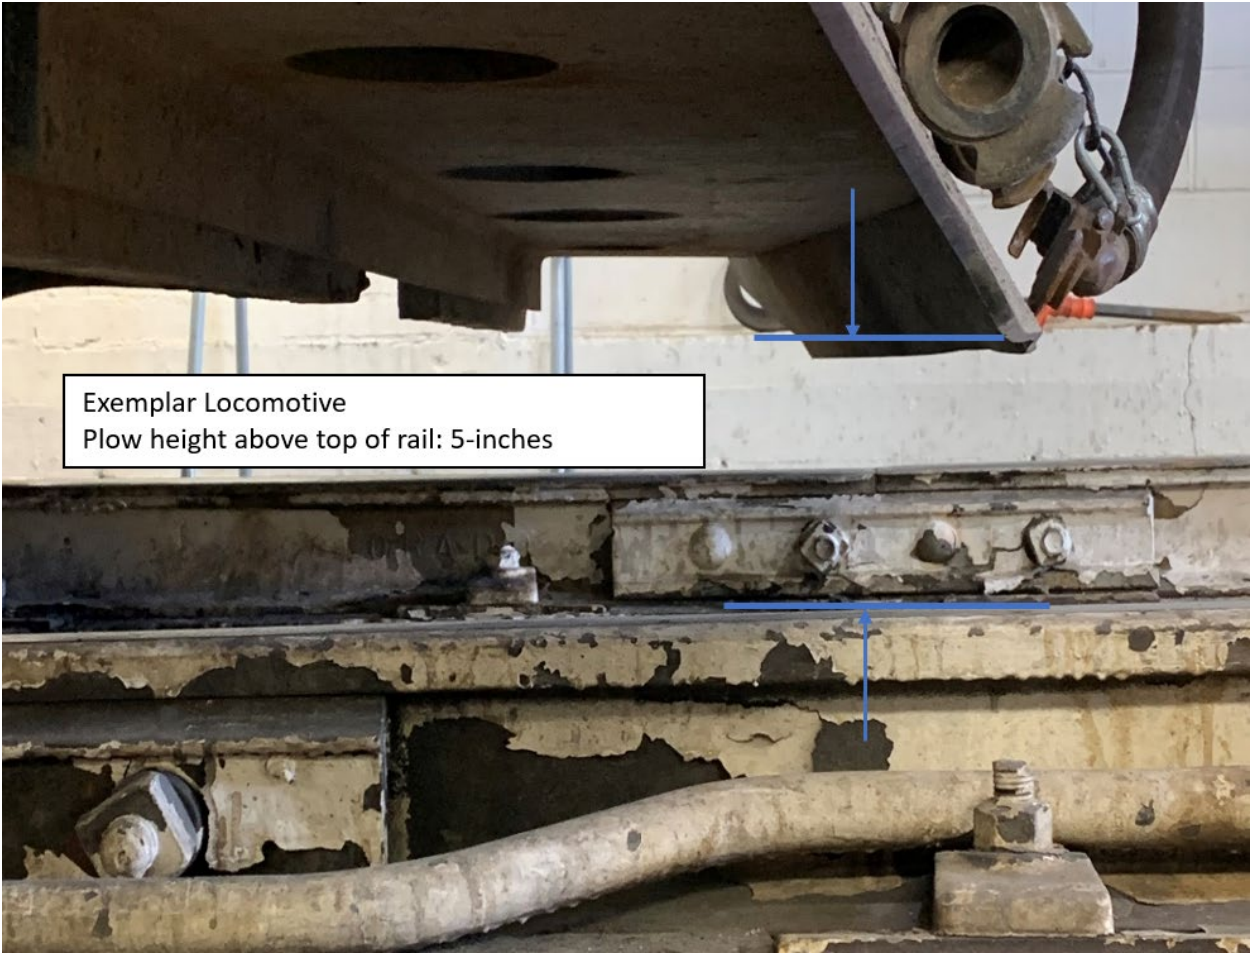
Clearance Images

- The distance from the ground to the top of the rail in the area of the accident is 6.25-inches. In some areas it might be slightly less due to ballast rock, dirt and other debris associated with normal railroad yard conditions.

- The distance from the top of the rail to the bottom of the plow on exemplary locomotive BNSF 1798 was 5-inches as measured in the BNSF Globeville locomotive facility

- The height of the plow above the rail is a Federally regulated item. Title 49 CFR Section 229.123(a) requires the plow to be 3-inches to 6-inches above the top of the rail. This height can change based on wheel wear, weight, and suspension.

- On February 24, 2022 (post-accident), the plow height was recorded at Alliance, Nebraska as 4-inches above top of rail.
- NTSB staff measured the lowest point of the locomotive between the rails and behind the plow, which corresponds with the traction motor gear cases. There is a traction motor and gear case on each axle. The gear case is approximately 6-inches above top of rail.
