## MEMORANDUM FOR RECORD

**Subject:** NTSB investigation ERA22LA138, N7943Y, Piper PA-30, February 28, 2022, Farmingdale, New York  
Information provided by Pilot Warren Wylie and Designated Pilot Examiner David Windmiller

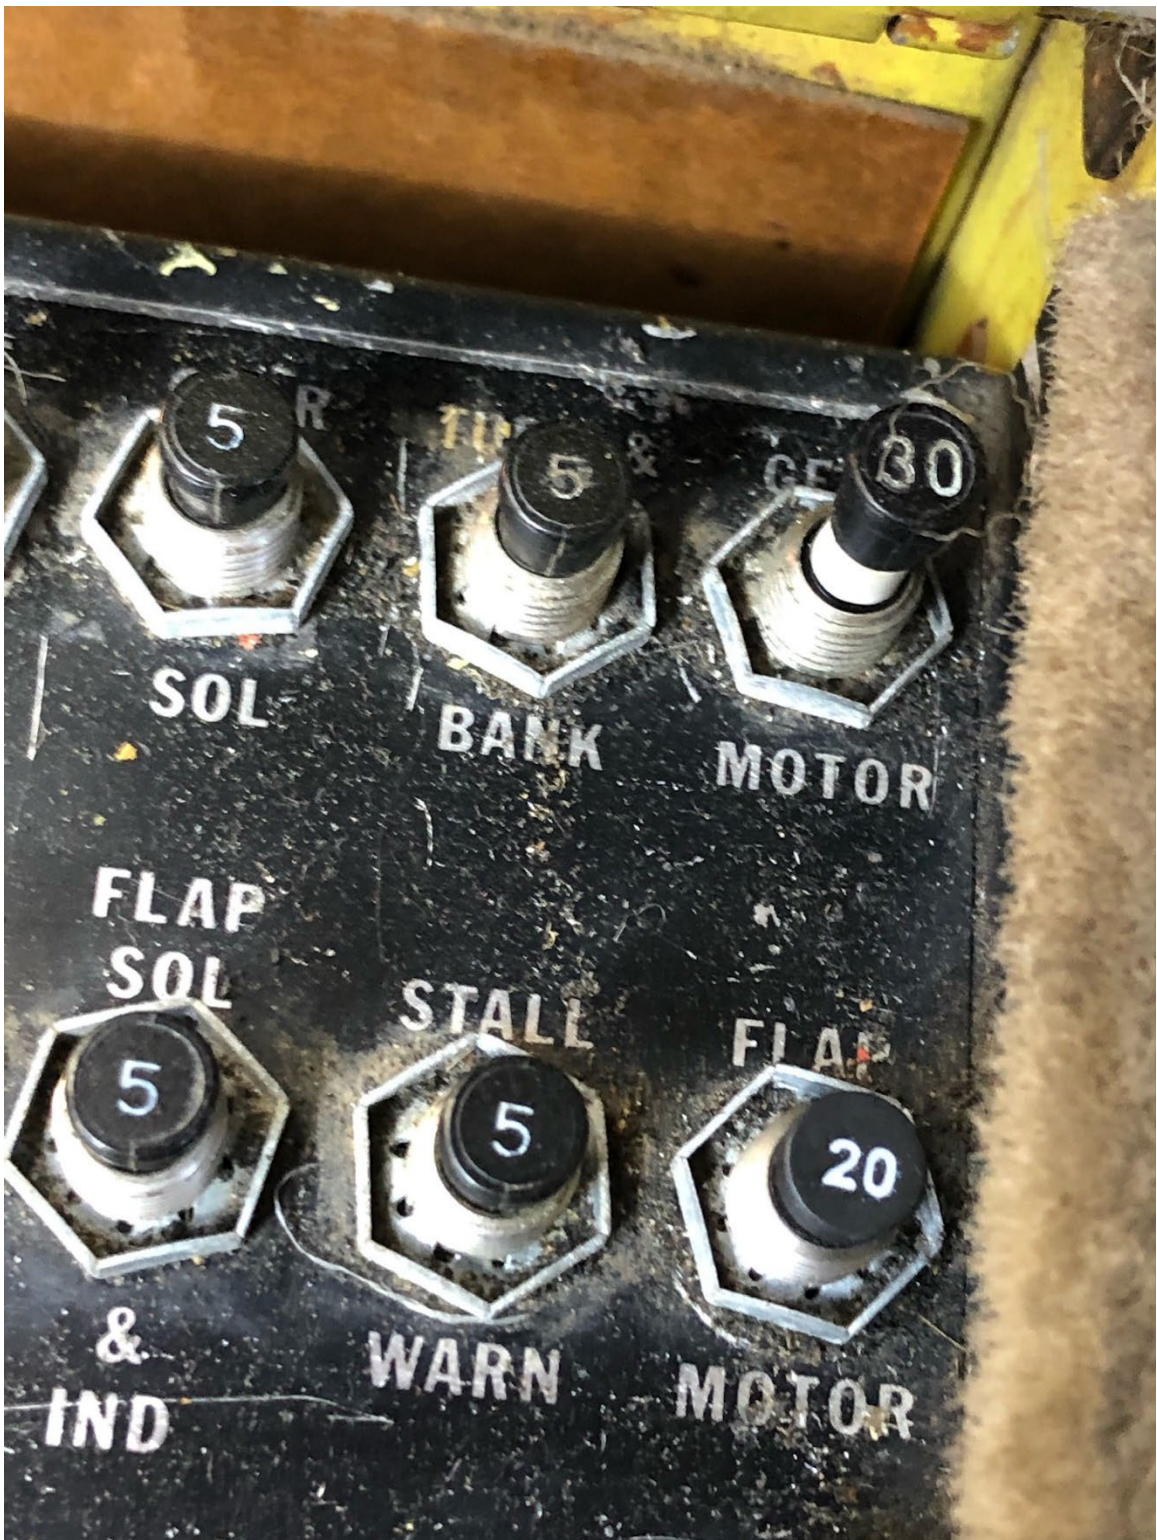
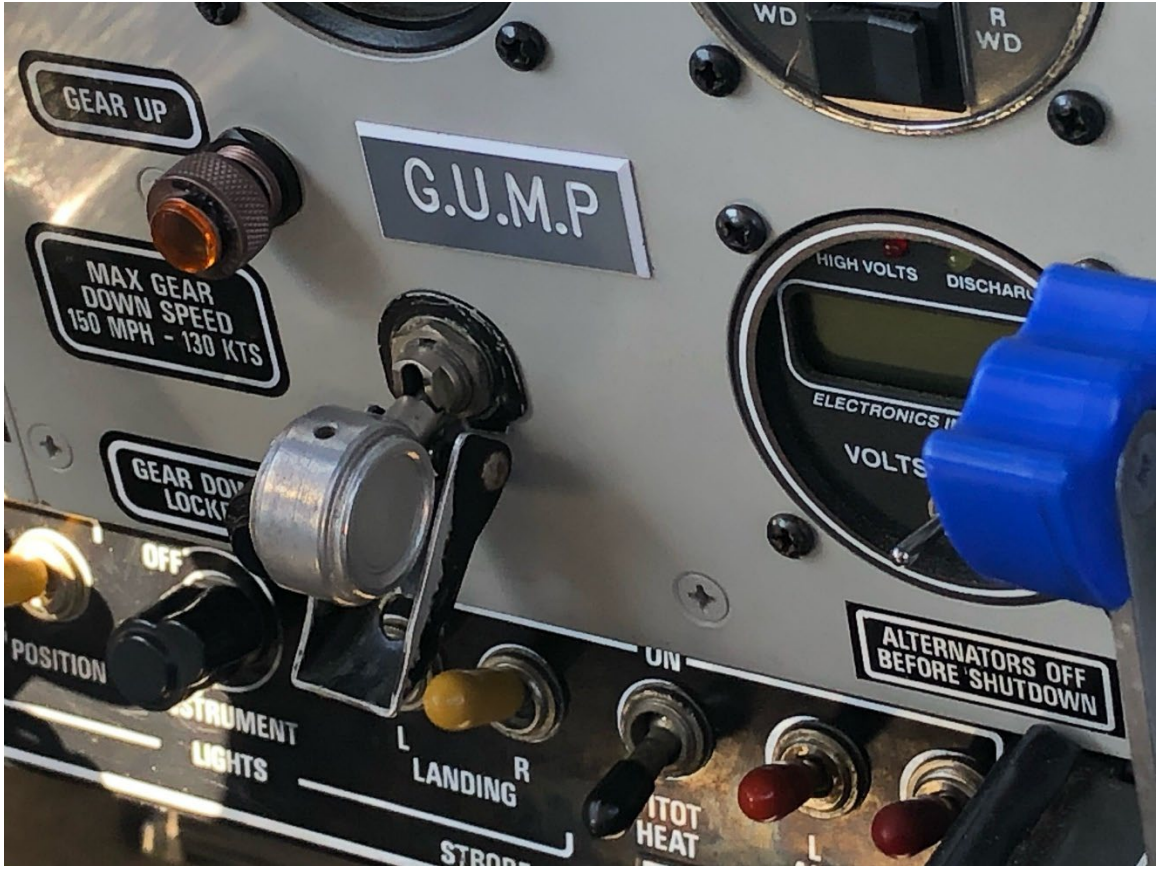
Approximately two weeks ago I was contacted by a gentleman from New Jersey, Warren Wylie, looking for a Checkride for a Multi add on to a Commercial certificate in a PA-30. I agreed to do this provided I was emailed the last 2 annual inspections on the aircraft in order to see the history on a 50+ year old airplane. The records looked good and I scheduled the checkride for this morning out of Atlantic ay FRG. The Plane looked quite good on my quick walk around after the recommending instructor and the applicant arrived. We proceeded to start the checkride. He did very well on the oral, maybe even above average. We went out to the airplane and did a complete preflight, with nothing abnormal. The flight was quite good again better then average. We completed all of the required tasks out east and had made one landing after the instrument approach to RWY 06, with a circle to land on Rwy 24 at HWV, (33 was notamed closed). We had cycled the gear numerous times during the checkride. Unfortunately the only gear down indicator on this older aircraft is one green light to the left of the gear handle. It is not visible from the right seat. Warren would hold his hand on the lever each cycle then say gear down. We were nearly complete with the checkride missing a short field and normal landing. He asked the tower at FRG for 1 touch and go followed by a full stop. We were cleared for a T&G with left traffic. Warren used the before landing checklist, then once again put the gear handle to the down position blocking the light but said gear down then removed his hand from the knob. The landing was right on par with a touchdown on the 1000' marker right on the centerline. At touchdown it was quite obvious that the landing gear was not down. Upon reaching a stop on the runway there was some smoke coming through the floorboards on the pilot's side. Warren was extremely upset and kept saying but I put the gear down! Upon opening the door and realizing the smoke stopped, I took out my phone and took a number of photos. The gear lever

was in the down position. It took a while to find the circuit breaker for the gear as it is buried under a floor panel, and the Landing Gear Motor 30 amp breaker was tripped. I will include the photo with this email. There were no injuries and we stayed with the airplane until it was recovered, then went back to Atlantic to meet with the FAA inspectors.
