MEMORANDUM FOR RECORD

Subject: NTSB investigation ERA21FA219, N9795B, Cessna 172RG, Miami Executive Airport (TMB), Miami, Florida, May 8, 2021. Information provided by Petr Kratochvil, representative of Flying Academy (Operator).

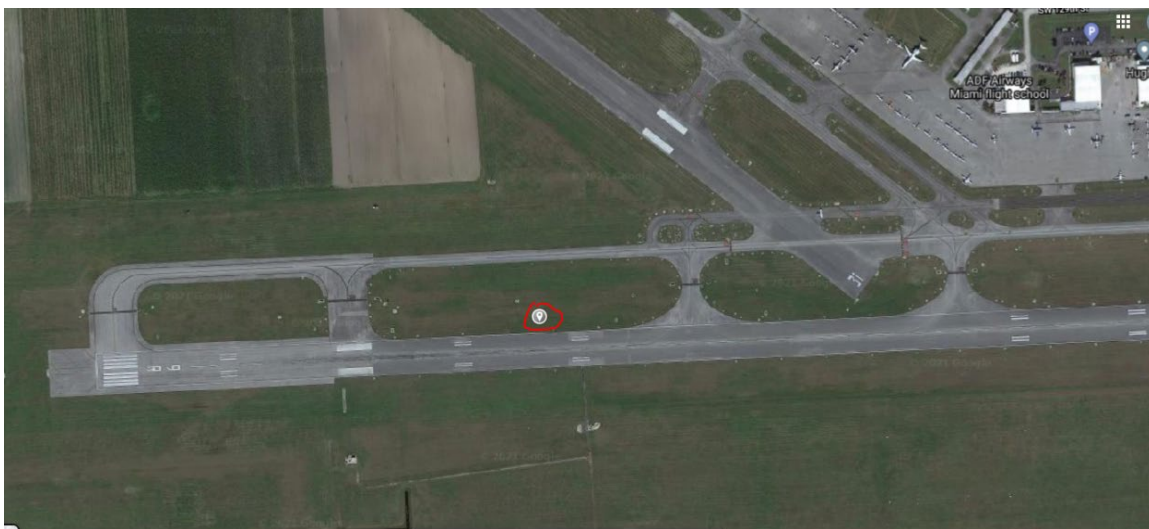
After the LH main gear colapse airplane went off the RWY 9R at KTMB airport. Approximate location of the AC after it stopped is marked on the picture:

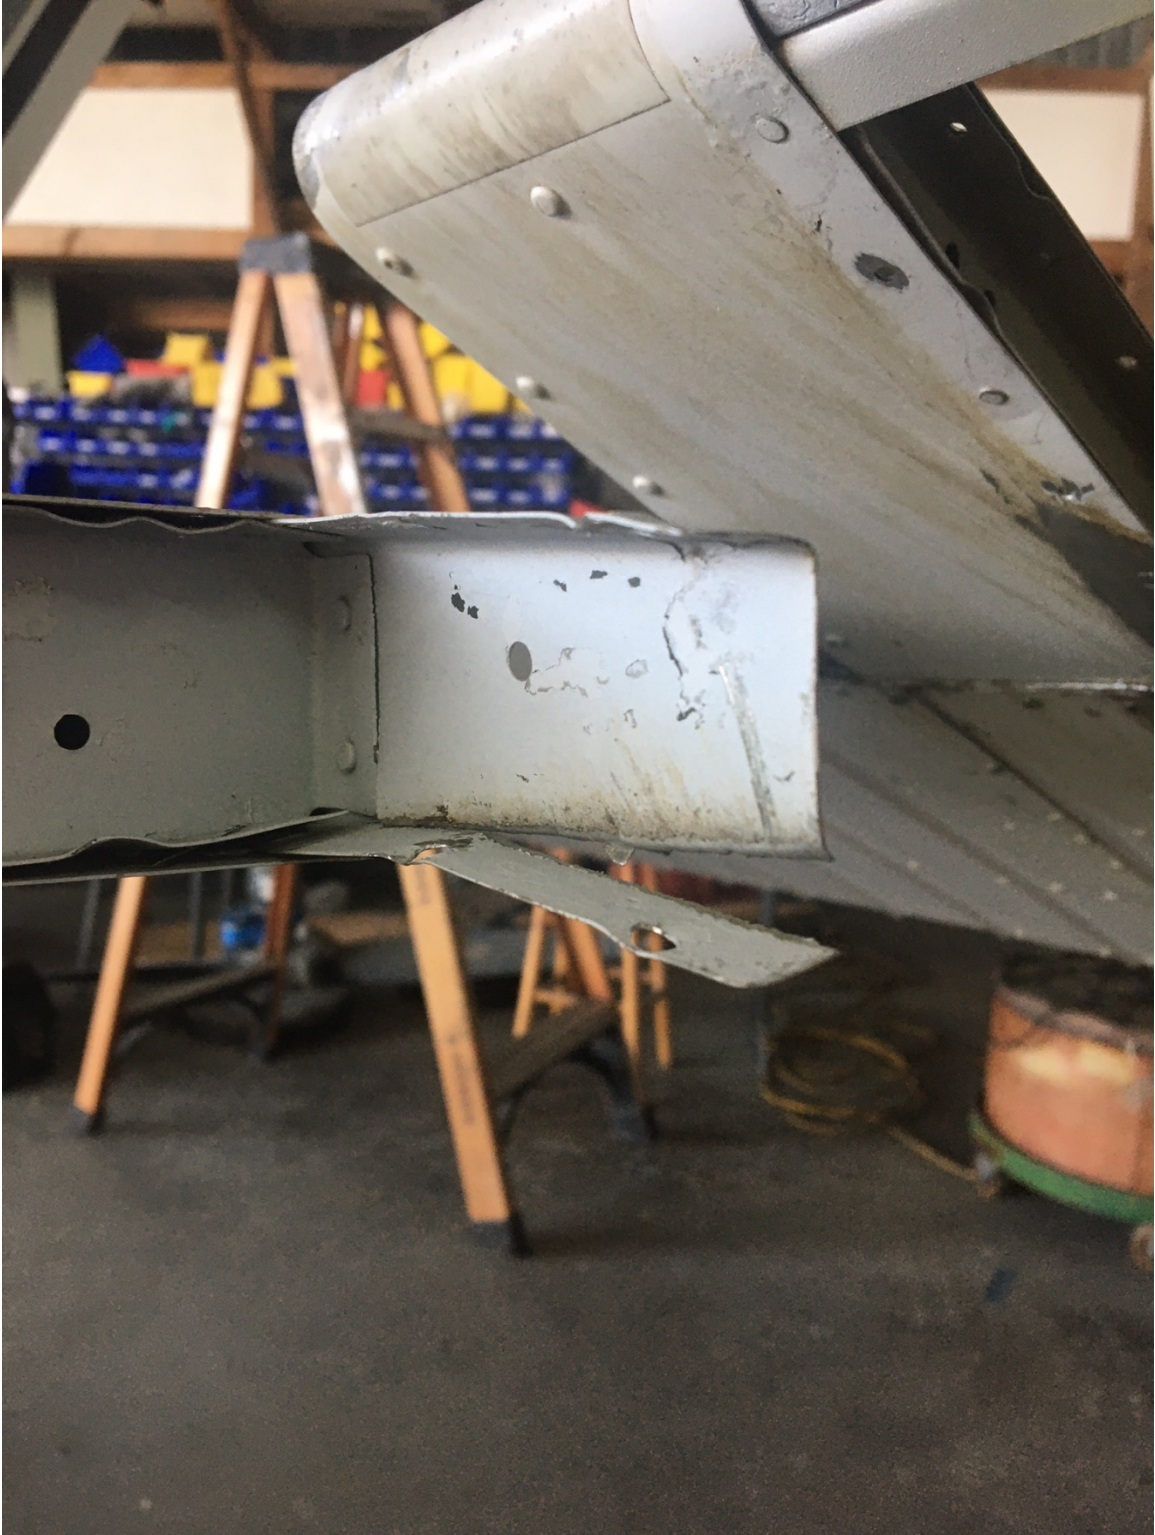
There is damage on LH side of the horizontal stabilizer, stabilizer tip and elevator. Furthermore LH brake line was damaged nearby the LH brake caliper. There is no further damage on other parts of the AC. See pictures of the damaged parts on the link bellow. We have also performed gear swing and manual gear extension with hand hydraulic pump (see recorded videos on the link bellow). On top of this, We have verified functionality of the gear unsafe warning microswitch + horn system that sounds when throttle is reduced without gear being locked in down position. All of these systems and tests did not revealed any technical issue or malfunction of any kind. Hydraulic system of N9795B operates normaly. Furthermore we have inspected all components of the main and nose landing gears, hydraulic lines, powerpack and actuators. This inspection did not revealed any malfunction or leakage from the circuit.

Figure 1 Damage to Left Side Horizontal Stabilizer Spar and Rib

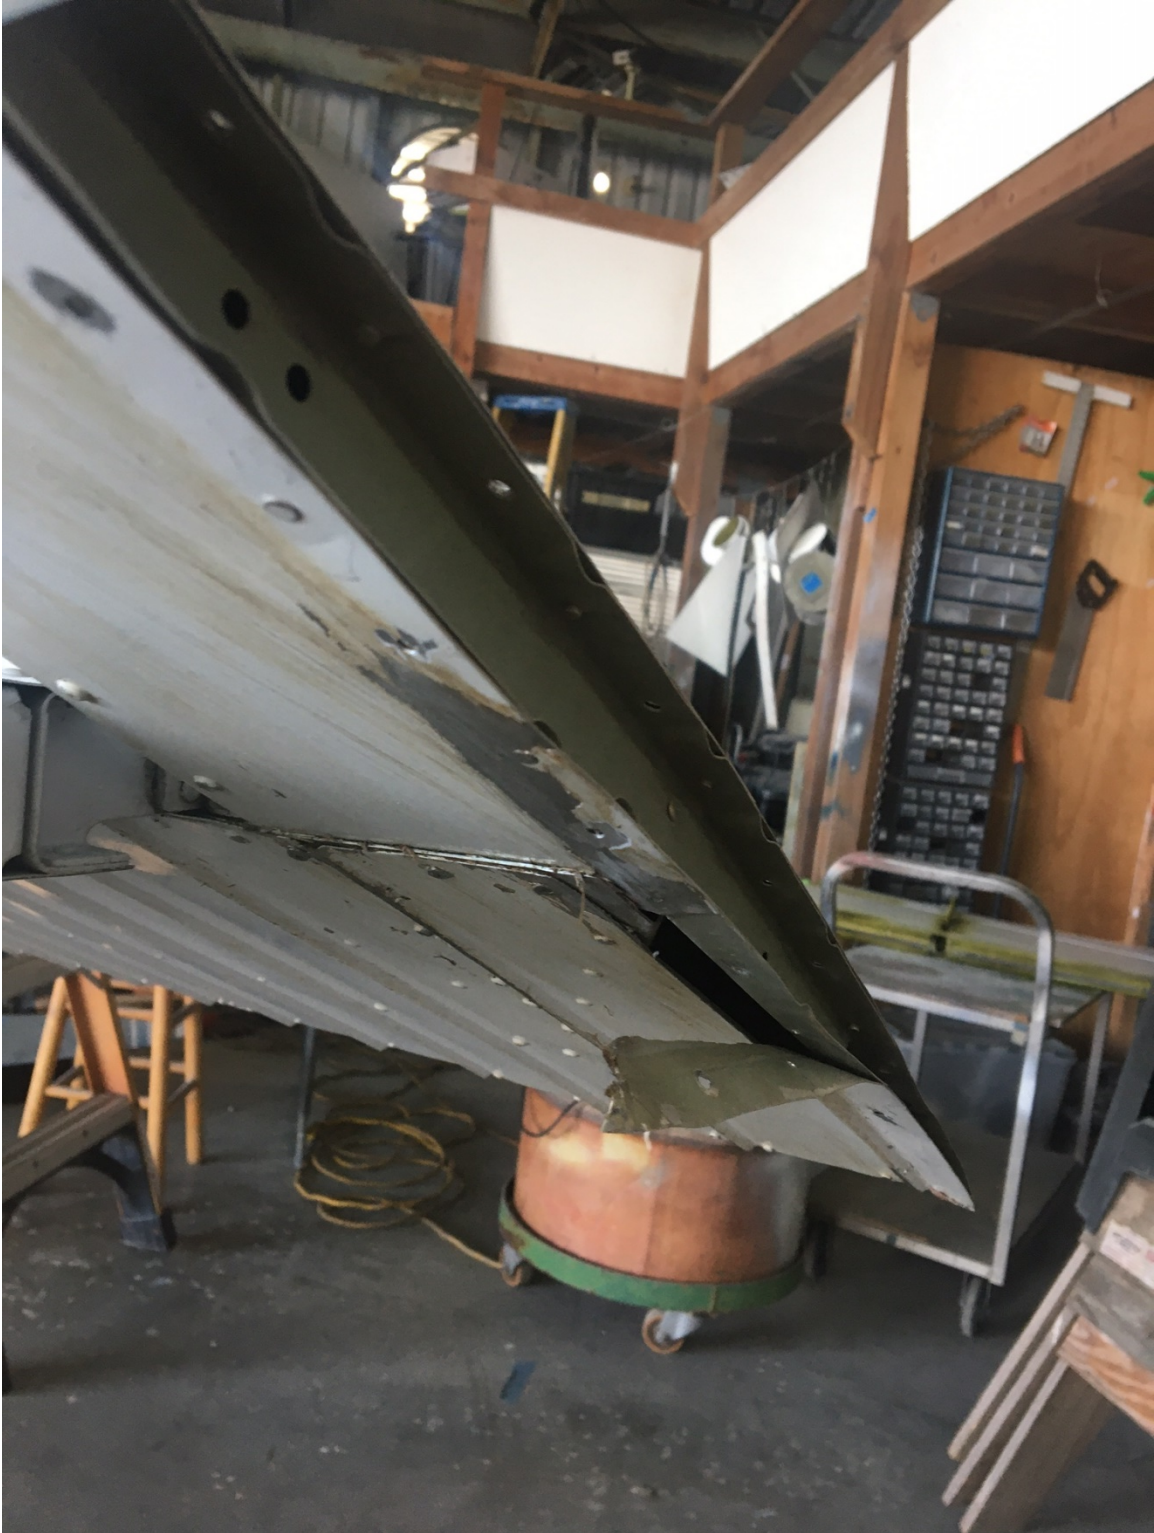
Figure 2 - Damage to Left Side Elevator
